ANC23LA080

## INVESTIGATION PHOTOGRAPHS

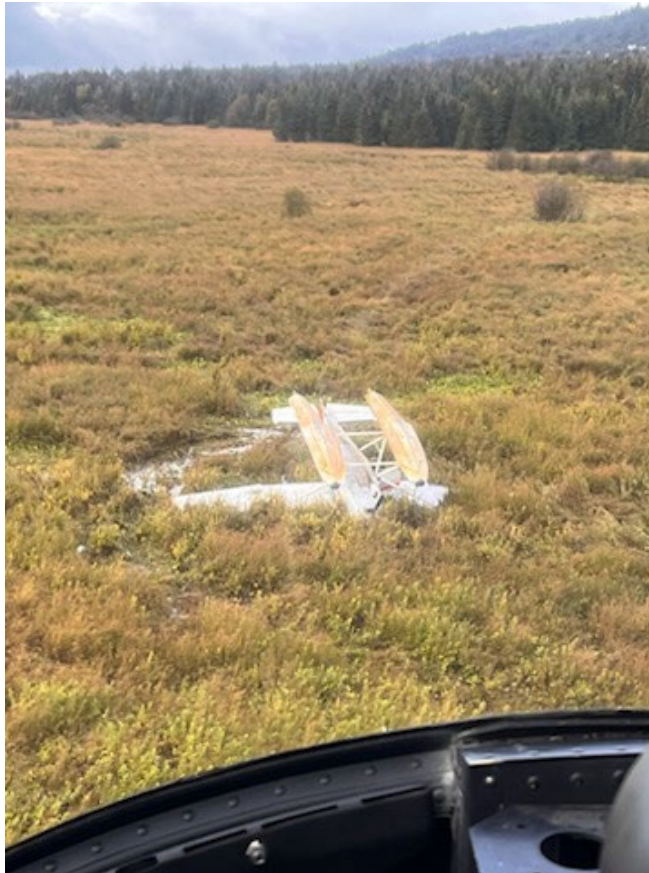
**Photograph 1 - View of the airplane inverted, where it came to rest. (Courtesy of the Federal Aviation Administration)**

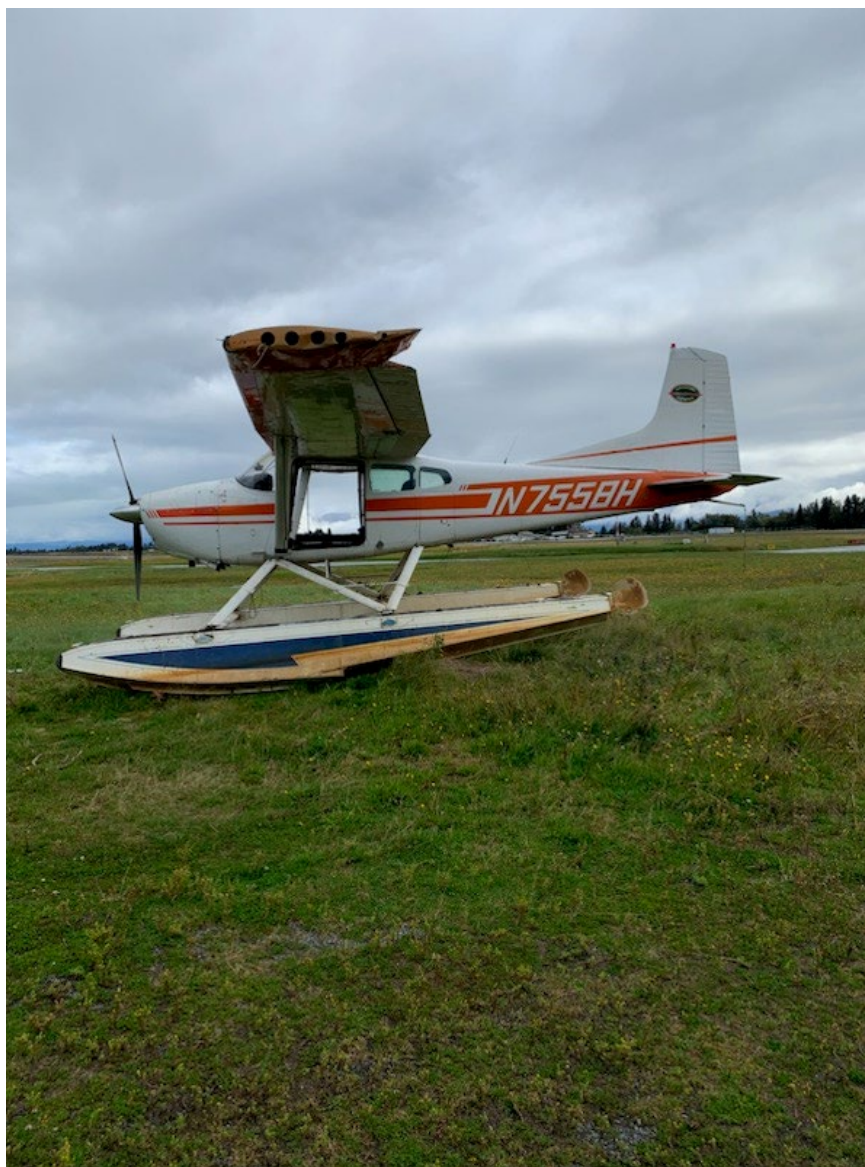
**Photograph 2 - View of airplane after recovery. (Courtesy of Federal Aviation Administration)**

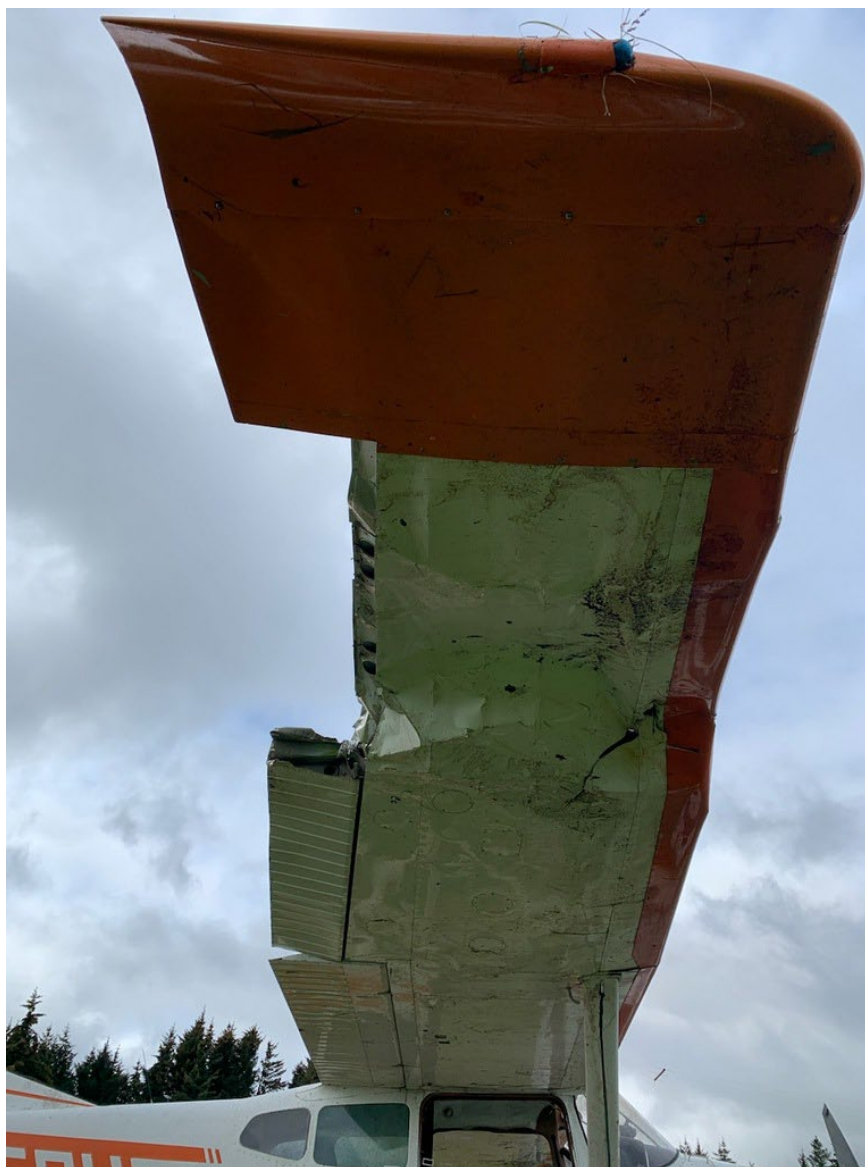
**Photograph 3 - View of damage to the right wing (Courtesy of Federal Aviation Administration)**
