# National Transportation Safety Board

ANC23LA080

## **ENGINE EXAMINATION**

Location: Homer, Alaska  
Date: September 18, 2023  
Time: 1400 AKDT  
Airplane: Cessna 185

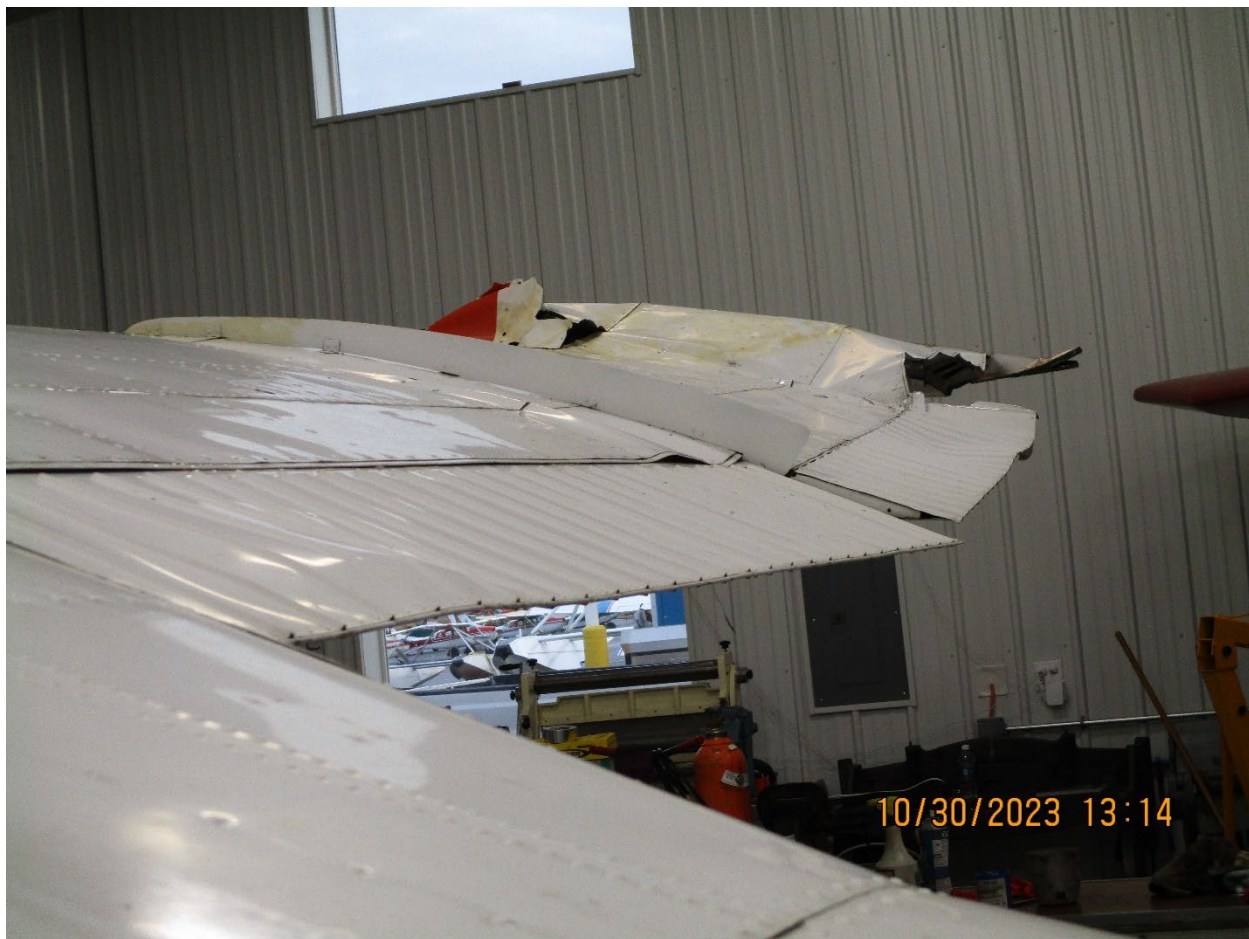
The right wing was substantially damaged, the left wingtip was also damaged.

**Figure 1 View of damage to right wing. (Courtesy of FAA)**

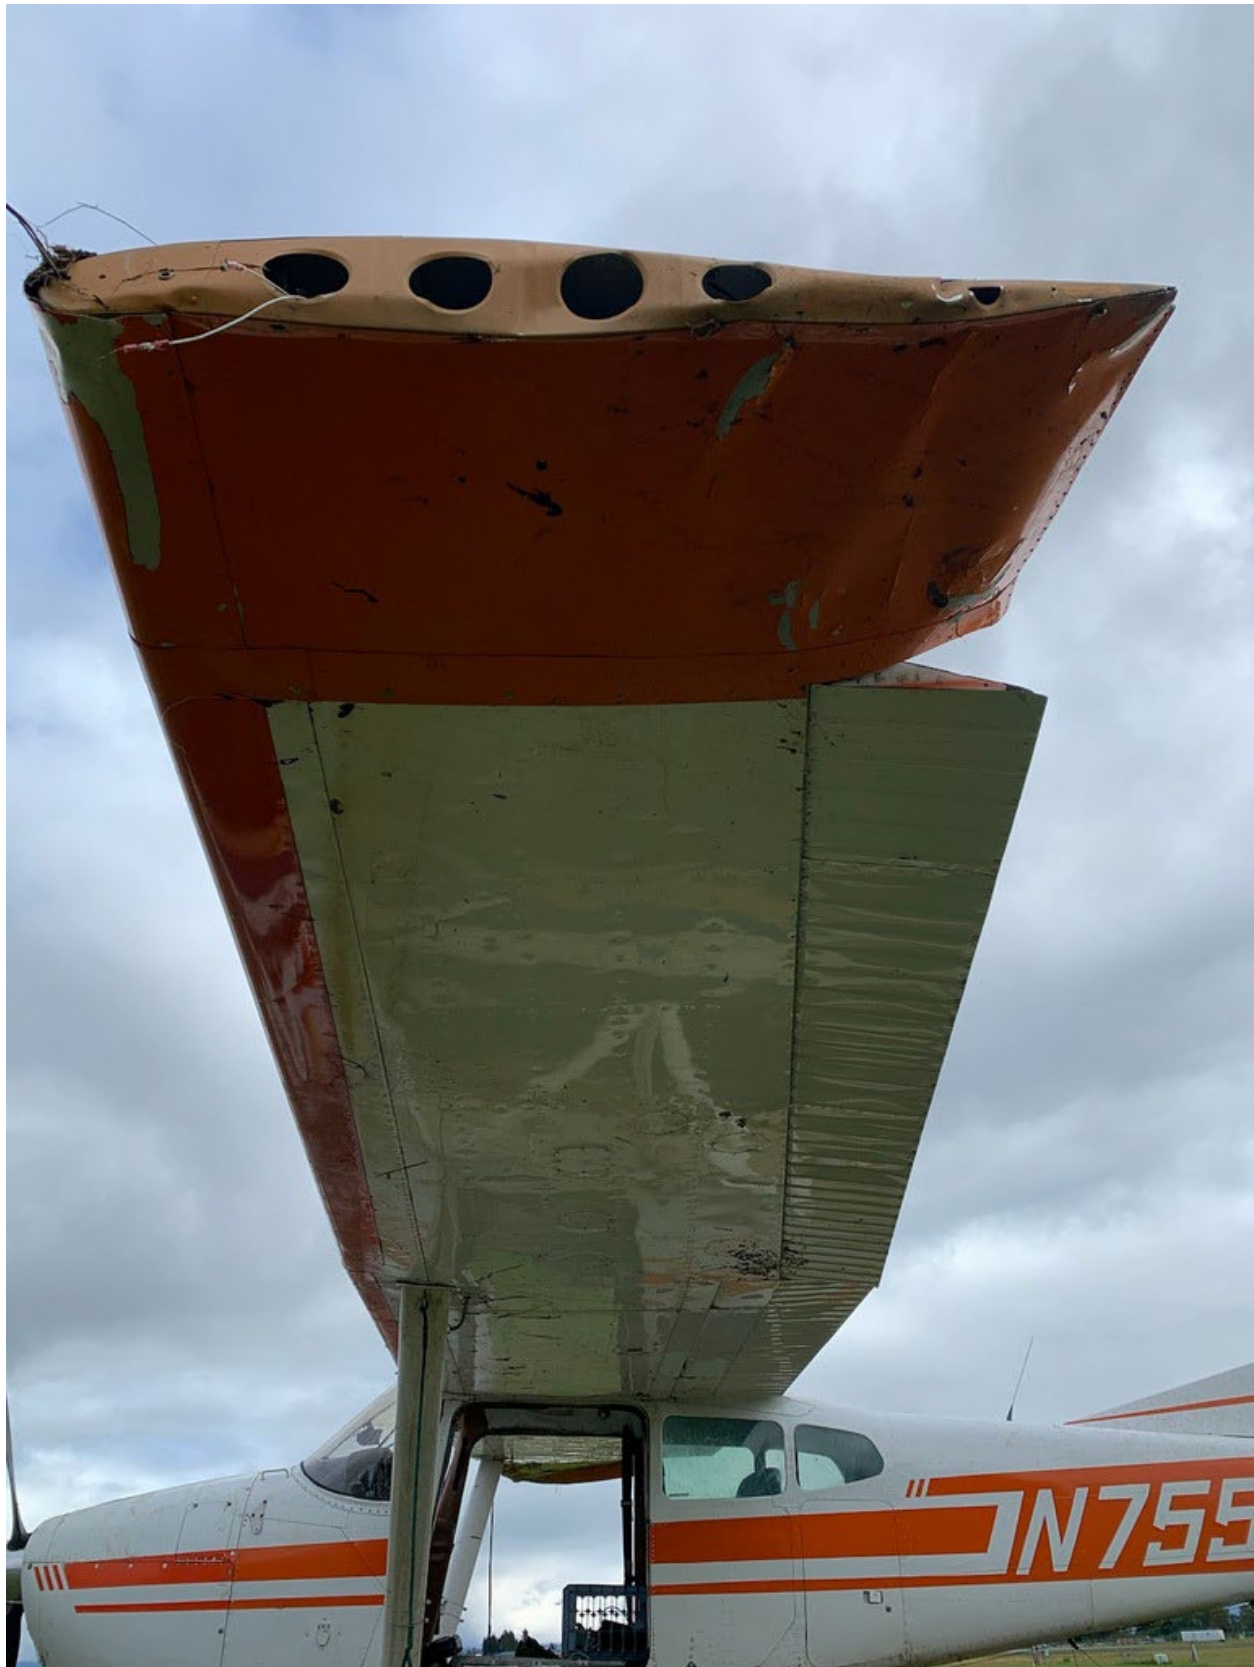
**Figure 2 View of damage to the left wing. (Courtesy of FAA)**

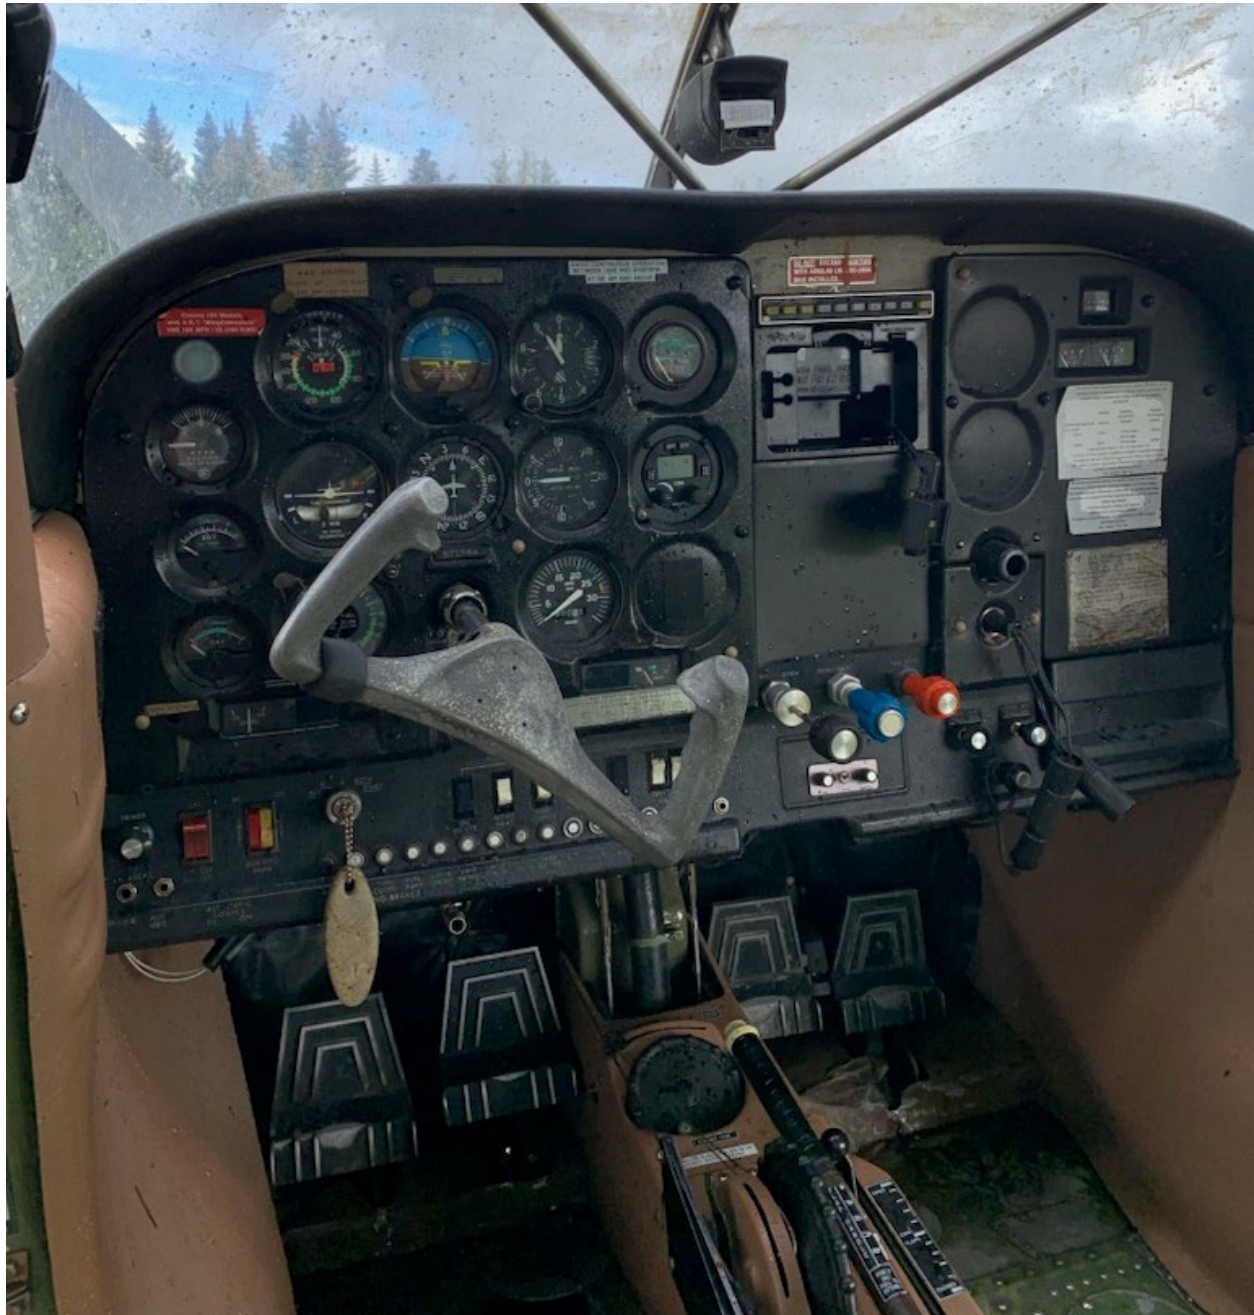
The cockpit was not damaged.

**Figure 3 View of the cockpit. (Courtesy of FAA)**

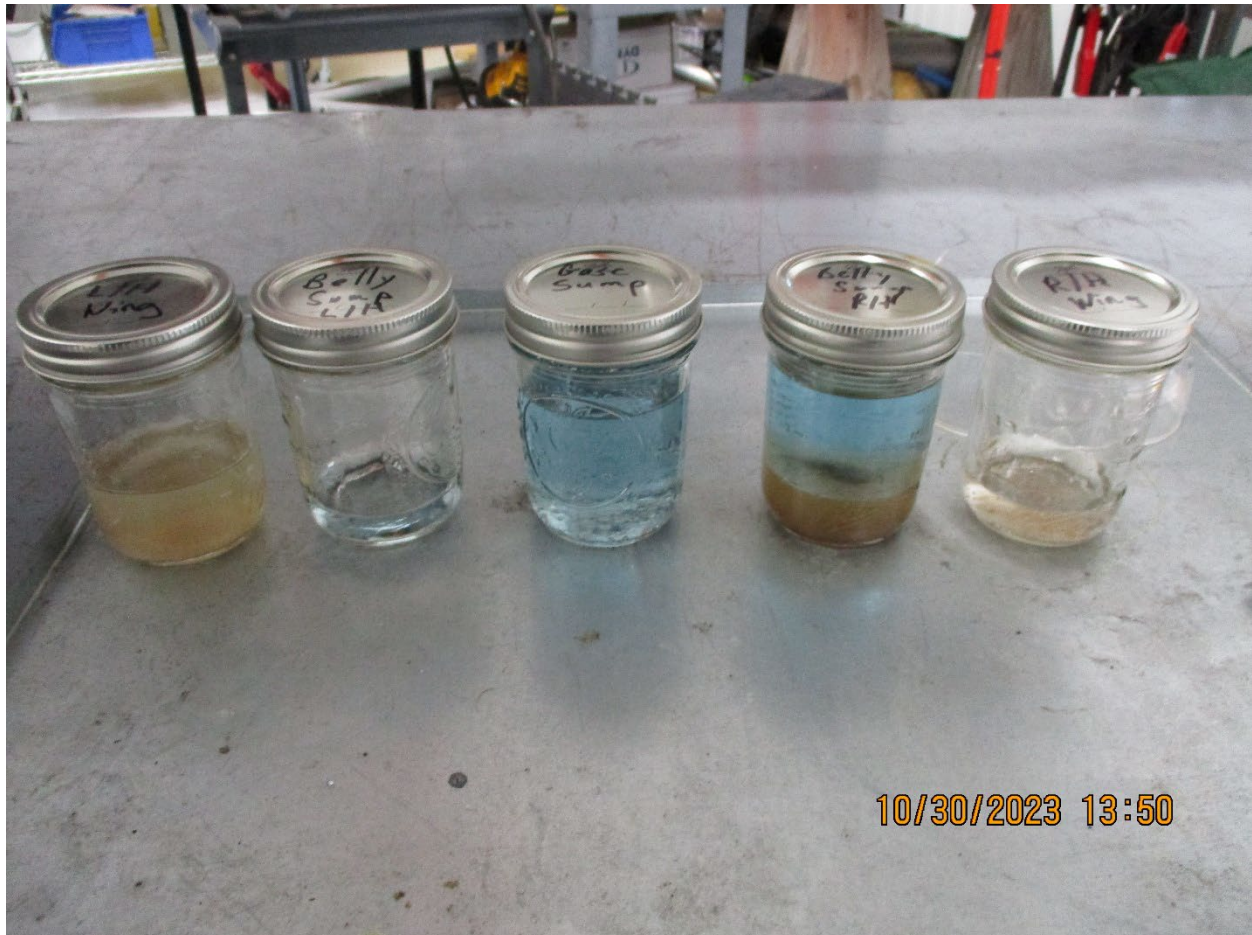
The fuel was supmed from the left and right wings and the gascolator. The fuel from the left and right wing sumps and belly sumps were contaminated with water

and debris. The fuel from the gascolator was free of water and debris. The finger screens were free of debris. The airplane sat inverted in swampy water prior to recovery. About 10 to 15 gallons of fuel were drained from the wings after recovery.

**Figure 4 Fuel samples from the left wing, left belly sump, gascolator, right belly sump, and right wing.**

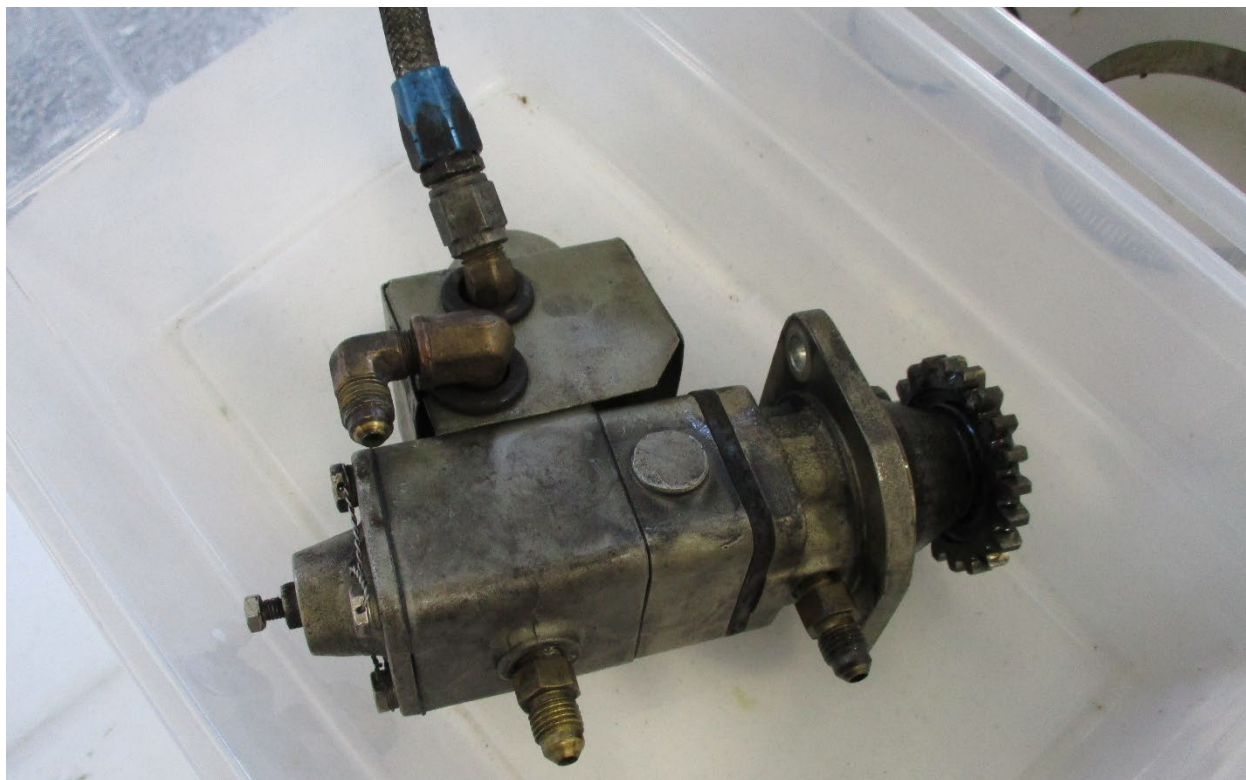
The electrical fuel pump was actuated and the unit pushed fuel through to the engine driven fuel pump. The engine driven fuel pump was bench tested and performed as designed within standards. The engine was manually rotated and internal continuity was confirmed and thumb compression was obtained. The magnetos were removed and spark was observed on all leads. The upper spark plugs exhibited normal wear.

**Figure 5 View of the engine driven fuel pump. (Courtesy of the FAA)**

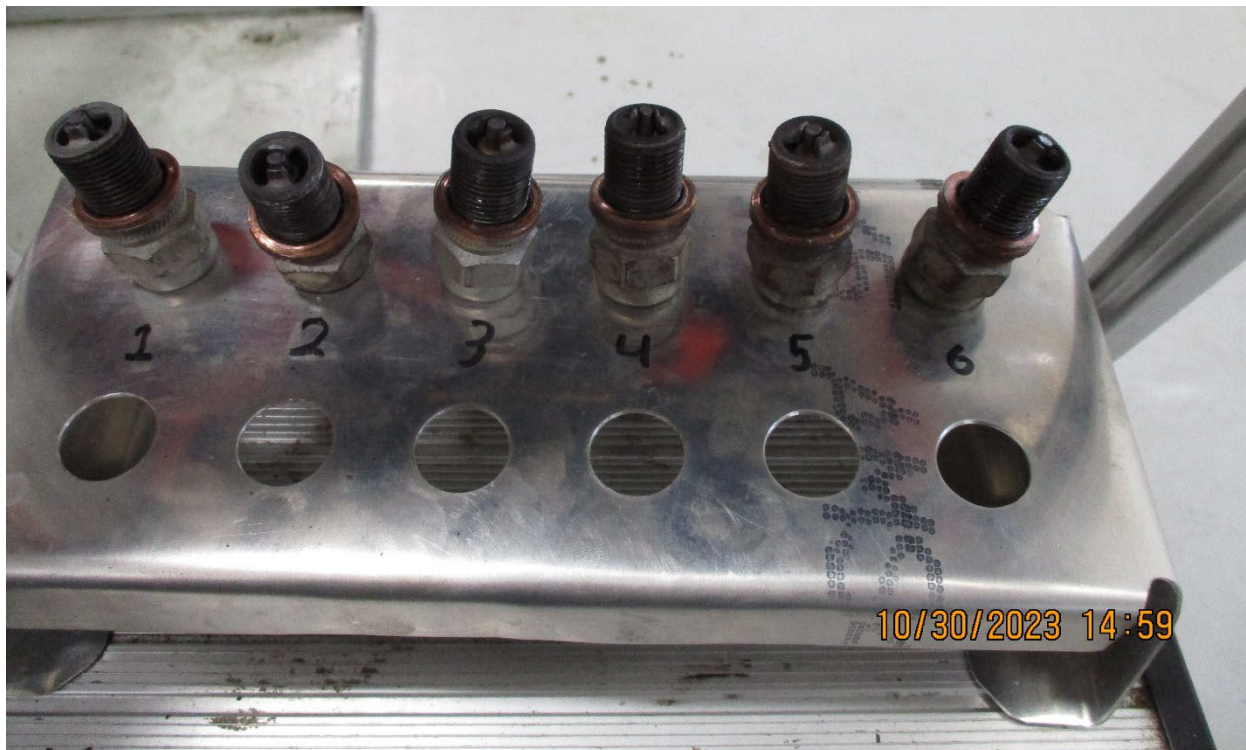
**Figure 6 View of the spark plugs. (Coursey of FAA)**

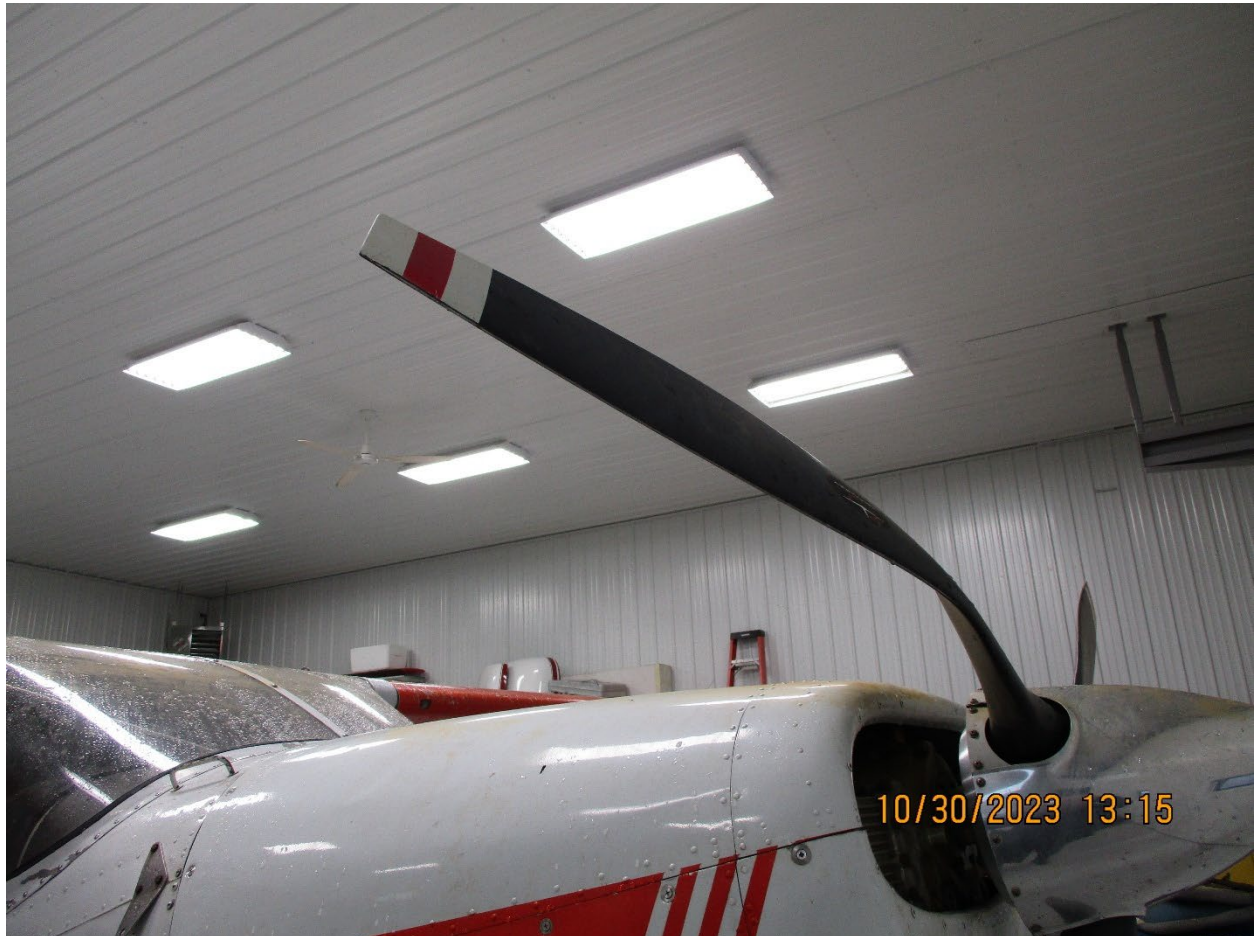
**Figure 7 One of the three propeller blades was bent aft. (Courtesy of FAA)**
