ANC23LA081

## INVESTIGATION PHOTOGRAPHS

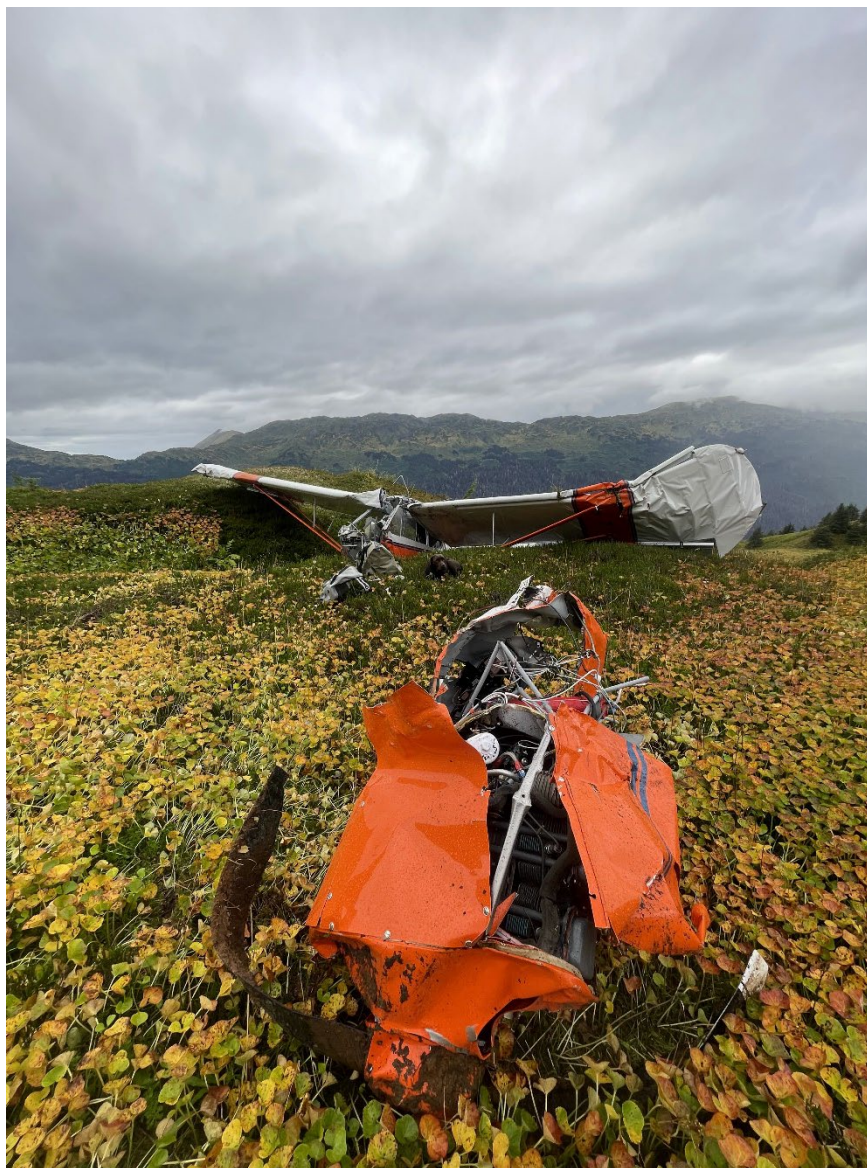
**Photograph 1 - View of airplane and engine where it came to rest. (Courtesy of FAA)**
