ANC23LA084

## INVESTIGATION PHOTOGRAPHS

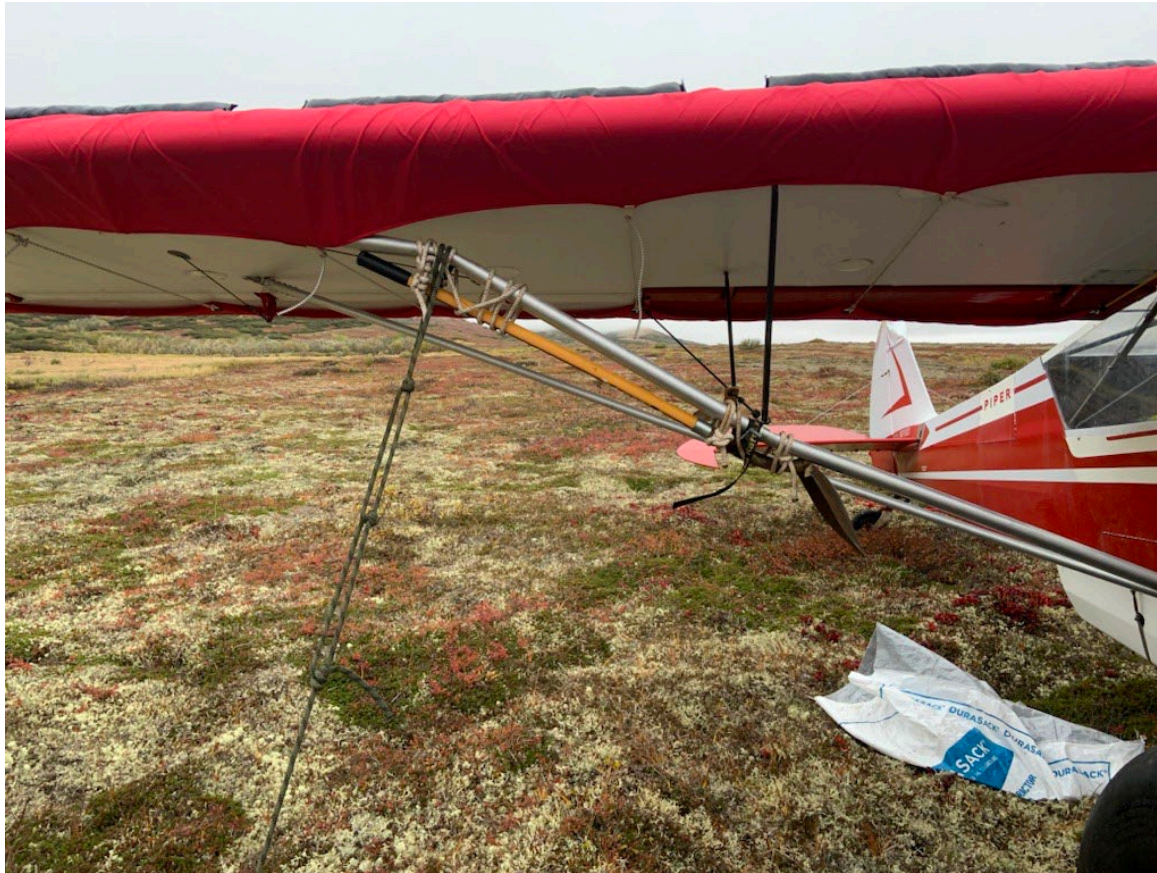
**Photograph 1 - Image of the right wing struts (Courtesy of Pilot)**

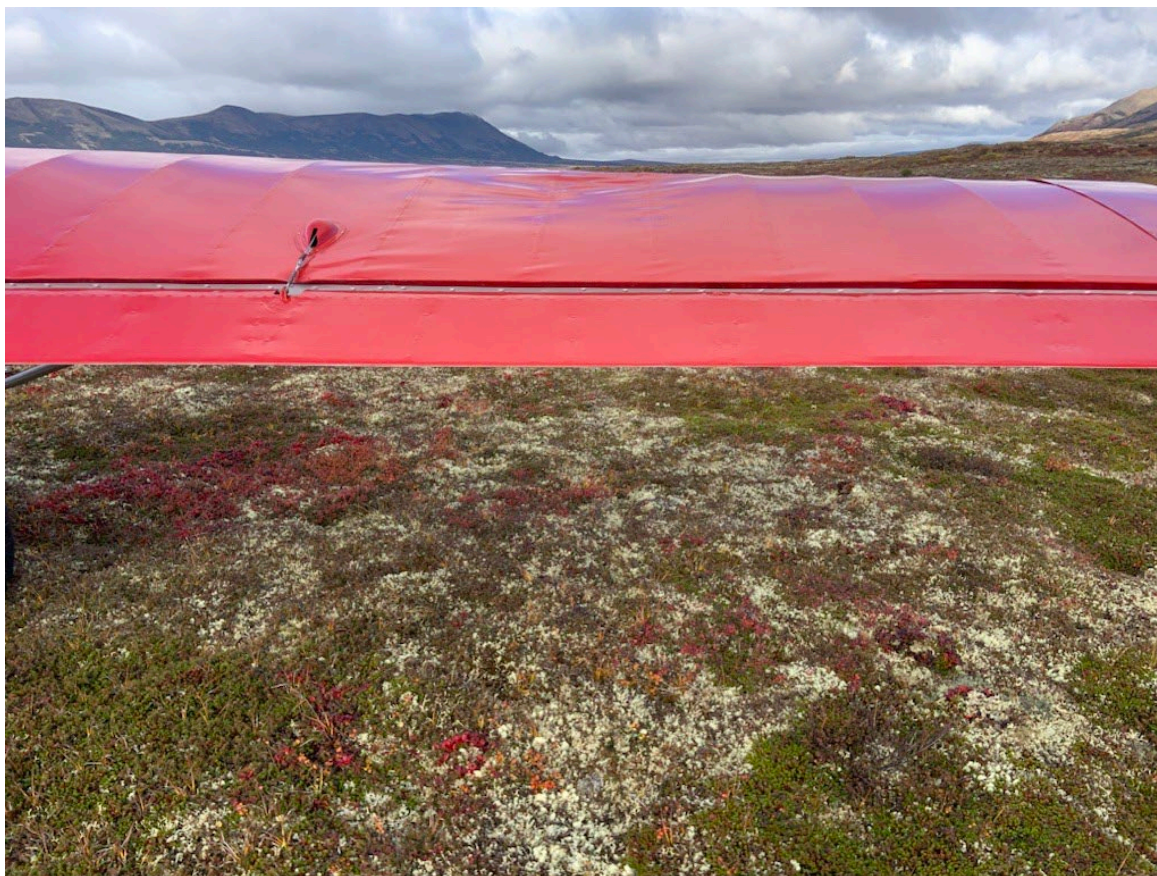
**Photograph 2 - Image of the right wing trailing edge (Courtesy of Pilot)**

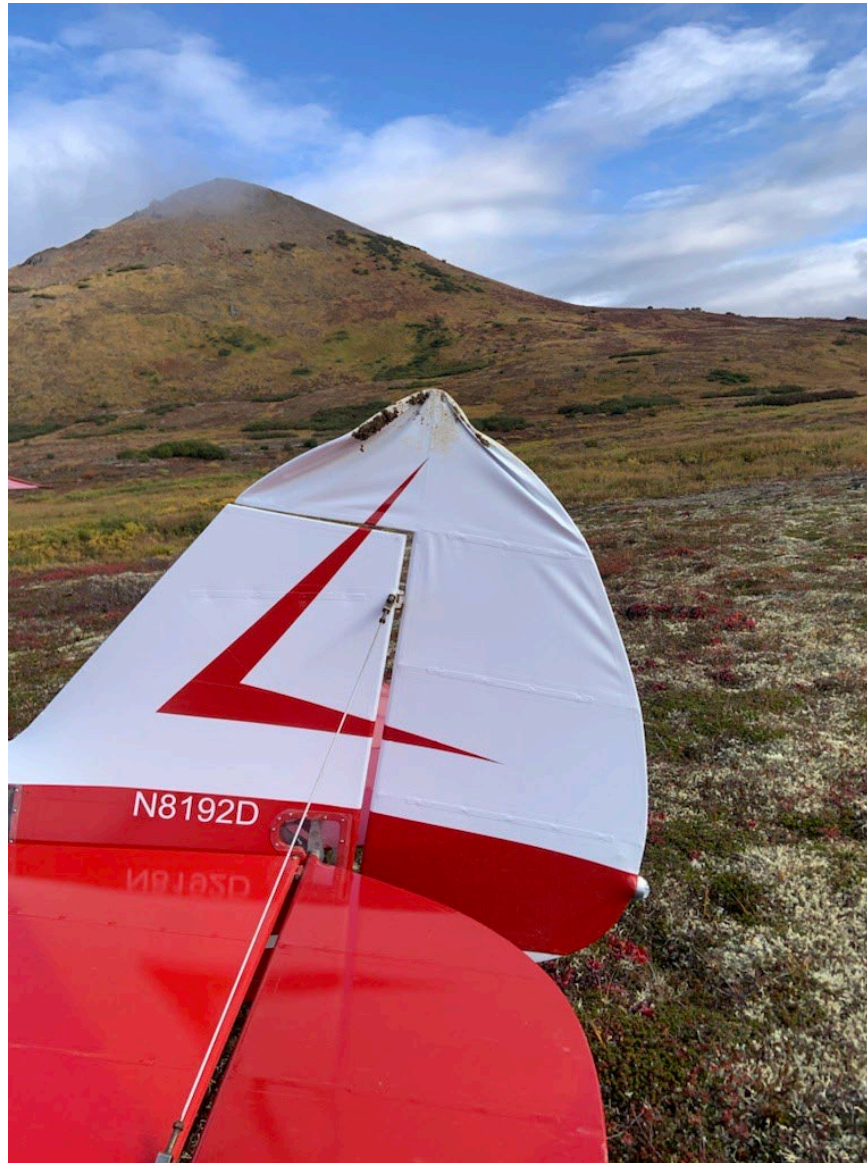
**Photograph 3 - Image of the empennage (Courtesy of Pilot)**
