# National Transportation Safety Board

## **MATERIALS LABORATORY**

Specialist's Factual Report 25-065

Location: Anchor Point, Alaska  
Date: December 8, 2023  
Vehicle: Piper PA-18-150  
Investigators: Mark Ward AS-ANC  
Clint Crookshanks AS-40

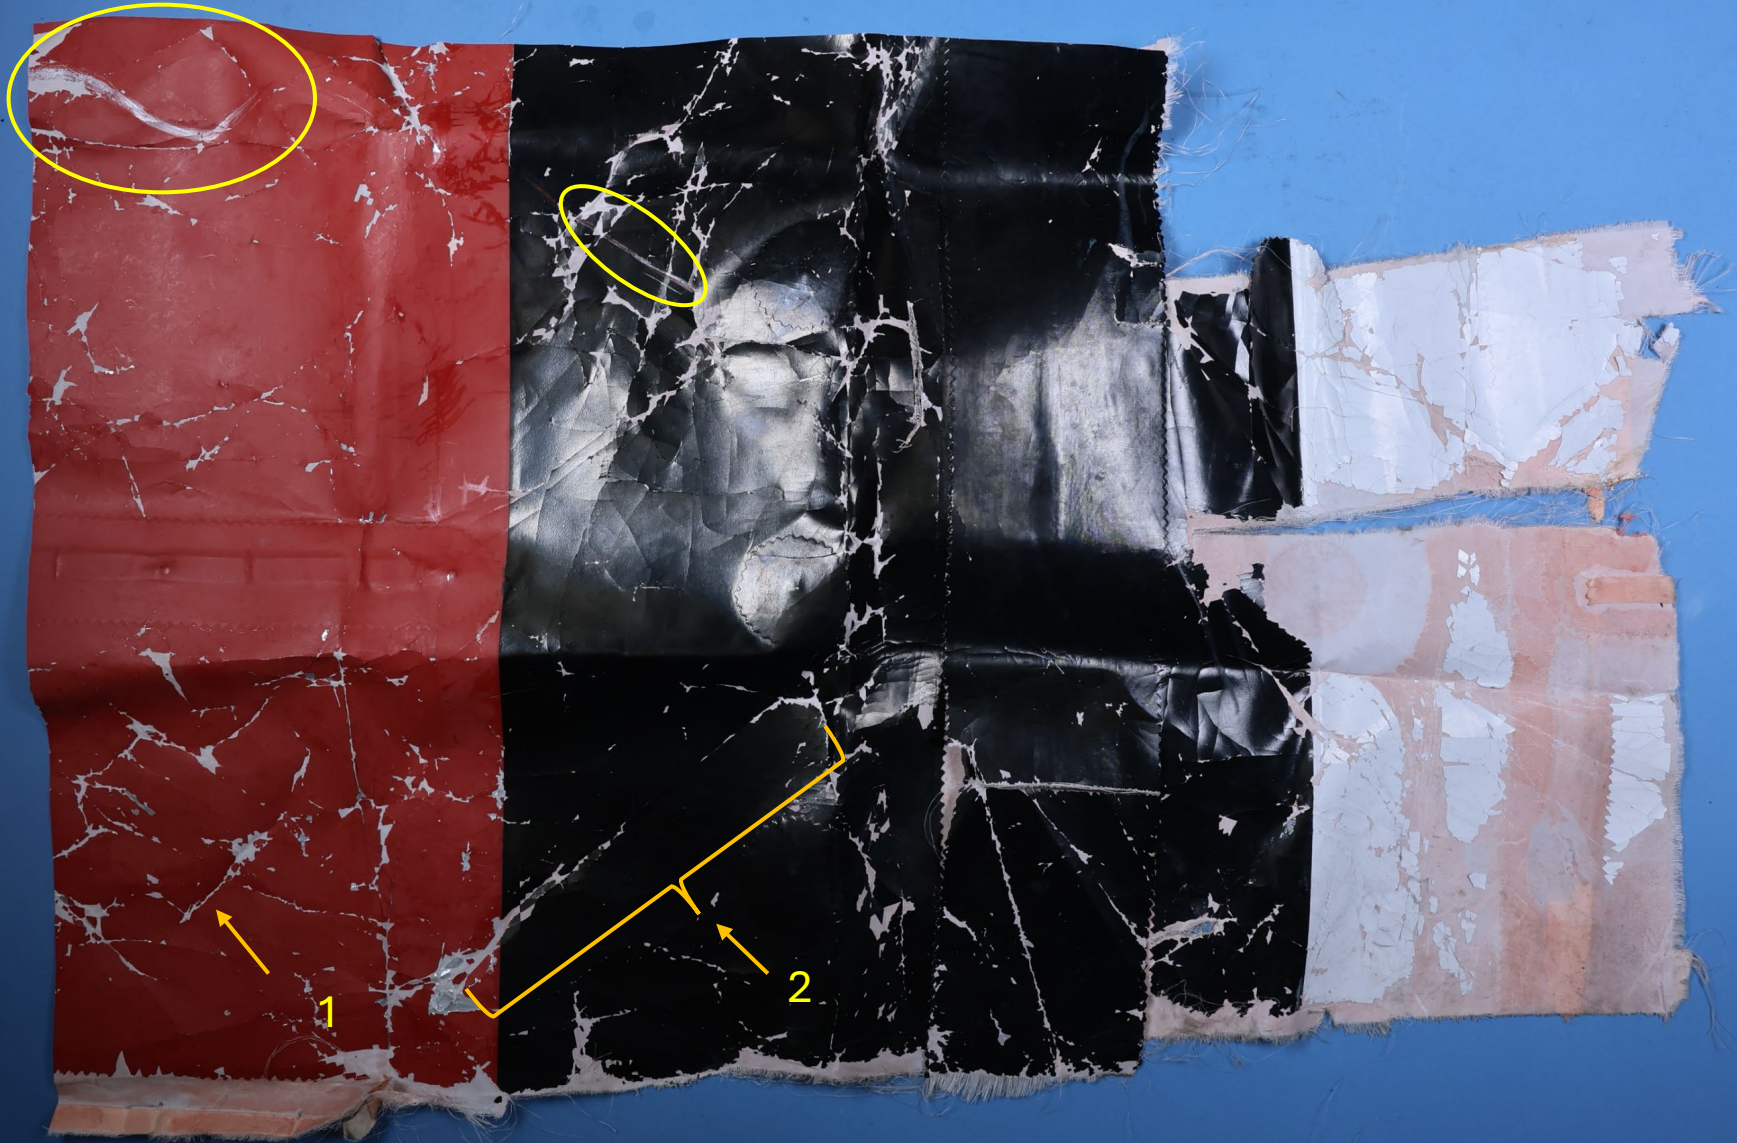
## Outboard

Arrow 1- This is a 1.5-inch crack in the paint. There is no discernible material in the crack and the fabric underneath appears to be clean.

Arrow 2- This is a cut into the paint approximately four inches long. It goes through the entire paint layer in several spots along the entire length. There is no discernible transfer in the cut.

Yellow circles- two (silver) transfer patterns. a flake from one of the silver transfers through the FTIR spectrometer. The silver one had several strong peak matches to several metallic paints.

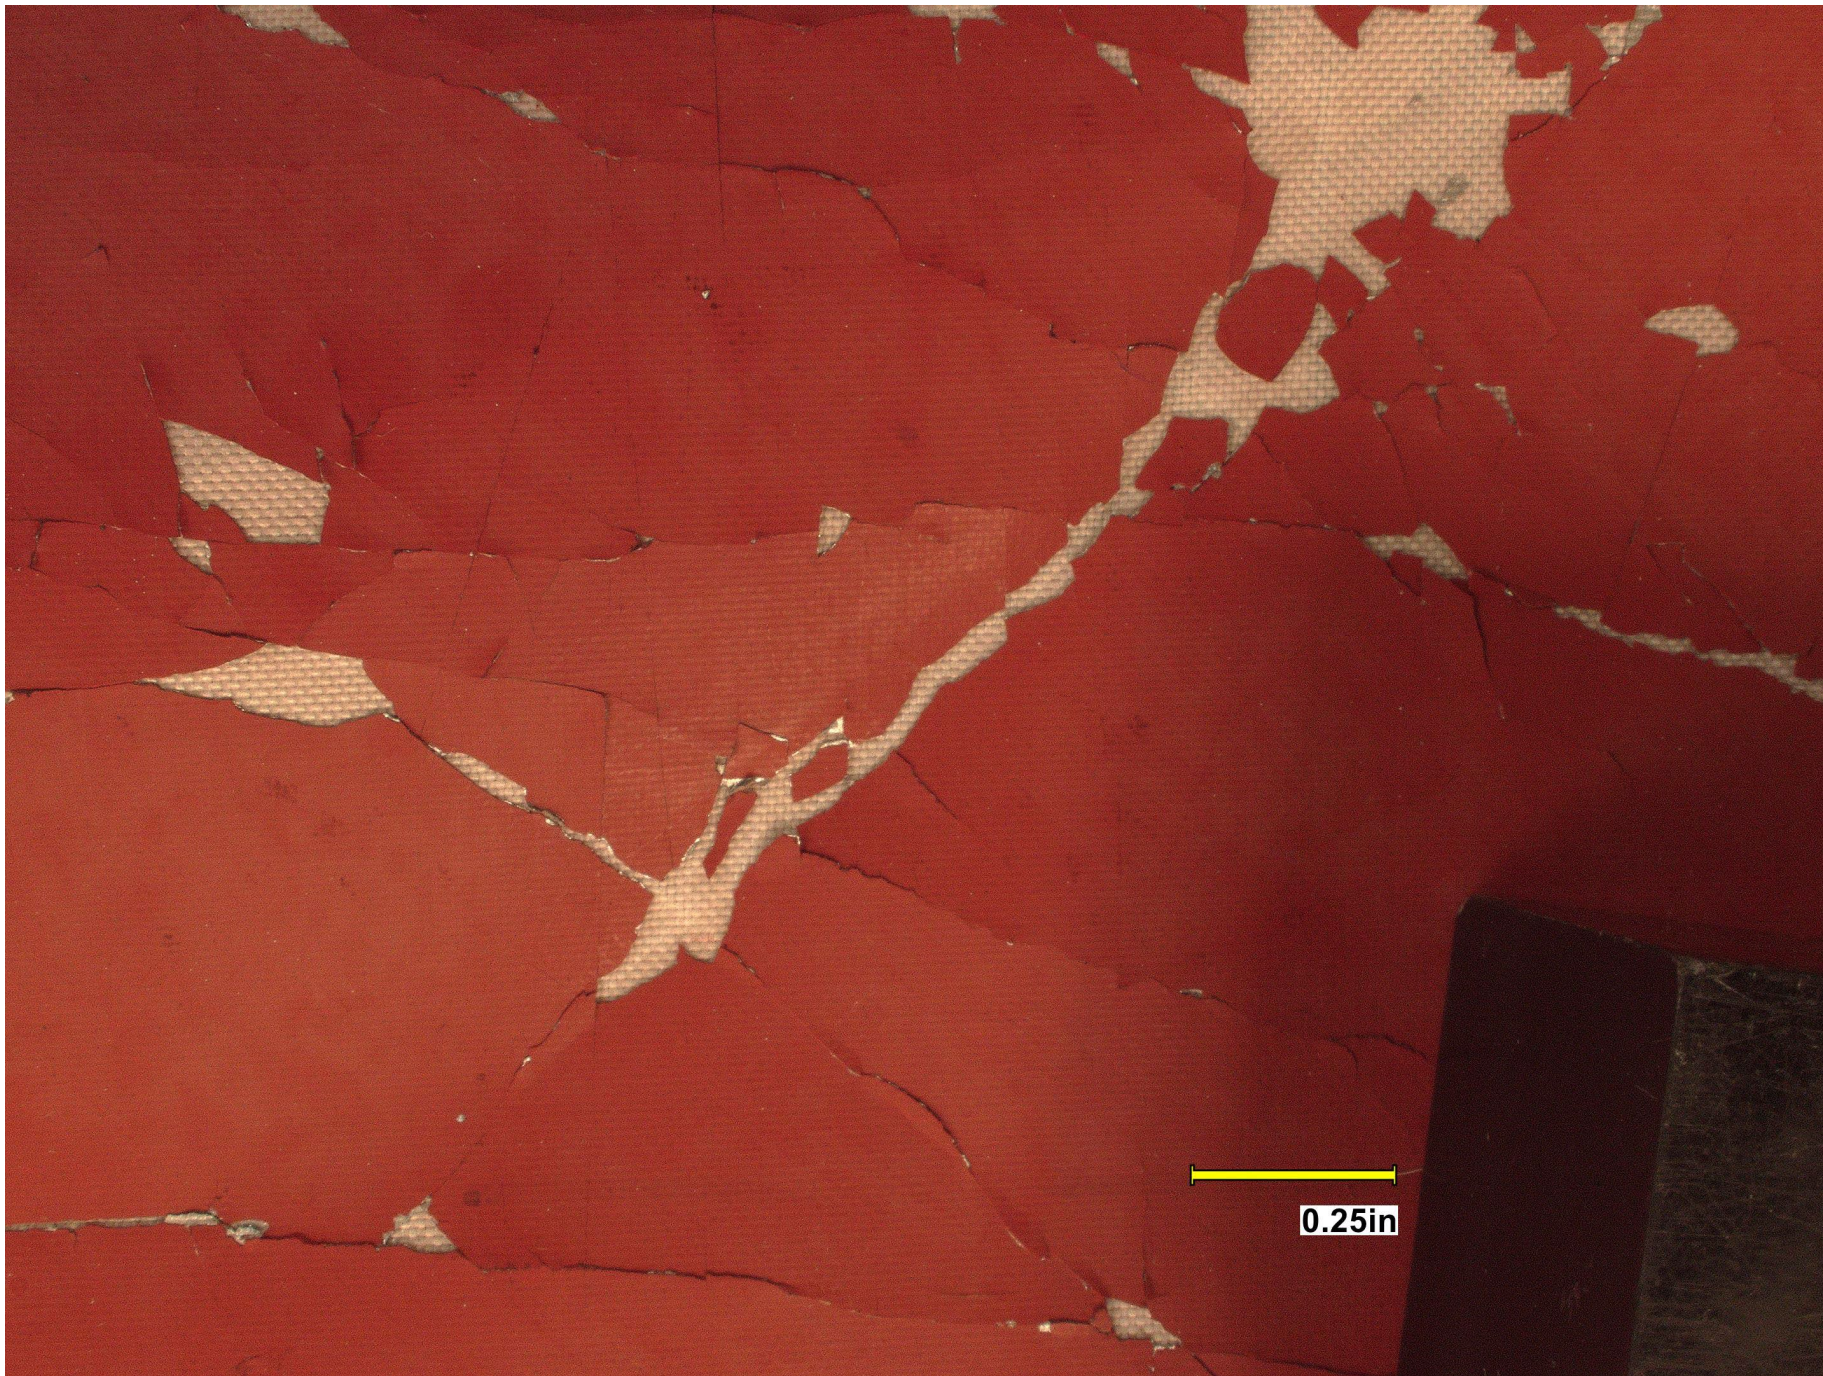
Closeup of area highlighted  
by Arrow 1 in Slide 1

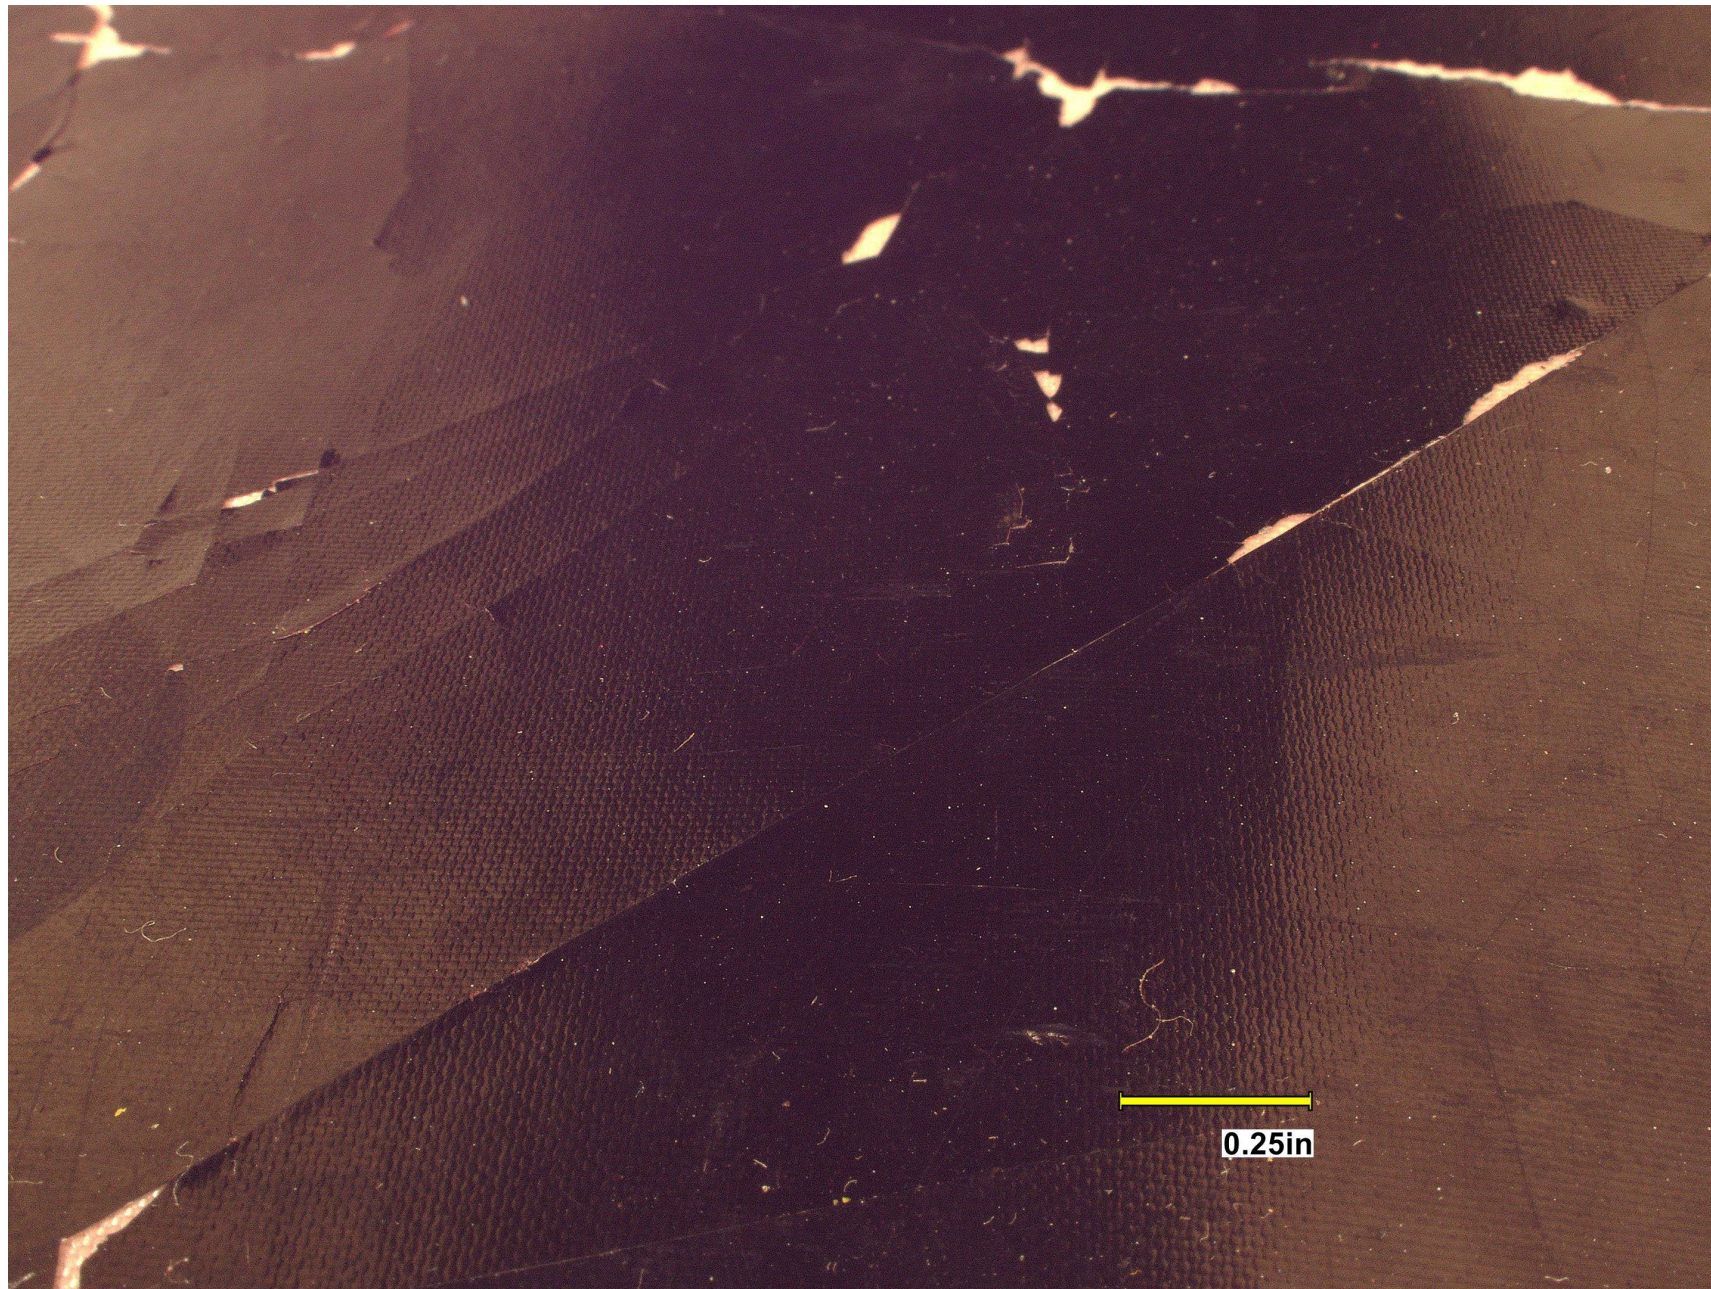
Closeup of area highlighted  
by Arrow 2 in Slide 1

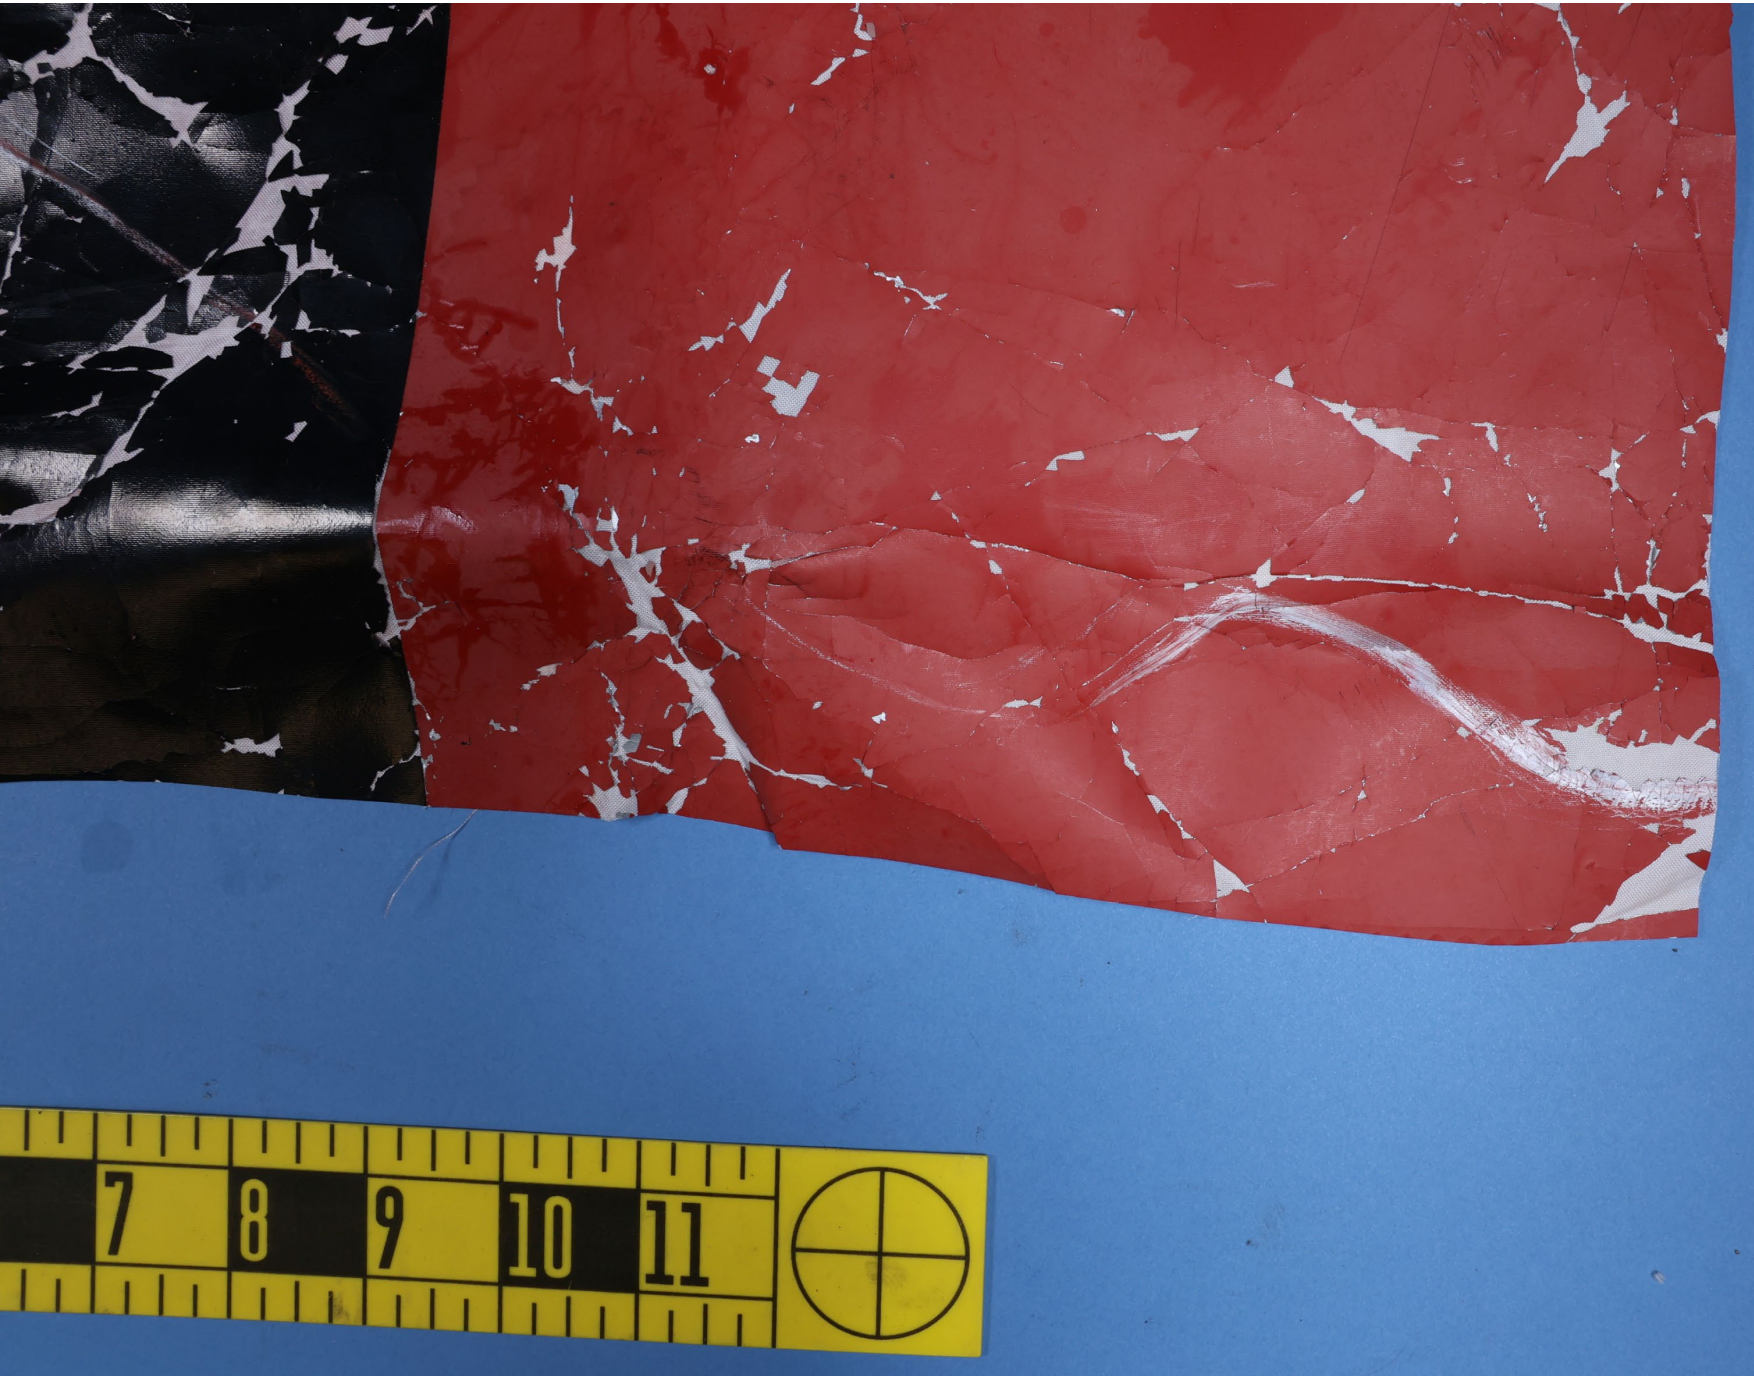
Closeup of area circle in  
large yellow in Slide 1

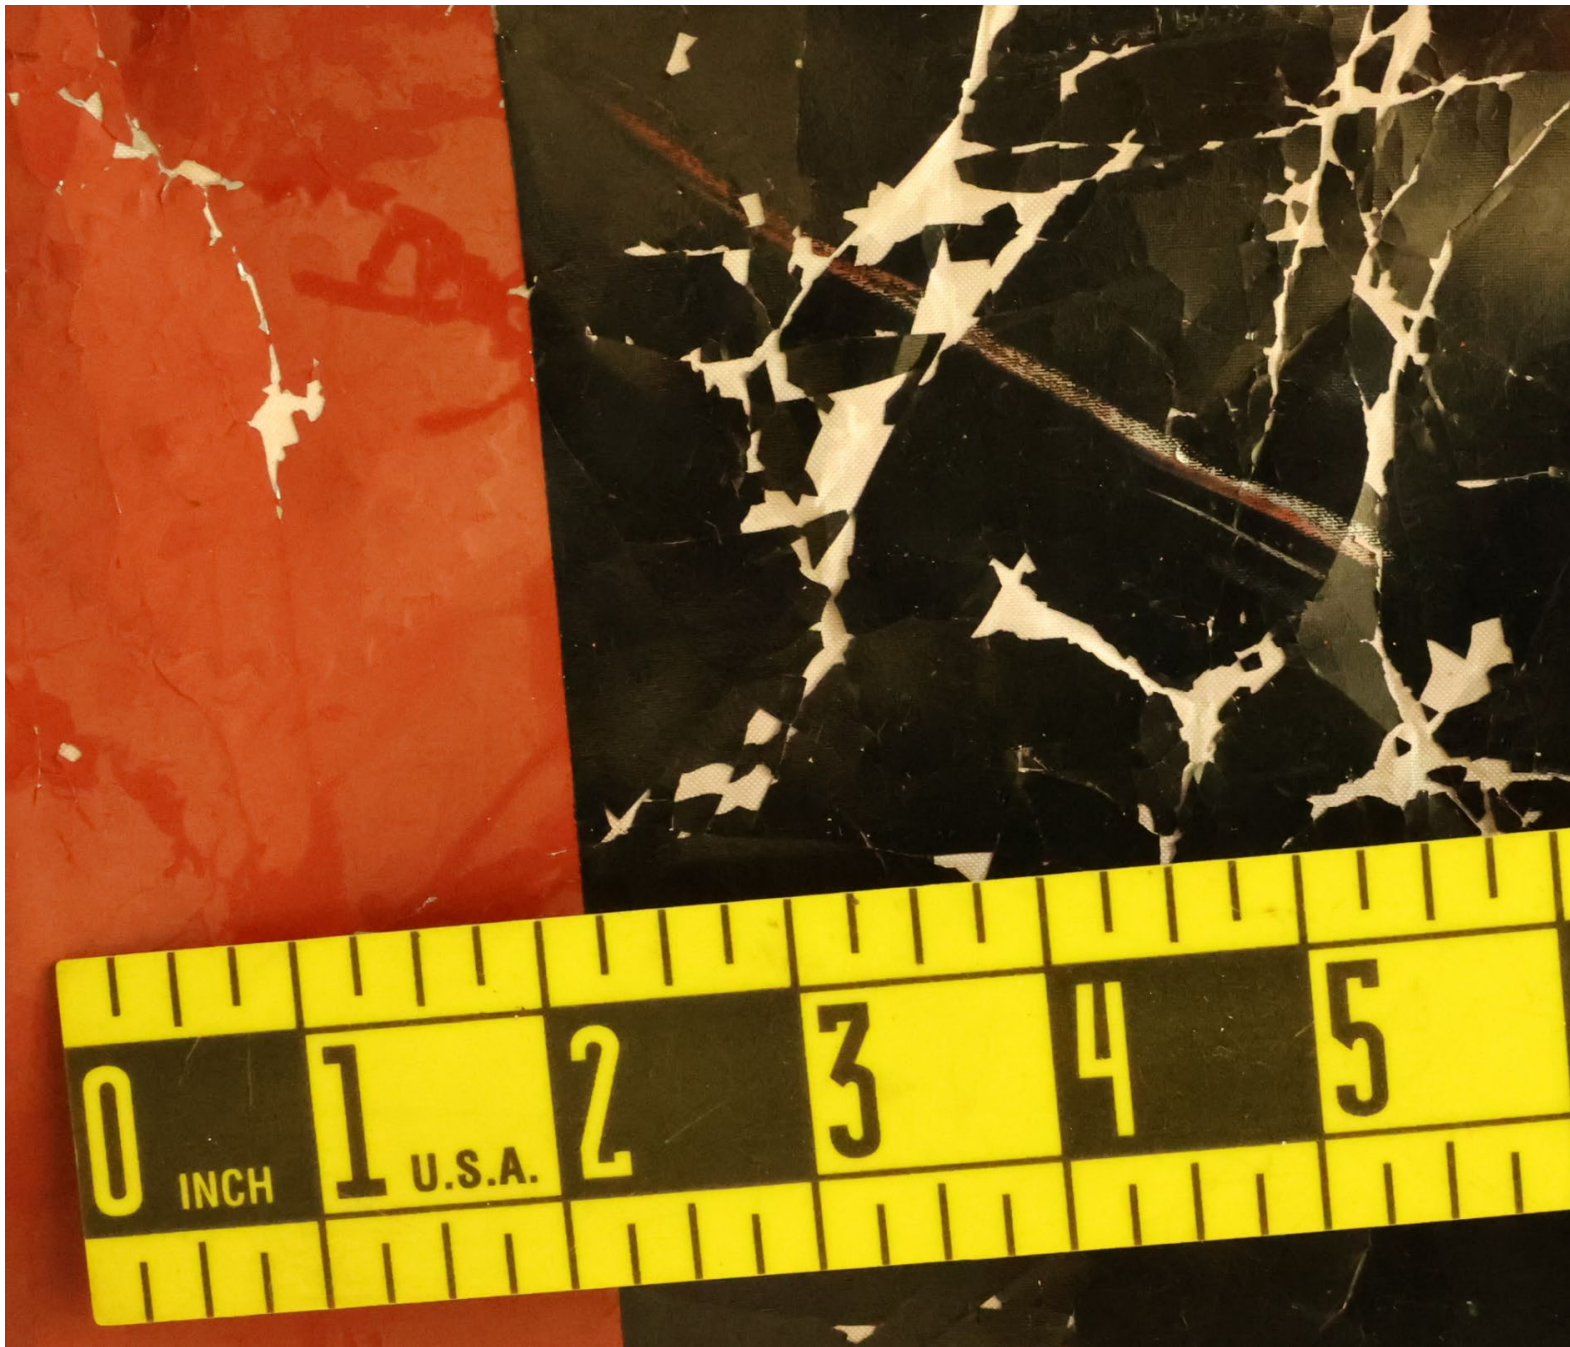
Closeup of area circle in  
small yellow in Slide 1

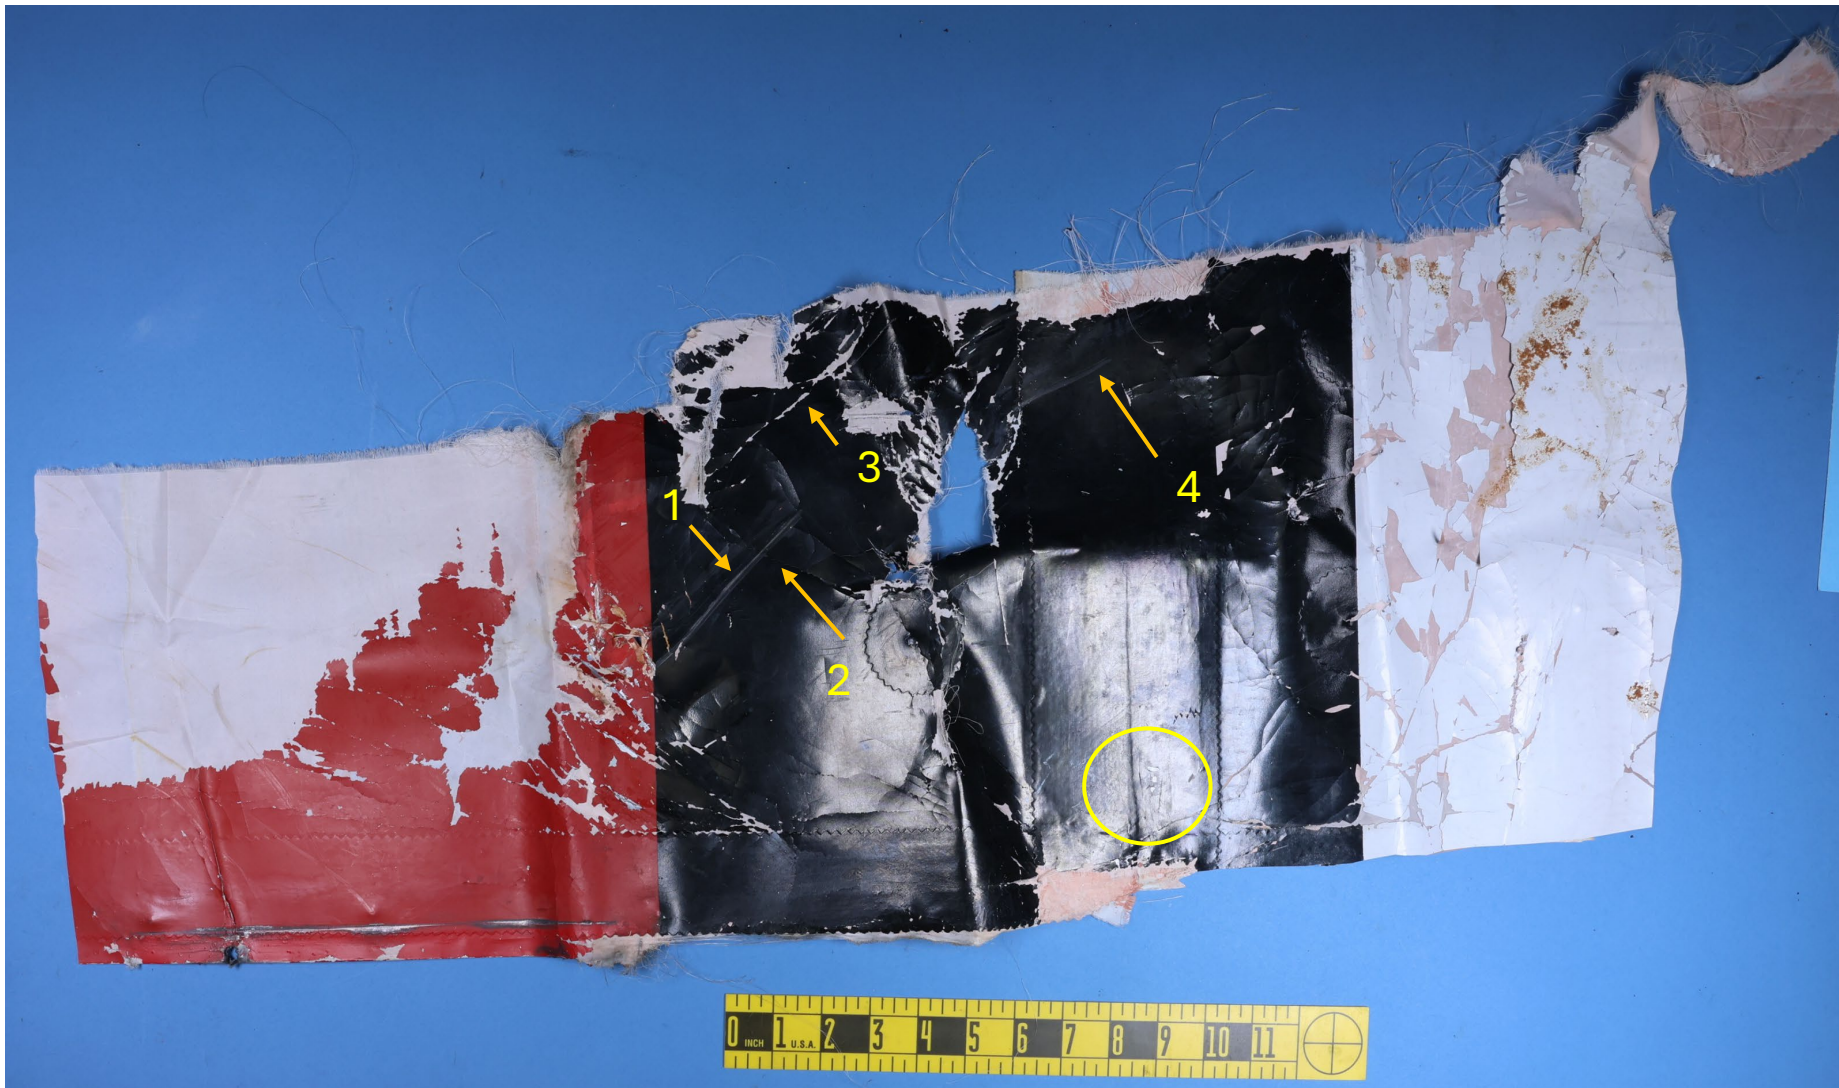
## Inboard

Arrow 1 and 2-This 3.5-inch mark is a very shallow gouge in the black fabric. There is no apparent material transfer. It looks like it just removed the topcoat of the paint layer.

Arrow 3-This is a 4-inch crack in the paint that exposes the fabric underneath. No transfer material seen.

Arrow 4-A similar gouge to the one marked by #1 and #2, approximately 2.5 inches long. No transferred material was found in the gouge.

Yellow circle- one transfer pattern (white). A small section of the white transfer through the FTIR spectrometer. The white transfer had some similarities to paint as well but not as strong of a match as the silver transfer.

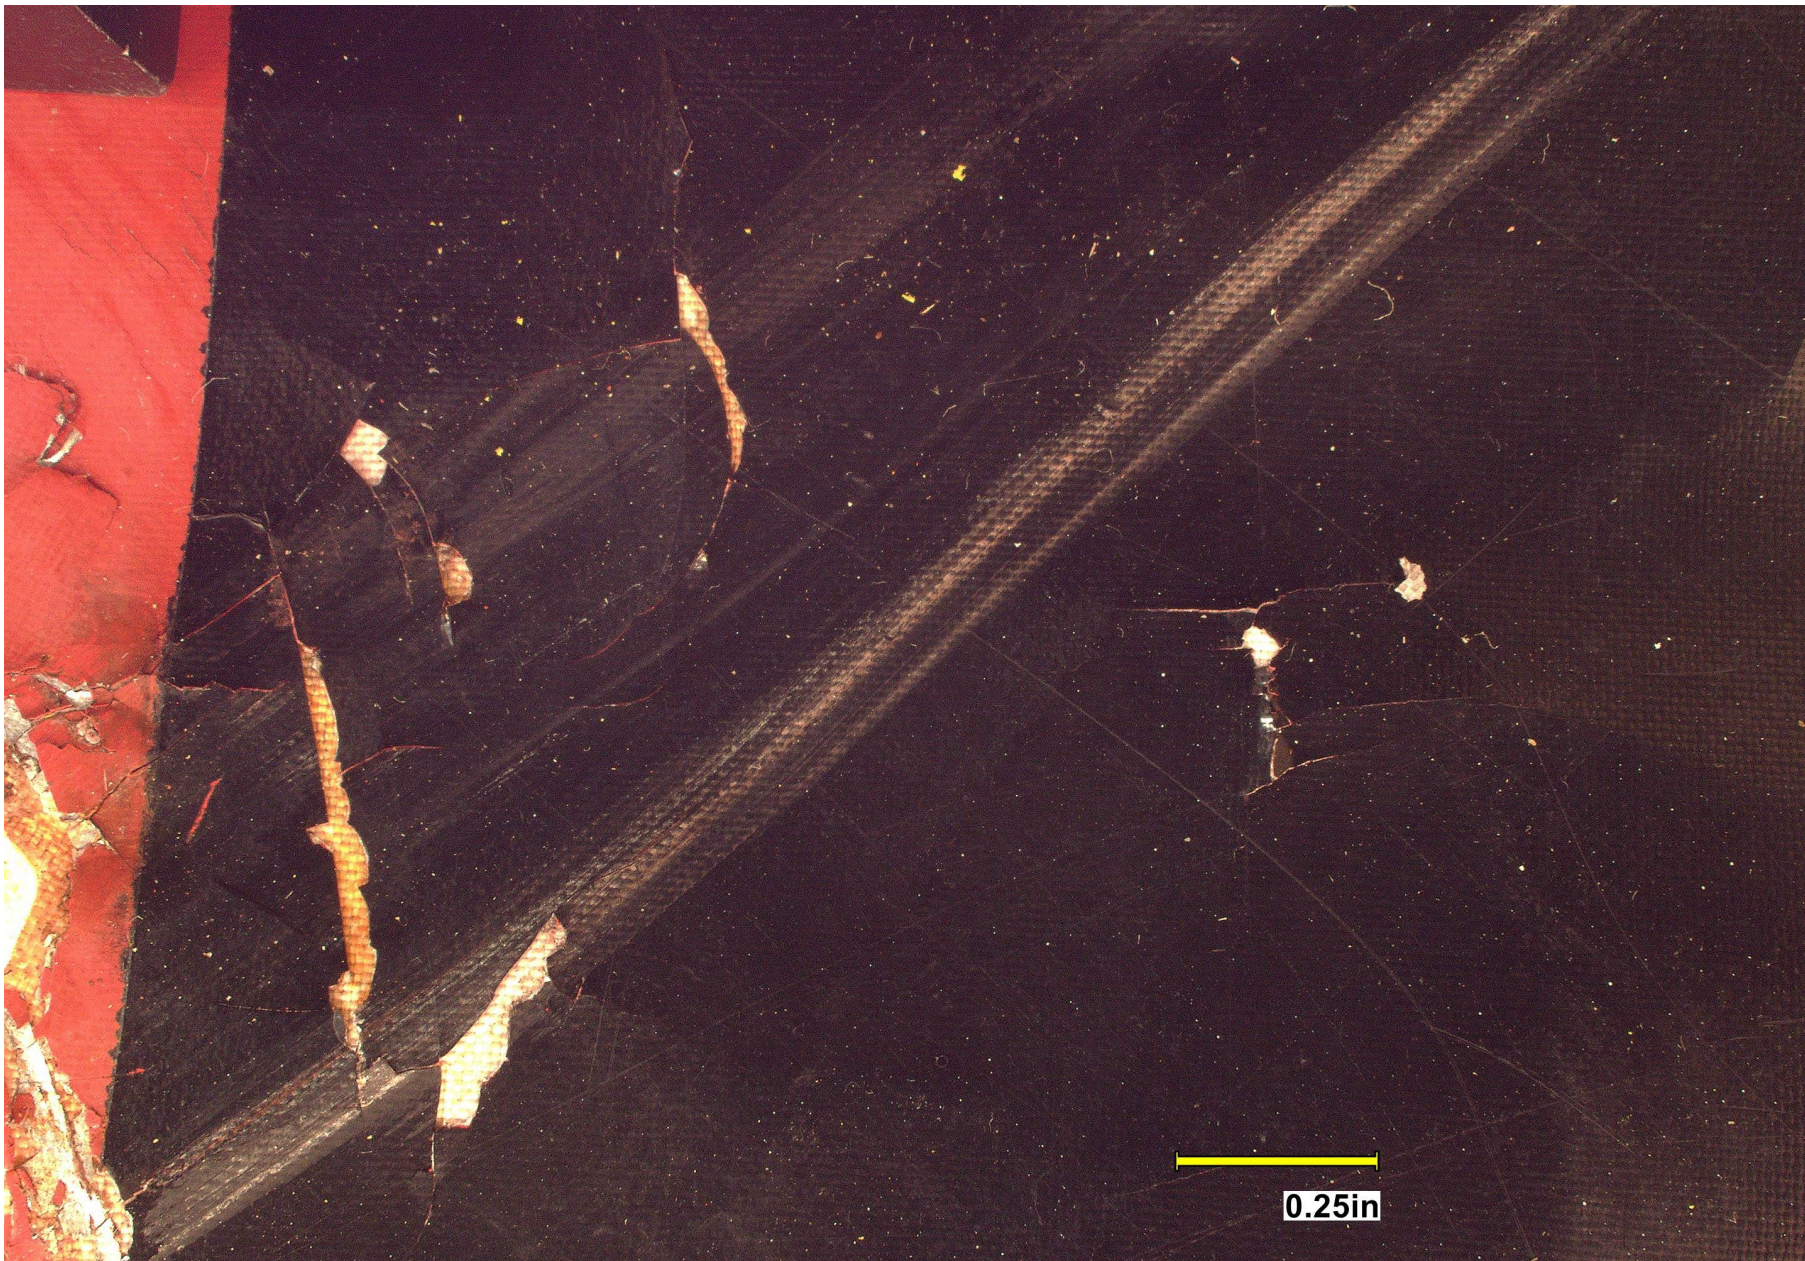
Closeup of area highlighted  
by Arrows 1 and 2 in Slide 6

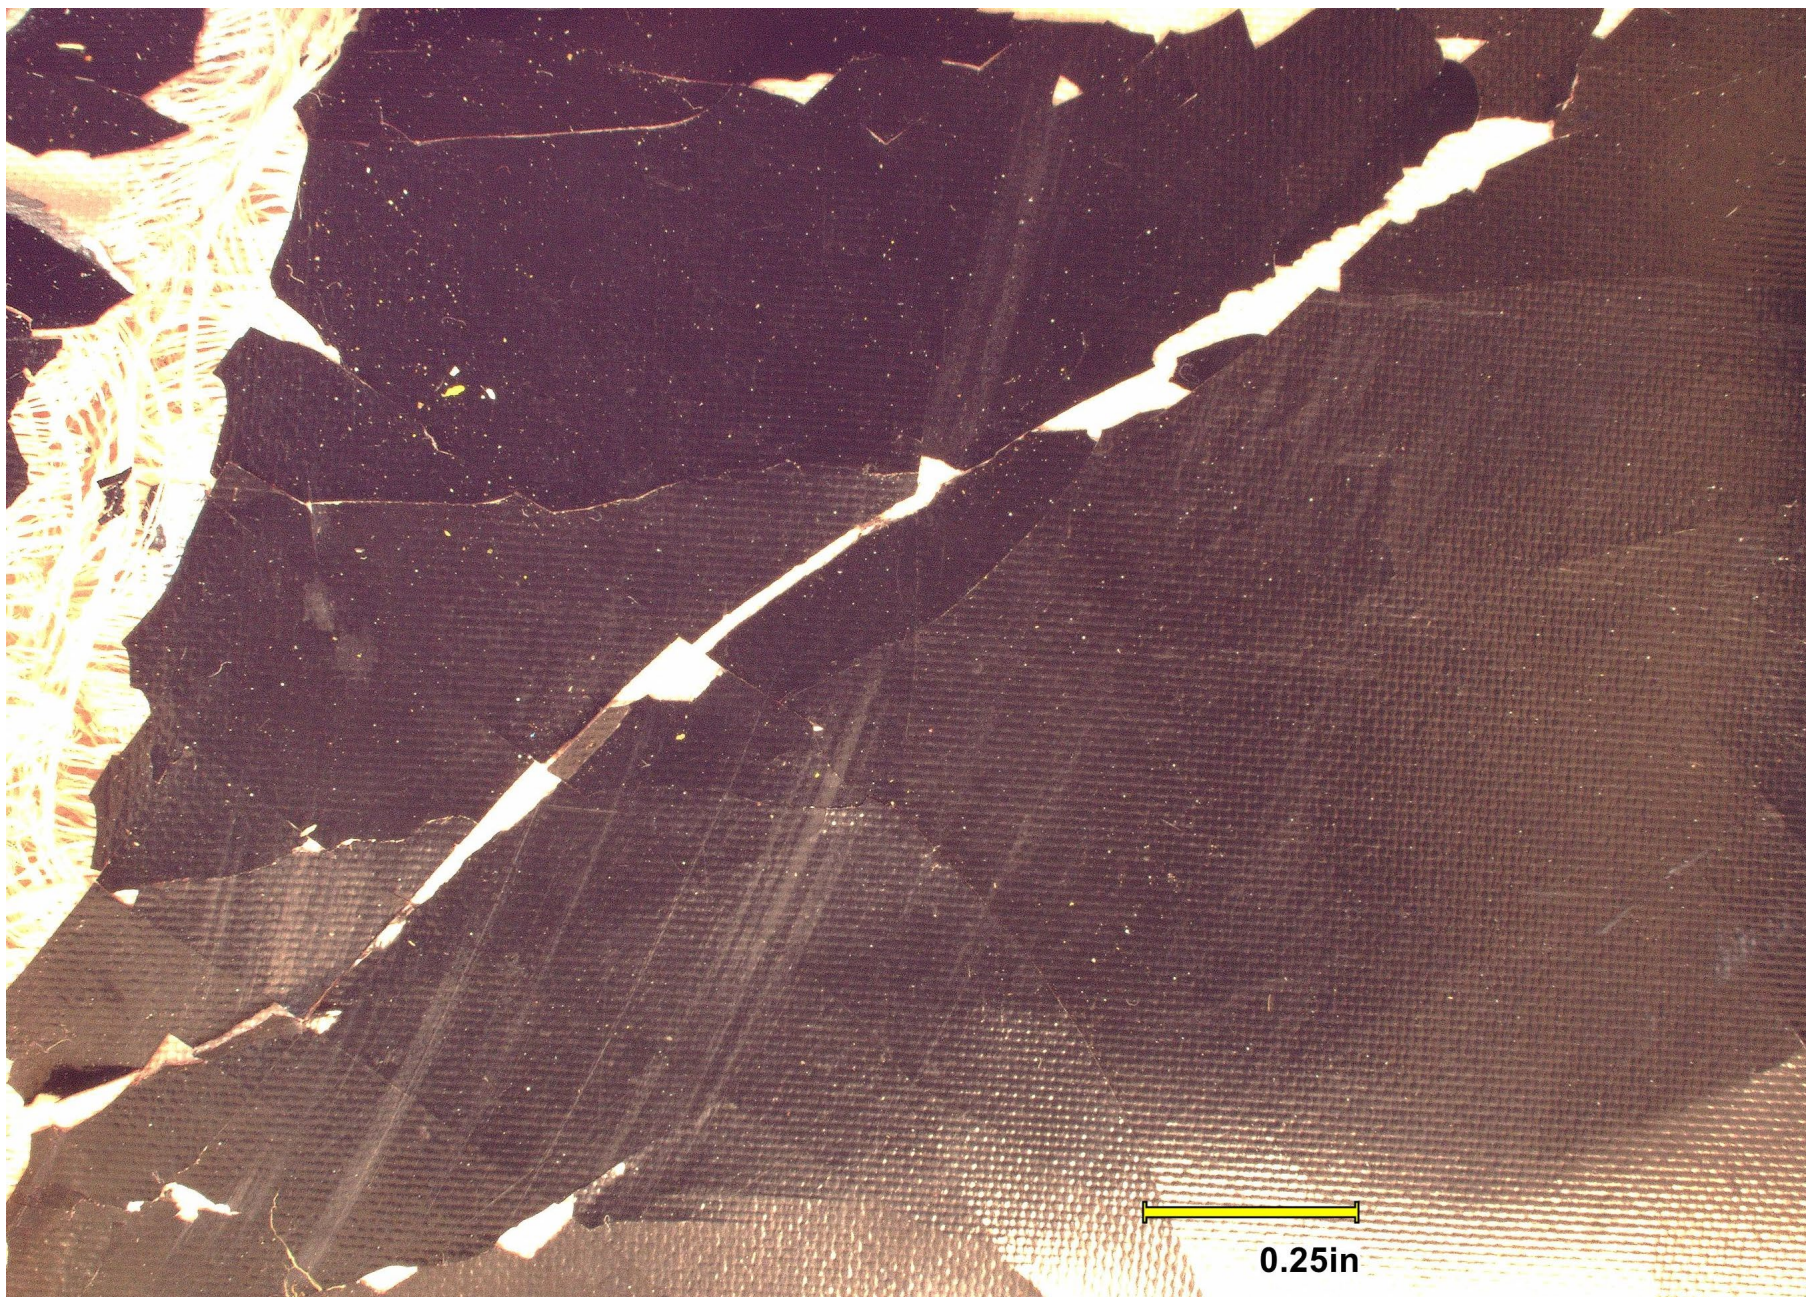
Closeup of area highlighted  
by Arrow 3 in Slide 6

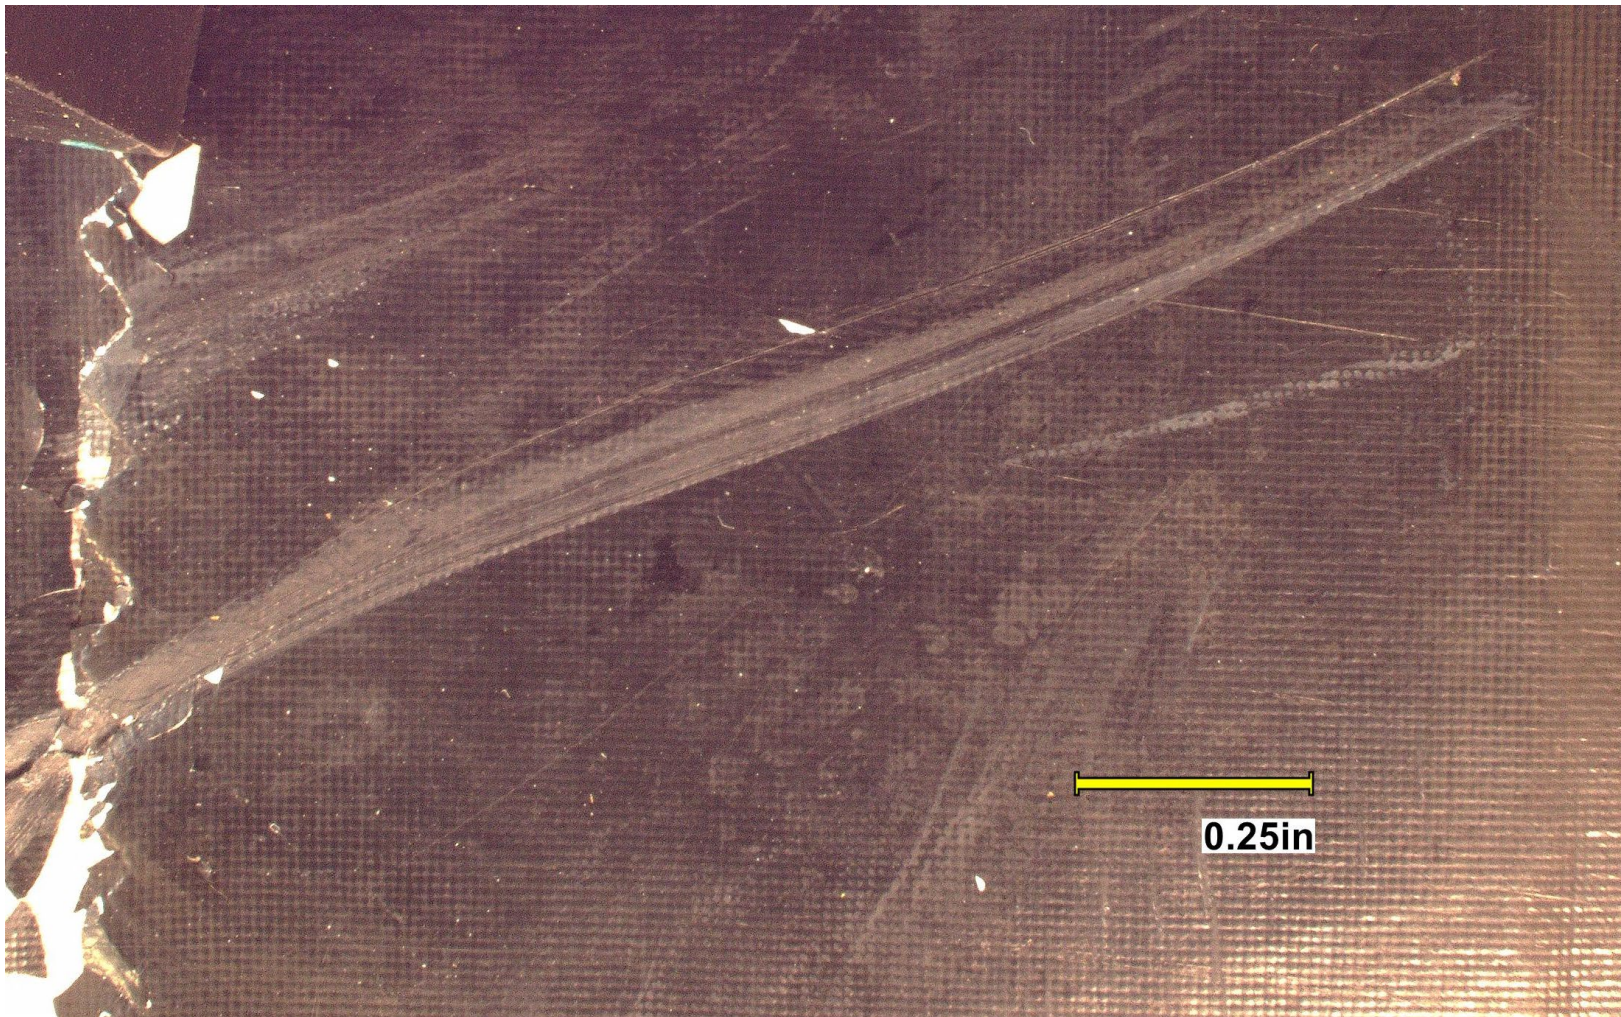
Closeup of area highlighted by Arrow  
4 in Slide 6

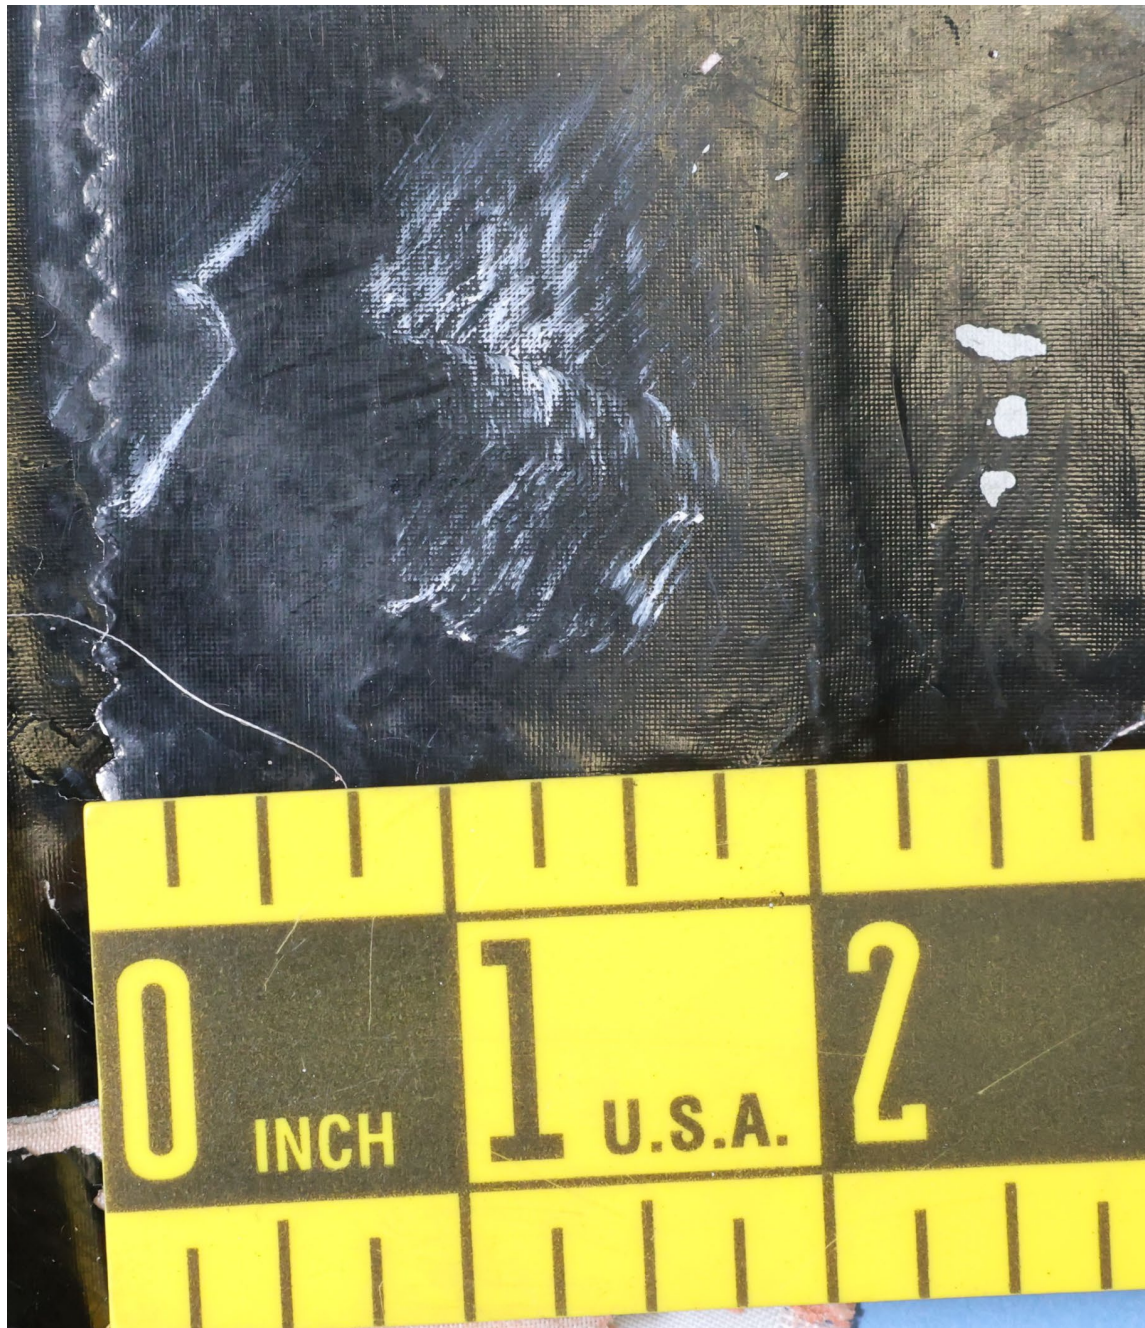
Closeup of area with white transfer highlighted by yellow circle in Slide 6
