# National Transportation Safety Board

## **MATERIALS LABORATORY**

Specialist's Factual Report 25-065

Location: Anchor Point, Alaska  
Date: December 8, 2023  
Vehicle: Piper PA-18-150  
Investigators: Mark Ward AS-ANC  
Clint Crookshanks AS-40

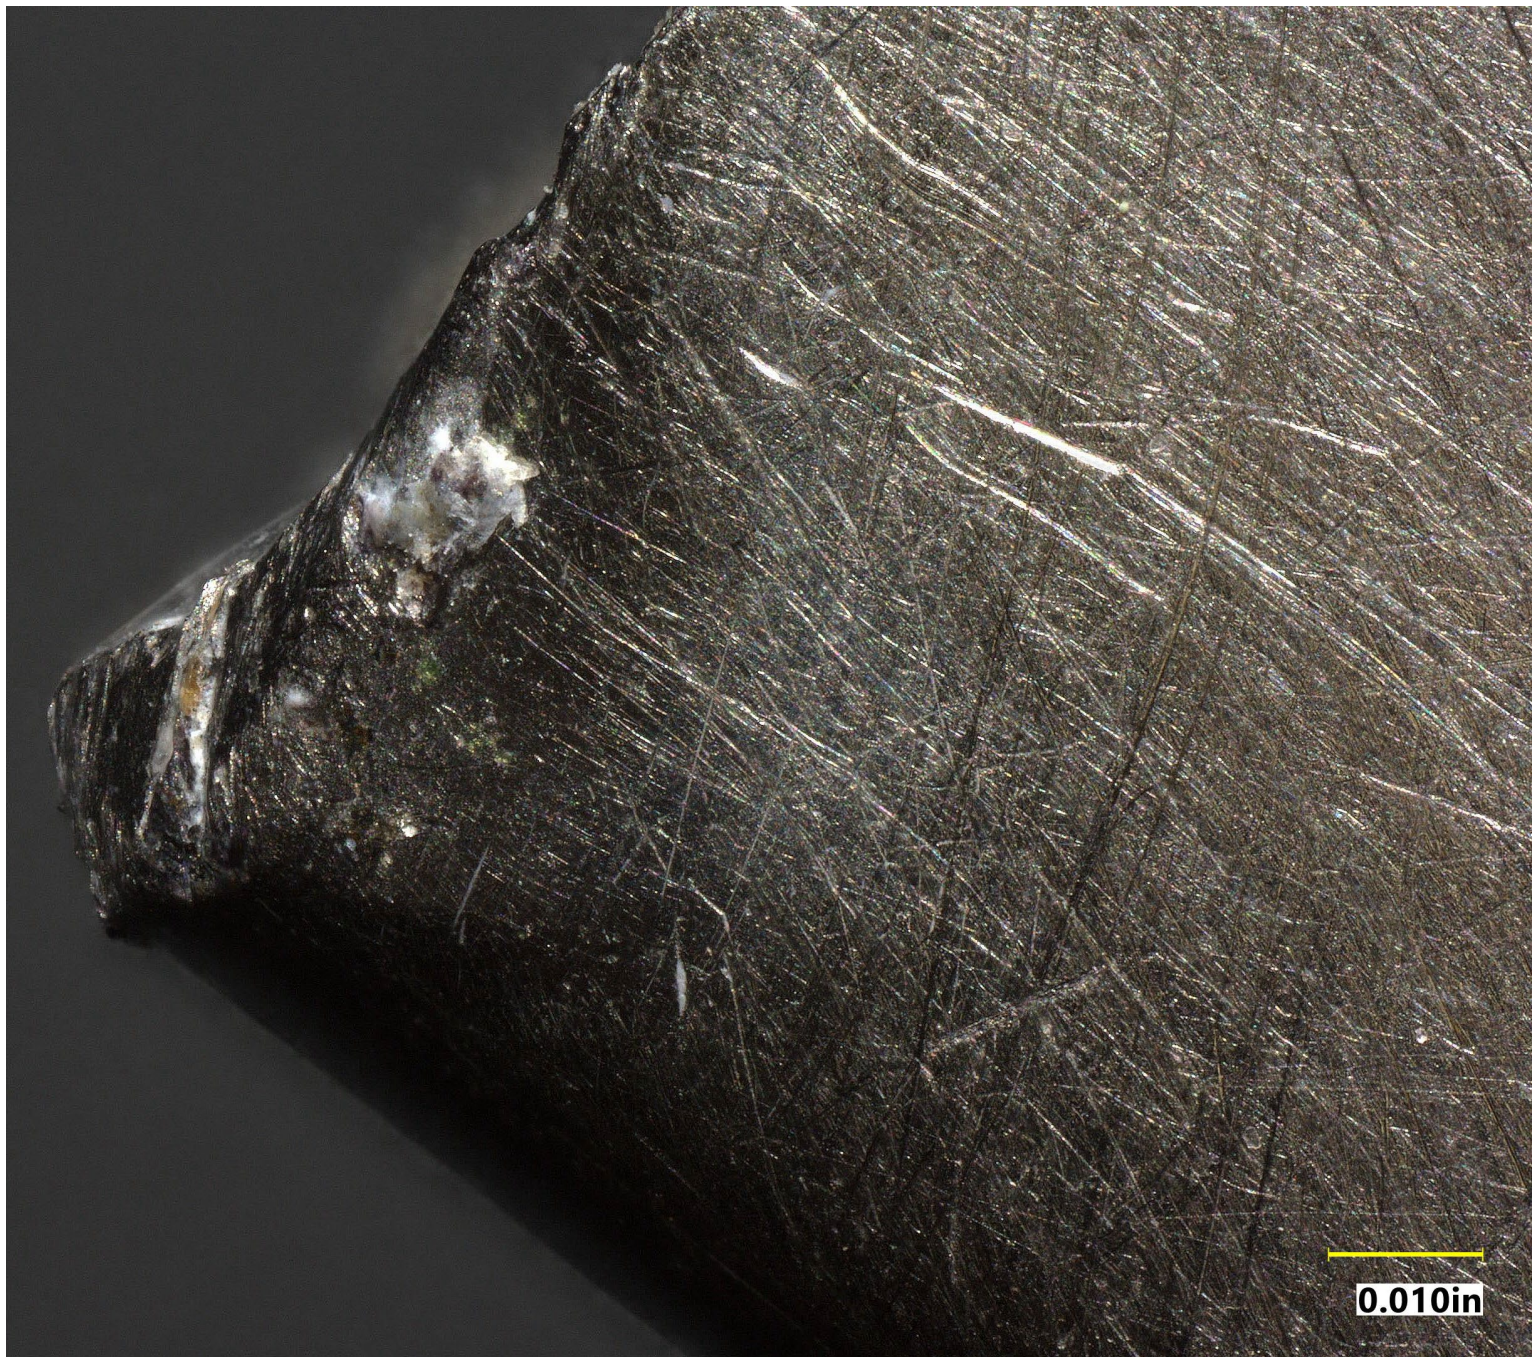
Closeup of section of fracture surface on blade. Fracture features indicate that the blade tip separated under overstress. No transfer marks were found.

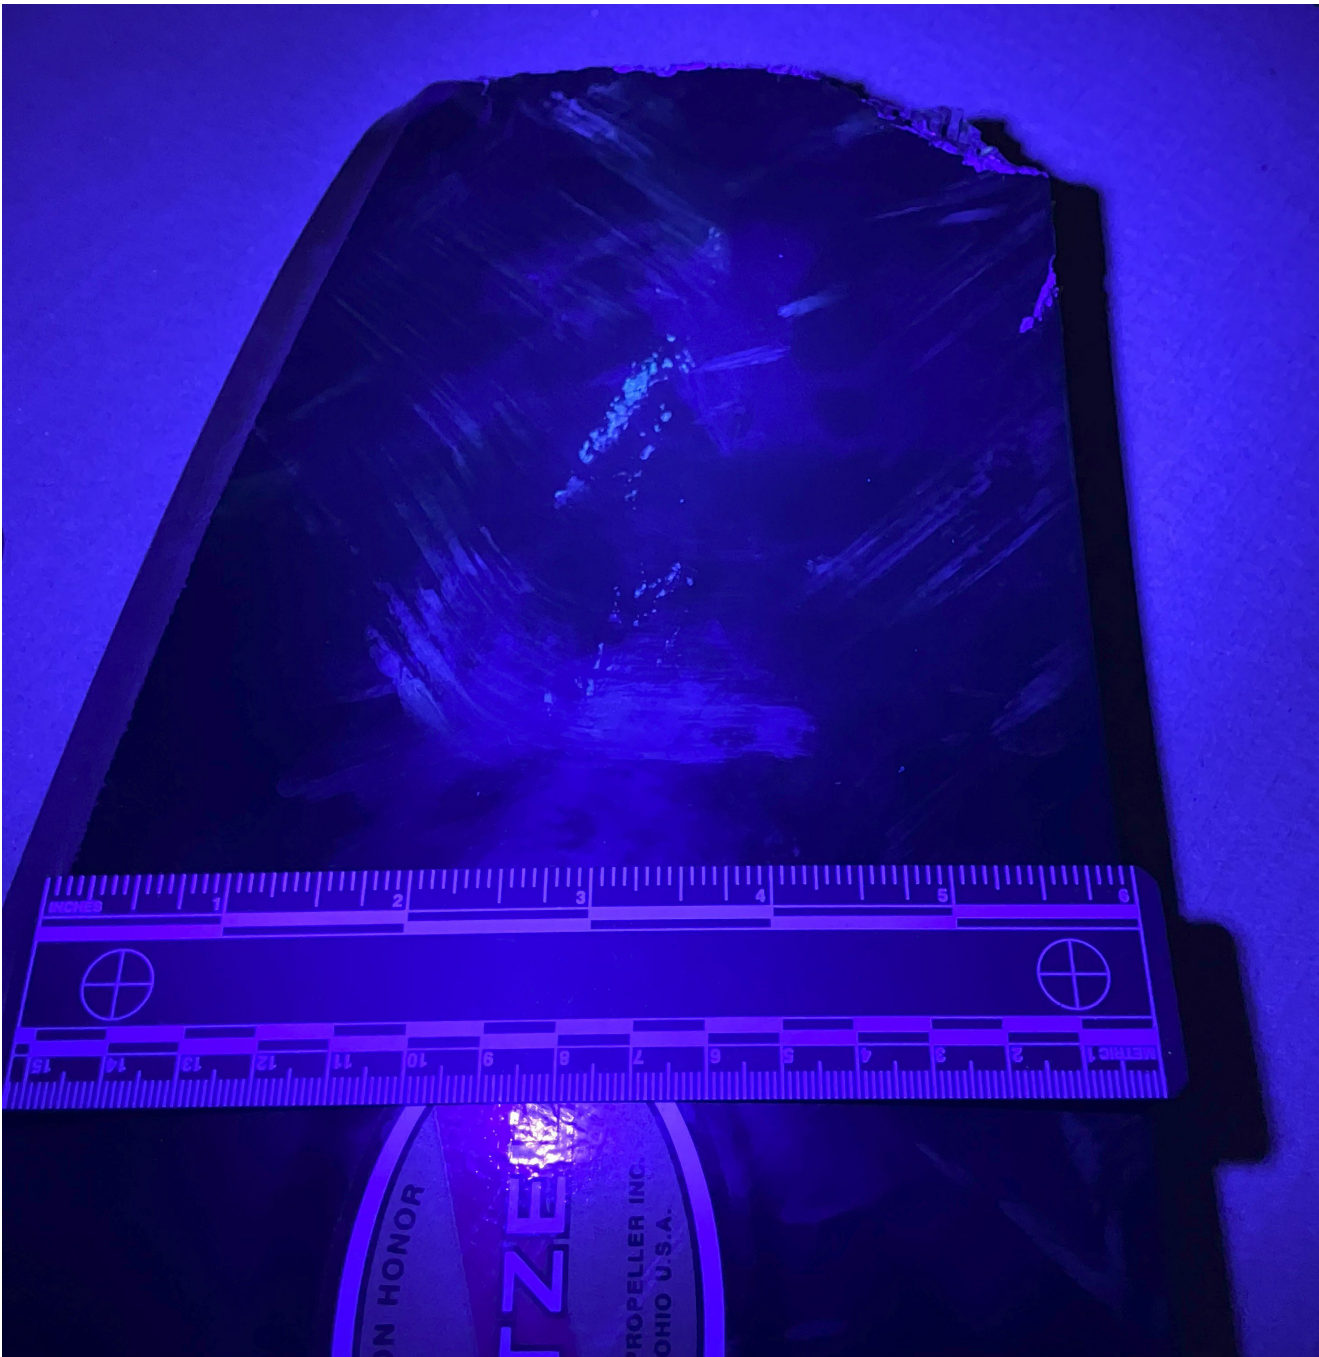
Photograph of front surface of blade under UV light

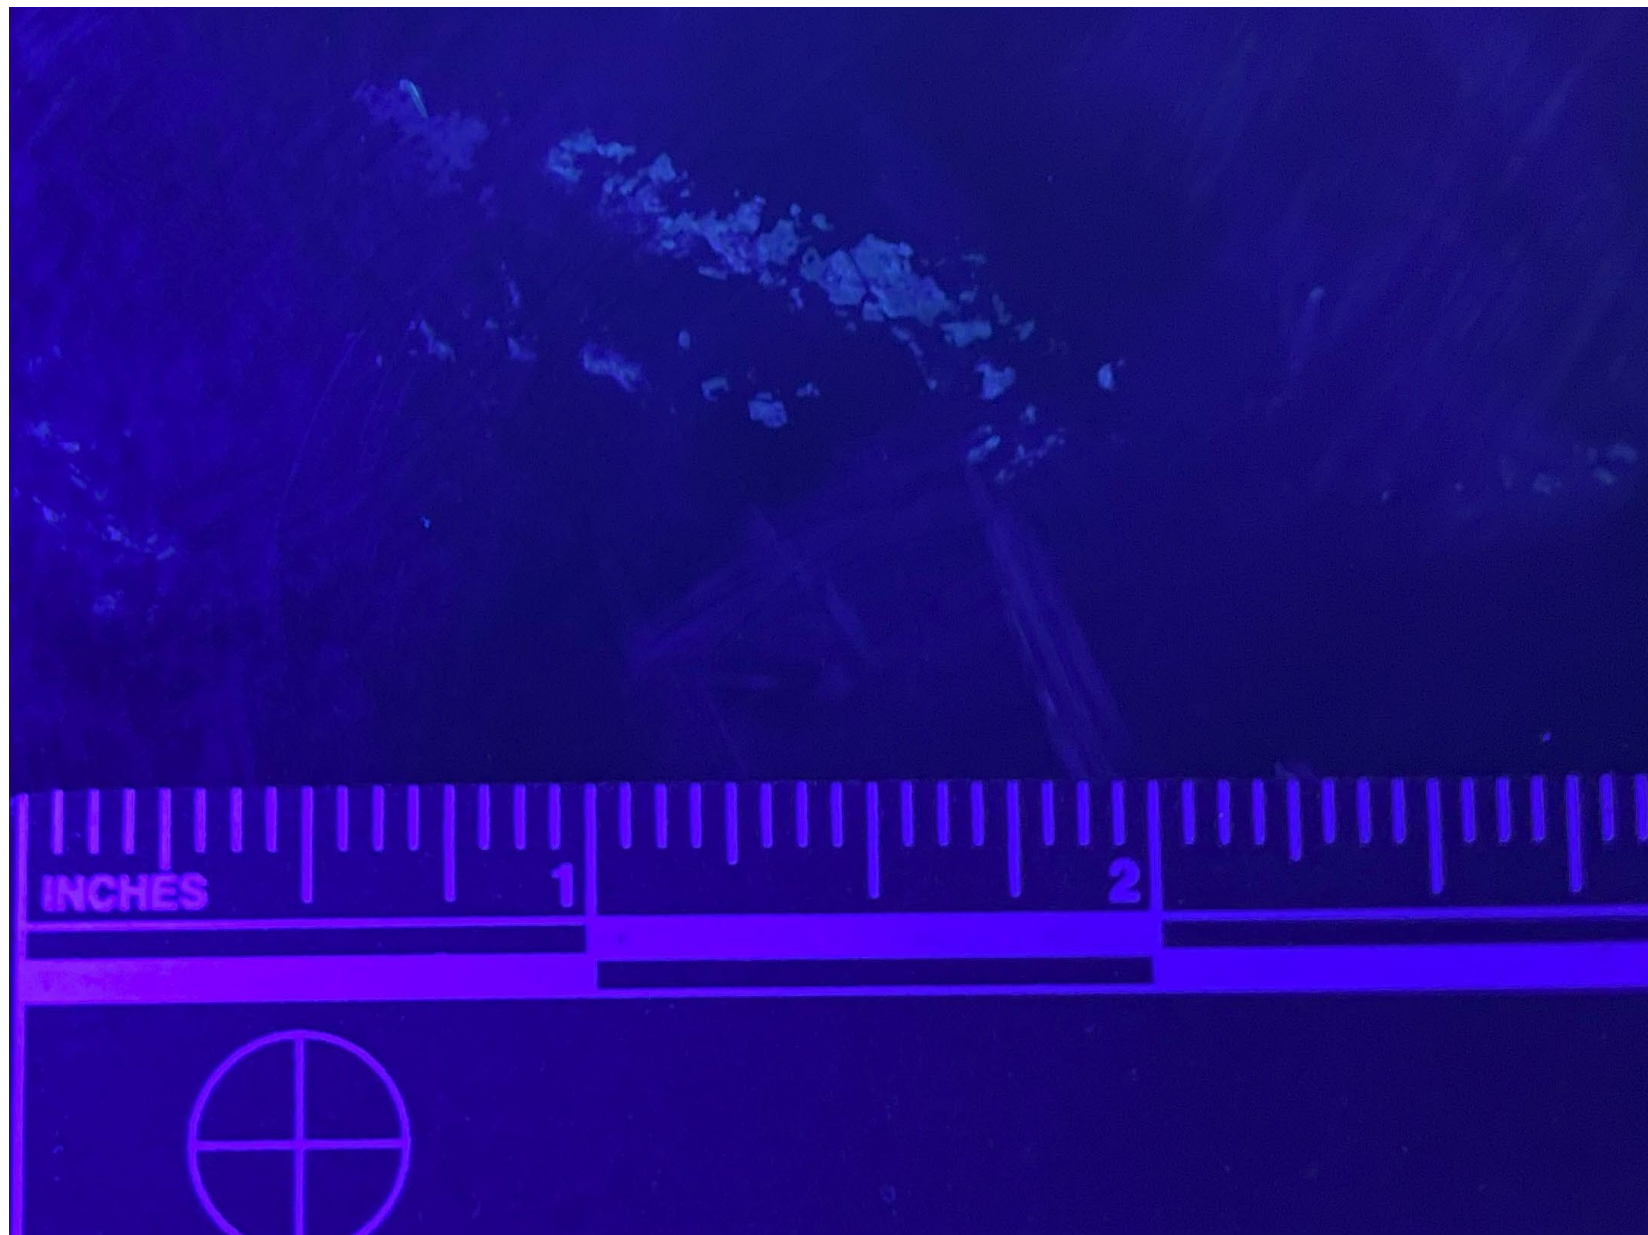
Closeup of foreign material  
deposited on surface of blade  
under UV light

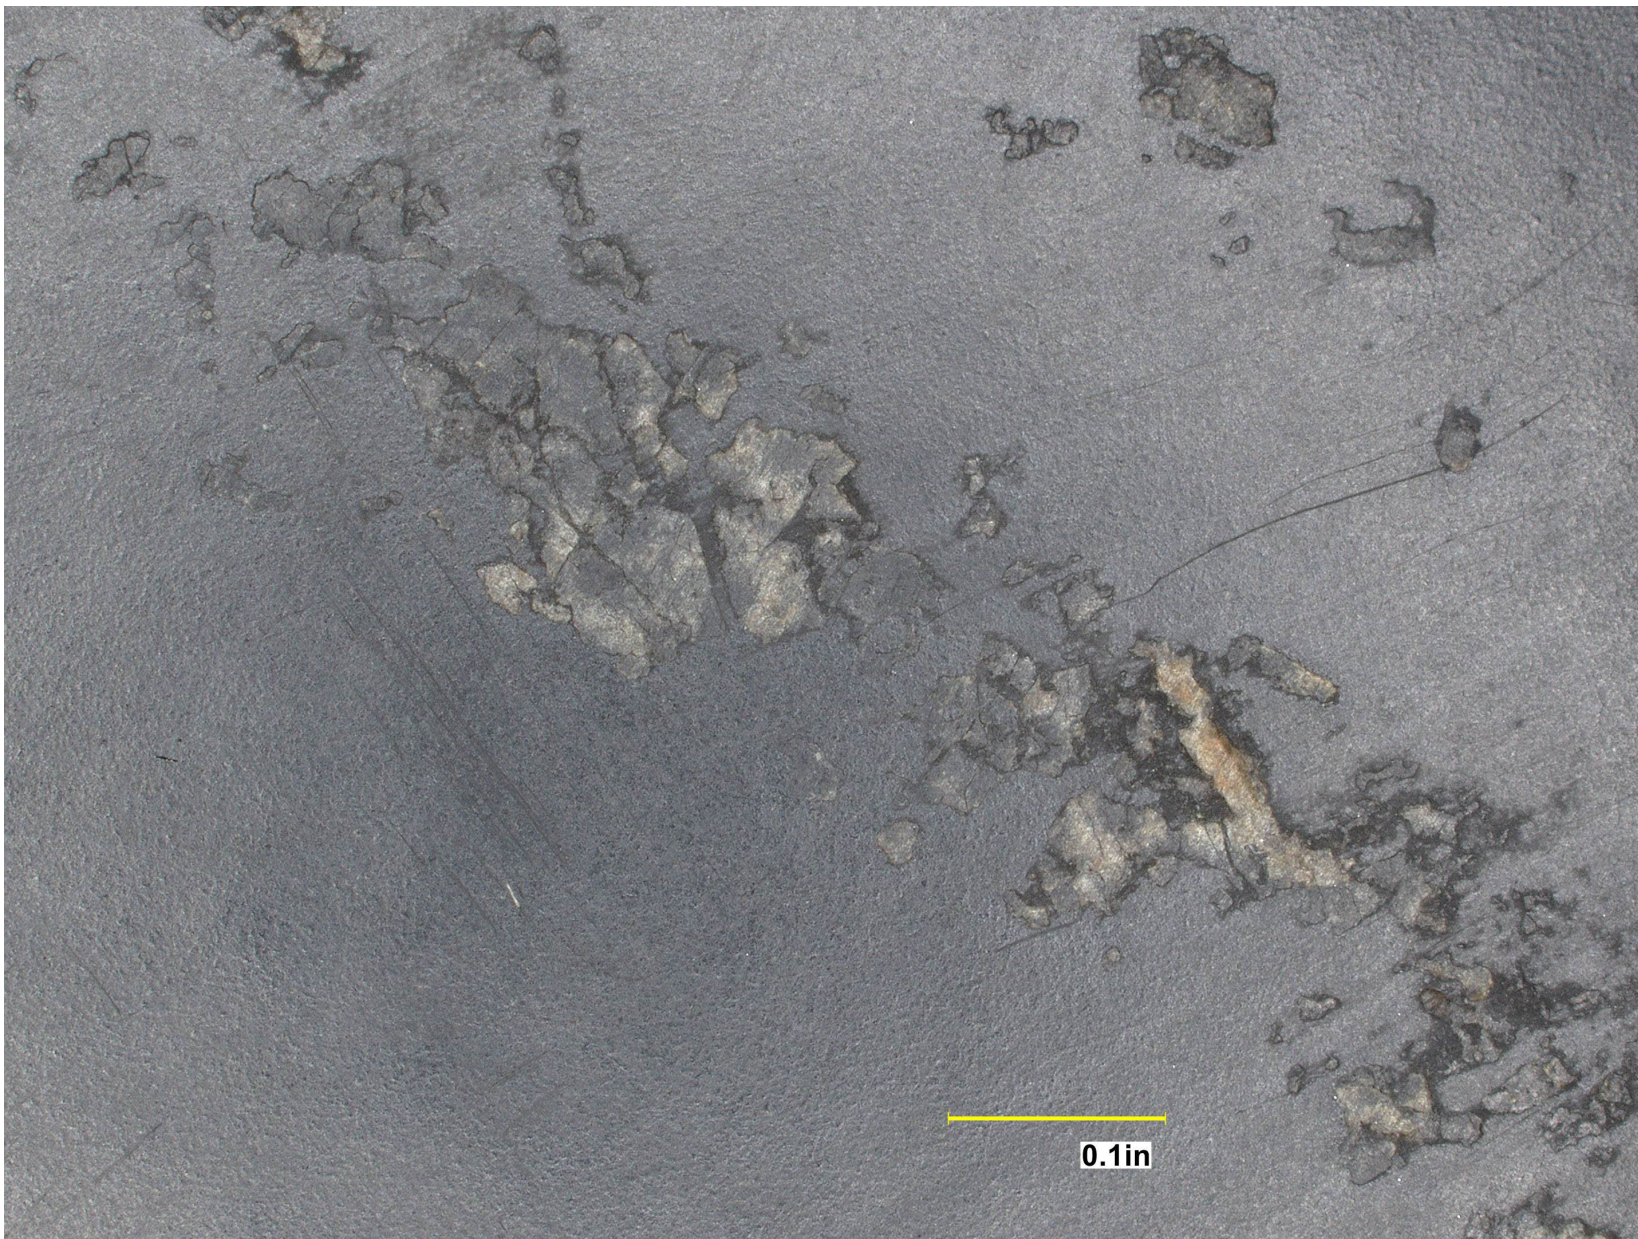
Closeup of foreign material deposited on surface of blade. Material was consistent with silicon likely soil/dirt as per X-ray fluorescence analysis.
