# National Transportation Safety Board

ANC24FA008

## **ENGINE EXAMINATION**

Location: Anchor Point, Alaska  
Date: December 8, 2023  
Time: 1315L  
Airplane: N1880P PA18-150

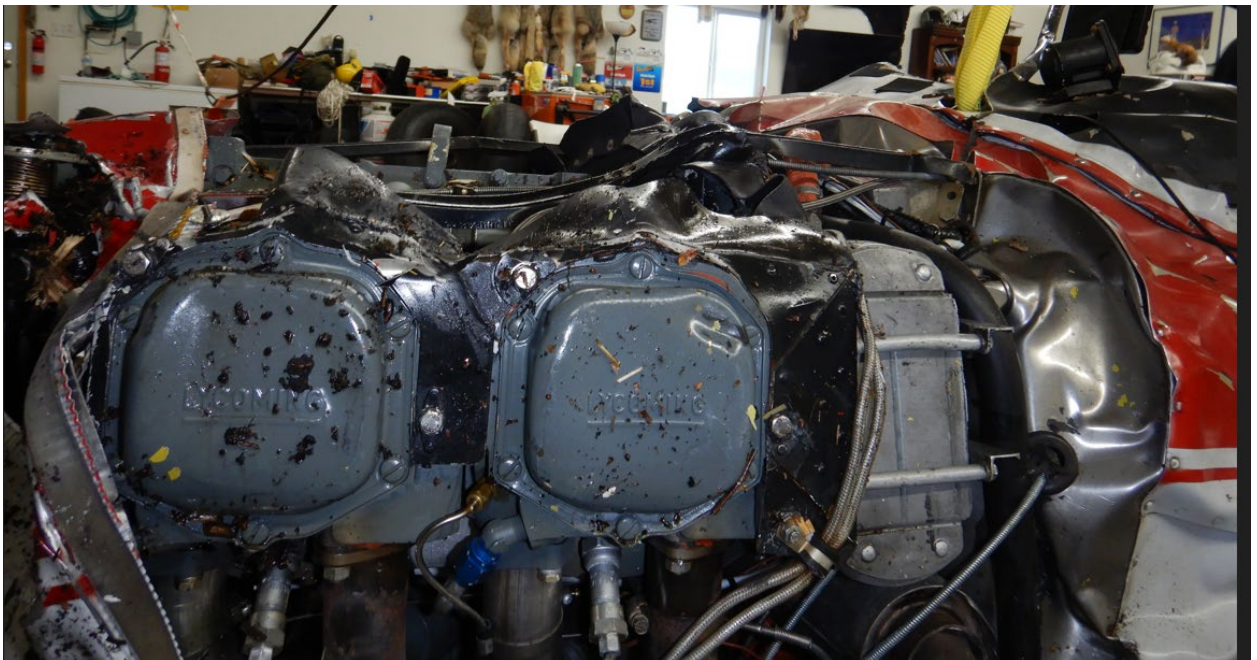
**Figure 1 Left side of engine**

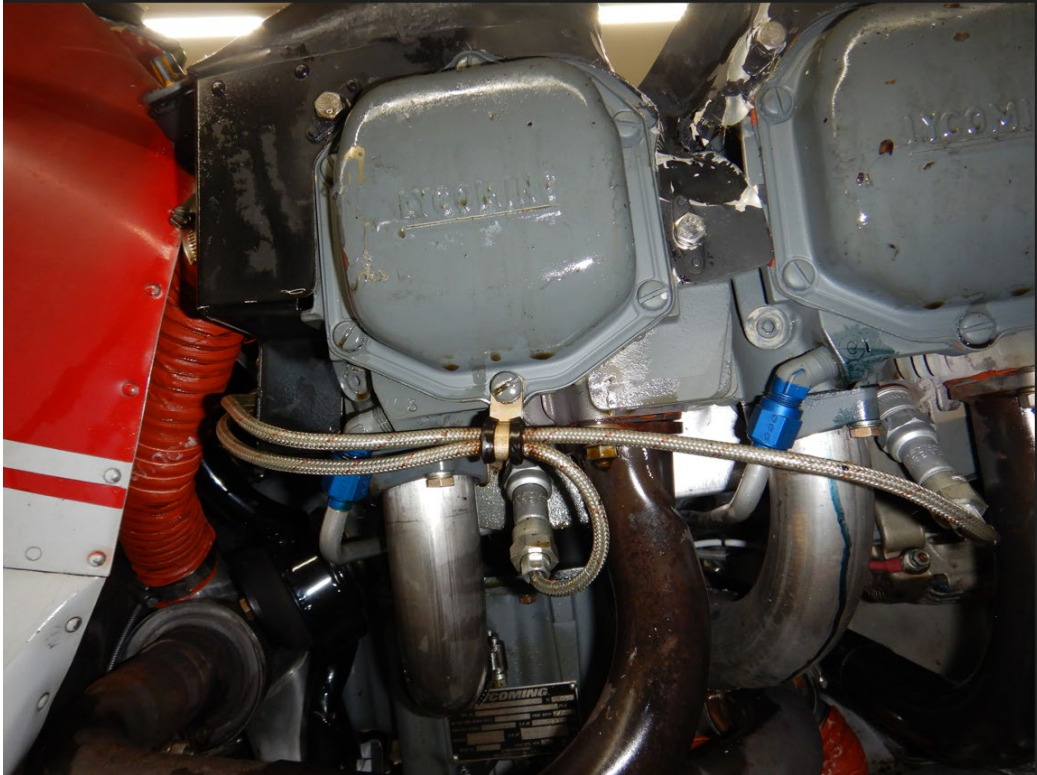
**Figure 2 Right side of engine**

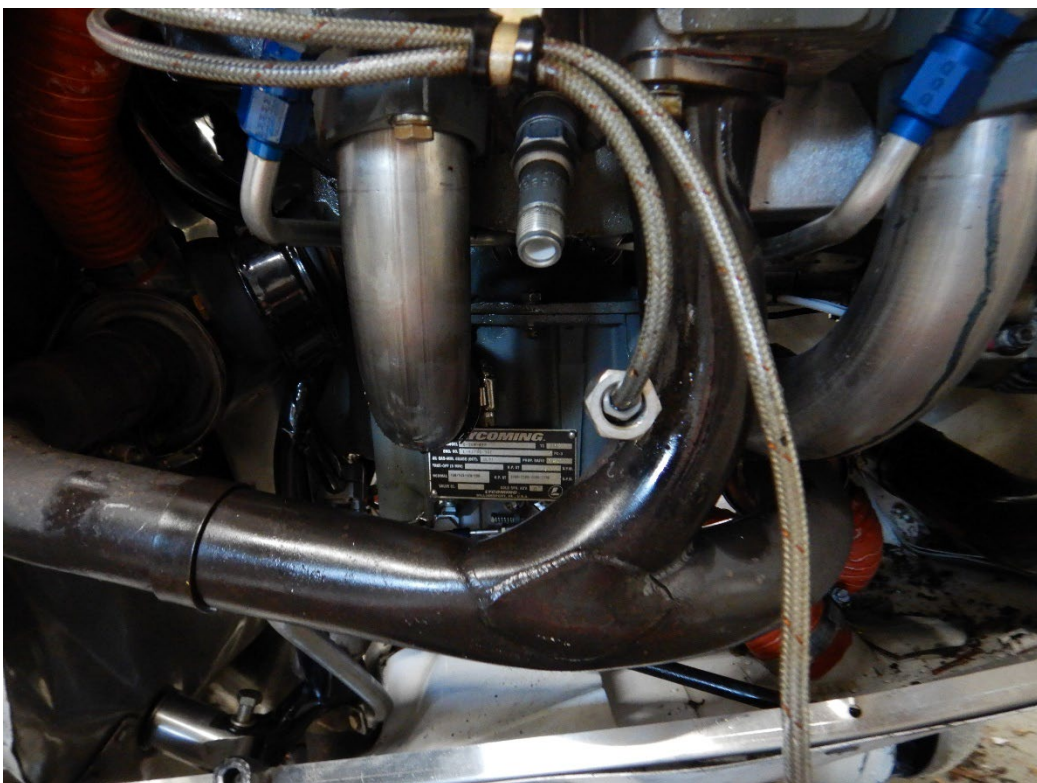
**Figure 3 Lower right side of engine**

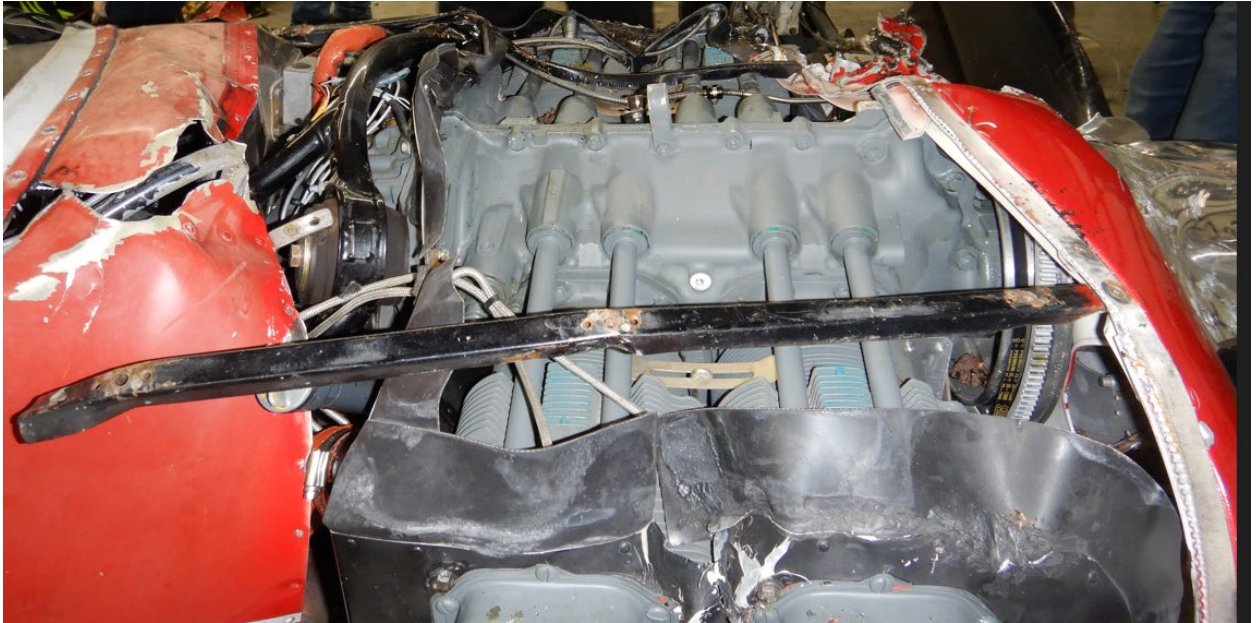
**Figure 4 Top right side of engine**

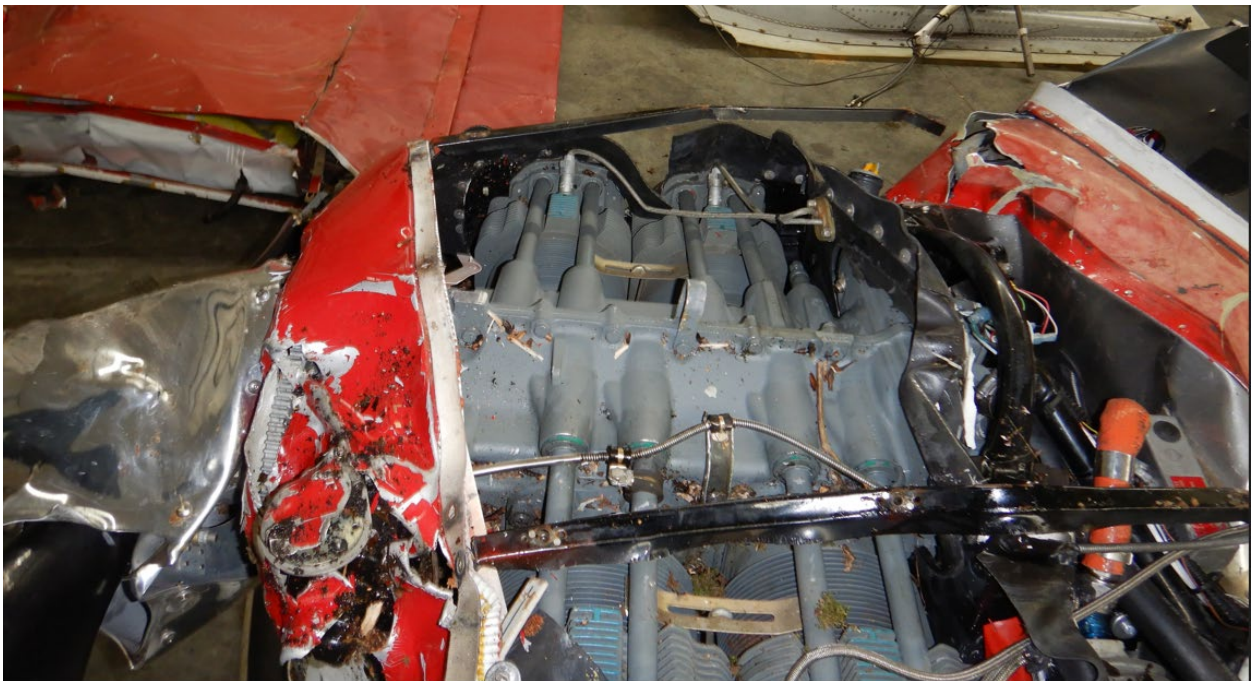
**Figure 5 Top left side of engine**

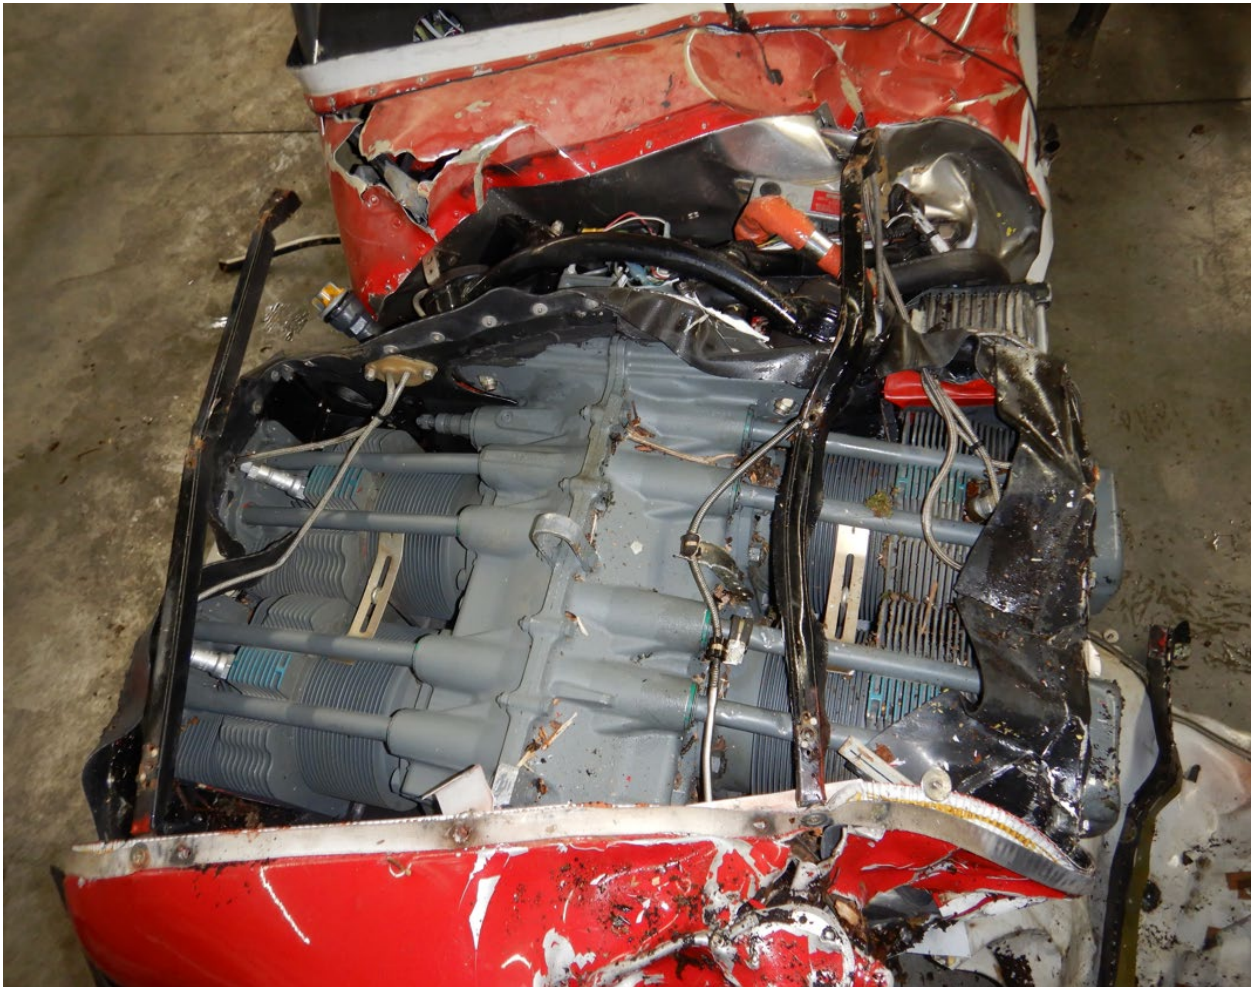
**Figure 6 Top view of engine**

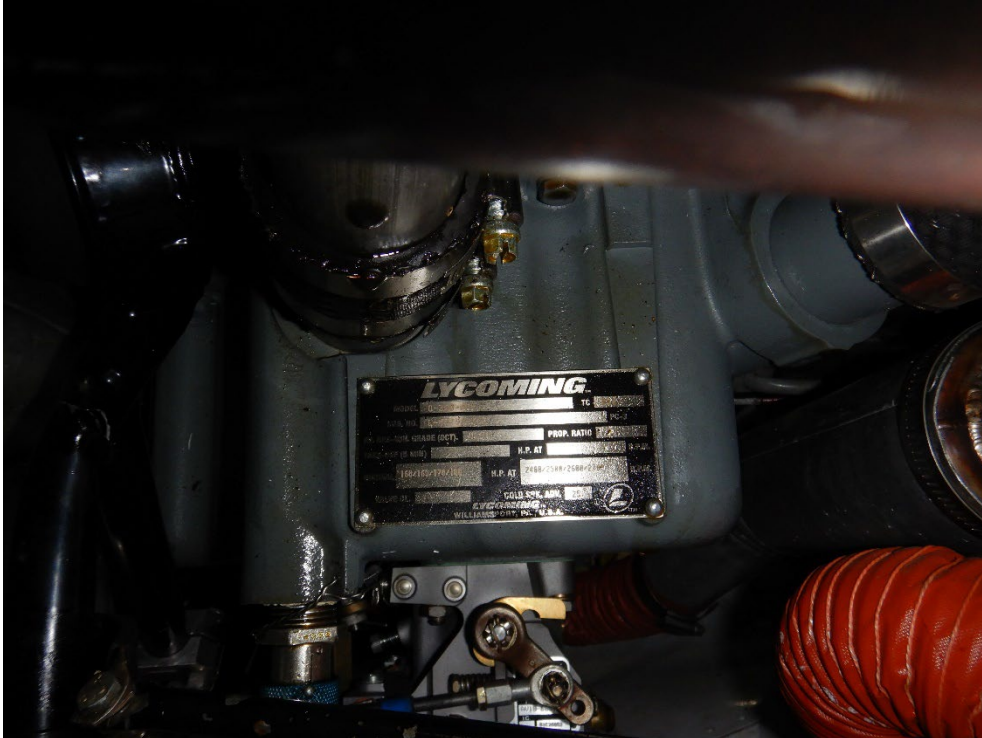
**Figure 7 Induction system on engine**

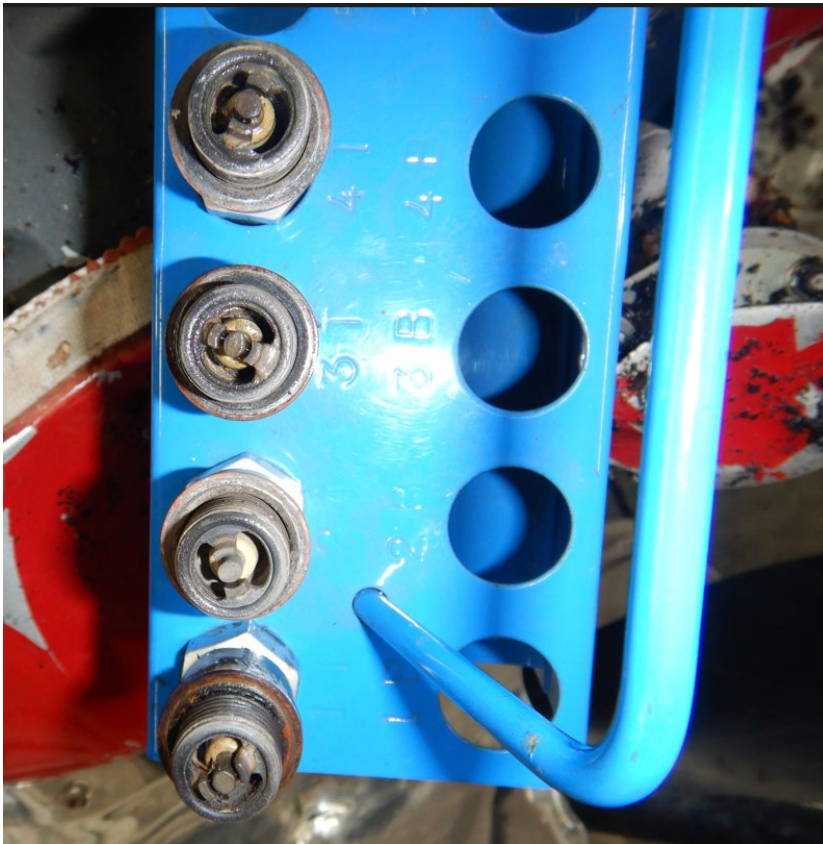
Both magnetos were tight. Exhaust system was intact and undamaged. Air inlet filter and screen were clean with no obstructions observed. All sparkplugs were secure. The top sparkplugs were removed, and all electrodes were normal. Engine crankshaft was rotated by the propeller. During rotation the impulse coupler in the magneto could be heard clicking. All valve covers were removed, and valve train moved normally, and thumb compression was observed in all cylinders. Spark was observed at each ignition lead end.

**Figure 8 Top sparkplugs from engine**

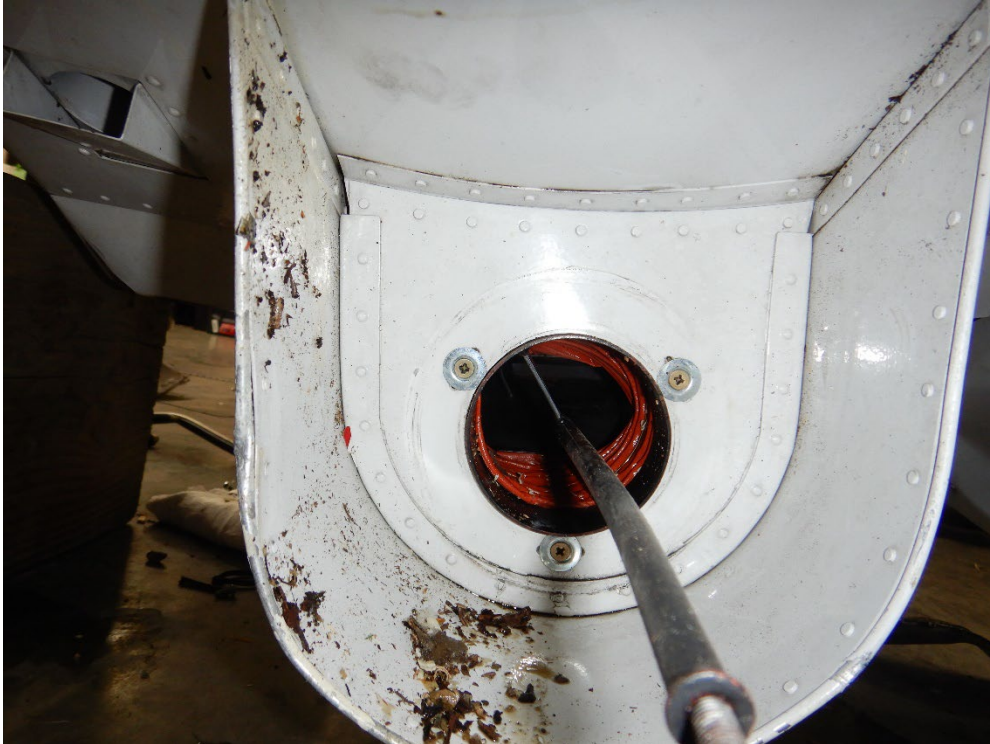
**Figure 9 View looking into air intake with filter removed**

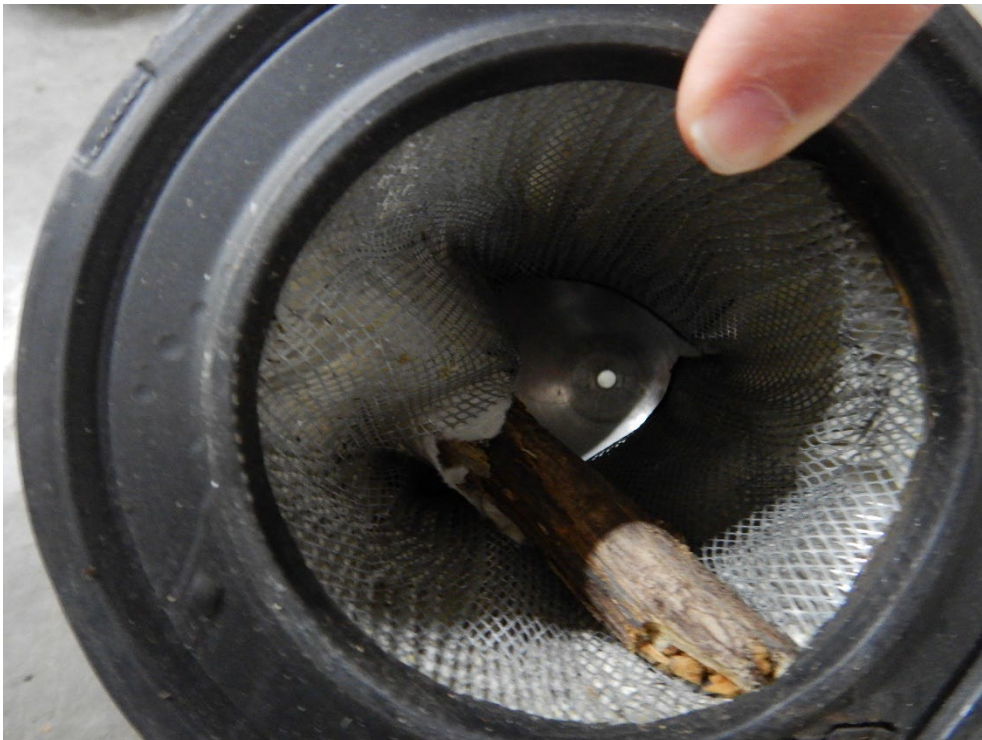
**Figure 10 Inside view of air intake filter**

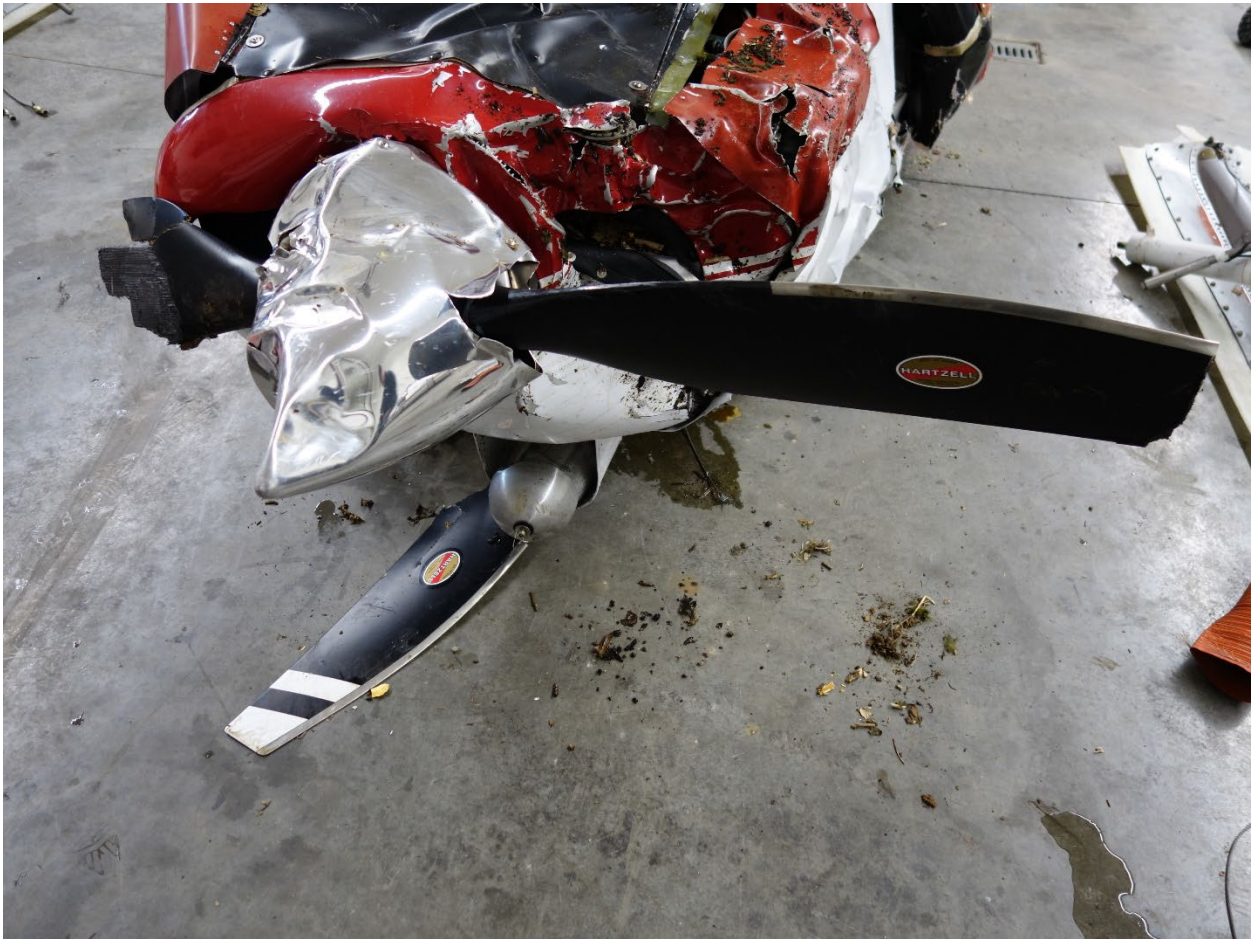
Propeller blade No.1 was folded under the airplane during impact and separated. Propeller blade No.2 had about seven and half inches of the tip separated from the main blade.

**Figure 11 View of airplane hub and propeller blades**

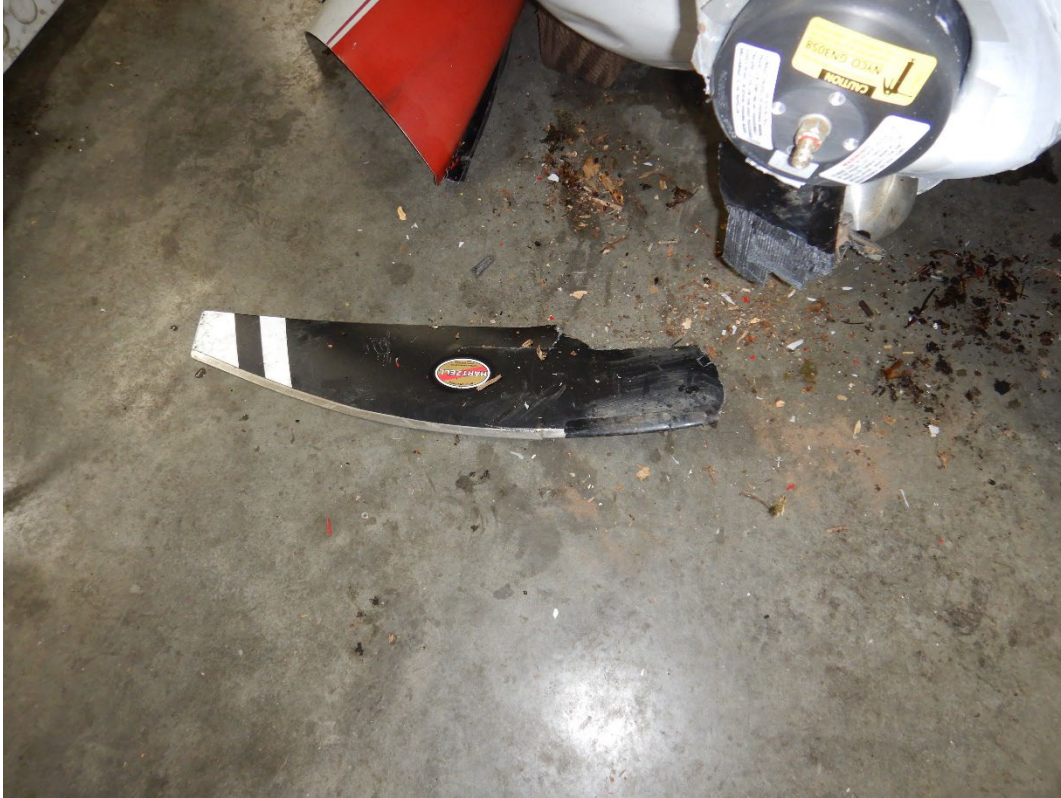
**Figure 12 No.1 propeller blade**

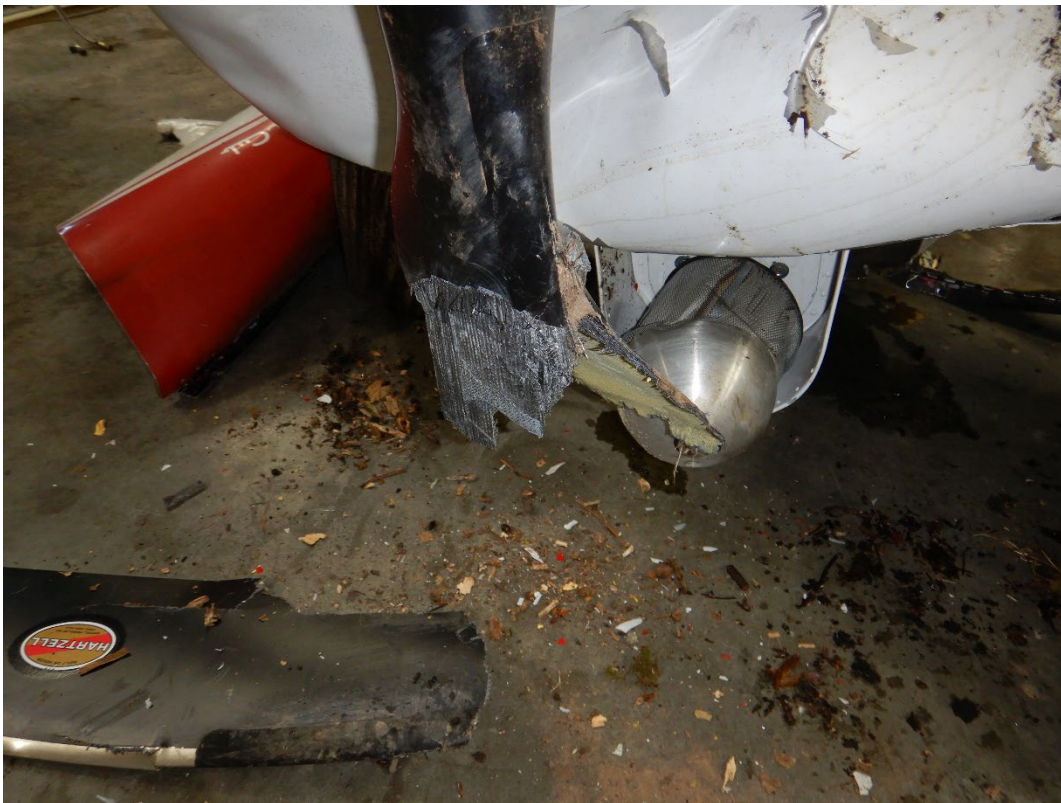
**Figure 13 No.1 propeller blade view of separation point**

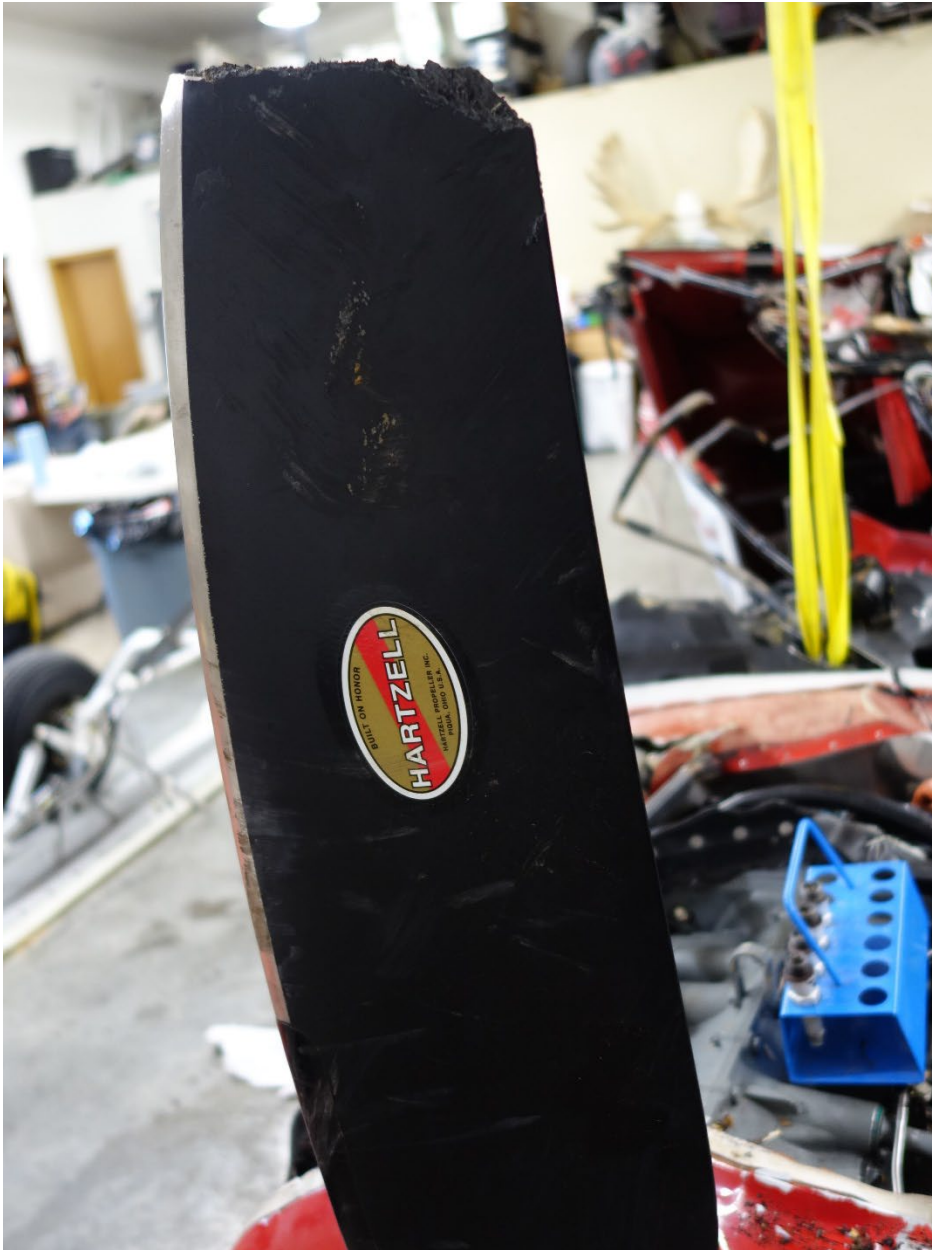
**Figure 14 No.2 propeller blade.**

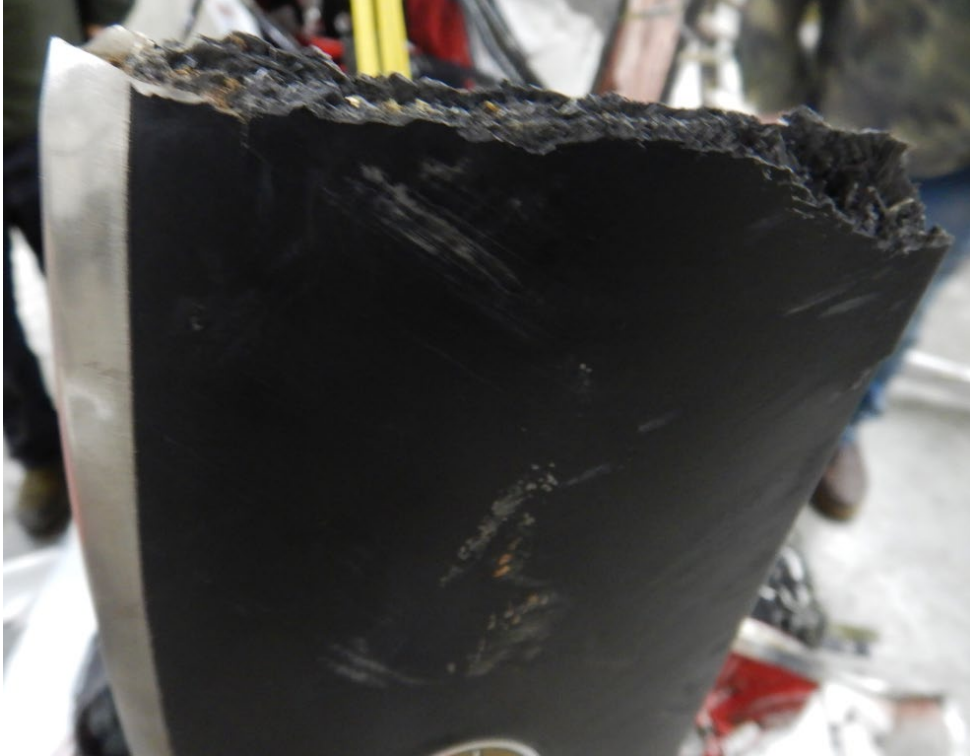
**Figure 15 No.2 propeller blade separation point**

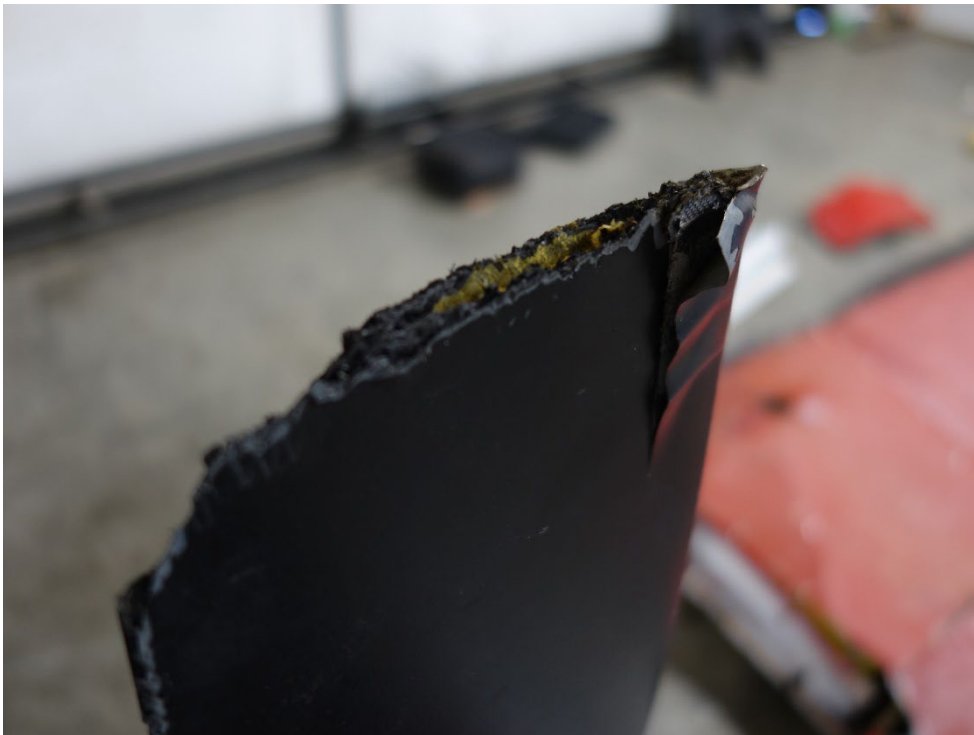
**Figure 16 No.2 propeller blade separation point**

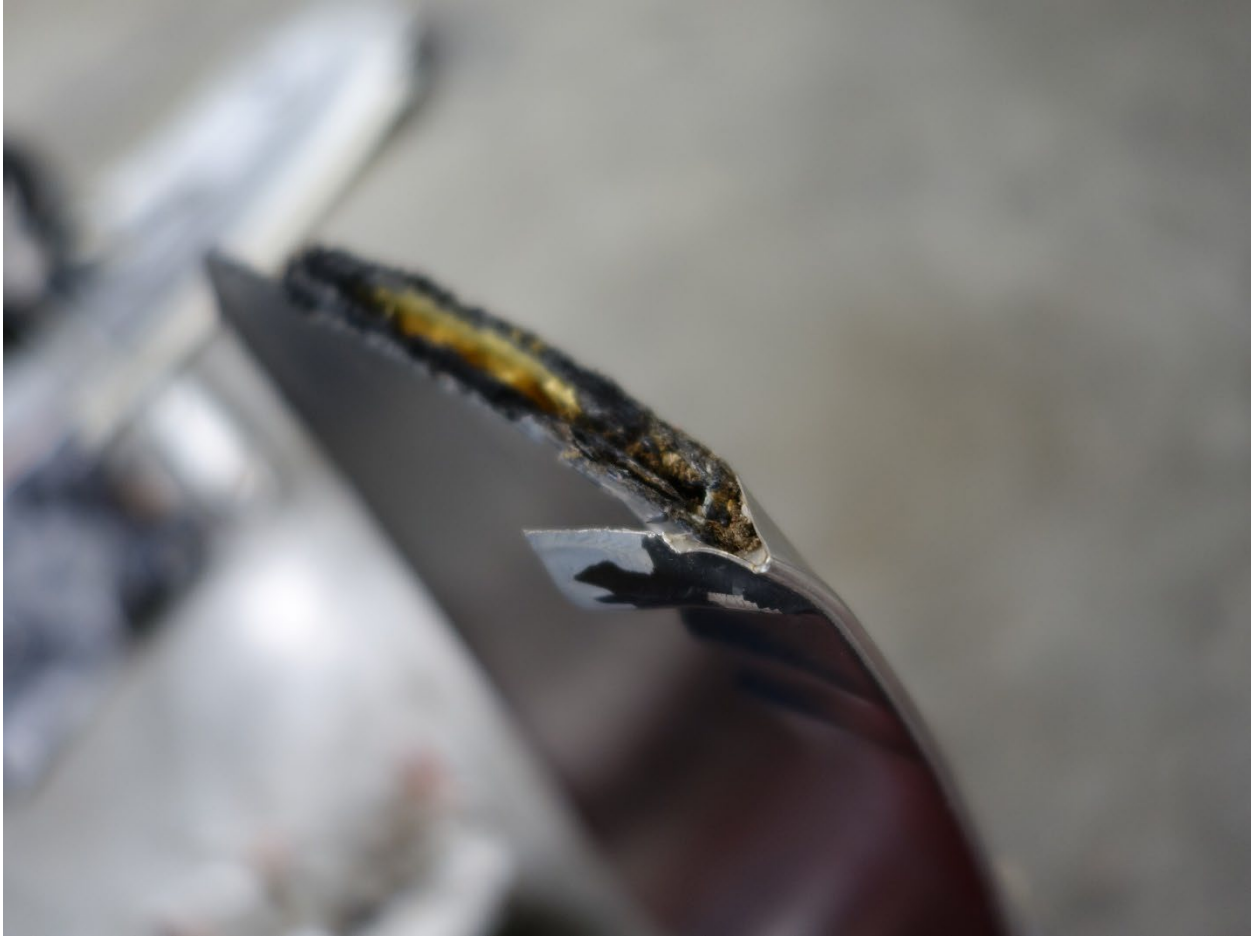
**Figure 17 No.2 propeller blade separation point**
