# National Transportation Safety Board

ANC24FA008

## STRUCTURES

Location: Anchor Point, Alaska  
Date: December 8, 2023  
Time: 1315 Alaska Standard Time (AST)  
2215 Coordinated Universal Time (UTC)  
Airplane: Piper PA-18-150, N1880P

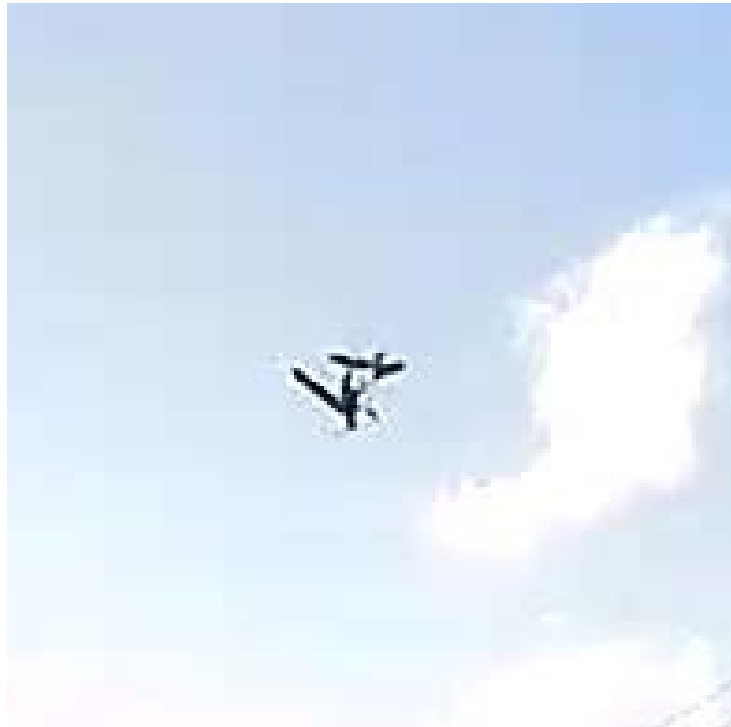
descended vertically before disappearing behind trees on the side of the road. Review of the video and flipbook showed the airplane was partially intact when it first came into view. The right wing appeared mostly intact and attached to the fuselage (Figure 1). The fuselage appeared mostly intact, but the aft fuselage was deformed left between the wing and tail. The empennage, landing gear, and wheel skis appeared intact and installed. The propeller did not appear to be turning during the descent. The left wing appeared to be fractured from the fuselage but remained attached to the fuselage by the wing struts. The left wing appeared deformed in a V-shape.

**Figure 1.** Cropped video frame of accident airplane during descent (NTSB photo)

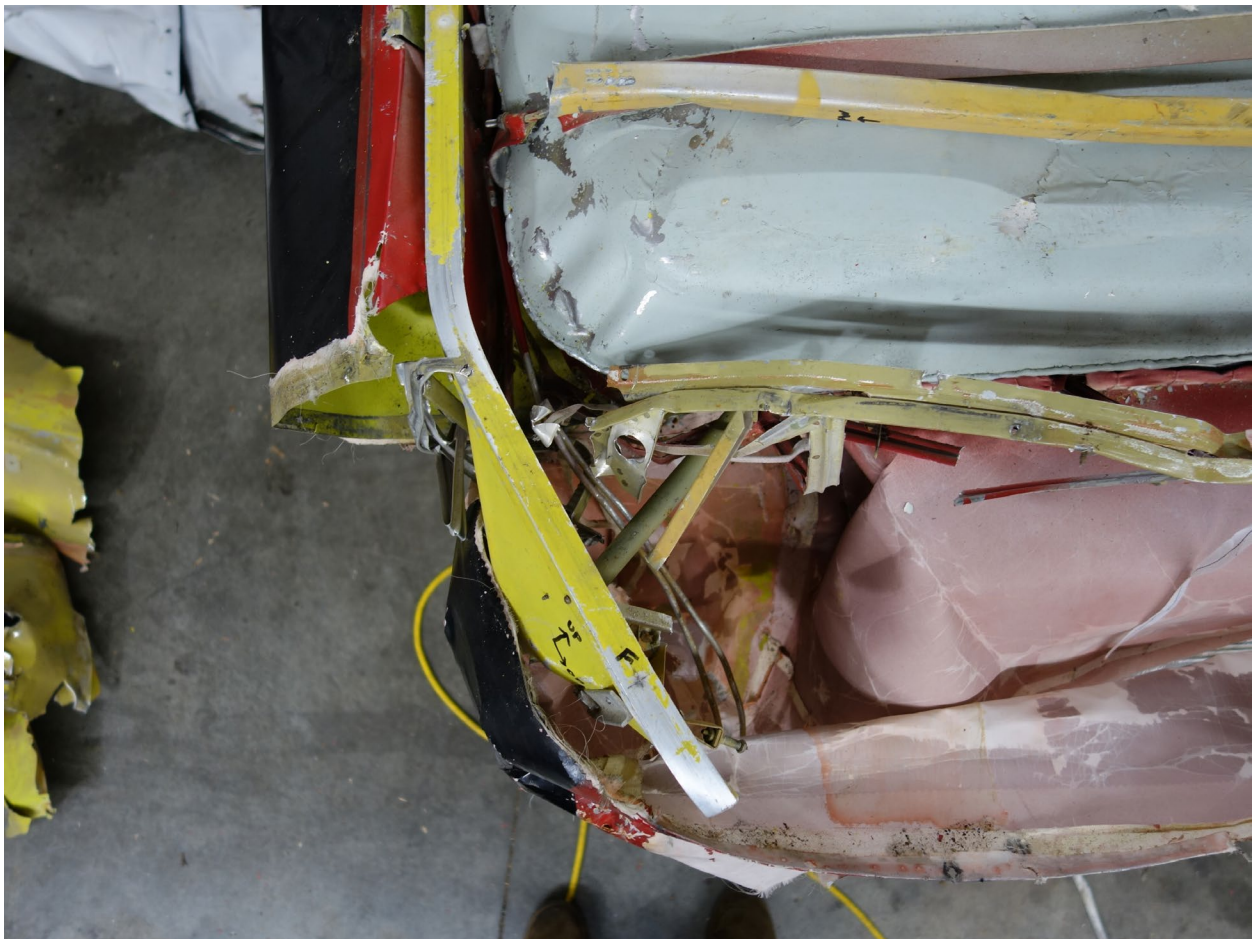
intact with the bolt installed. The aft wing attach point was intact with the bolt installed but the wing fitting was fractured from the wing and the lug was jammed down against the fuselage. The forward spar upper cap was fractured near WS 46, and the lower cap was fractured near WS 40. The forward spar was deformed aft and twisted leading edge up near WS 34 (Figure 3). The outboard 2 inches of the forward spar upper cap was twisted leading edge down adjacent to the fracture. There was a diagonal crease in the forward spar web that ran from about WS 34 at the upper cap to about WS 40 at the lower cap. The left wing leading edge skin remained attached between the root and the joint near WS 34. The WS 34 leading edge rib was crushed aft against the forward spar.

**Figure 3.** Left wing forward spar fracture, looking down (Piper photo)

All the wing fracture surfaces examined exhibited an angled, dull, grainy appearance consistent with overstress separation. There was no appreciable corrosion or evidence of pre-existing fractures noted.

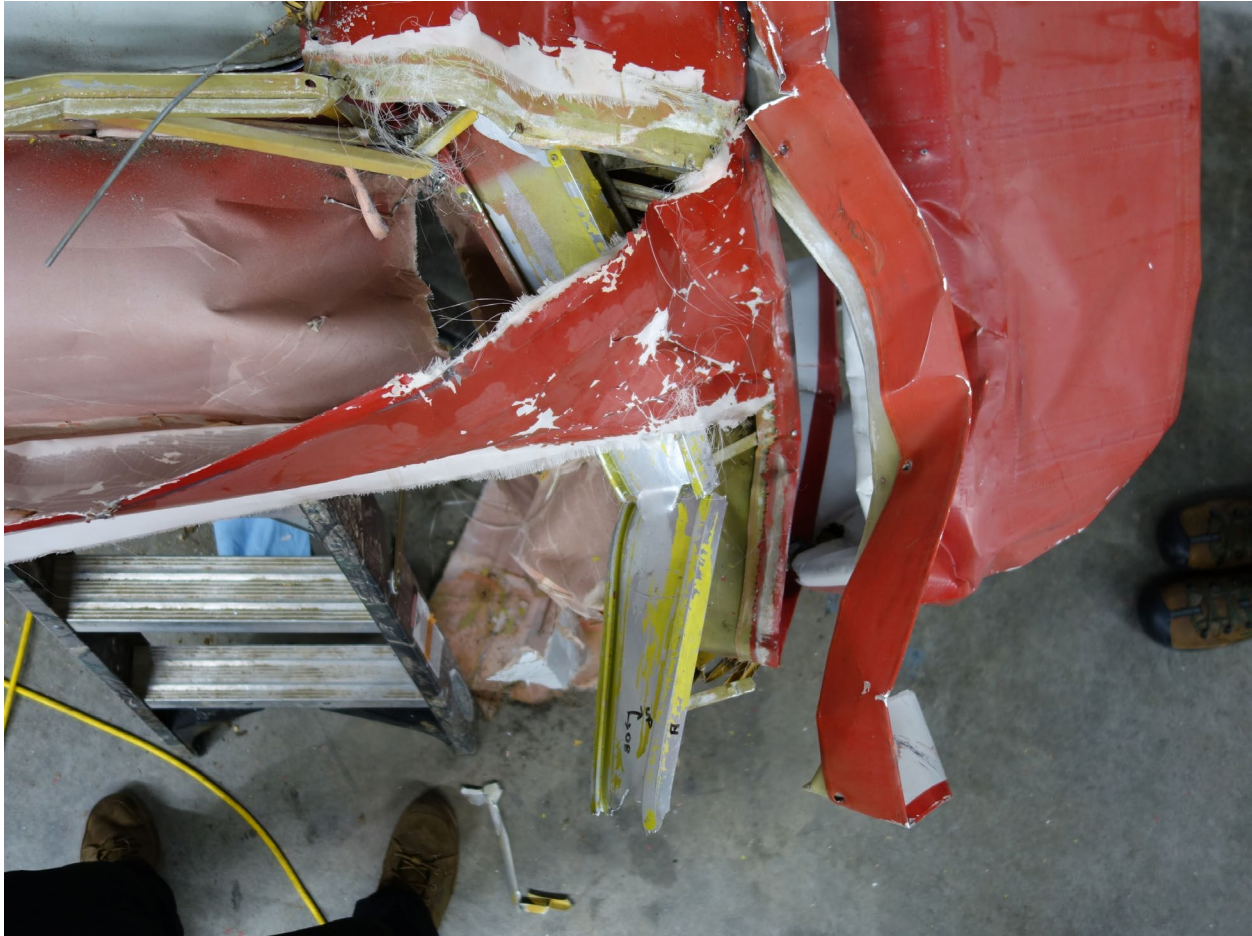
The aft spar was partially fractured near WS 46 and fully fractured near WS 56. The aft spar was deformed aft and twisted leading edge up between about WS 28 and WS 46 and deformed forward between about WS 46 and WS 56 (Figure 4).

**Figure 4.** Left wing aft spar fracture, looking down (Piper photo)

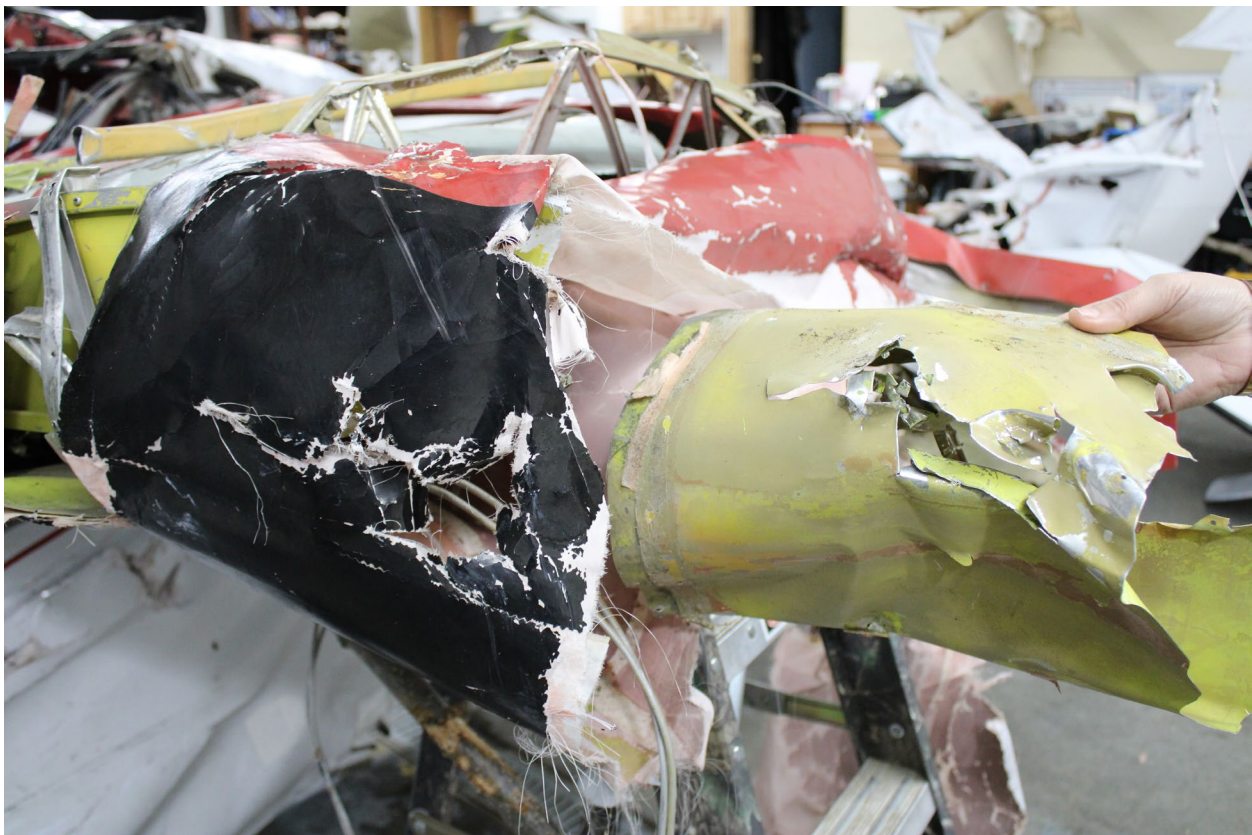
The leading edge skin between the joints at WS 34 and WS 67 was separated and fractured into two pieces. The skin pieces were flattened and there was damage consistent with impact noted between WS 36 and WS 62 (Figure 5). The upper portion of the leading edge skin between WS 40 and WS 50 had mechanical tearing damage and the lower portion had an upward semi-circular impression. The leading edge fabric was torn and damaged coincident with the leading edge skin damage. There were diagonal witness marks on the upper leading edge fabric in an inboard and aft direction.

**Figure 5.** Left wing leading edge skin and fabric damage (NTSB photo)

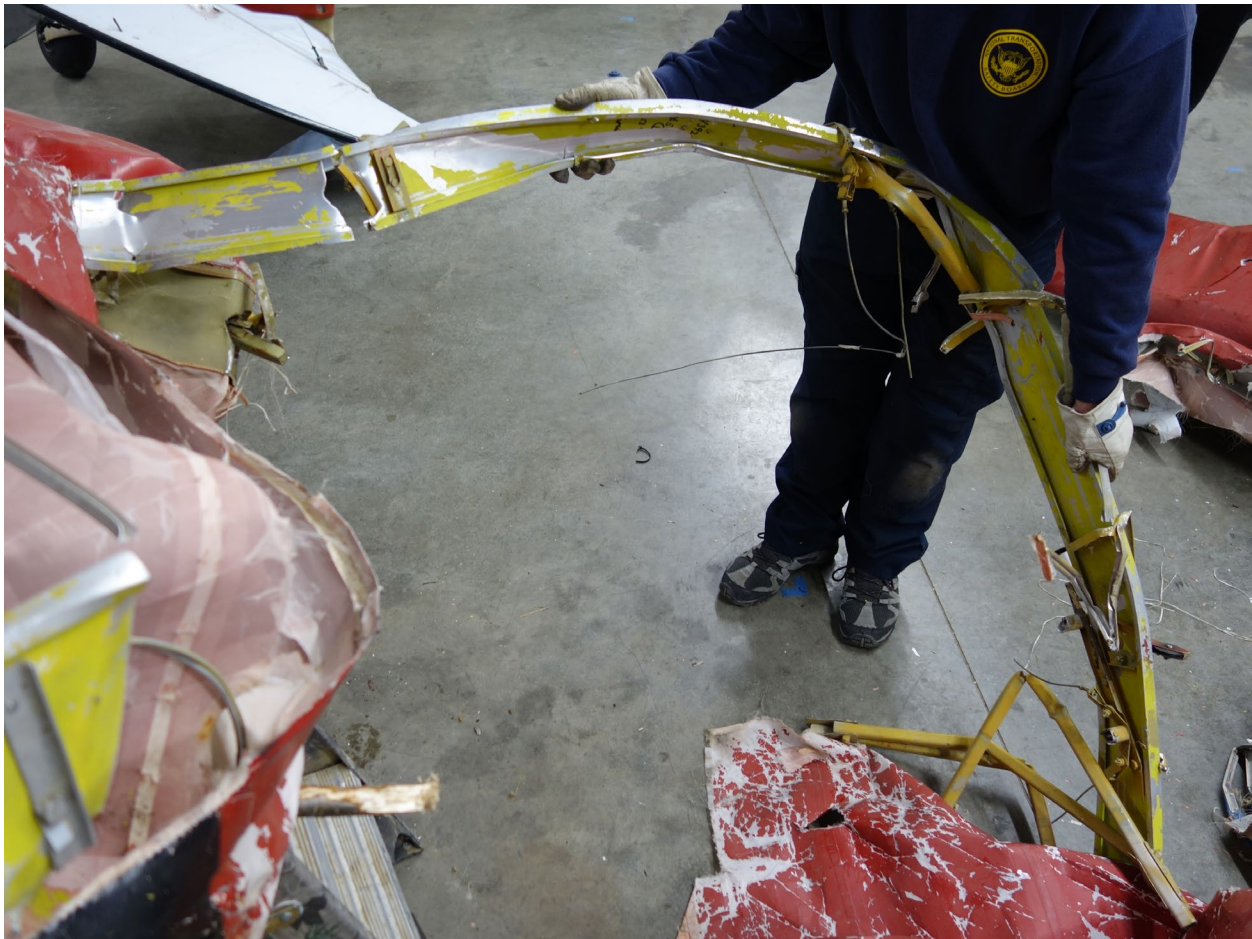
The aft spar was deformed forward in a large arc and twisted leading edge down between the fracture near WS 56 and a fracture between WS 133 on the upper cap and WS 136 on the lower cap (Figure 6). There was a fracture in the lower cap near WS 90 and a fracture in the upper cap near WS 97 coincident with chordwise bending deformation. The aft spar was mostly intact and straight from WS 136 to the tip. There was no reinforcement installed on the rear spar in the area of the lift strut attach fitting which would be consistent with the installation of an STC to increase the gross weight (STC SA00997CH). The original Piper style truss ribs were damaged and mostly separated from the spars and retained by the fabric stitching. The left aileron remained attached to the outboard aft spar section and was deformed spanwise aft and down about 90° near the mid-span point. The three aileron hinges were intact and free to move with the hangers attached to the aileron. The inboard aileron hanger was fractured about 1 inch aft of the aft spar and the center hanger was pulled from the rear spar. The center hanger bolt remained installed in the aft spar.

**Figure 6.** Left wing aft spar deformation (NTSB Photo)

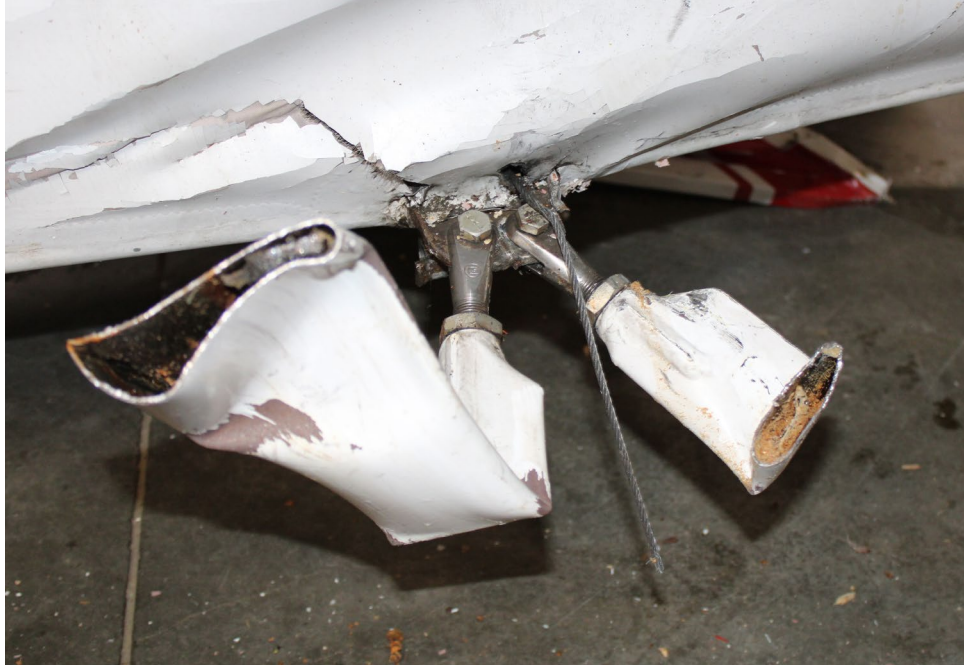
The left forward and aft lift struts remained attached to the fuselage and the spars on scene but were cut during recovery. The leading edge of the forward lift strut was facing aft, and the leading edge of the aft lift strut was facing forward at the lower ends where they attached to the fuselage (Figure 7). There was hardened and crystalized linseed oil inside the lower ends of the lift struts where they were cut. The lower lift strut attach points were disassembled. There was no nut on the aft lower attach bolt but there was a cotter pin and washer installed. The low-profile castellated nut on the forward bolt was fractured through one side. The tangs of both lower strut fittings were spread apart and the bolts had mashed threads. The fuselage lugs were deformed down, and both holes were elongated.

**Figure 7.** Left lift struts, lower ends, attached to fuselage (NTSB Photo)

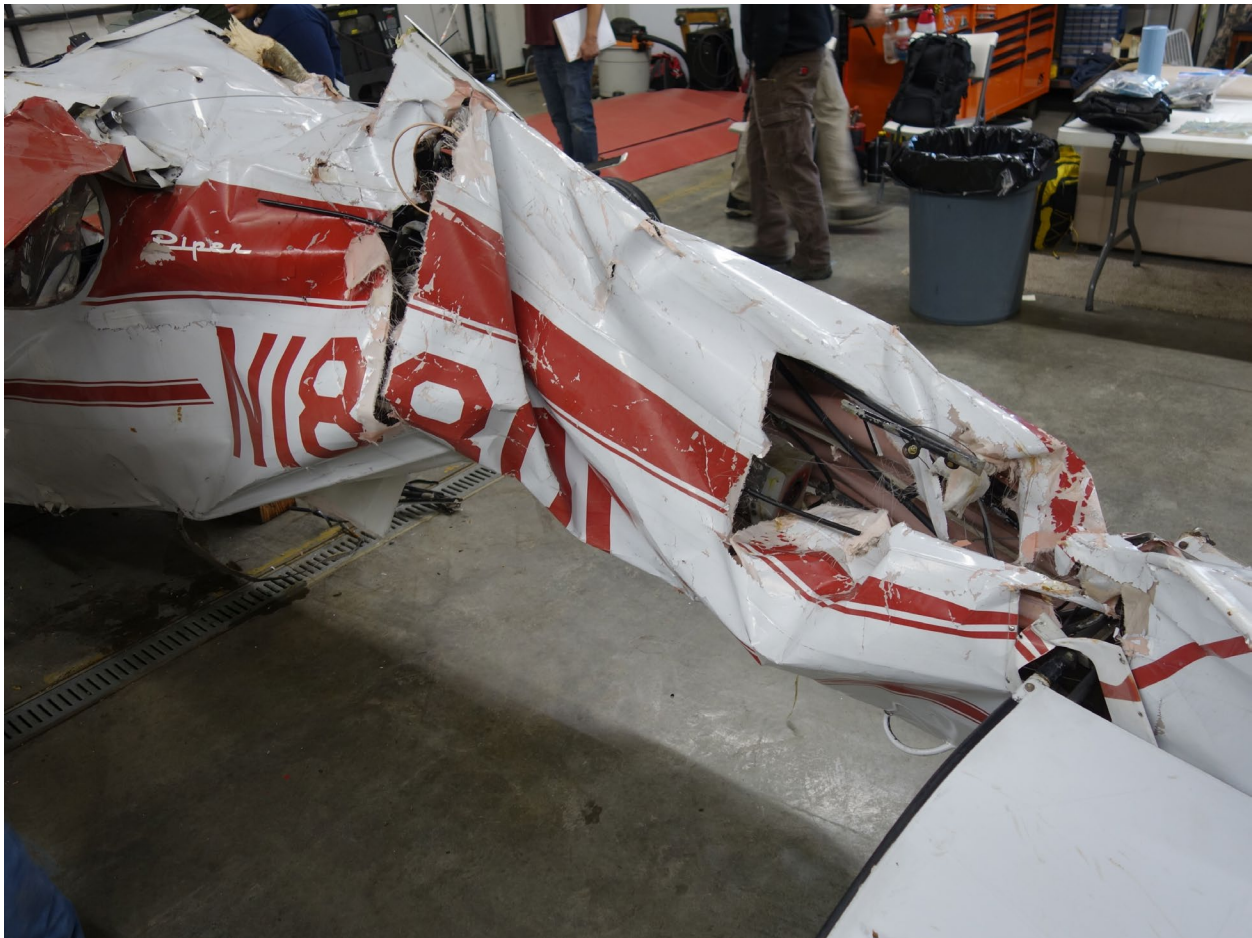
The airplane impacted the tree and brush covered terrain in an inverted, nose low attitude. A tree had penetrated the aft fuselage from the upper to lower surfaces just forward of the vertical stabilizer. The left side of the aft fuselage appeared to be crushed inward in the vicinity of the N-number (Figure 8). The fabric was cut away and the tube truss structure was examined. Figure 9 identifies the individual truss elements that were bent and fractured.

**Figure 8.** Aft fuselage, left side (Piper photo)

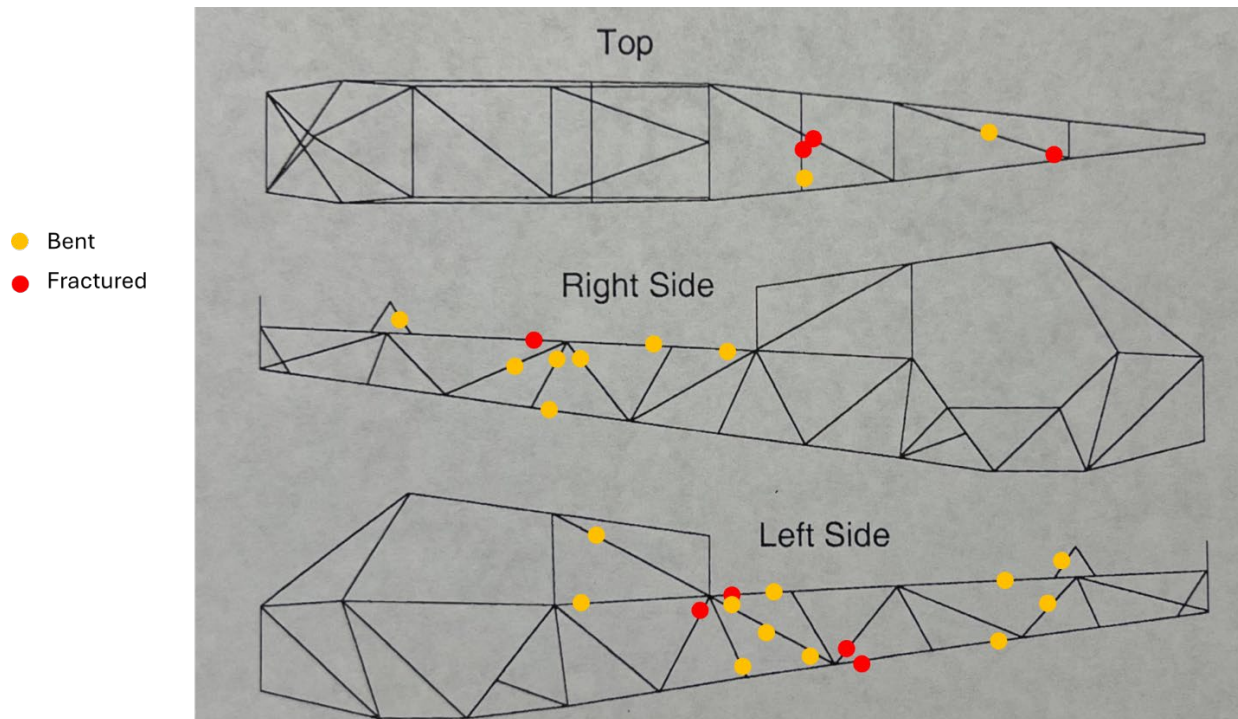
**Figure 9.** Fuselage truss structure damage (NTSB diagram)

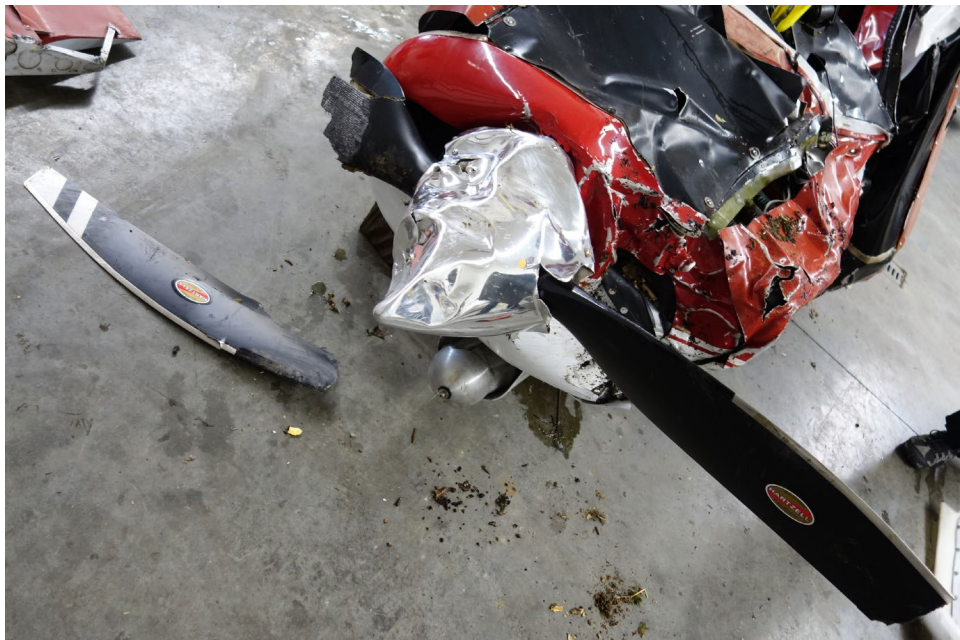
The airplane was equipped with a Hartzell two bladed, constant speed propeller with composite blades (HC-C2YR-1N/NG8301). The propeller hub remained attached to the engine with portions of the composite blades still installed and the spinner still attached (Figure 10). The spinner was crushed against the hub around half the circumference on the side that was facing down at the impact site. One of the propeller blades was fractured near the shank and was found beneath the nose of the airplane with the blade butt pointing down towards the fractured blade. This propeller blade exhibited a jagged fracture with damage to the leading and

**Figure 10.** Propeller and spinner (NTSB photo)

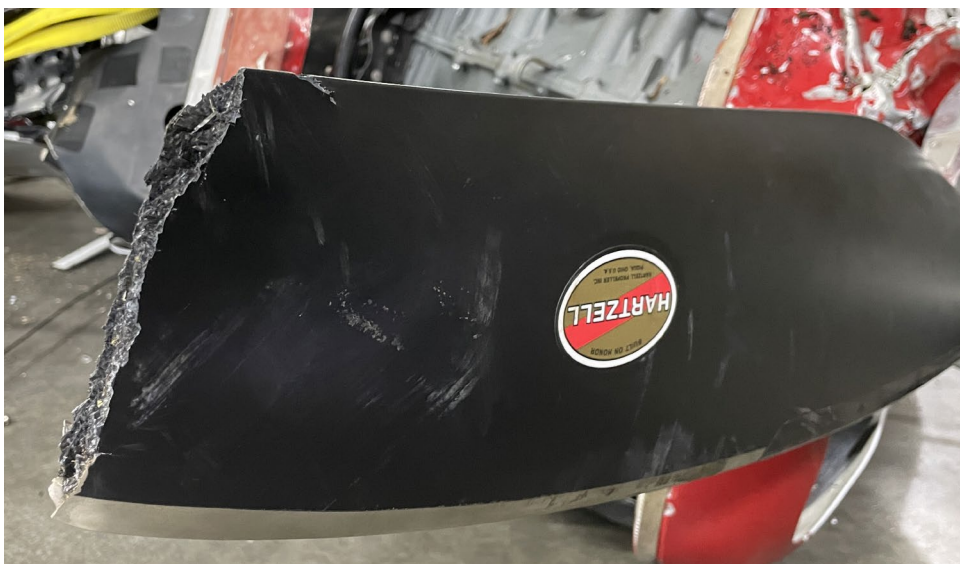
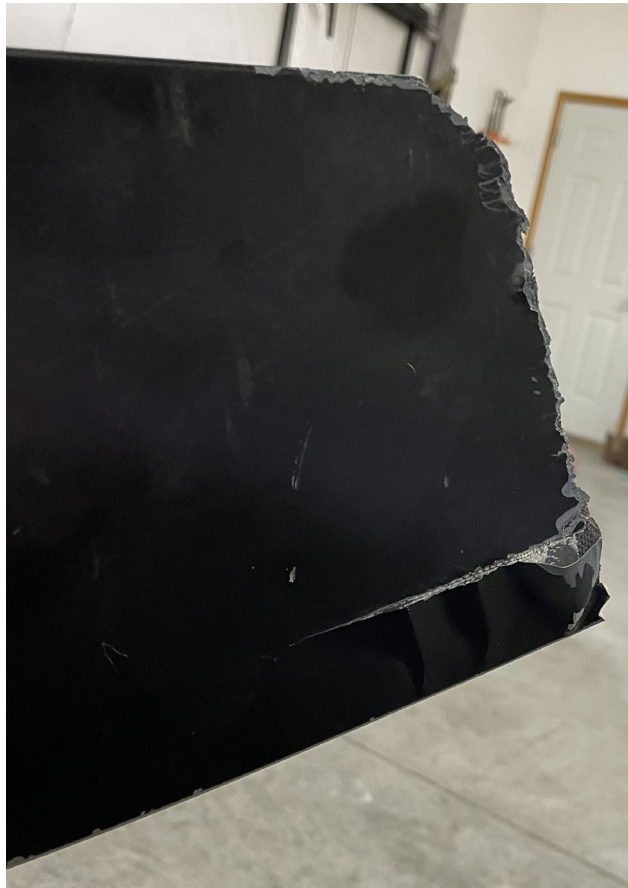
trailing edges and camber and face sides around the fracture. The other propeller blade was missing about 7.5 inches of the blade tip. The blade tip was not recovered. The propeller blade with the missing tip had some chordwise scuffing on the camber side and had a transverse fracture from leading edge to trailing edge (Figure 11). The metallic leading edge erosion strip was deformed aft at the fracture location and the face side of the erosion strip was buckled (Figure 12). Swabs of the camber and face sides of the fractured propeller blade were taken for testing. Testing by the Smithsonian Institution's Feather Identification Lab did not find any trace of bird DNA. The fracture propeller blade was sent to the NTSB Materials Lab for further examination.

**Figure 11.** Propeller blade with missing tip, camber side (NTSB photo)

**Figure 12.** Propeller blade with missing tip, face side (NTSB photo)
