# National Transportation Safety Board

ANC24FA008

## **AIRPLANE PERFORMANCE STUDY**

Location: Anchor Point, Alaska  
Date: December 8, 2023  
Time: 1315 Alaska standard time (AKST)  
Airplane: Piper PA-18-150, N1880P

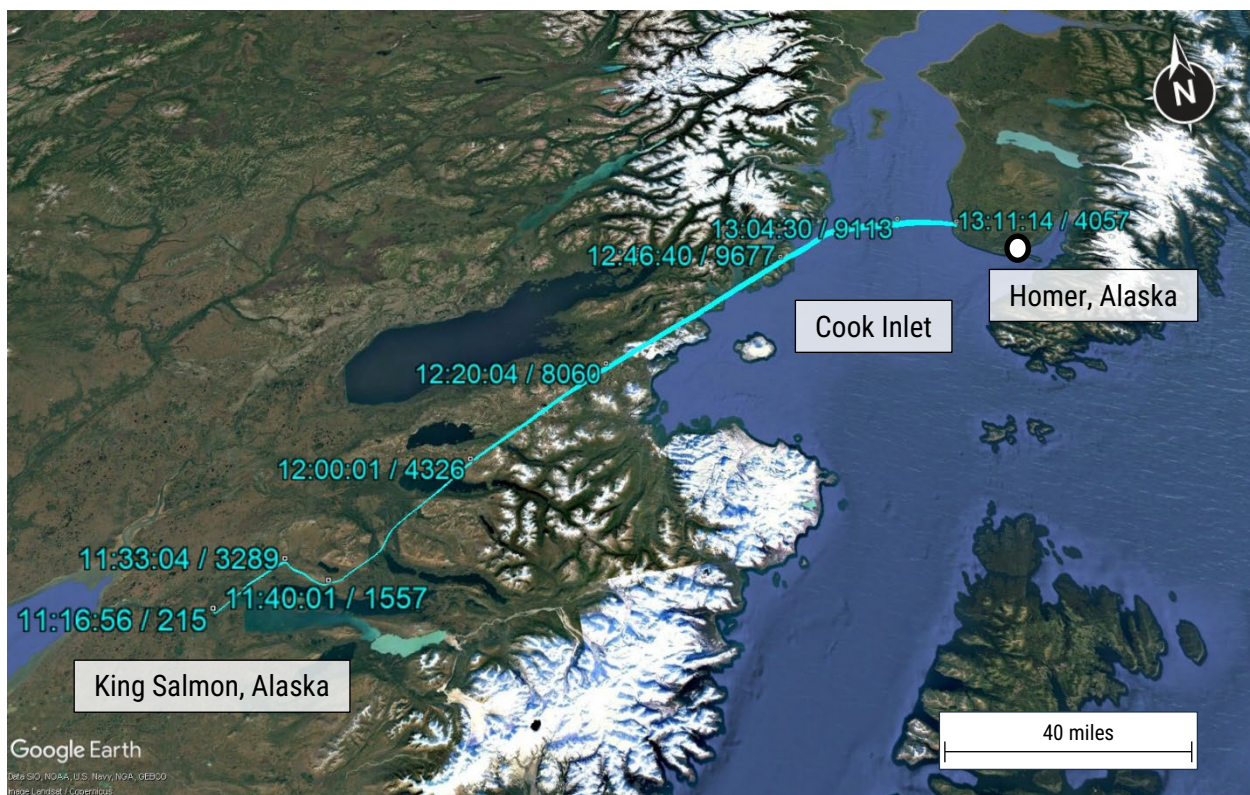
The airplane departed from a private airstrip near King Salmon, Alaska, at about 11:23 AKST. It was expected to fly northeast, cross the Cook Inlet to Anchor Point, Alaska and then turn southeast towards its intended destination of Homer, Alaska. Figure 2 shows the airplane's flight path and Figure 3 shows the altitude and speed profile. The airplane climbed to an altitude of 9,680 ft by 12:46:38 as it started to cross the Cook Inlet.

**Figure 2.** GPS flight path with selected times and altitudes notated.

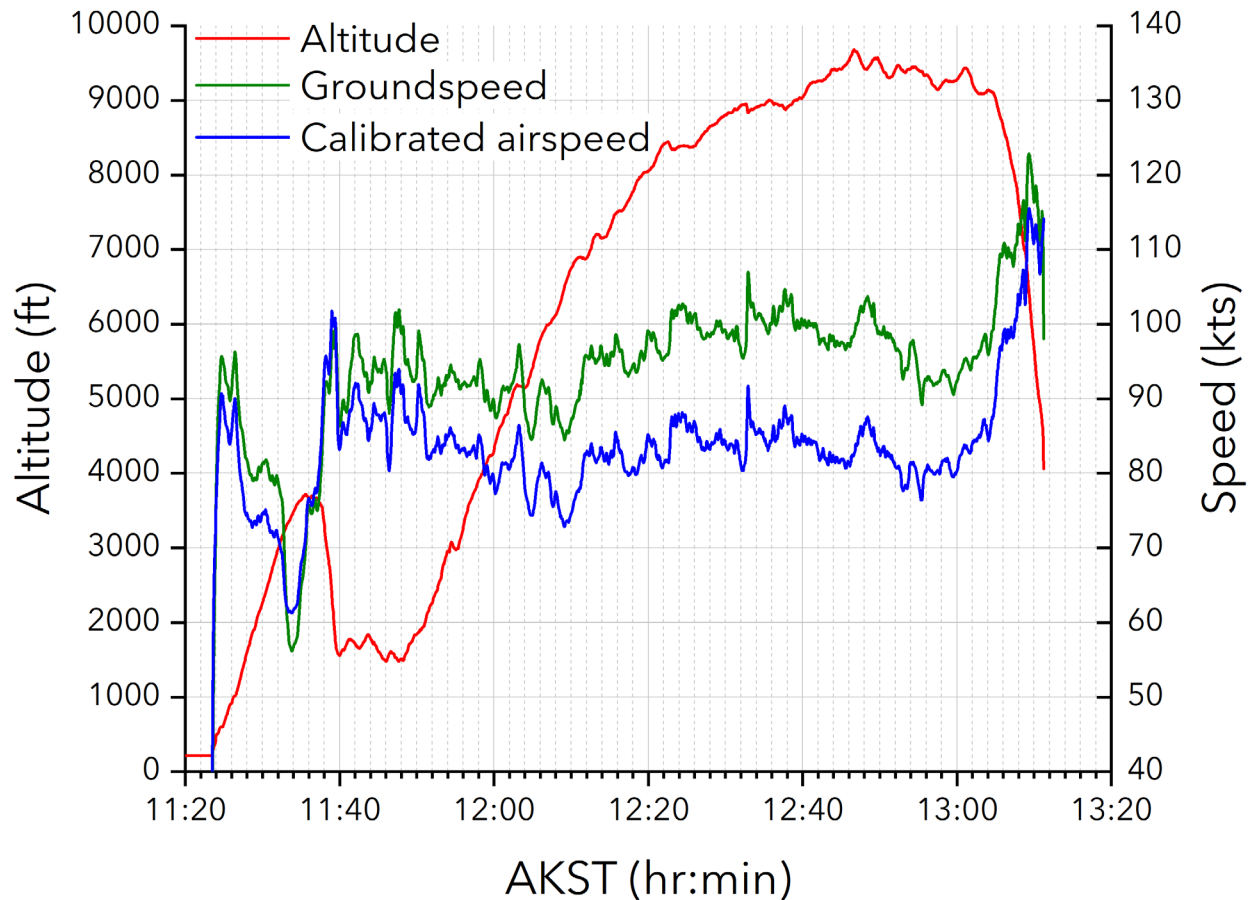
**Figure 3.** Corrected altitude with recorded groundspeed and calculated calibrated airspeed.

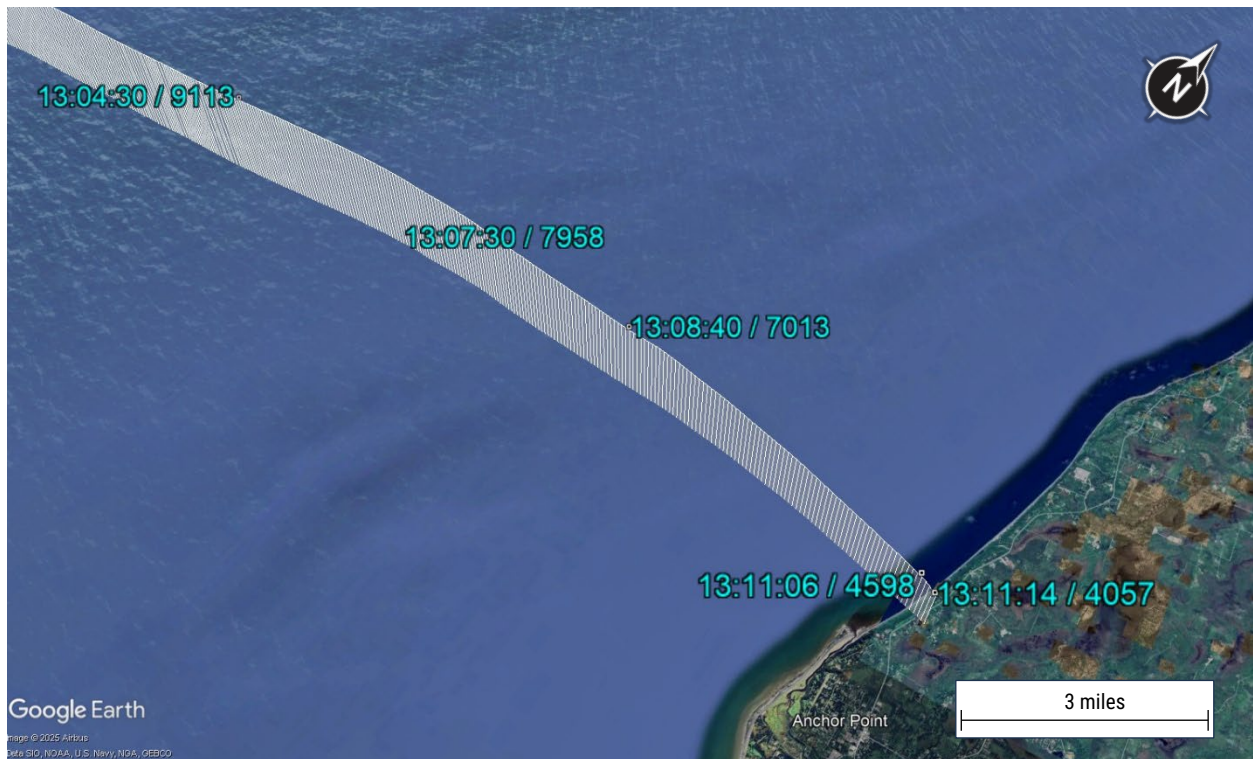
Beginning at 13:04:30, the airplane began to descend while still over the water. Figure 4 shows the end of flight and Figure 5 shows the airplane's descent rates and airspeed. The airplane's speed increased as it descended. Just after 13:11 the airplane was again over land and its descent rate increased to 4,000 fpm.

**Figure 4.** GPS flight path with selected times and altitudes notated.

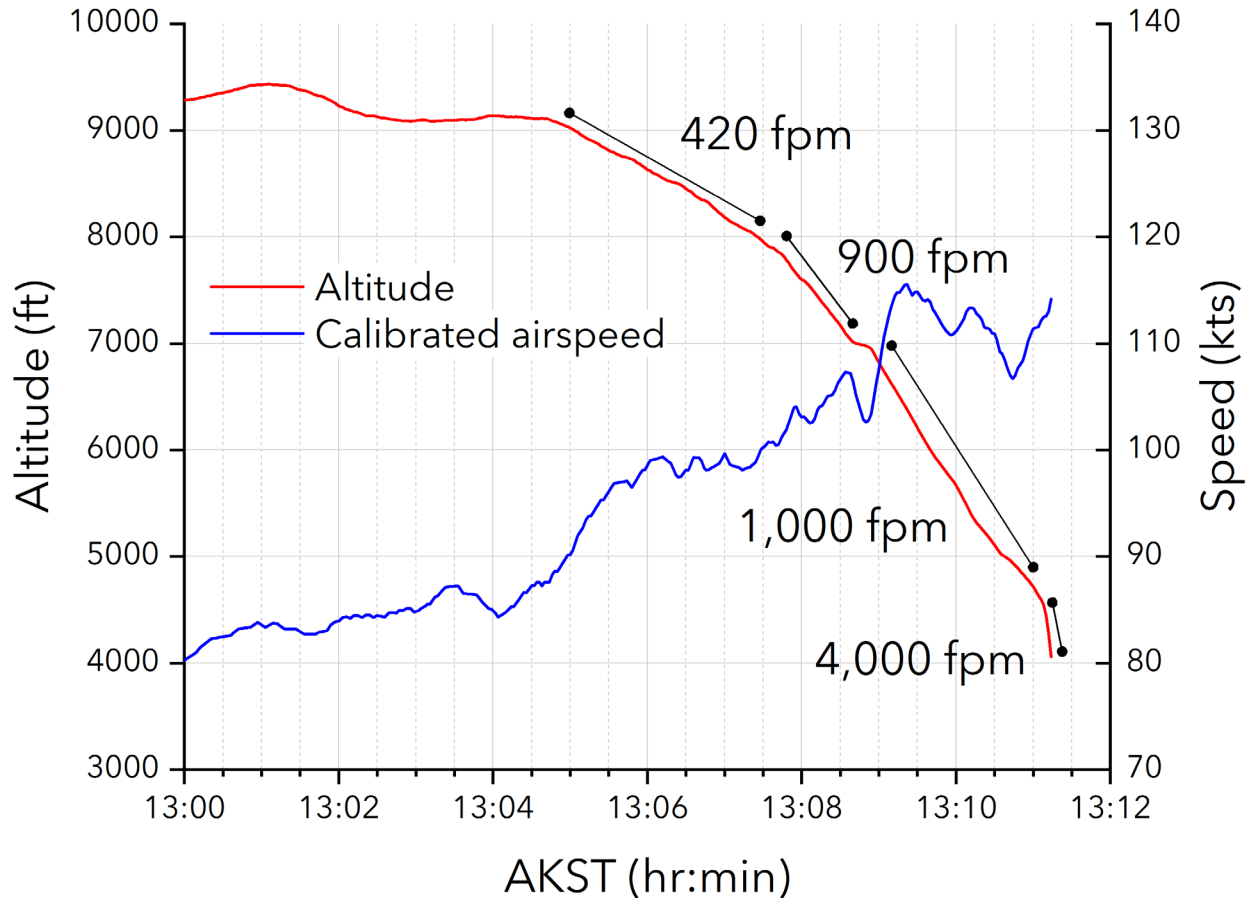
**Figure 5.** Corrected altitude with calculated calibrated airspeed.

The listed maneuvering speed,  $V_a$ , for the PA-18 is listed as 83 kts, indicated airspeed<sup>1</sup>. The maximum cruising speed is 106 kts and its never exceed speed,  $V_{ne}$ , is 133 kts [1]. During the descent over water, the airplane had been gaining airspeed above the maneuvering speed and maximum cruise speed. It remained below the never exceed speed, but the airspeed was increasing as the data ended.

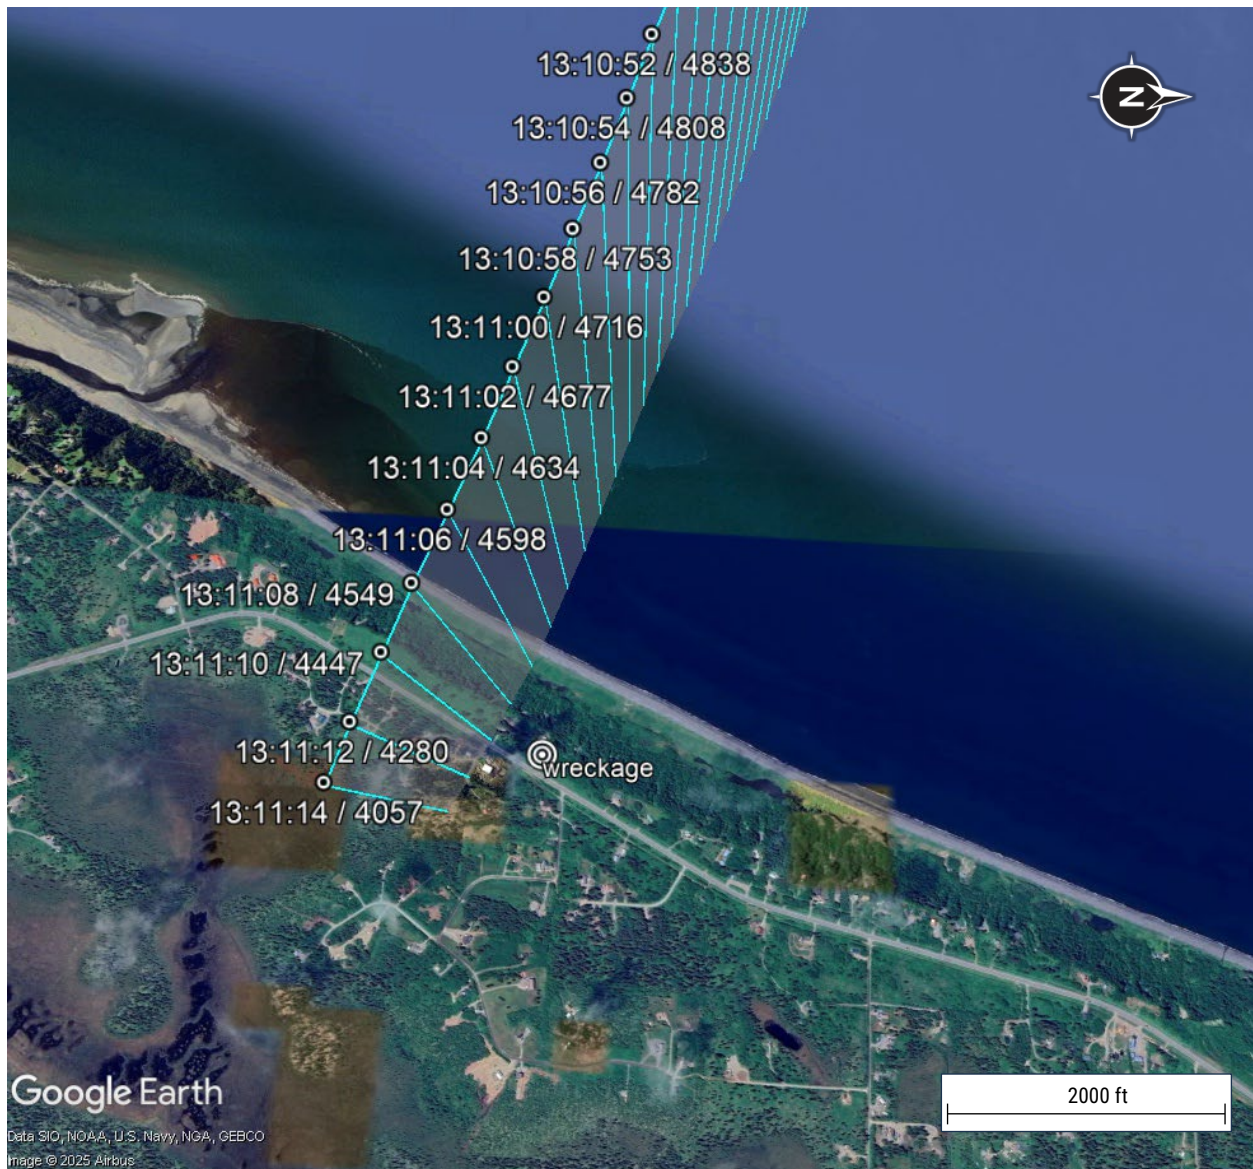
GPS data ended at 13:11:14 when the airplane was at an altitude of 4,057 ft and a calibrated airspeed above 110 kts. The wreckage was located 900 ft from the final GPS location, but oriented in the opposite direction of the final flight track (Figure 6). The elevation in the area of the wreckage is 200 ft.

**Figure 6.** GPS flight path with selected times and altitudes notated and the wreckage located.
