# National Transportation Safety Board

ANC24FA029

## ENGINE INVESTIGATION

Location: Fairbanks, Alaska  
Date: April 23, 2024  
Time: 10:03 Local  
Airplane: Douglas C54D

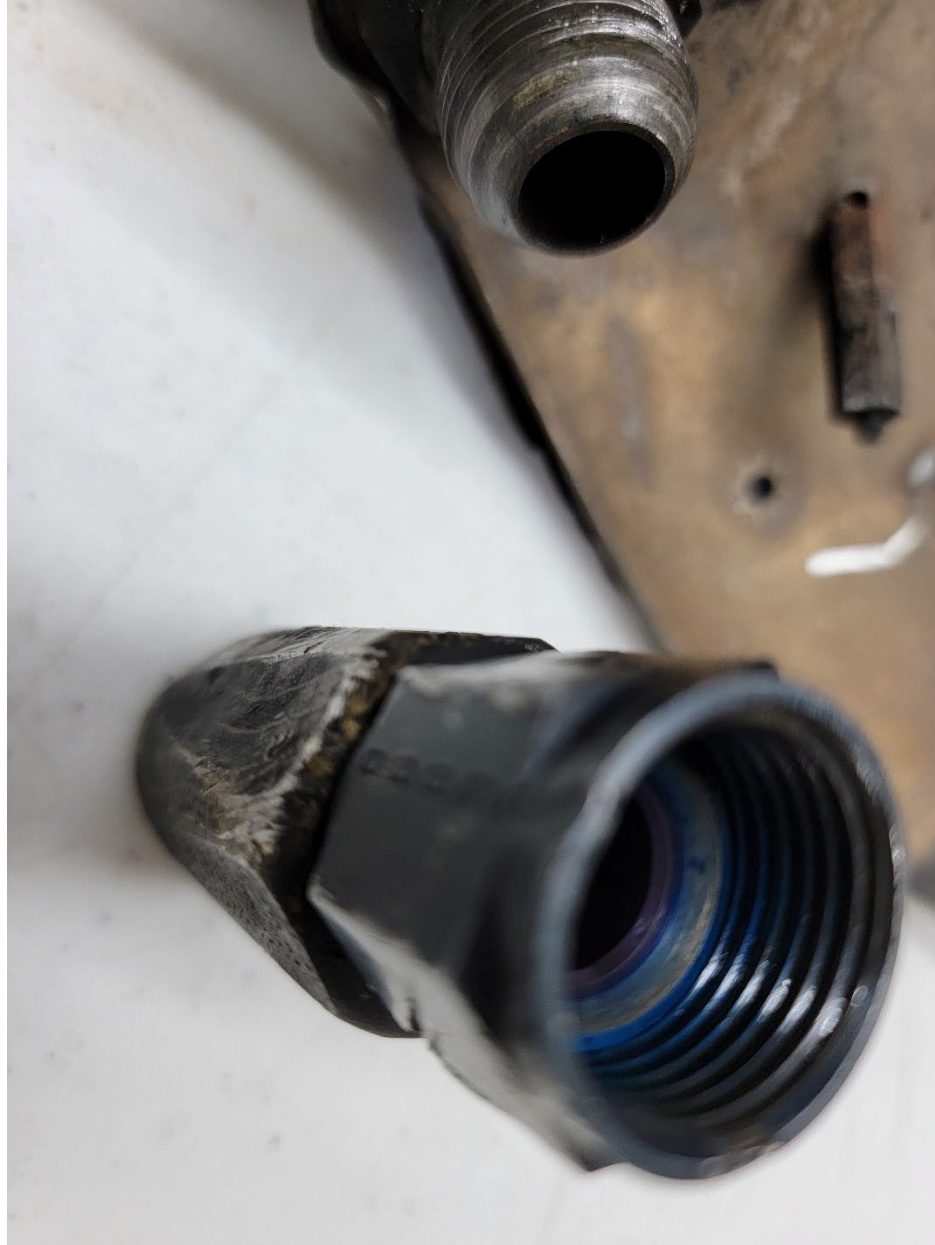
One AN-8 hose fitting was found in the exhaust heat shield area. The hose had burned from the fitting and the threads were in good condition with no apparent mechanical damage.

**Figure 1 AN-8 hose fitting found in the exhaust heat shield with undamaged threads.**

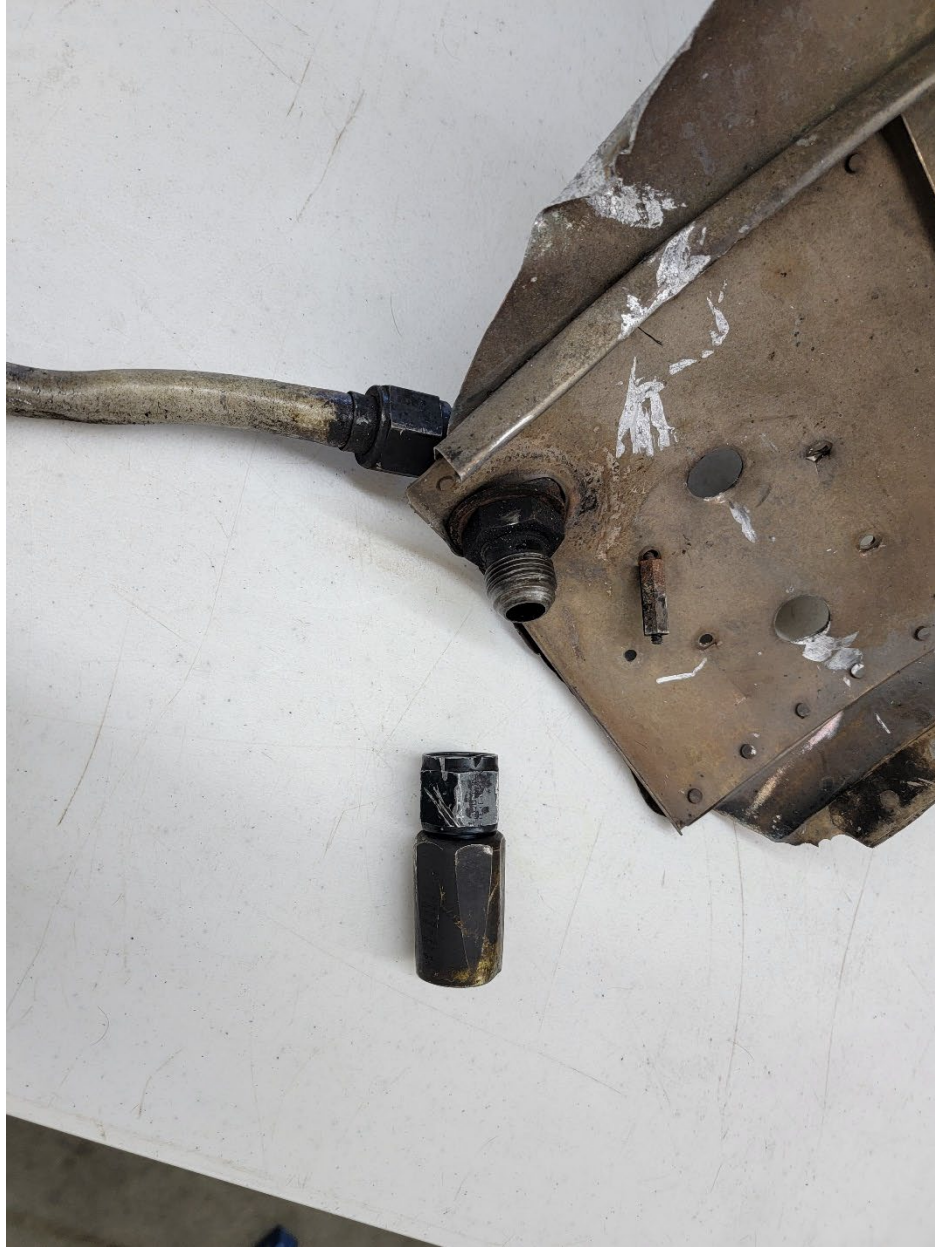
A portion of the firewall, which was separated from the engine, engine mount, and remaining portion of the airframe, had a 90-degree elbow -8 sized AN bulkhead fitting installed. One end of the fitting had a B nut and metal hard line installed. The opposing end did not have a B nut or hose attached. The threads of the fittings were intact and undamaged. This fitting was part of the propeller feathering system.

**Figure 2 Firewall connection of the propeller feathering system.**

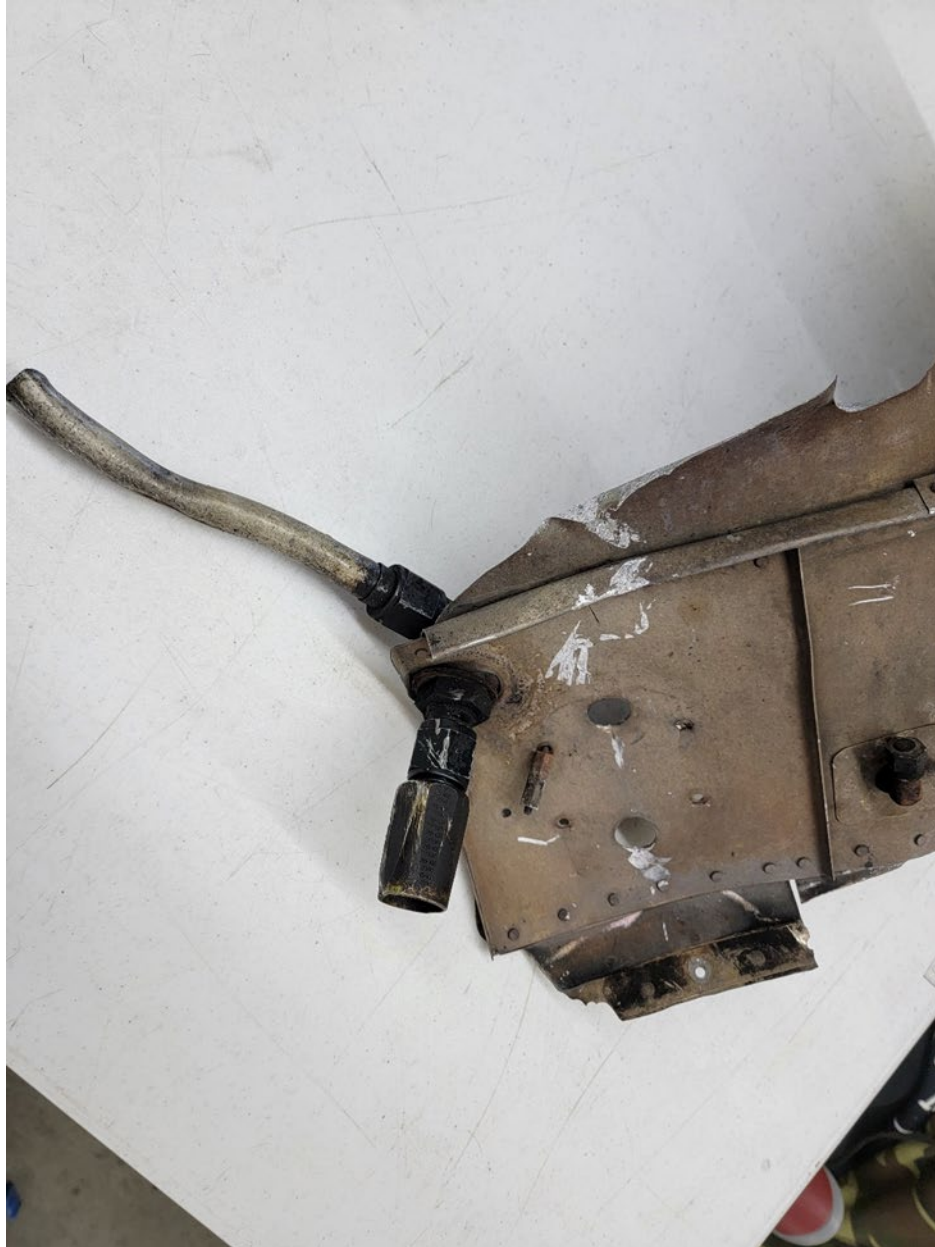
**Figure 3. View of the AN-8 nut connected to the firewall fitting. Matching up the two parts found in the wreckage.**

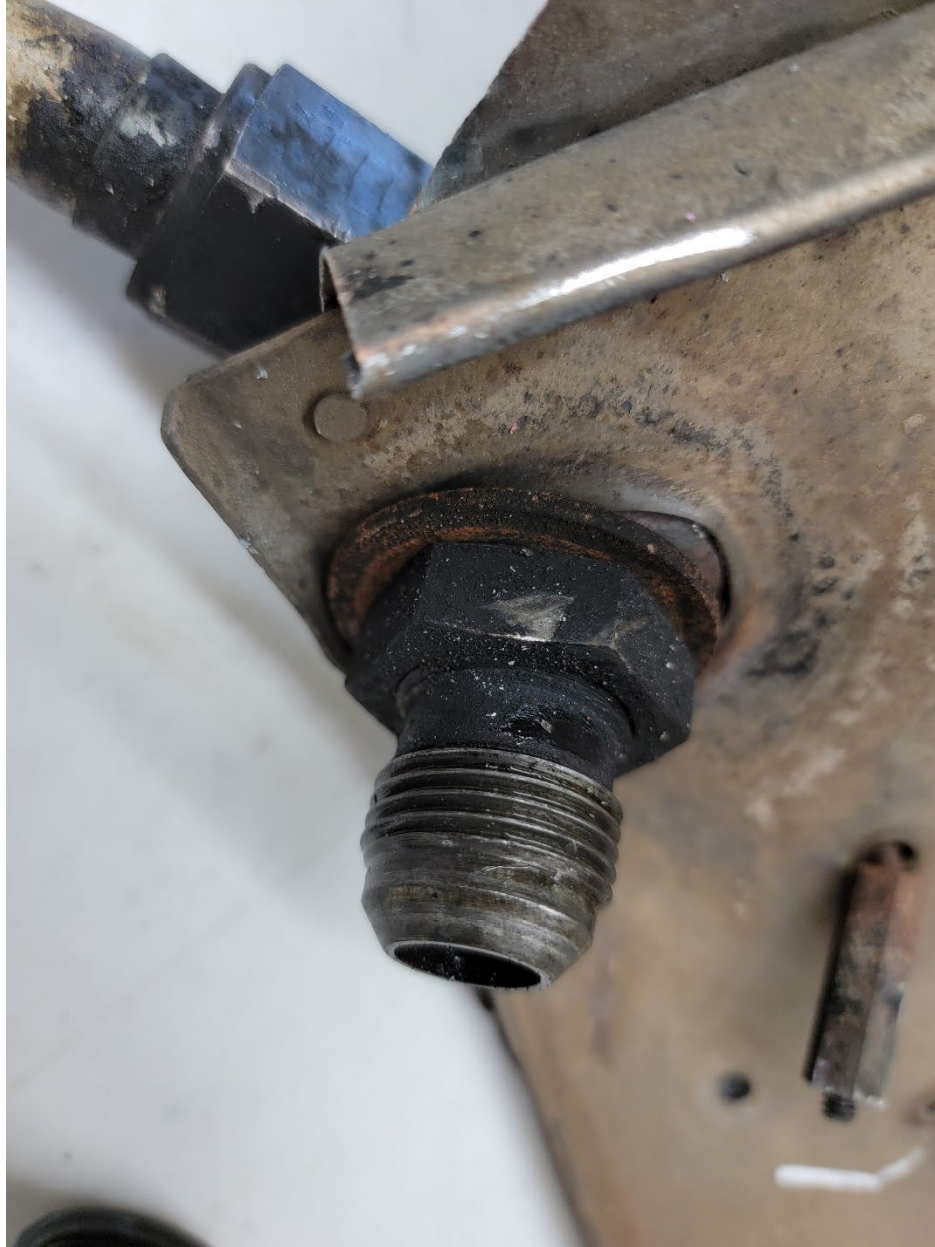
**Figure 4. View of the undamaged fitting connected to the firewall.**

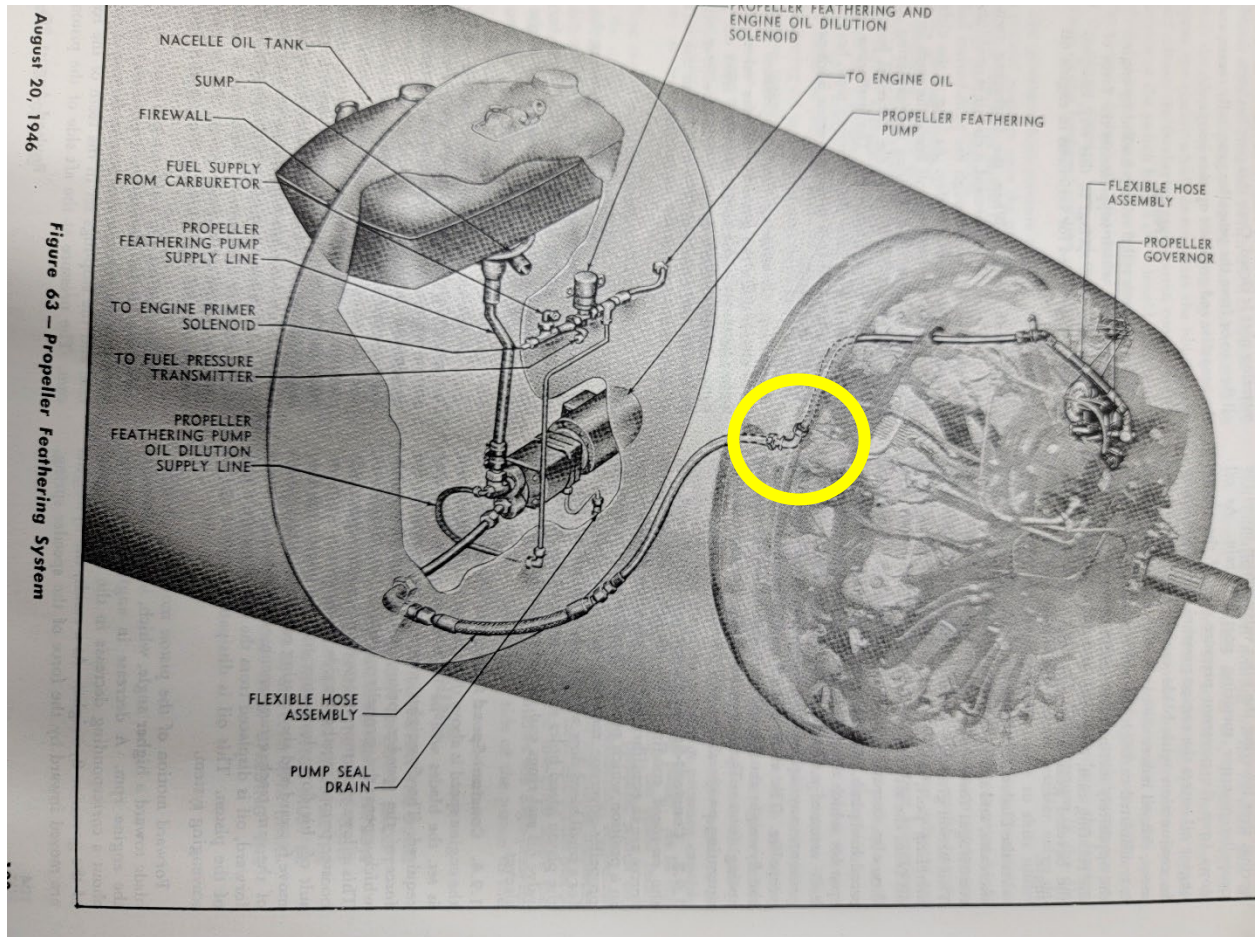
**Figure 5 Location of the firewall section found. Part of the propeller feathering system.**

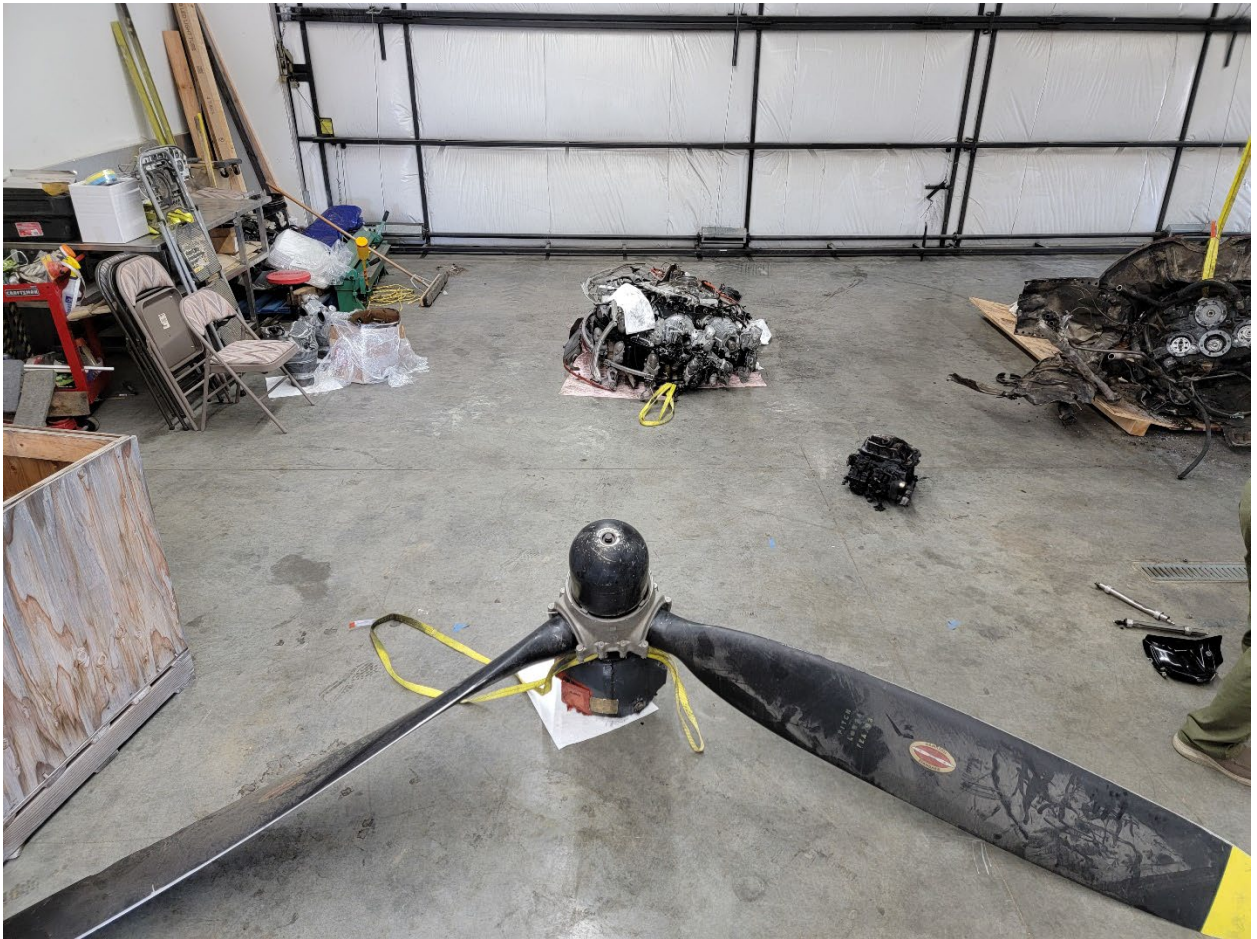
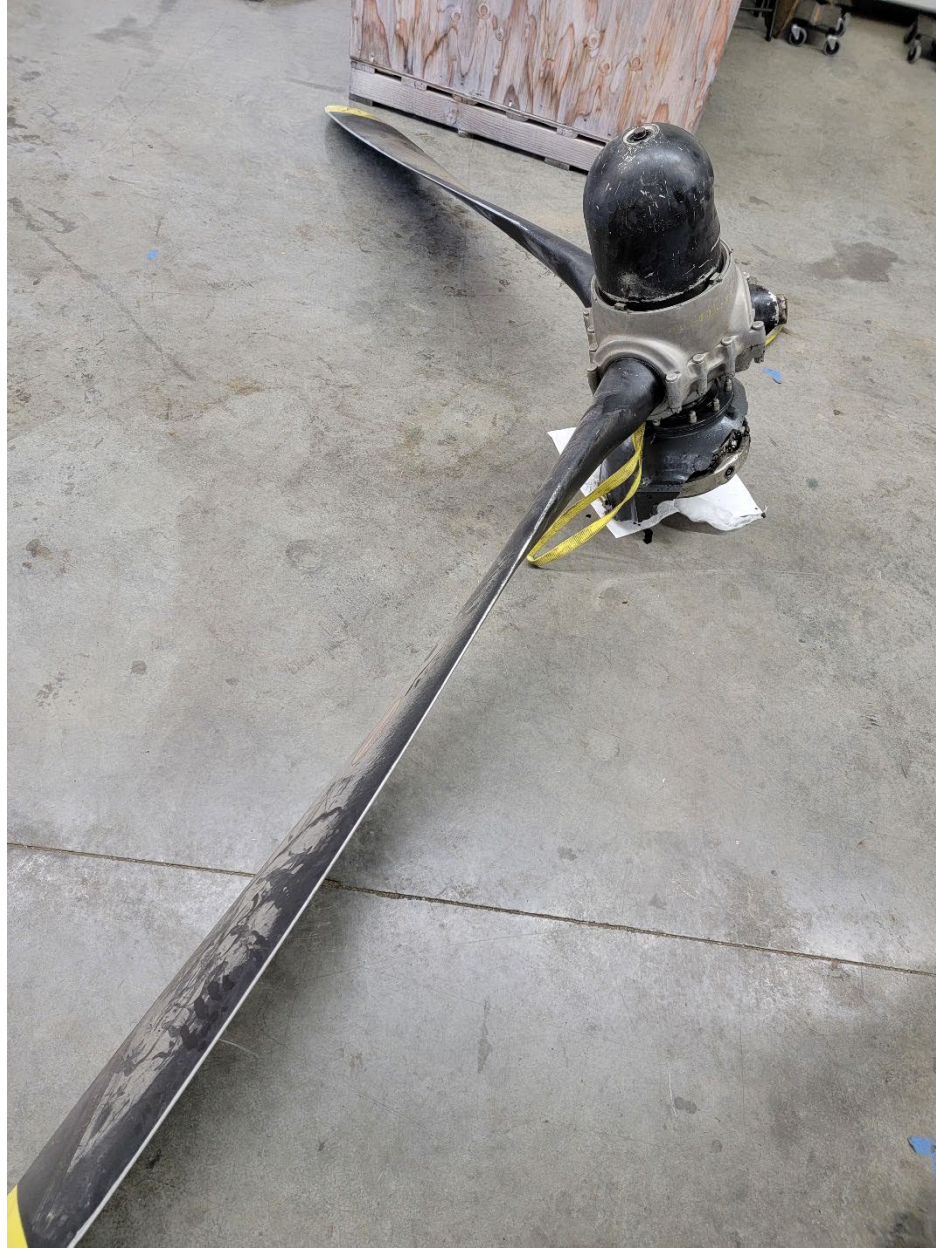
The propeller remains attached to the propeller flange and gearcase. One blade was separated at the hub and not recovered. The two remaining propeller blades remained attached to the propeller hub and were relatively undamaged. Propeller blades were between un-feathered and feathered.

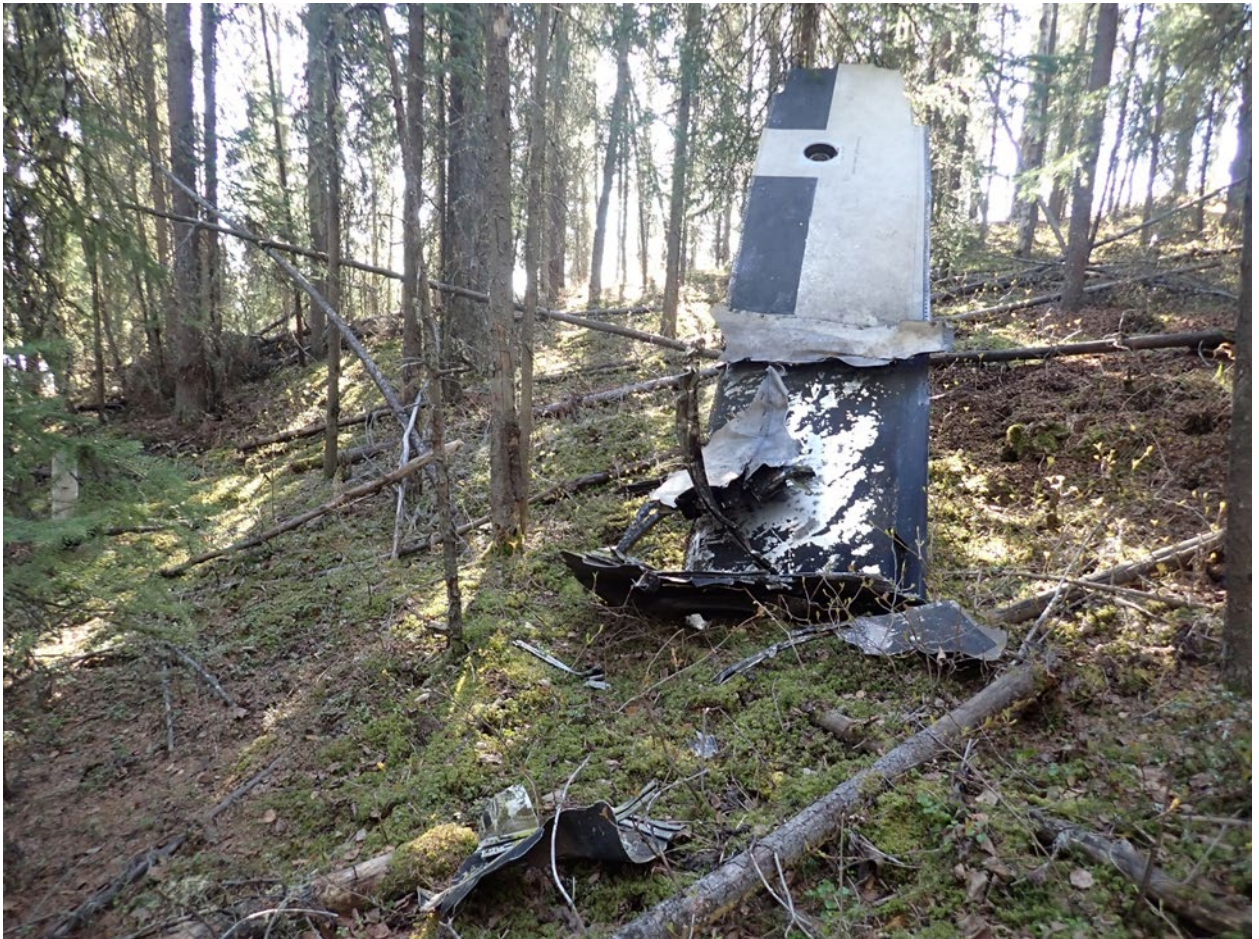
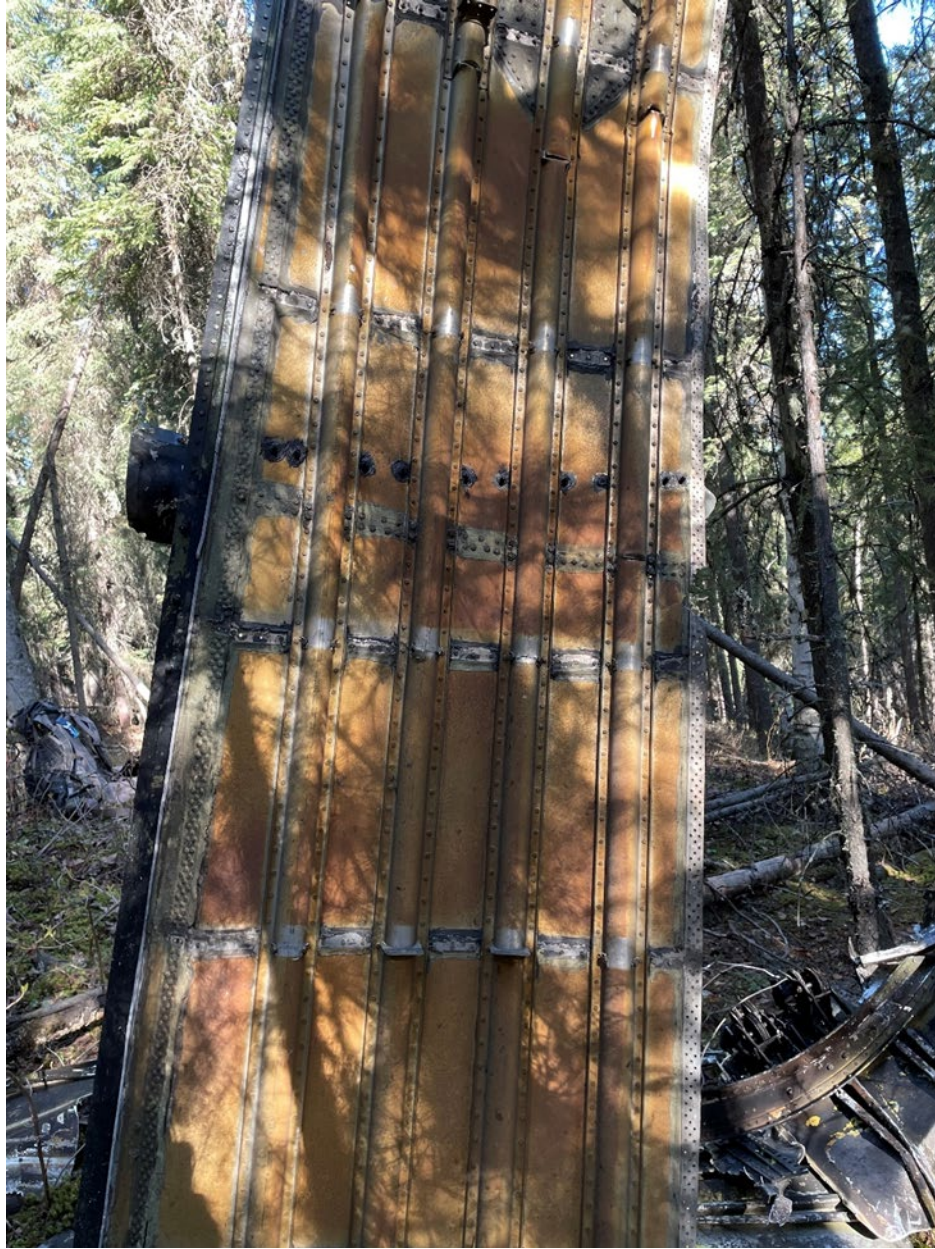
Using video surveillance, a likely area where the explosion occurred was identified and was sent to the Alaska State Troopers (AST). AST searched the area from a helicopter and located debris from the accident airplane. On May 15, 2024, three NTSB investigators hiked into the location. Two large sections of the upper left wing, the aileron bell housing and numerous small aluminum fragments were found in a generally straight line within about 150 yards. The upper/outside skin of the metal found revealed evidence of melted metal spewed across them. A portion of

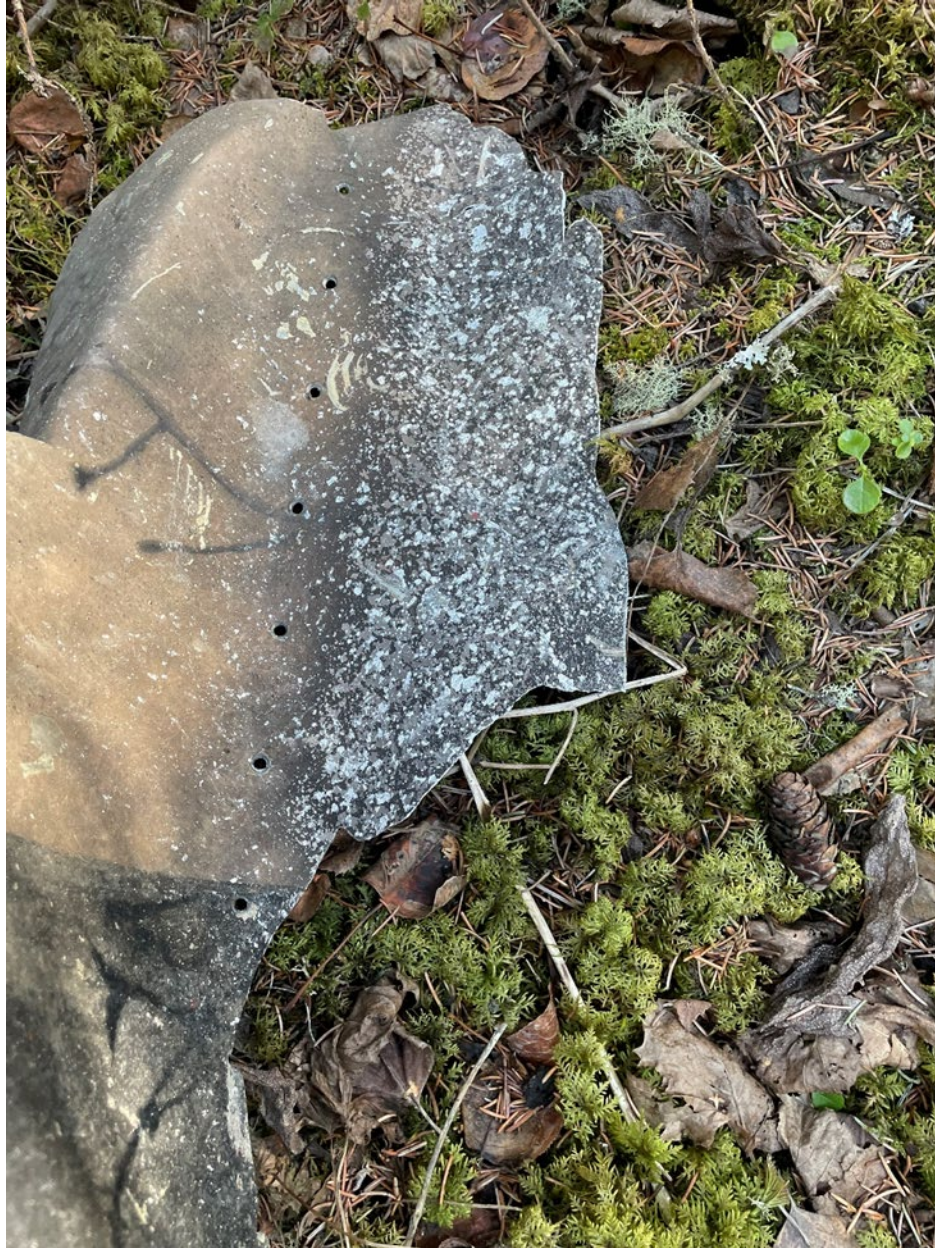
**Figure 14 View of the melted metal spewed across the upper surface.**
