# National Transportation Safety Board

ANC24FA032

## WRECKAGE EXAMINATION

Location: Nondalton, AK  
Date: May 17, 2024  
Time: 1145L  
Airplane: Taylorcraft BC12-D N95744

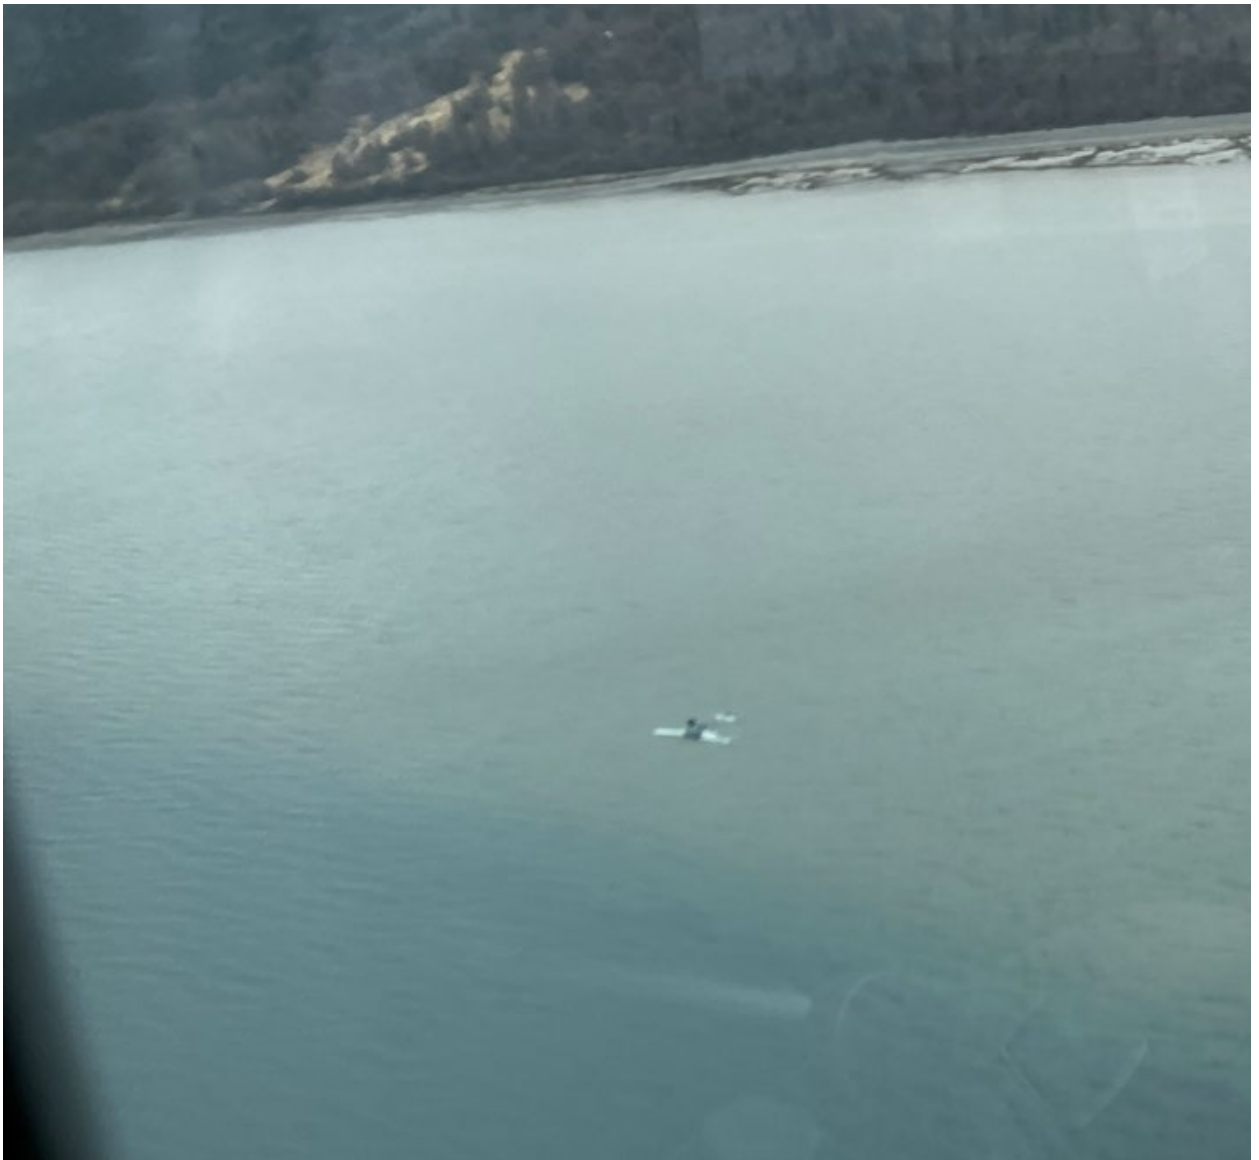
About 19 miles from the departure airport (Port Alsworth). The airplane was upside down with only the tundra tires above the water line. The fuselage was pointed 90 degrees to the left of a direct flight path with the nose of the airplane facing a southeast direction.

**Figure 1 View of accident airplane at accident site. Photo provided by search team.**

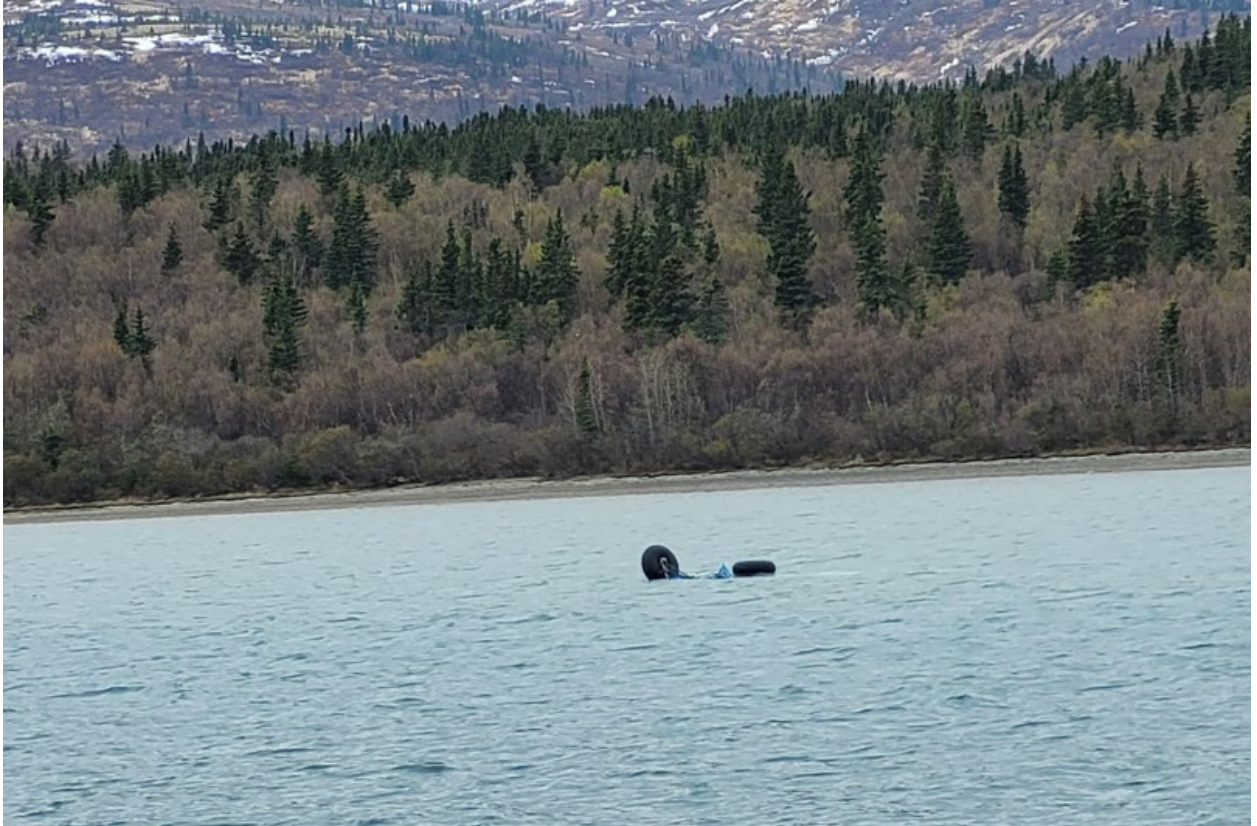
**Figure 2. View of accident airplane before recovery operations. Photo provided by recovery team.**

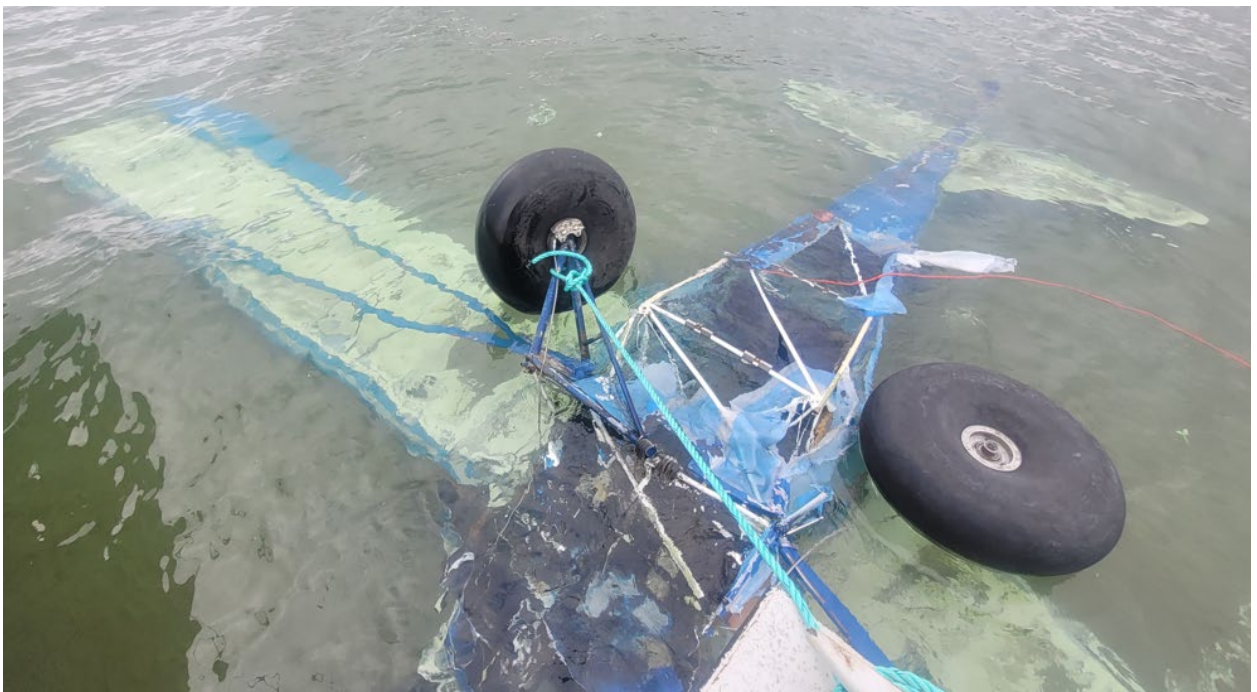
**Figure 3 View from above the water looking down at the airplane at the accident site. Photo provided by the recovery team.**

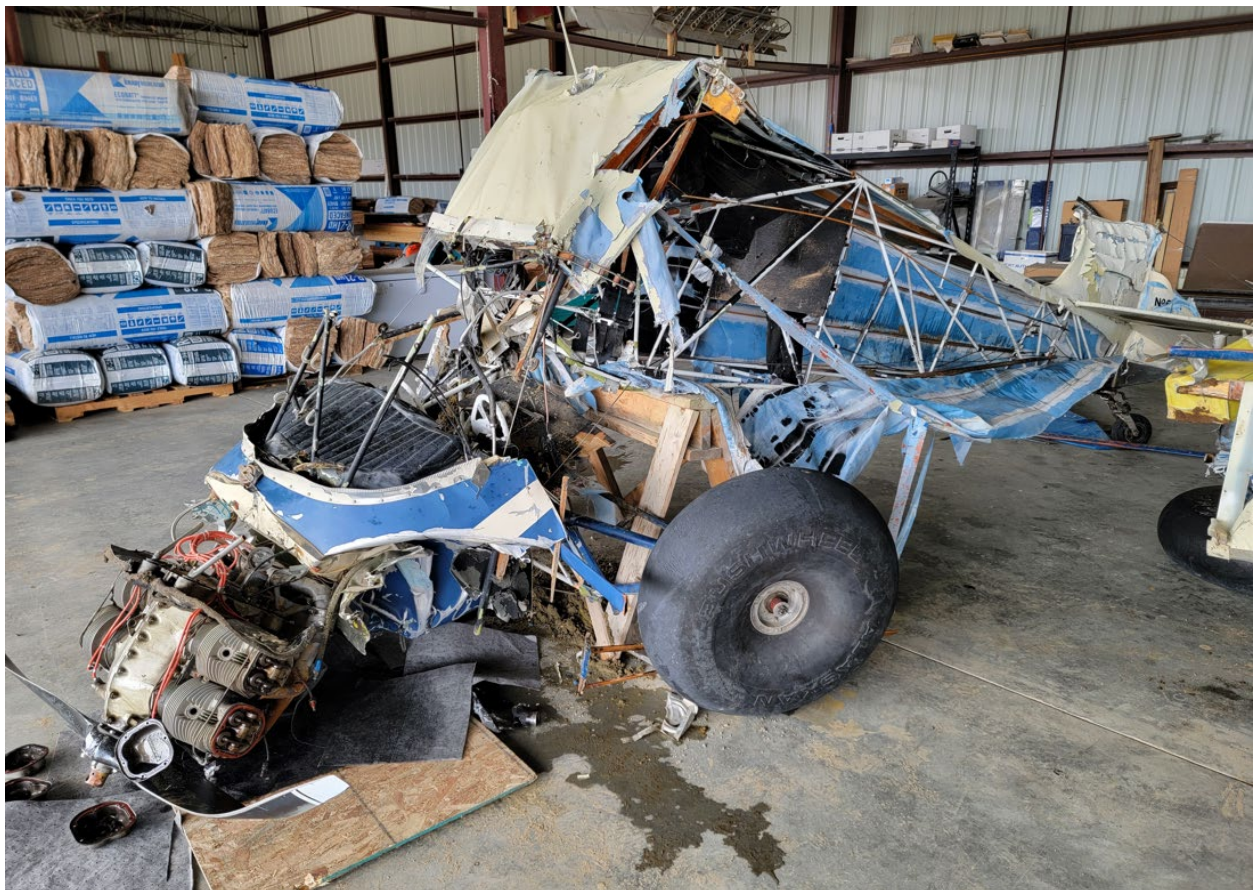
The fuselage from the firewall to aft of the passenger compartment had numerous impact fractures. The underbelly fabric was separated from the firewall to about 6 feet from the tail.

**Figure 4 Left front view of accident airplane**

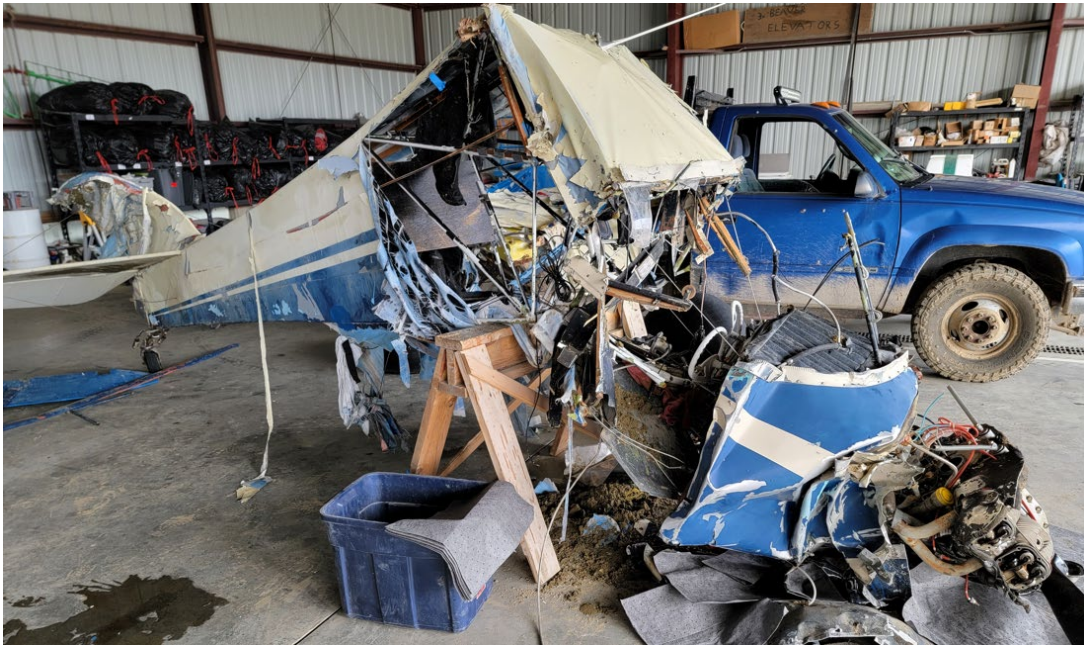
**Figure 5 Right front view of accident airplane during wreckage examination.**

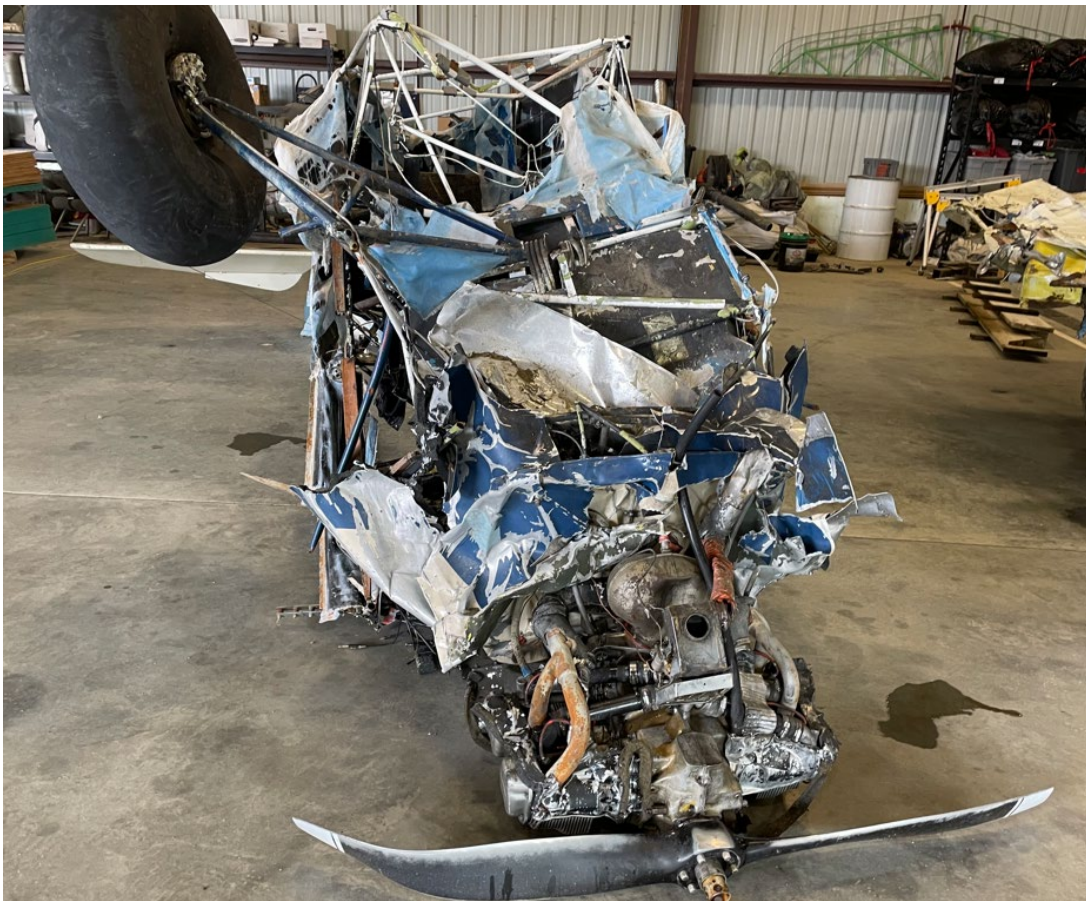
**Figure 6 View of the underside of the accident airplane during wreckage examination.**

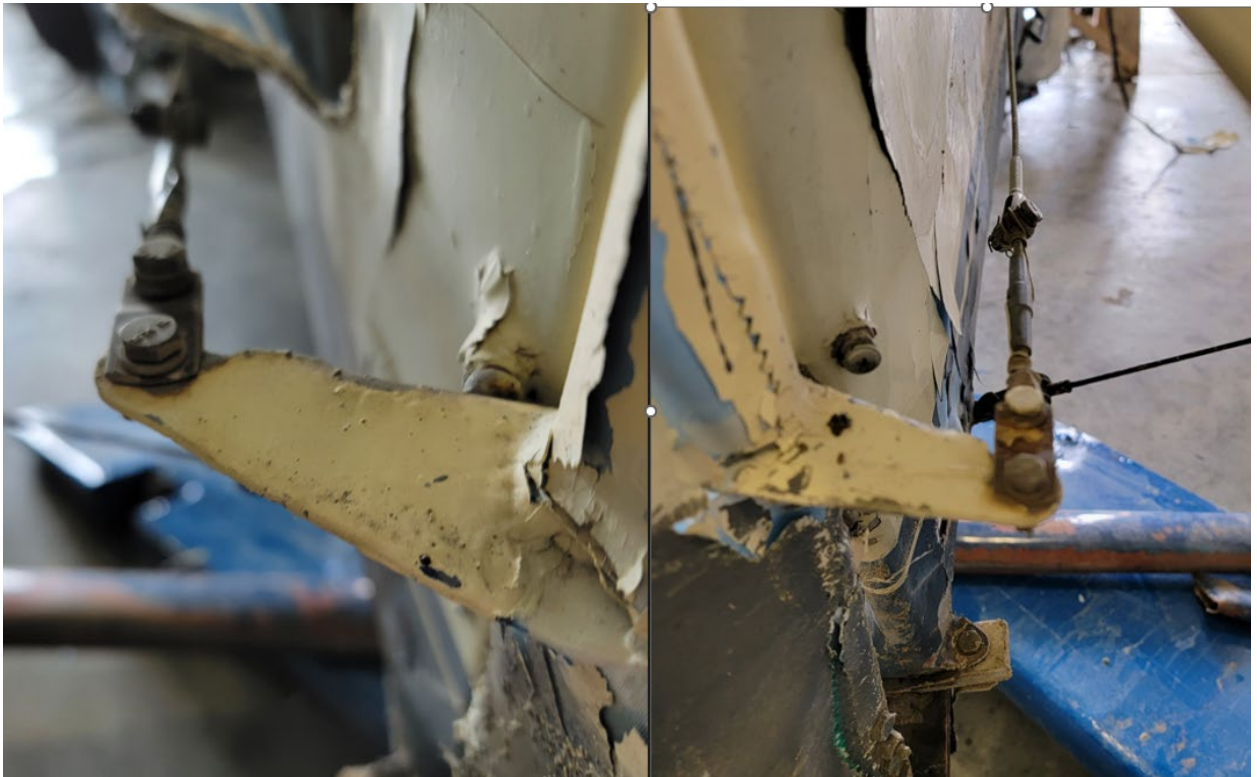
The empennage was largely still intact. The rudder was destroyed and was held together by the fabric. The rudder was still attached to the lower and upper attachment points. The top of the vertical stabilizer was impact damaged. Flight control cables were attached to the rudder horn with no breaks to the attachment to the rudder pedals in the cockpit.

**Figure 7 View of the flight control cables attachment to the rudder horn.**

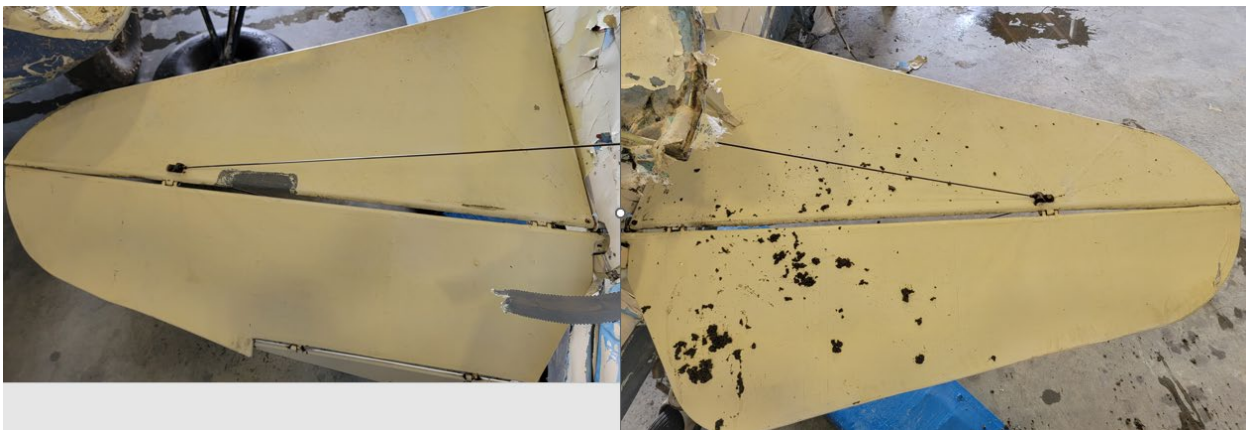
Both horizontal stabilizers and elevators were undamaged. They were still attached to all attachment points. Flying wires were undamaged. Flight control cables were still attached to the elevators with no breaks in the cable from the elevator into the cockpit. The elevator trim tab was undamaged but the bolt connecting the trim control cable to the trim tab was missing.

**Figure 8 The left and right upper view of the horizontal stabilizers and elevators.**

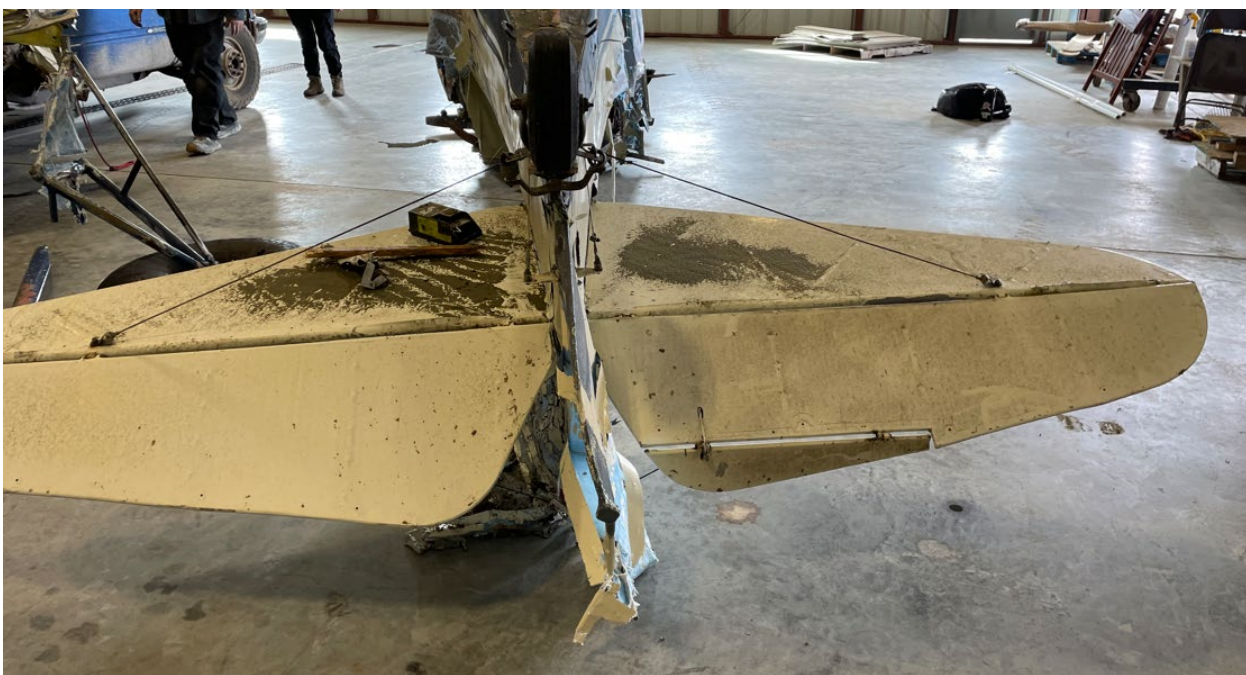
**Figure 9 The underside view of the left and right horizontal stabilizers and elevators.**

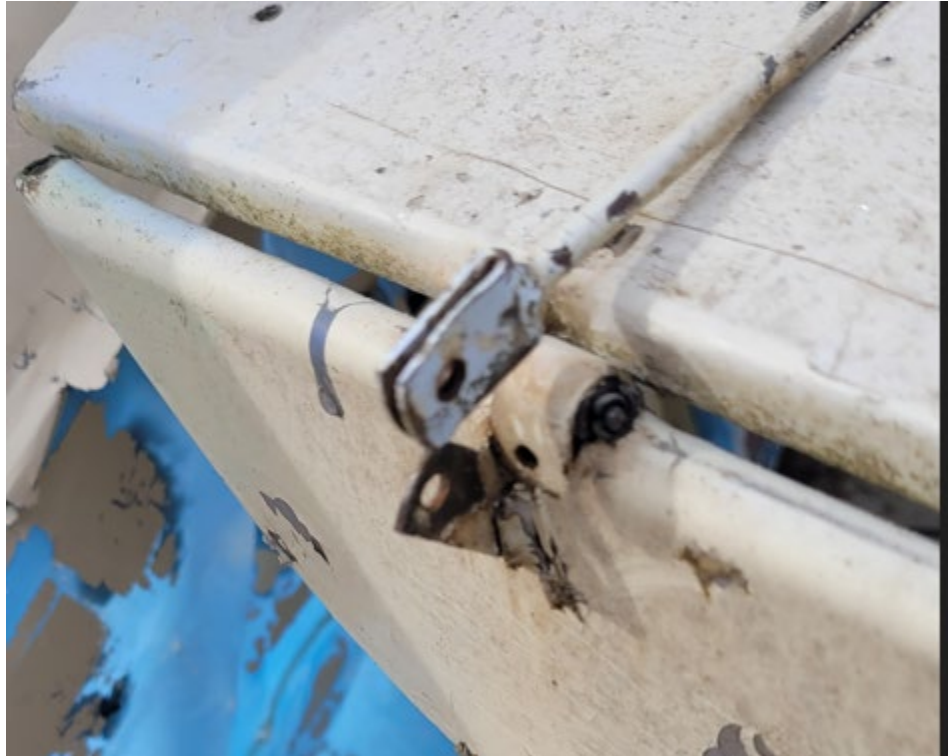
**Figure 10 view of missing bolt in the attachment of the control cable to the elevator trim tab.**

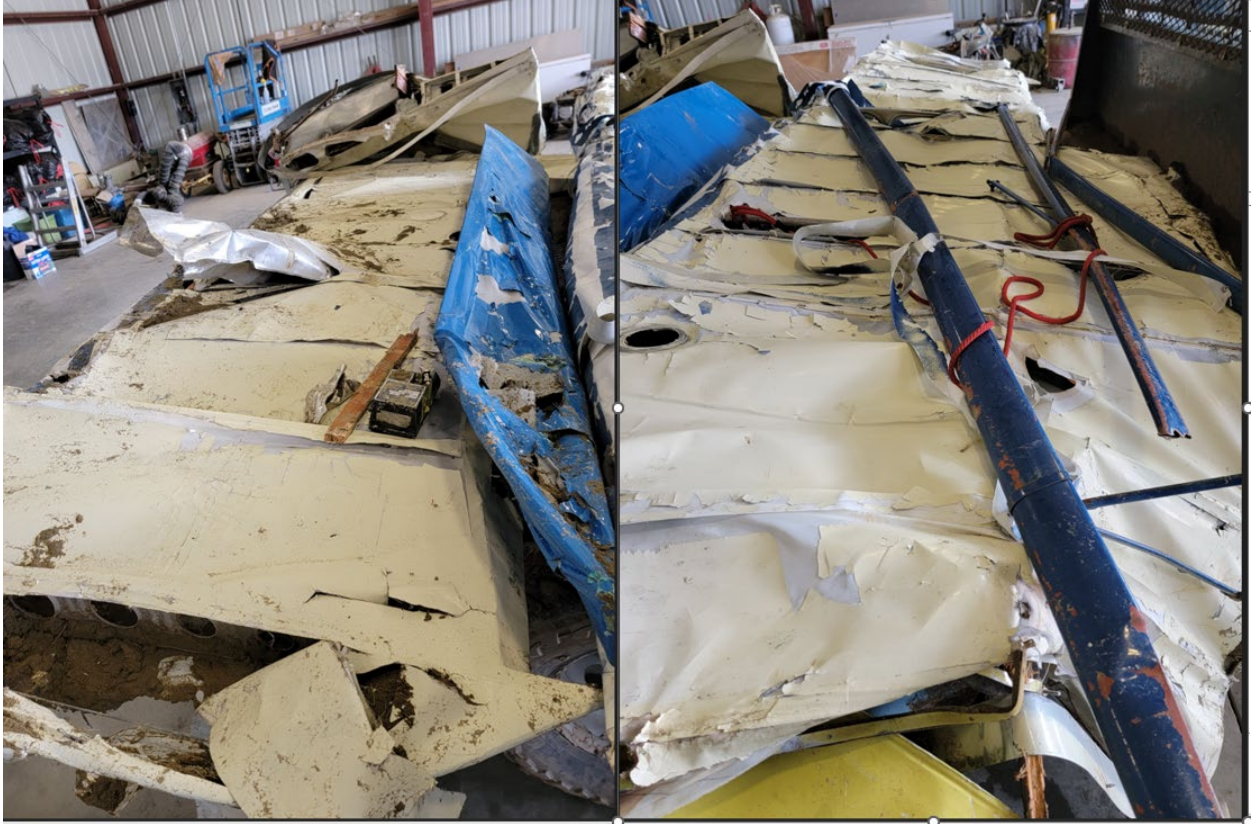
Looking at photos taken before recovery, the wings look undamaged. Wings were attached to the fuselage. Wing struts were connected with no visible damage. Ailerons look undamaged and still attached to the wing. During examination, the arm that controls the aileron movement was fractured from impact and recovery. The flight control cables were still attached from that bell housing arm to the fuselage where it was cut or an overload break occurred during recovery. From the fuselage the aileron cables were undamaged to the cockpit controls.

**Figure 11 View of the left and right wings at recovery site.**

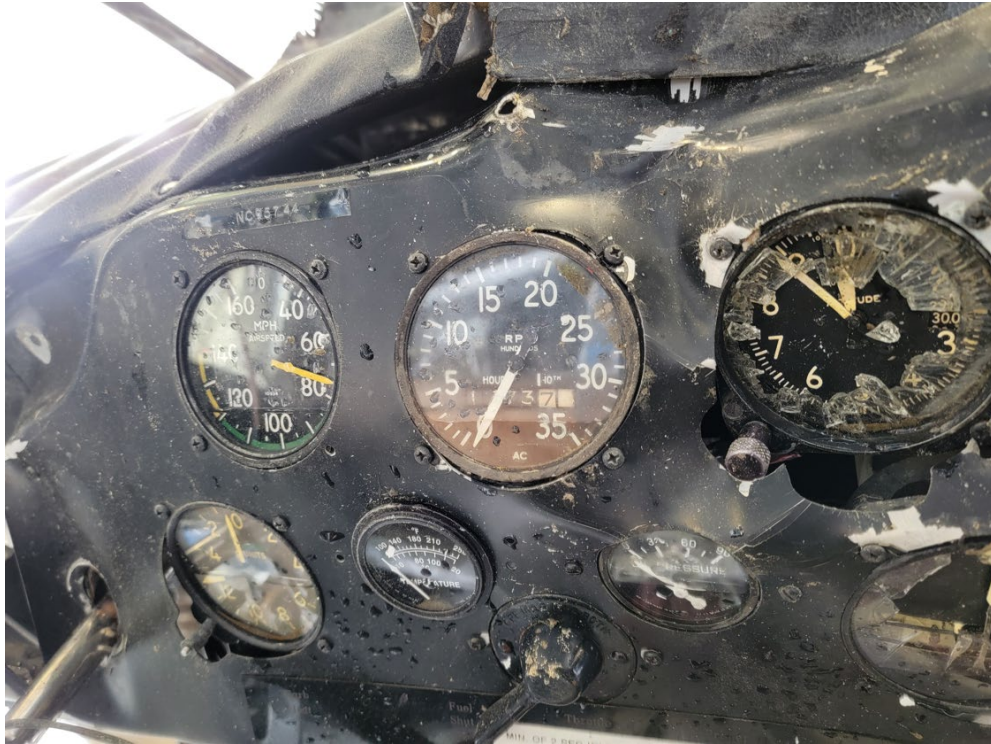
**Figure 12 View of cockpit instrument panel.**

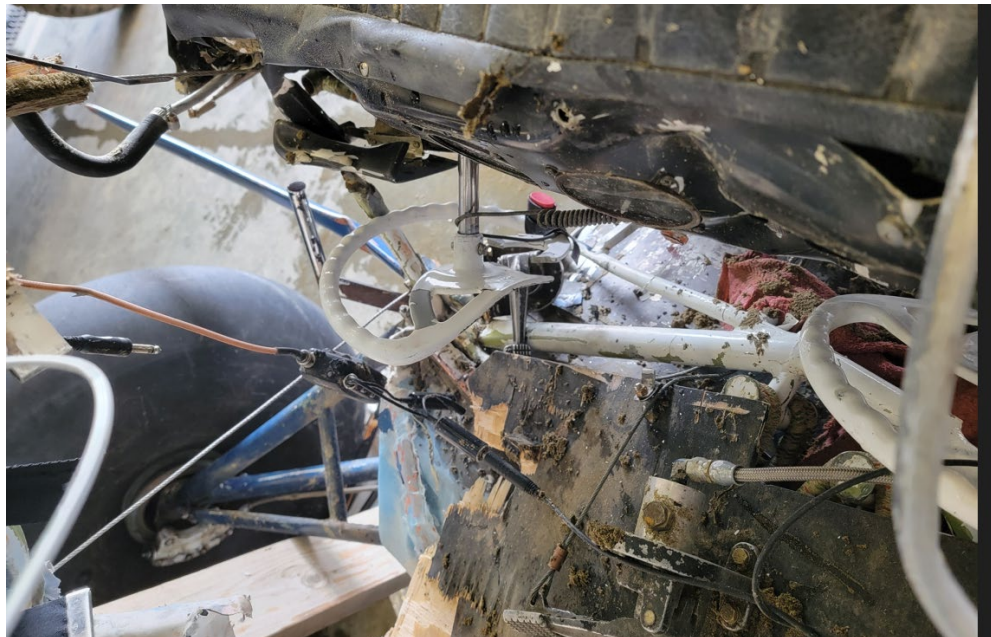
The fuselage tubes in the cockpit area had numerous overload fractures. The flight control yokes showed high impact loads. No gear or cargo was seen in the water or during the examinations.

**Figure 13 View of flight control yokes in the cockpit of the accident airplane.**

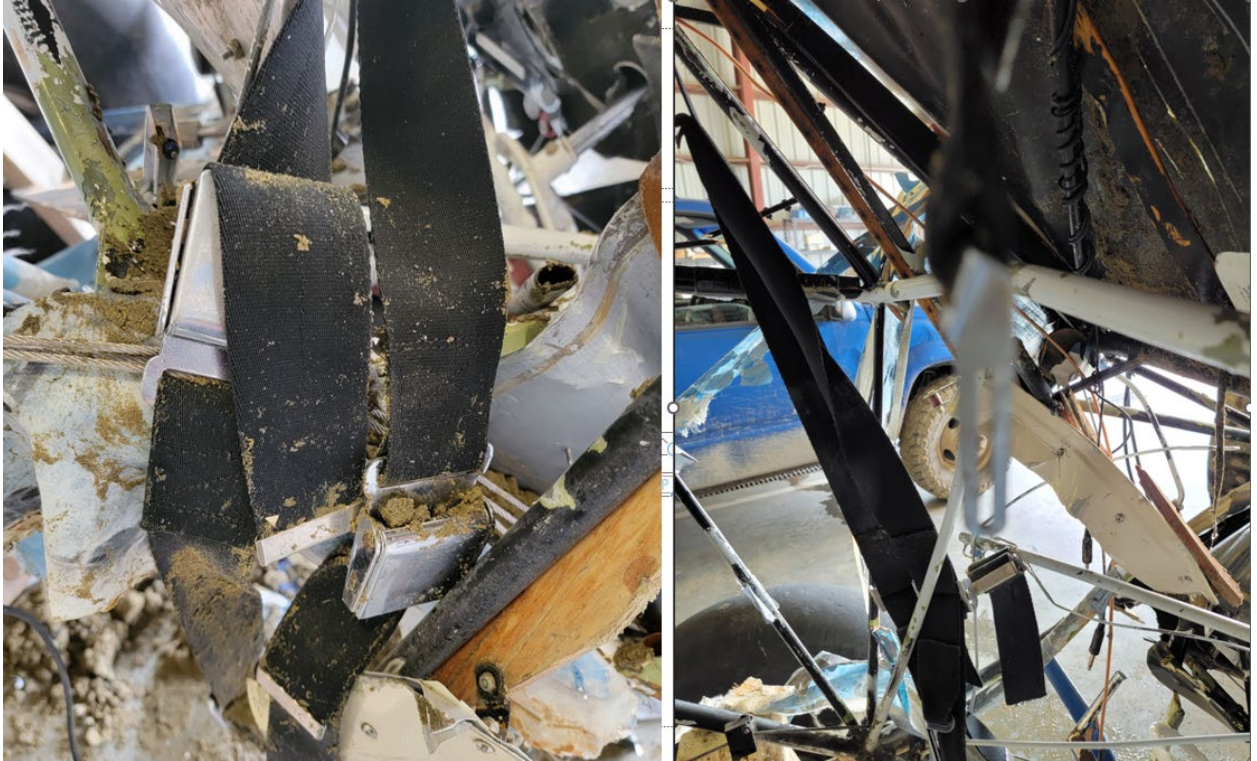
The airplane was equipped with a four-point seatbelt harness. The occupants had to be cut out of the airplane. The main seat buckle is still attached with a cut

either left or right of the buckle. The shoulder portion of the harness are undamaged and not attached to the buckle with one harness tucked up into the ceiling. The shoulder portion of the seat belts were not used. Resulting in additional head trauma during impact.

**Figure 14 View of buckles and unattached shoulder harness.**

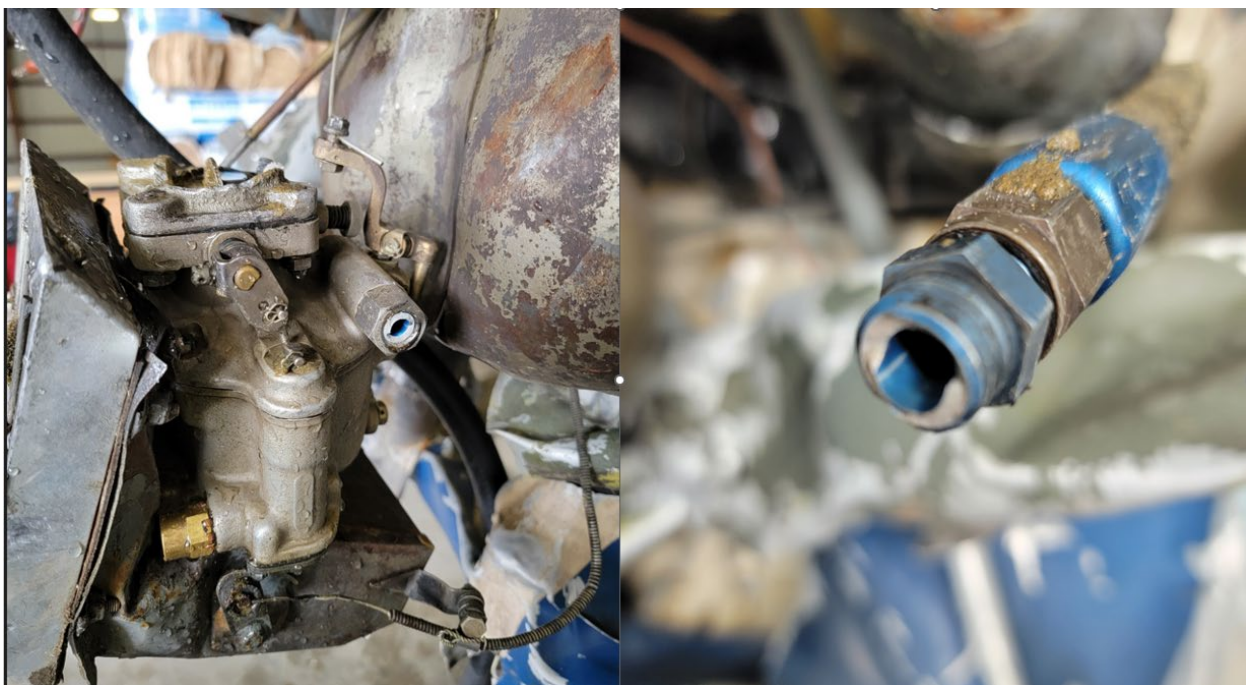
The airplane was on its back, when flipping the airplane upright there was a brief smell of fuel. The accelerator pump was functional. A borescope was used in the fuel system with no blockage, or abnormalities observed. Fuel line was impact separated at the carburetor. The carburetor was impacted separated from the induction system.

**Figure 15 View of fuel line connection into the carburetor.**

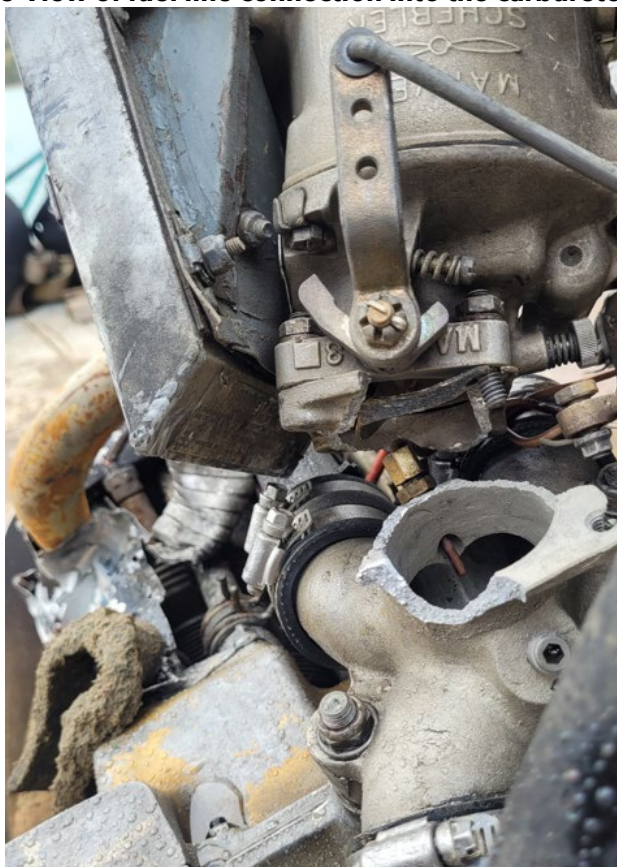
**Figure 16 View of facture break between the carburetor and induction system.**

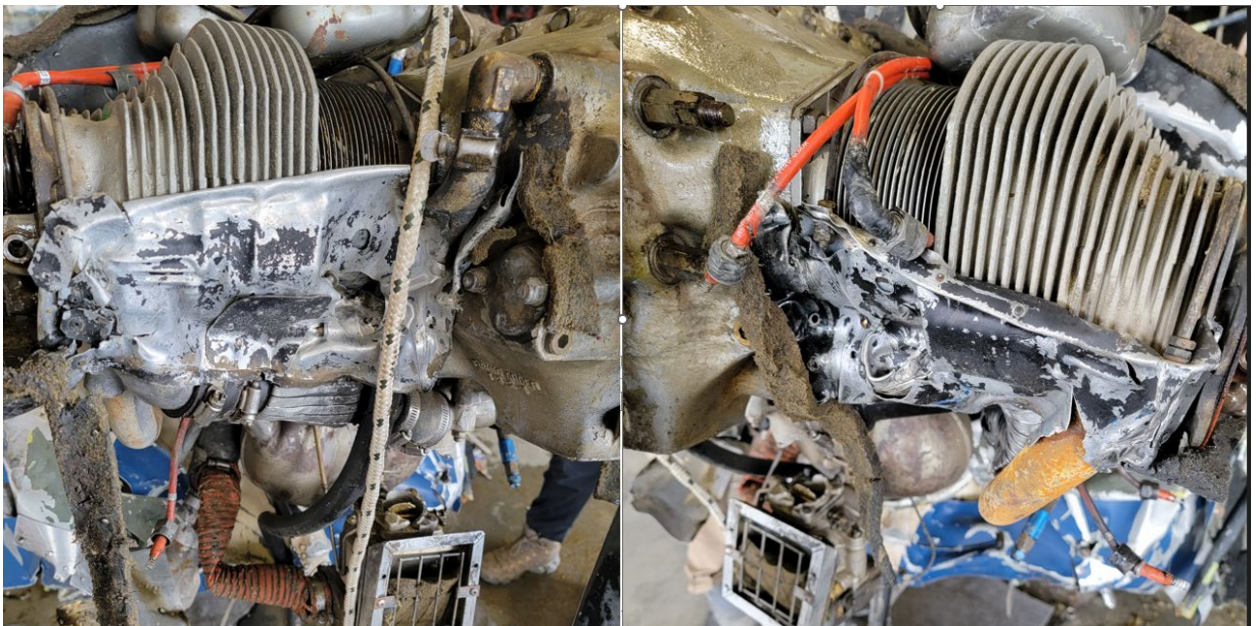
**Figure 19 Left and right view of damage to engine baffling on the front of the engine.**

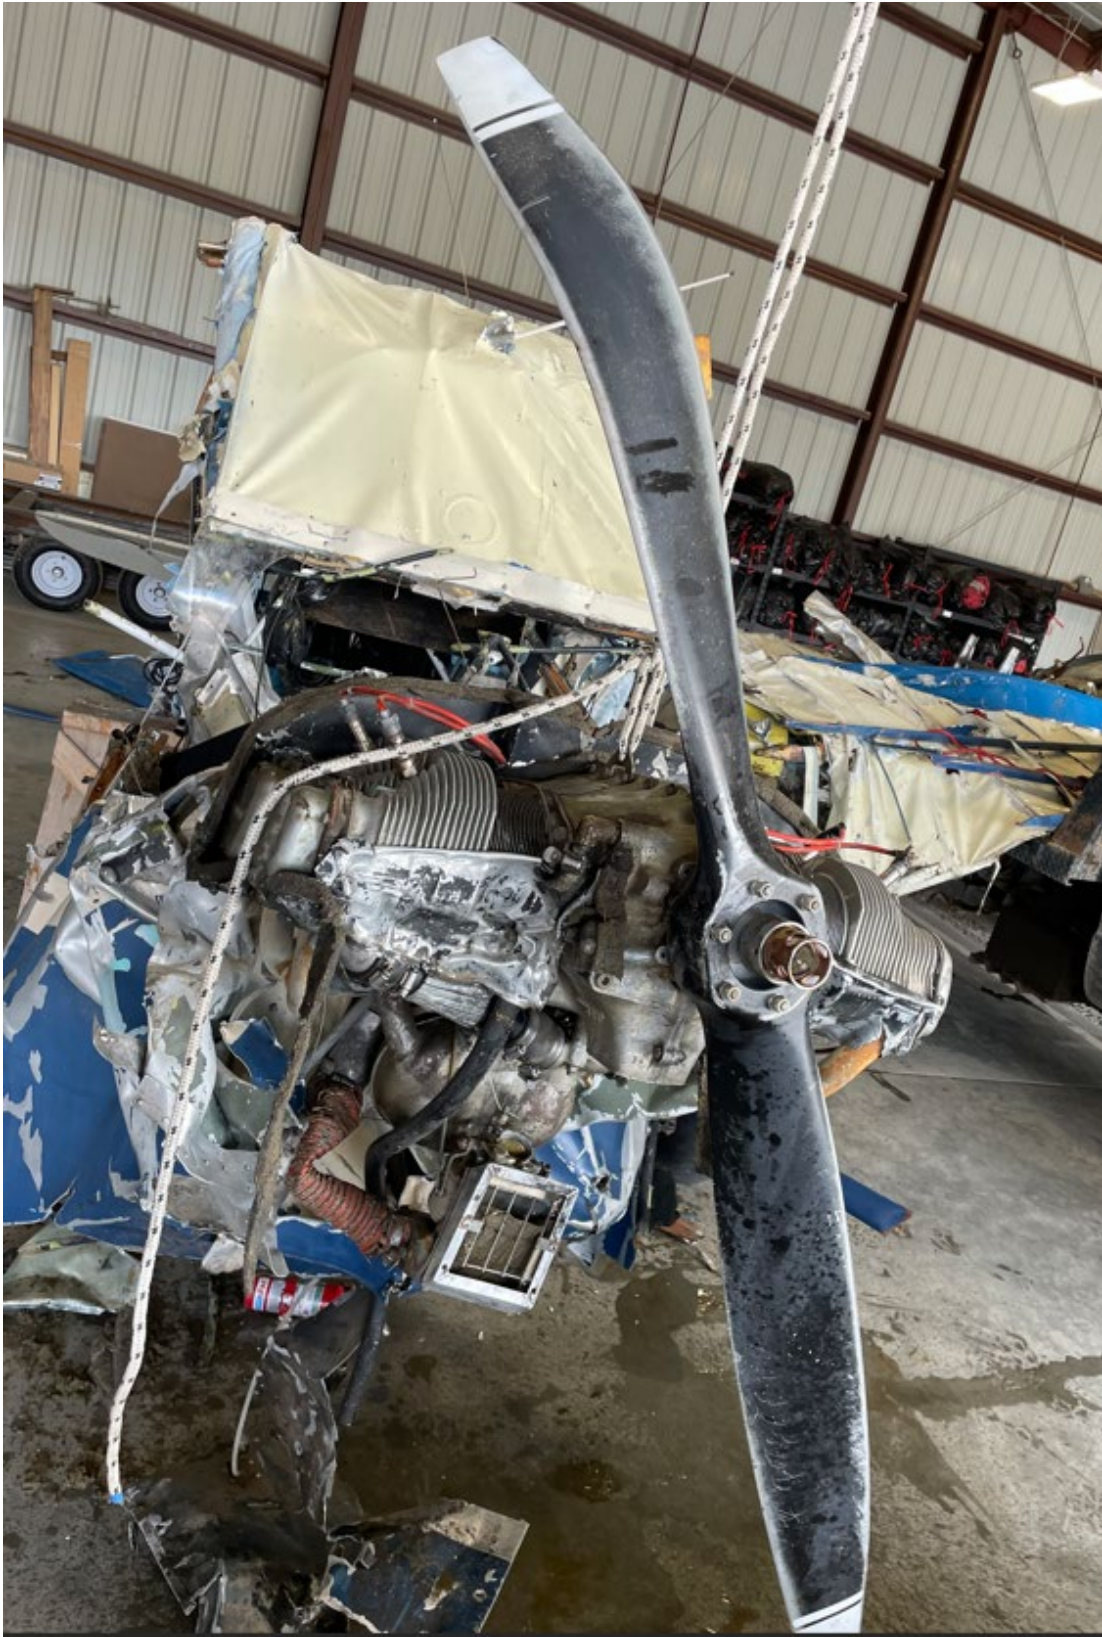
**Figure 20 View of impact damage to the front of the engine and damage to the engine propeller.**

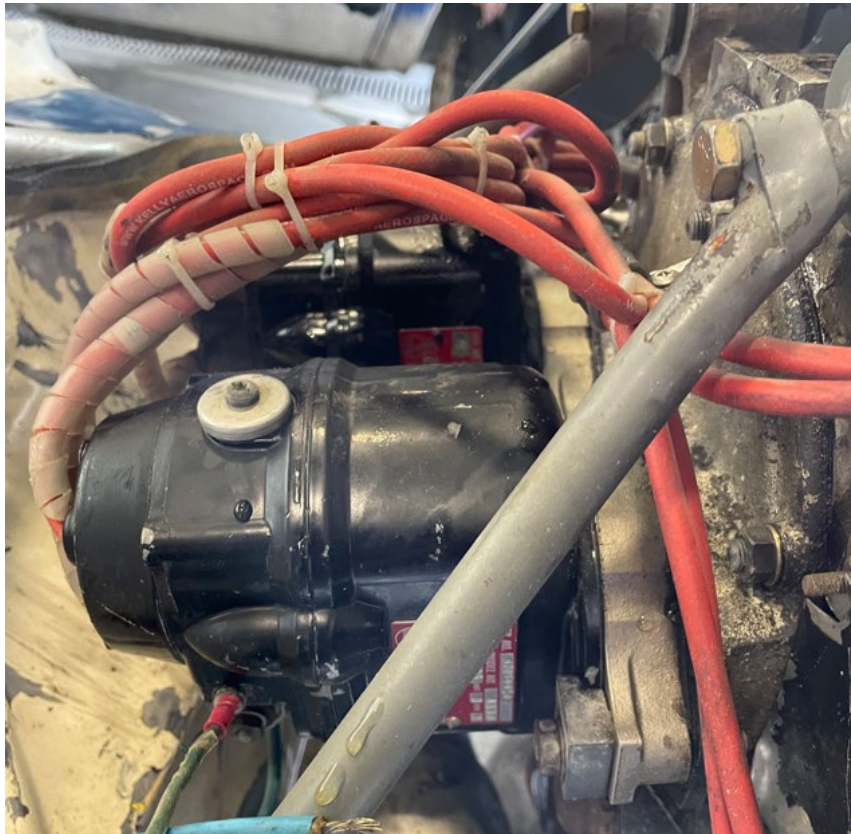
The engine had slick magnetos installed. Serial #93050033 and 93050020. Both magnetos looked fairly new, they were securely attached to the engine. Each magneto produced spark when rotated by hand. The high-tension ignition leads looked in good serviceable condition. The top cylinder spark plugs were removed. Two of the spark plugs were packed with mud and the other two had some mud with an oily appearance. A borescope was used to inspect all cylinders, the air intake system, fuel induction system and exhaust system. No blockages or abnormalities were observed.

**Figure 21 Right side view of the magnetos as installed on the engine.**

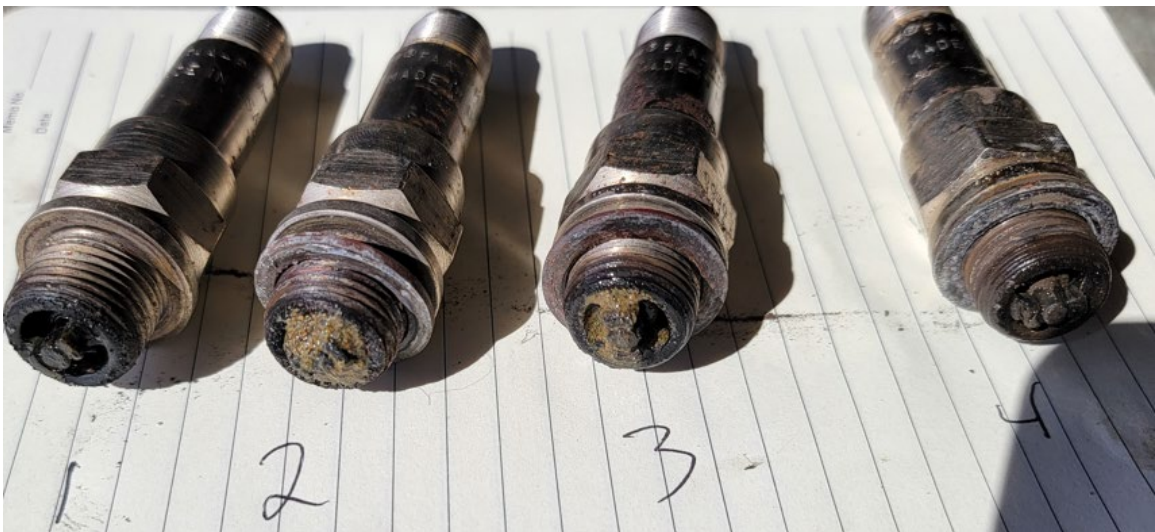
**Figure 24** View of the top sparkplugs.

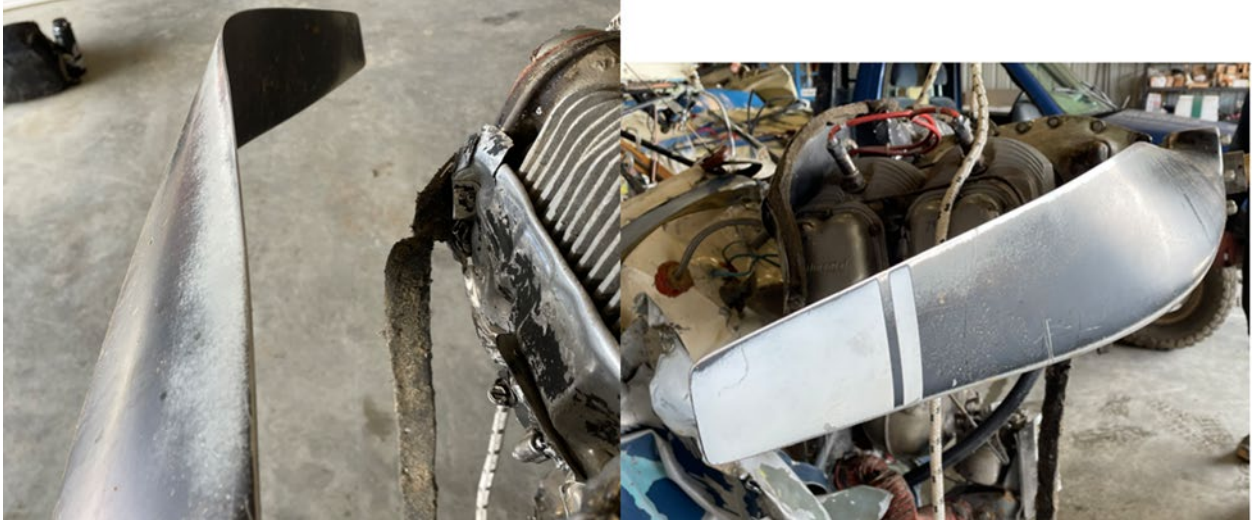
The propeller exhibited bending of the blades consistent with the engine producing power at the time of impact.

**Figure 25 View of the damage to one side of the propeller.**

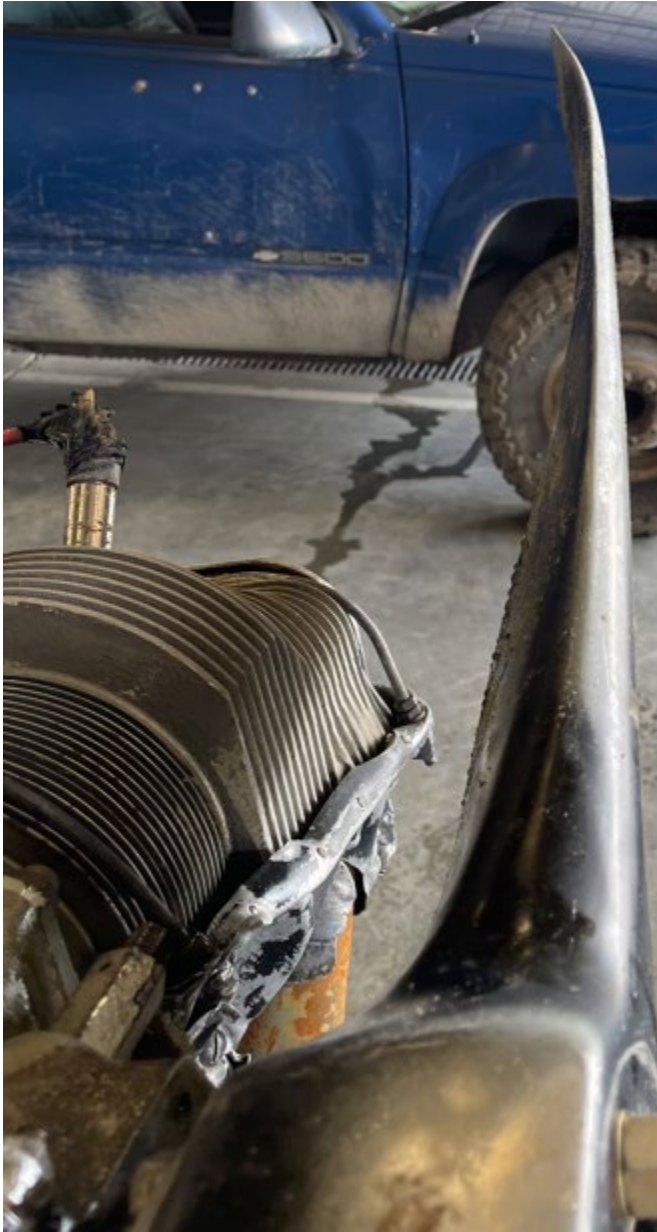
**Figure 26 View of damage to the other side of the propeller.**
