# National Transportation Safety Board

ANC24FA063

## **WRECKAGE EXAMINATION**

| Aircraft Make/Model/Registration: | Robinson / R44 / N144KW |

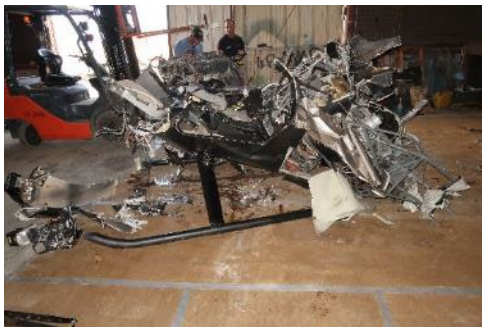
**Figure 1 Fuselage**

The left landing skid was fractured at the rear landing skid tube saddle, the front cross tube remained attached to the skid. The front cross tube was attached to the fuselage, the rear cross tube had separated from the fuselage at the upper left tube joint. The right landing skid tube was fractured behind the forward skid tube joint. The upper drive belt sheave remained attached to the helicopter frame. The engine had separated from the frame and the frame tubes were fractured at multiple locations. The main gear box (MGB) had fractured and separated from the airframe. The MGB, rotor mast, and main rotor remained together as an assembly. All 4 tail cone attach bolts remained attached to frame tubes with all 4 having tail cone skin fragments sandwiched in-between the bolts and frame. The tail cone had separated from the frame with skin folding and tearing on the left side tail cone attachments and buckling evident on the right side at the tail cone bay 1 and 2 splice. Buckling was also evident at bay 5. The tail fin and tail rotor remained attached to the tail cone.

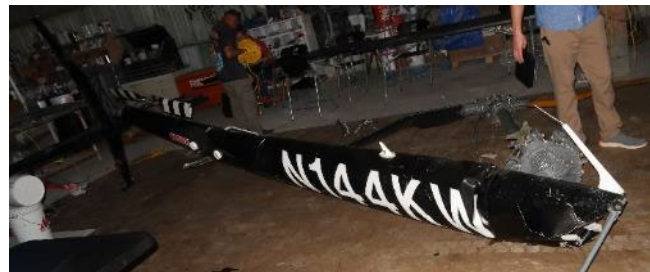
**Figure 2 Tail cone, tail and tail rotor.**

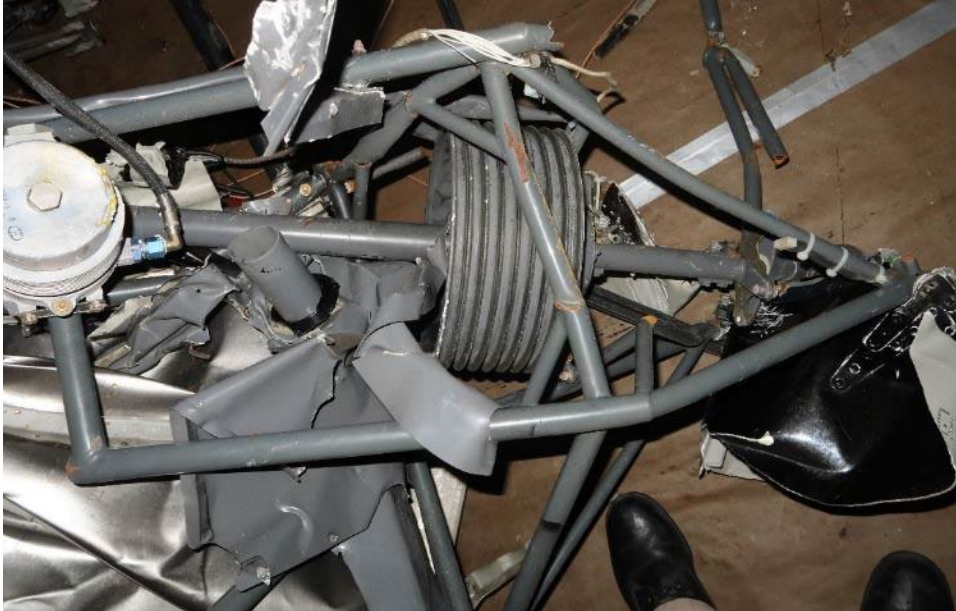
The airframe structural tubes, where the tail cone attaches, exhibited bending from right to left. Structural tubes were fractured in bending or deformation. No fractures or tube separations at the welded joints were observed. Tube fracture surface characteristics were deformation and 45° shear lips with the fracture surface having red oxidation deposits.

**Figure 3 Aft airframe structural members showing right to left deformation.**

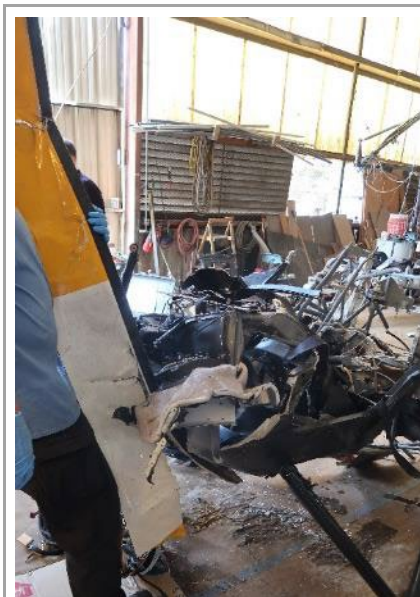
The nose of the cockpit/cabin (fiberglass) was broken in multiple pieces. Fragments of both front cockpit doors were present. The main cabin doors were missing. The forward chin area, on the right of the landing lights, exhibited an angled straight cut that pointed to a semicircular vertical floor crushed area under the copilot's seat.

**Figure 4 Approximate angle the main rotor blade passed through the cockpit.**

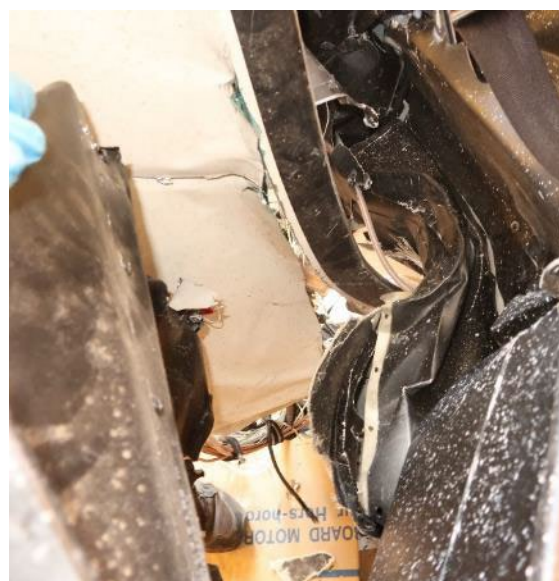
**Figure 5 Crushed cabin floor structure deformed semi circularly aligned with the leading edge of the main rotor blade.**

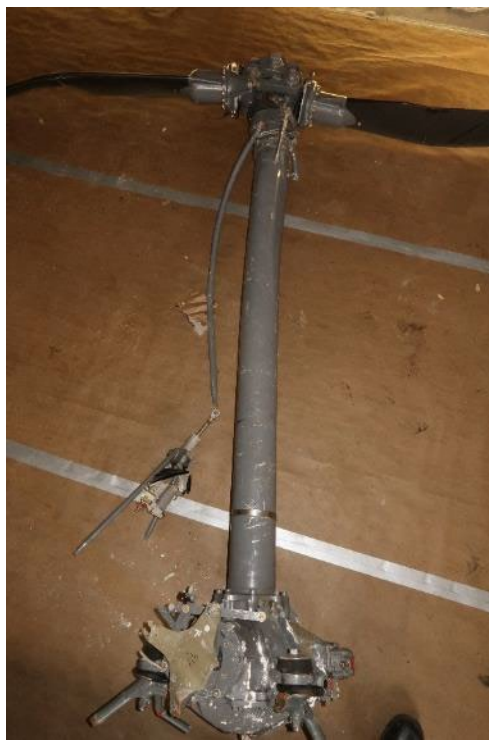
**Figure 6 Main rotor gearbox, mast, and rotor head.**

The mast tube remained attached to the MGB base, with a slight bend (to the right) at the top. Both swashplates, rotor head, and main rotor blades were present on the drive shaft. The top of the drive shaft was bent above the swashplate.

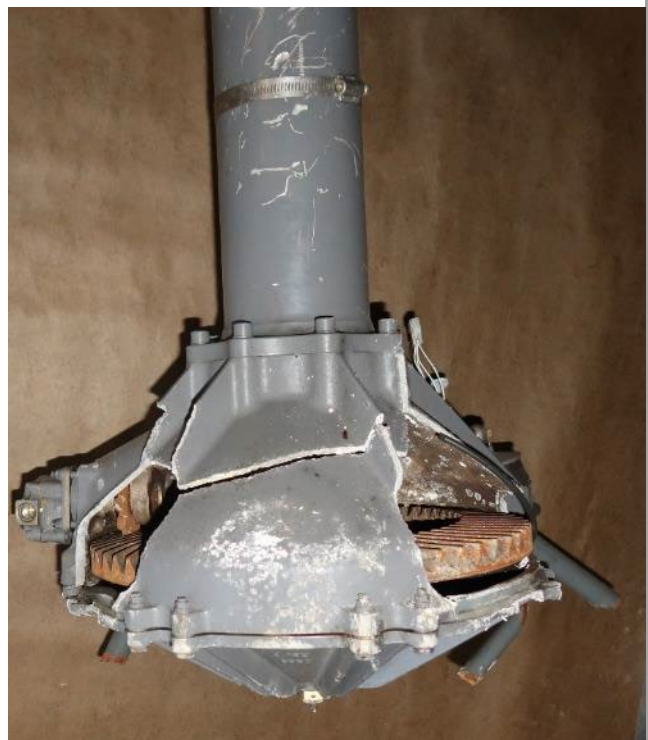
**Figure 7 Foreword end of the gear box with case separations, and revealing the ring gear.**

The transmission/main gear box (MGB), mast, and main rotor separated from the airframe as a single assembly. The two aft transmission mounts and attach bolts had pieces of frame connected. The two forward mounts had been liberated via fracture of the MGB case on each side. Both forward mounts with fragments of the MGB case remained attached to the helicopter frame. The ring gear could be inspected through the holes in the transmission case. No evidence of damage or unusual wear was identified on the ring gear. The magnetic drain plug was examined and had a single 1/4 inch piece of ferrous material. The input pinion to the MGB ring gear was seized. The flex coupling flanges were deformed and the two bolts connecting to the input pinion were connected. The drive shaft side of the flex coupling had one arm torsionally sheared off and the other had ripped away at the bolt hole. Both connecting bolts were present on the drive shaft side flange. Two teletemp indicators were on the transmission. The hydraulic pump teletemp had the 220° F square as black, the 230° F and 260° F were dark gray, 240° F, 250° F, and 270° F were light gray. The MGB teletemp had the 220° F box as gray, and all others as light gray.

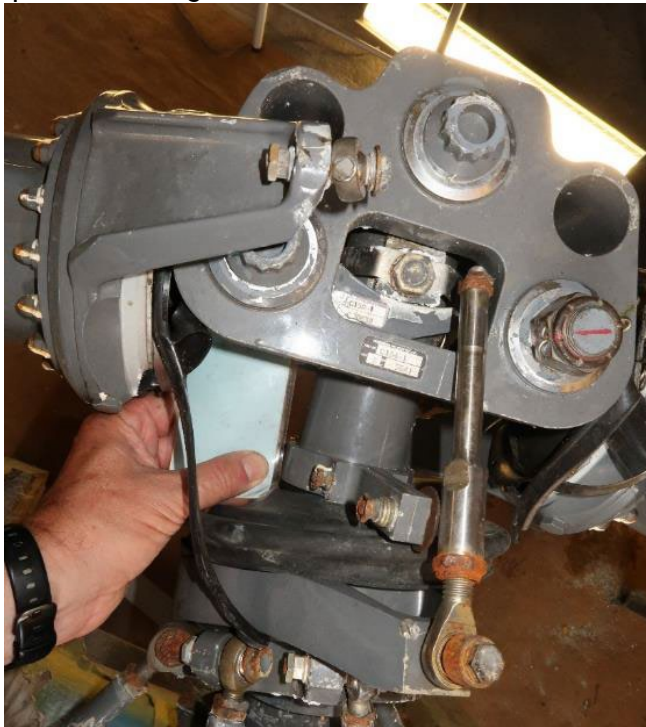
The rotor head was attached to the drive shaft located inside the mast tube. Both main rotor blades (MRB) pitch bolts were connected, and the teetering hinge moved in a rocking motion. The pitch links on each blade were fractured at each pitch horn connection rod end. The mast bump (teeter stop) on the red blade had the elastomeric block split in half horizontally, with a witness mark on the drive shaft. The blue blade teeter stop was missing the elastomeric block, but a horizontal witness mark was observed in the center of the block frame on the drive shaft. On each side of the rotor head there were contact witness marks that matched the curvature of each blades spindle housing/blade root.

**Figure 8 Rotor head and mast illustrating the bend of the drive shaft and the broken pitch link.**

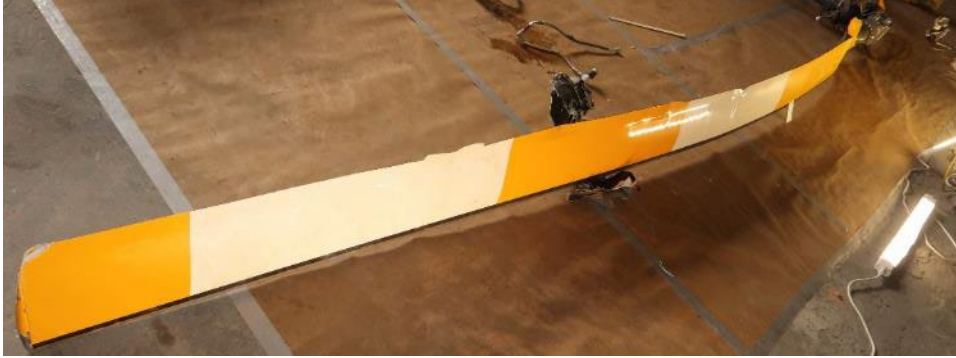
**Figure 11 Blue Main Rotor Blade.**

The entire blue blade remained attached to the rotor hub. The blade had a trailing edge buckle 2.5 feet from the blade root, and had a permanent continuous downward lengthwise bend. The pitch bolt was removed. The pitch bolt hole was observed to be out of round. The spindle tusk was slightly bent downward.

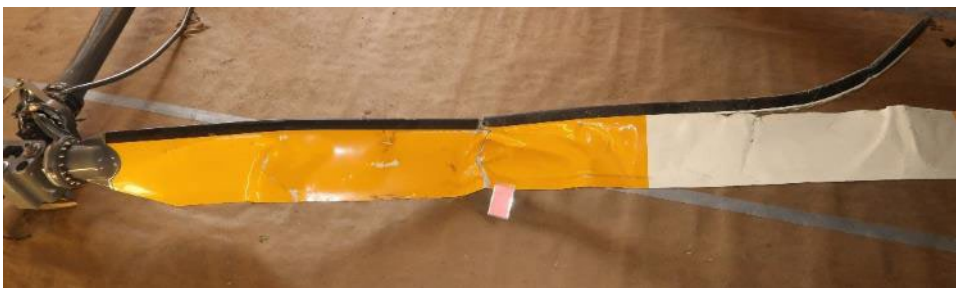
**Figure 13 Red Main Rotor Blade:**

A 9 foot section of blade remained attached to the rotor hub. At the fractured end, a two foot section of leading edge had separated in a forward bend from the blade body. The blade had downward bend 2.5 feet from the root and there was a chordwise buckle 4.5 feet from the root. The remaining outboard section of blade (approximately 7.5 feet) was not recovered. The chordwise fracture area was characterized by torn blade skin and 45° shear lip features on the leading edge stainless steel spar. The bottom (black) side of the blade had a scattered distribution of small whiteish marks where the black paint had chipped off.

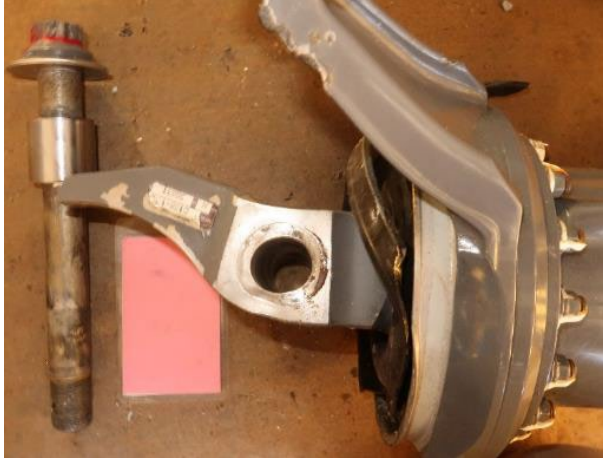
**Figure 14 Pitch bolt and spindle tusk.**

The pitch bolt was removed and the pitch bolt hole was observed to be out of round. The spindle tusk was slightly bent, but bent less than the blue blade's tusk.

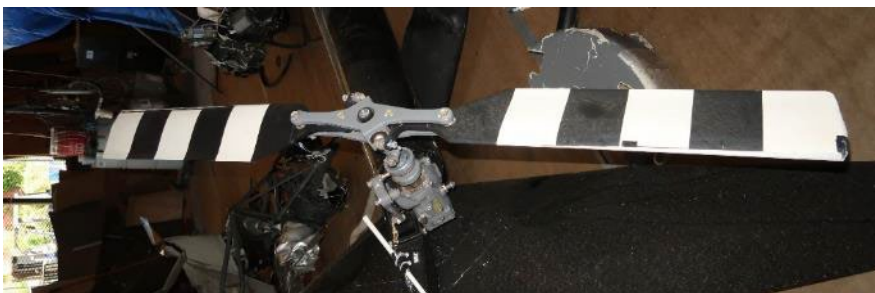
**Figure 15 Tail rotor assembly.**

Both tail rotor blades were attached to the tail rotor hub. Both pitch links were attached and both blades moved in concert when manipulated by hand. No leading edge damage on either blade was observed. Both blade tips exhibited indications of a corrosion or possibly a repair.

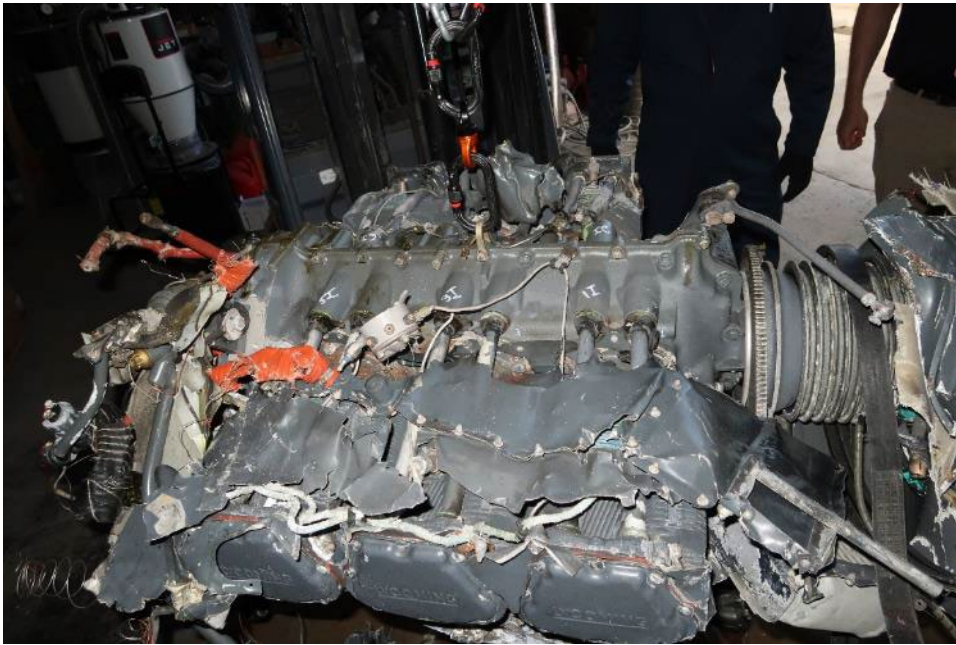
**Figure 16 Top view of the engine as recovered.**

The engine had separated from the airframe and was located by recovery divers about 40 feet from the fuselage wreckage. All 6 cylinders were attached to the engine case and there was no damage to the engine case halves. The engine drive belt sheave and fan were attached to the forward end of the engine. The valve covers on the left side of the engine (helicopter's right side) had been hydraulically deformed into the valve rockers. The valve covers on the engine's right side were undamaged. Push rods for the number 2, 4, and 6 cylinders (engine left side) were bent or broken, the push rod tubes on the 1, 3, and 5 cylinders were dented but remained relatively straight. All valves and rockers were intact. The starter ring had broken free, however, there was a starter ring grind mark on the engine oil cooler. The engine could not be rotated by hand. Holes were drilled into the engine case to examine the connecting rods, camshaft, and crank shaft.
