# National Transportation Safety Board

ANC24FA085

## **WRECKAGE EXAM**

Location: Remote Location  
Date: August 31, 2024  
Time: 10:00  
18:00  
Airplane: PA-18 150, N7154Z

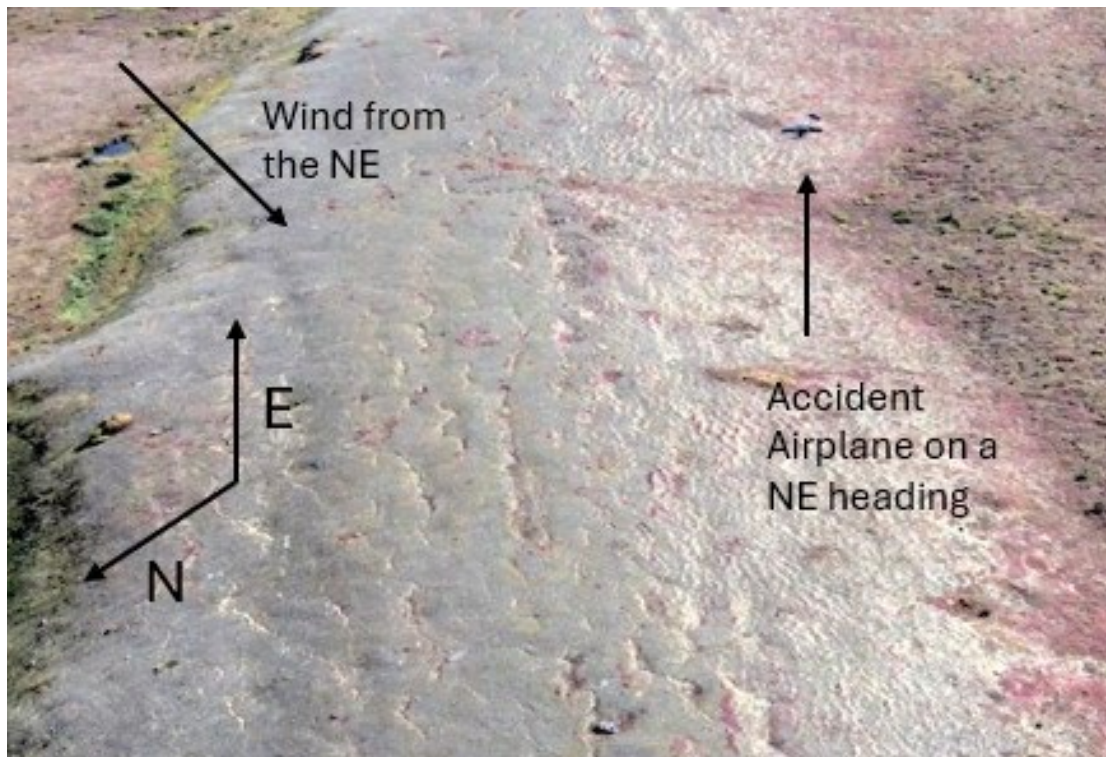
**Figure 1 Accident Ridge**

The accident occurred on a remote landing strip located at 2,500'. The terrain is a rocky, undulating ridge located about 61 miles southeast of McGrath Alaska (Figure 1).

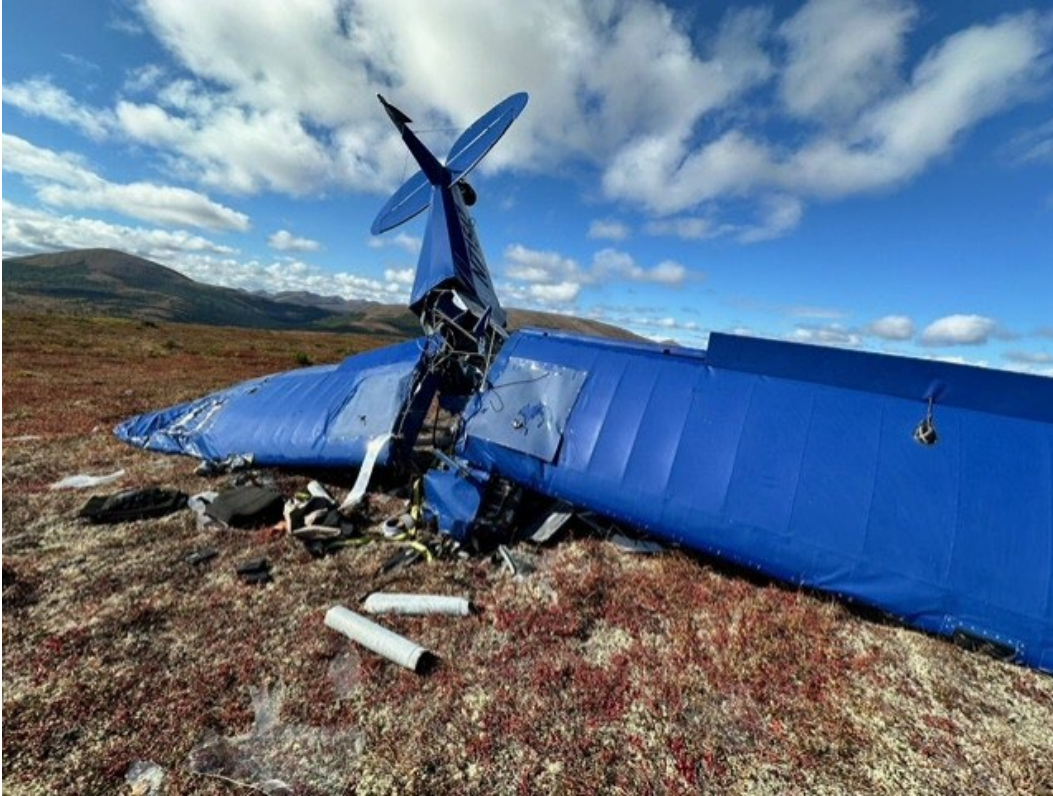
**Figure 2 Accident airplane**

On September 2, 2024, an on site airframe examination was conducted by the IIC. The airplane was found on the south side of the ridge on a northeast heading. The airplane was in a near vertical position with the tail bent slightly to the right (Figure 2). The right wing tip had impact damage signatures, indicating it impacted the ground prior to the left wing. The left wing leading edge had little impact damage.

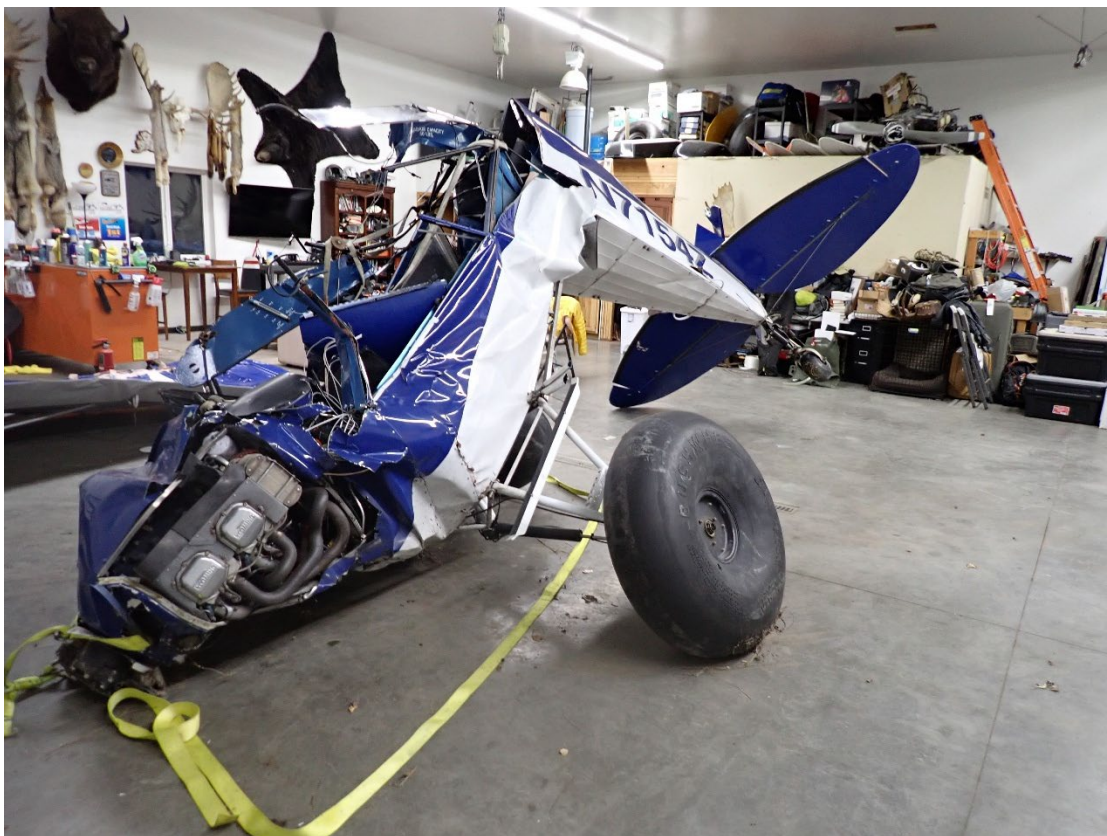
**Figure 3 Accident airplane at wreckage exam**

The Piper PA-18 150 airplane, N7154Z, SN 18-8268 was presented with the wings removed (Figure 3). The Northern Airframes, LLC widebody fuselage, FAA PMA P/N AF18 serial number 078 was modified with a metal bottom cover, but was fabric covered otherwise. The fuselage was impact damaged throughout, with concentrated impact damage aft of the cabin area where the frame buckled. The fuselage frame had been cut in several places by the recovery personnel.

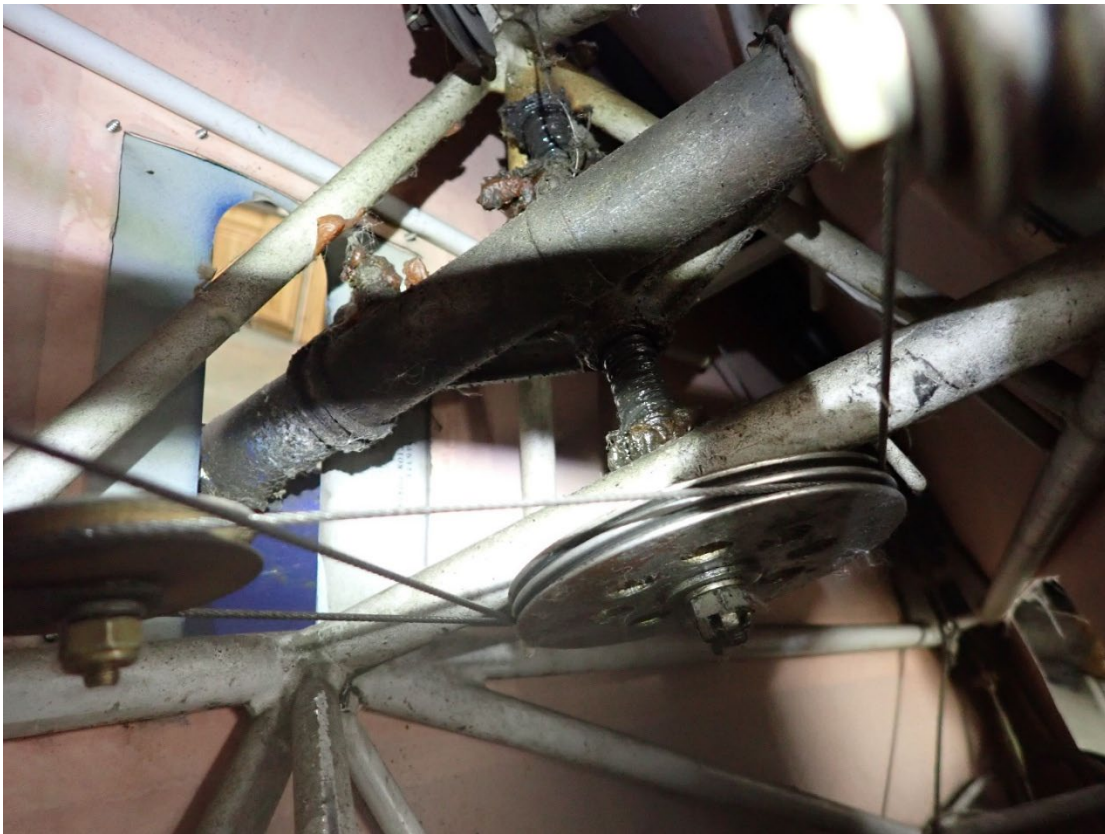
**Figure 4 Jack screw**

Fabric was removed along the left side of the tail section to expose the rudder and elevator cables and pulley system. The cables and pulleys were intact and continuity to the cockpit was confirmed. The trim indicator wire was fabricated from .032" galvanized wire and was found to be broken mid-way down the tail section. The pitch trim indicator pin was in the full nose-down position during the on-scene examination. The lower portion of the pitch trim jackscrew had approximately 10 threads exposed, which equates to a neutral to slightly nose down setting (Figure 4). 8 threads is consistent with a neutral setting. 17 threads is consistent with a full nose down setting.

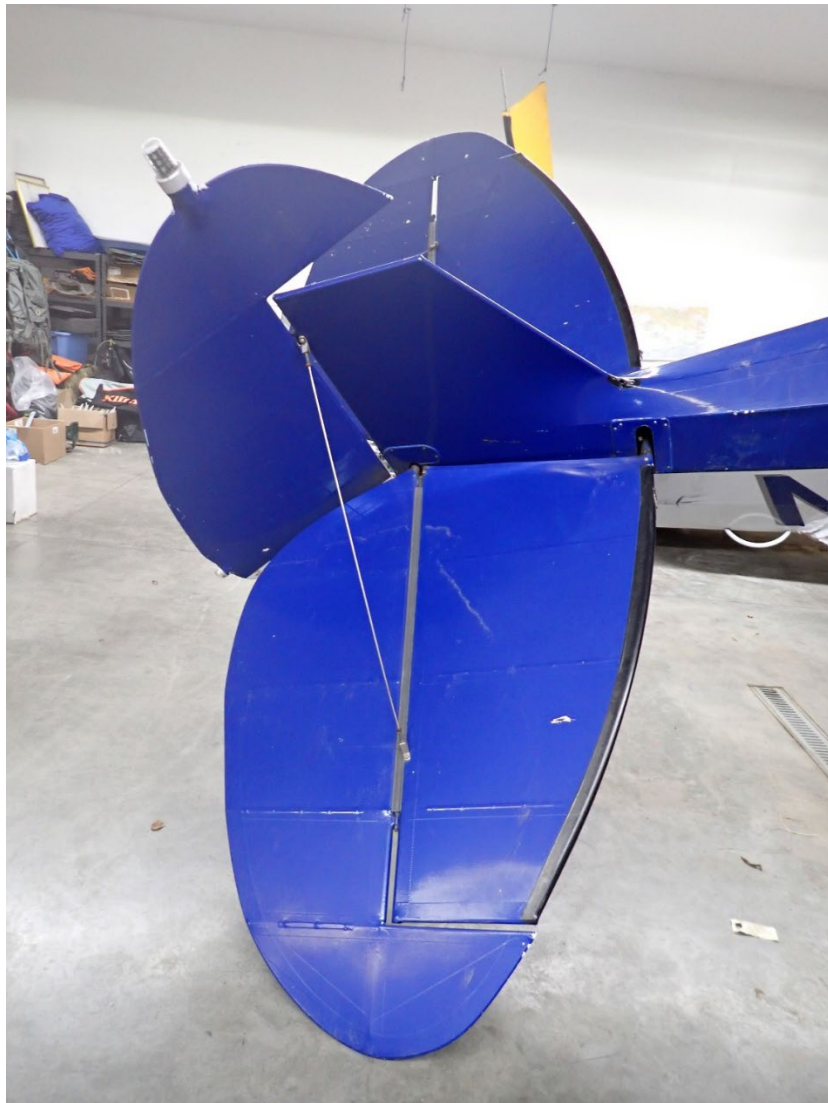
**Figure 5 Empennage**

The empennage remained attached to the fuselage with minor damage (Figure 5). The vertical and horizontal stabilizers were oversized surfaces. The tail wheel was a modified Acme Aero tail wheel assembly with a hydraulic strut. The right spring chain was attached to the tail wheel assembly with paracord; otherwise, the tail wheel assembly was unremarkable. Alaskan Bushwheel Inc. FAA PMA Part Number PQ1557NM ABI-3200B Bush wheel assembly serial number 400052 was installed.

The horizontal stabilator was modified with vortex generators. The horizontal stabilizer remained attached at the hinges. The pitch trim control cables remained attached to the trim control wheel and the trim actuator. The trim actuator remained attached to the stabilizer bar. The tension rods remained attached and unremarkable.

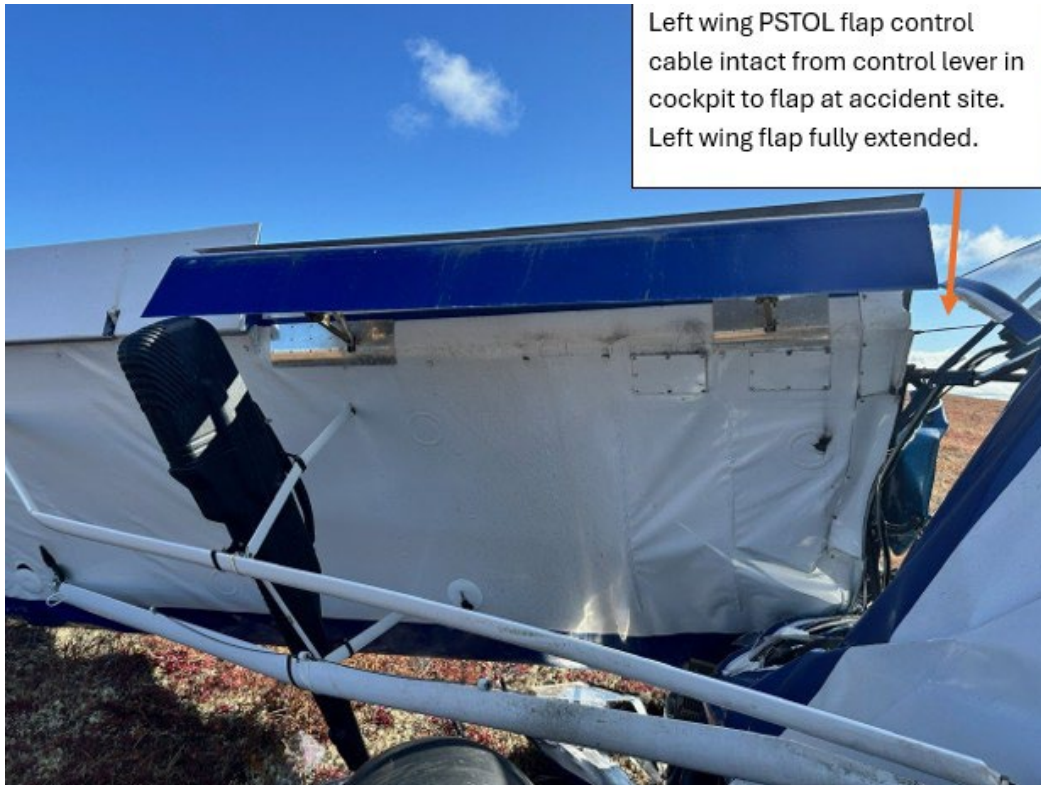
**Figure 6 Left wing PSTOL flap with cable attached**

Airframes Alaska, LLC FAA PMA double slotted flaps Part number PSTOL-0001 were installed on both wings (figure 7, 10). The flaps are spring loaded and require cable tension to maintain full flap extension. The left-wing flap was observed to be fully extended at the time of the accident, the control cable from the flap to the flap lever was attached at the accident site (Figure 6). The modified left inboard flap hinge rod was impact separated. The flap remained attached to the wing at both hinges. The flap was impact damaged.

Left wing PSTOL flap control cable intact from control lever in cockpit to flap at accident site. Left wing flap fully extended.

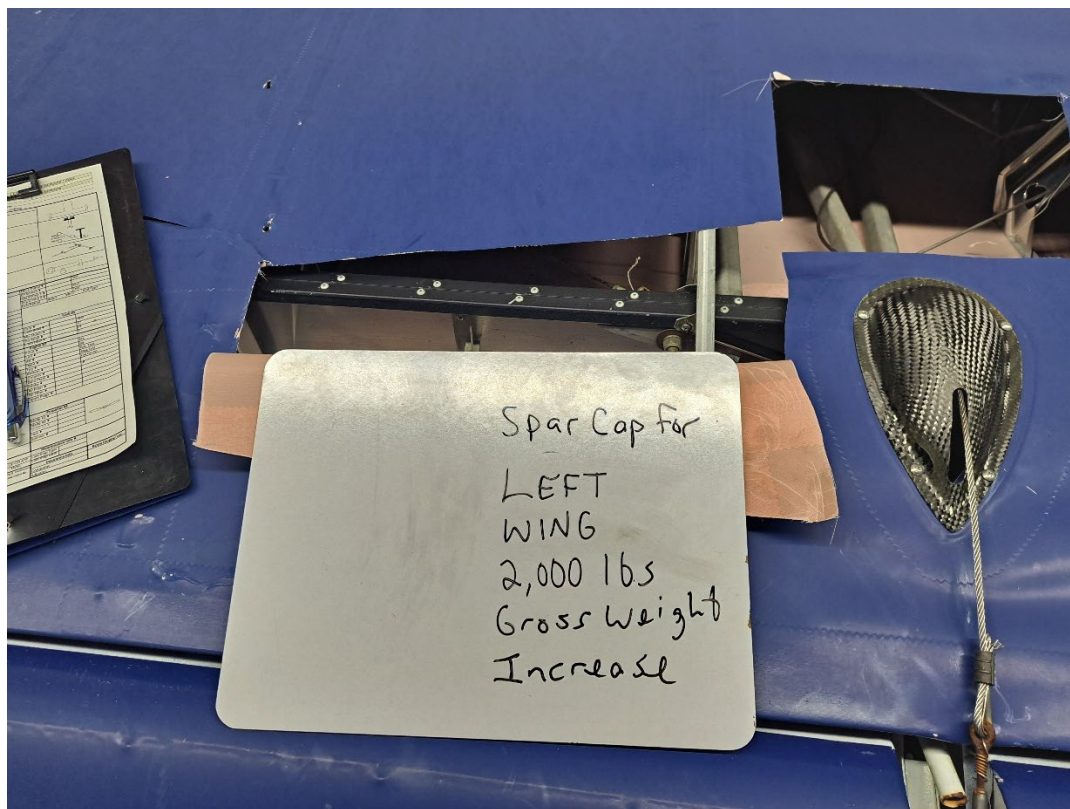
**Figure 8 Left wing spar cap for gross weight increase**

The left wing spar was observed to have a modified spar cap installed on the top of the spar near the wing strut attachment area consistent with an increased gross weight modification. Fabric was removed from a section of the wing, a spar cap for the WipAire 2,000 lb gross weight increase STC was observed to be installed (Figure 8).

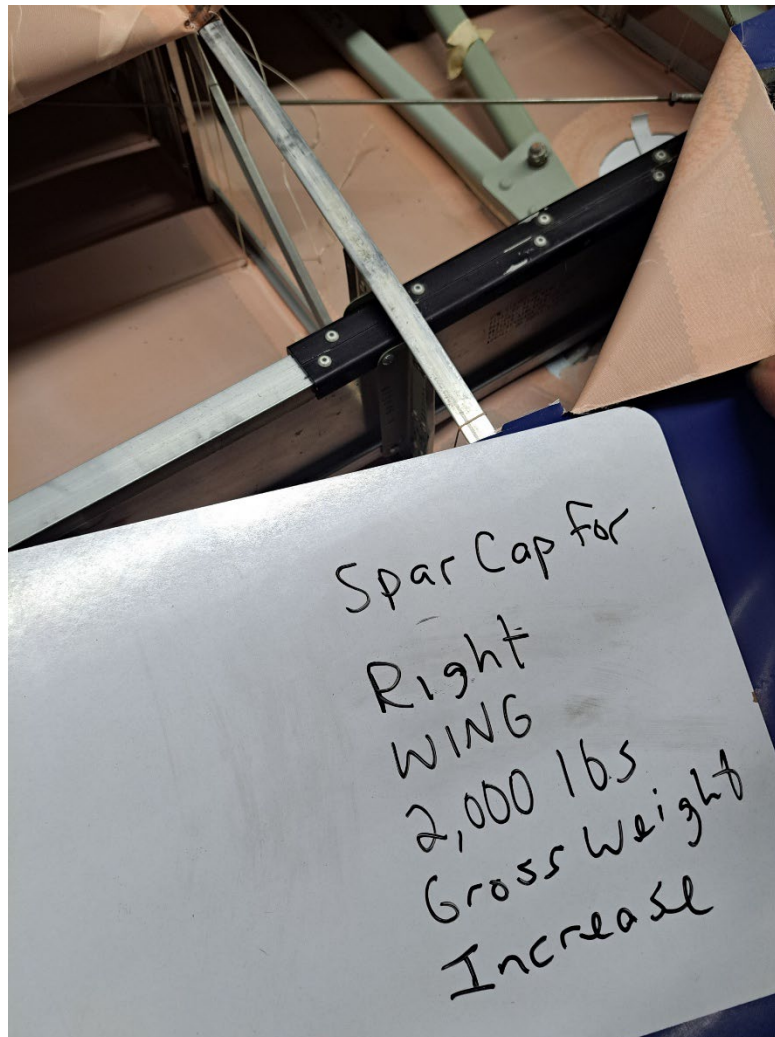
**Figure 9 Right wing spar cap for gross weight increase**

The wing spar was observed to have a modified spar cap installed on the top of the spar near the wing strut attachment area consistent with an increased gross weight modification (Figure 9).

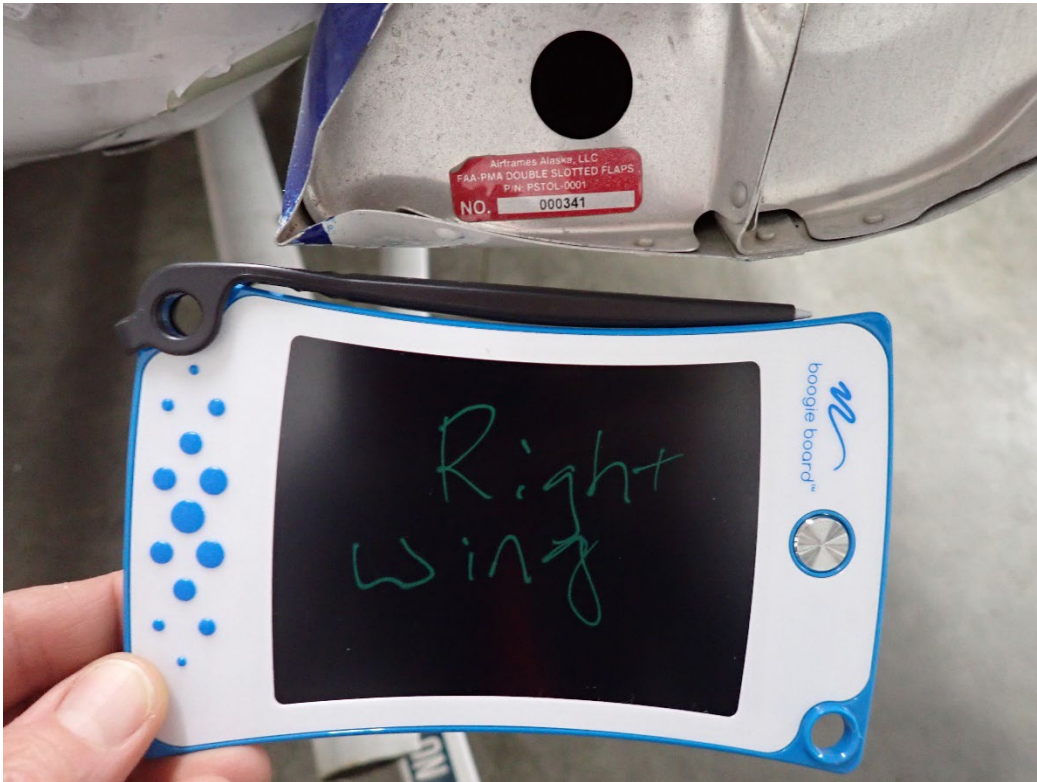
**Figure 10 Right wing PSTOL flap data tag**

On the right wing the Airframes Alaska, LLC FAA PMA double slotted flap Part number PSTOL-0001 was in the retracted position and the flap control cable was separated at the wing root area. Cable continuity was confirmed, except for this separation, and the flap was operated by moving the cable. During operation, the flap contacted the aileron inboard edge and the wing mounted gun case. The flap remained attached to the wing at both hinges. The flap was impact damaged.

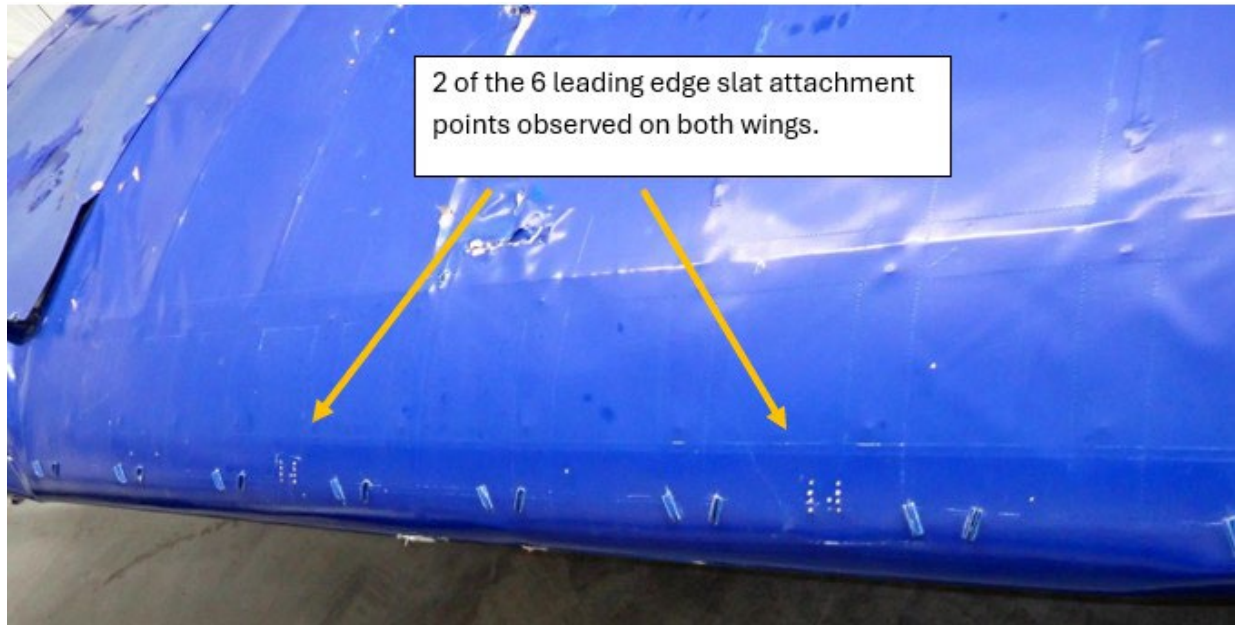
**Figure 11 Leading edge slat attachment points**

Attachment points for previously installed leading edge slats were present on both the left and right wing (Figure 11). There are 6 points of attachment along each wing. The fabric on the wing was found to be slightly faded when compared to the fabric along the leading edge of each wing.

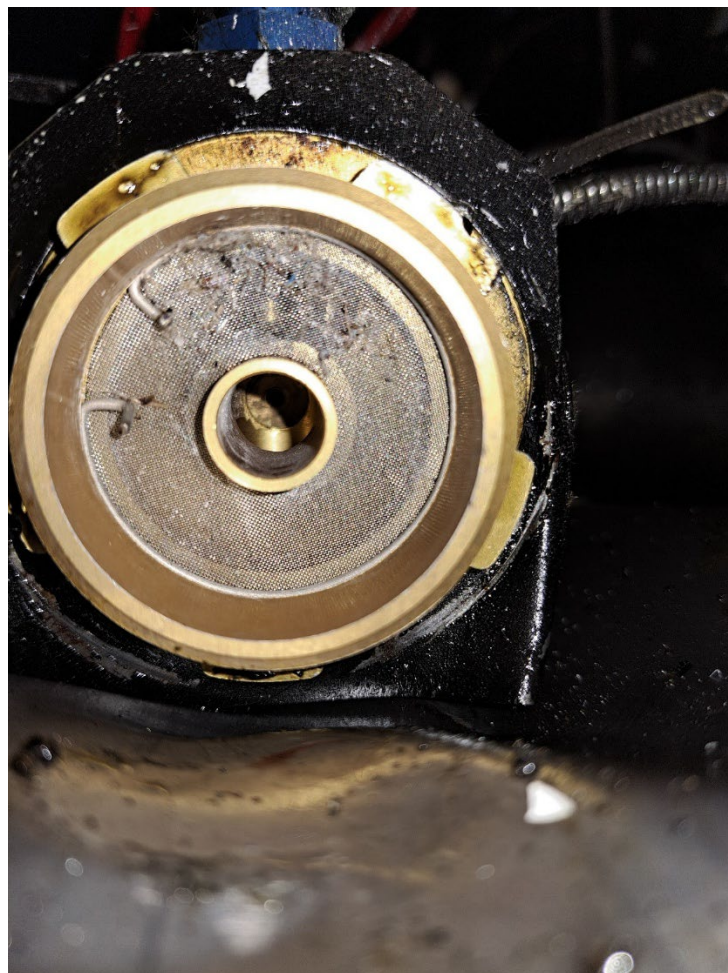
**Figure 12 Gascolator screen**

The gascolator was disassembled, no fuel was present and a small amount of debris was observed on the screen (Figure 12).

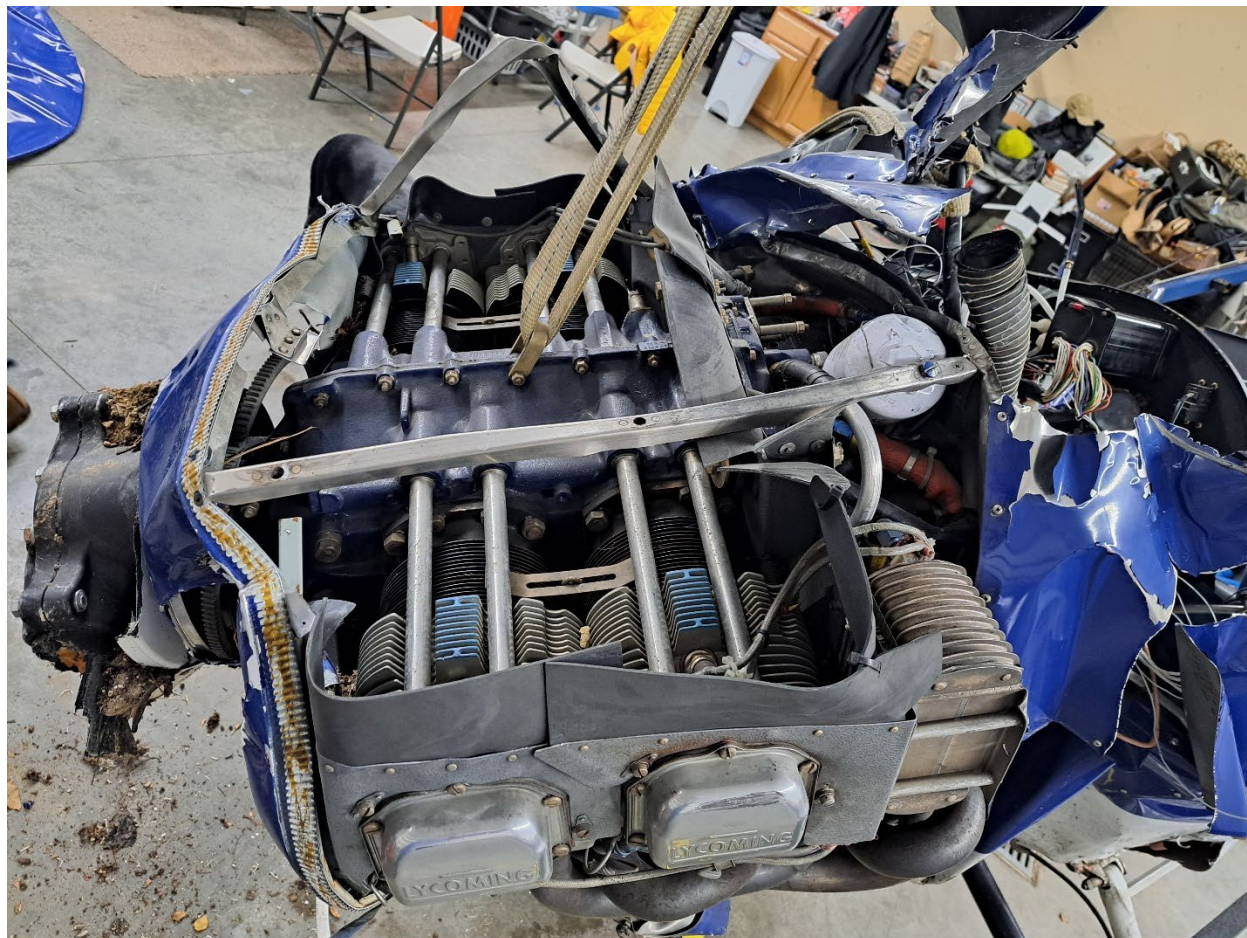
**Figure 13 Accident airplane engine**

A Lycoming O-360-C2A engine, serial number L-12478-36A a four-cylinder, air cooled, direct drive, horizontally opposed, normally aspirated (carburetor), internal combustion engine was installed (Figure 13, 14). The engine remained attached to the airframe and was in good condition. The engine had sustained extensive impact damage to the underside and was pressed against the firewall. The engine cowling was cut from the airframe. Thumb compression was confirmed on all 4 cylinders.

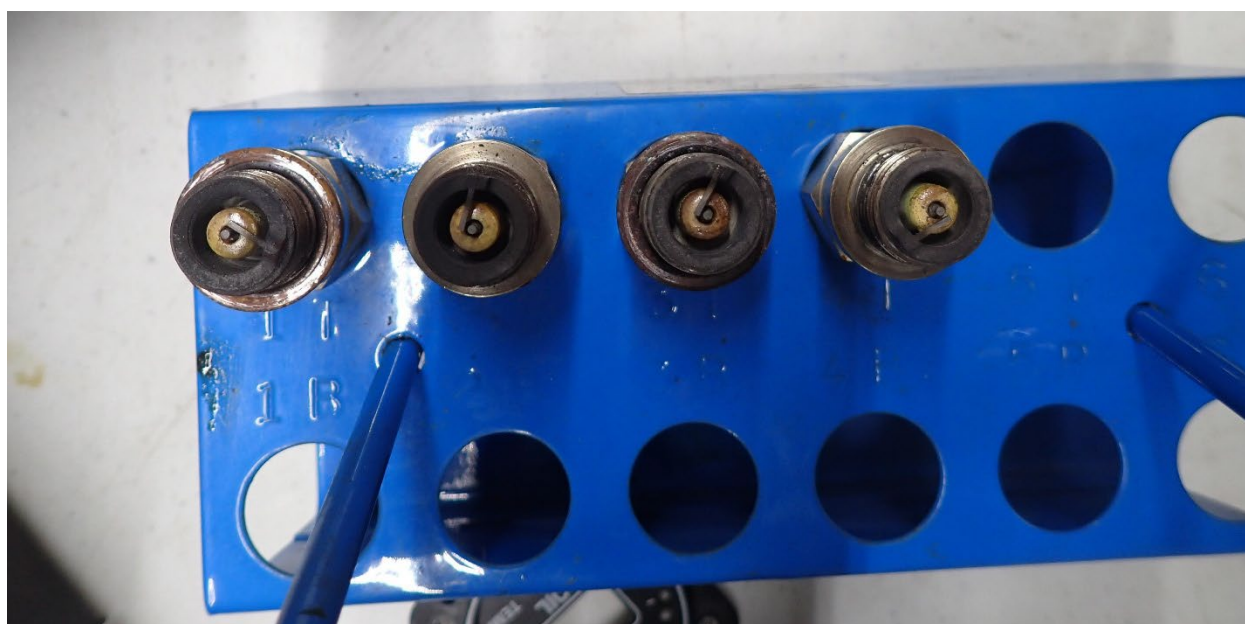
Figure 15 Top 4 spark plugs

The spark plugs were secure at each position with their respective spark plug leads attached. The 4 top fine wire spark plugs were removed and were observed to have normal wear when compared to the Champion Check-A-Plug chart (Figure 15). The ignition system was tested by rotating the magnetos with the propeller hub and observing sparks at the respective top spark plug lead terminals. All but cylinder No. 3 exhibited good spark. Cylinder No. 3 top spark plug ignition lead was observed to have been impact separated near the magneto.

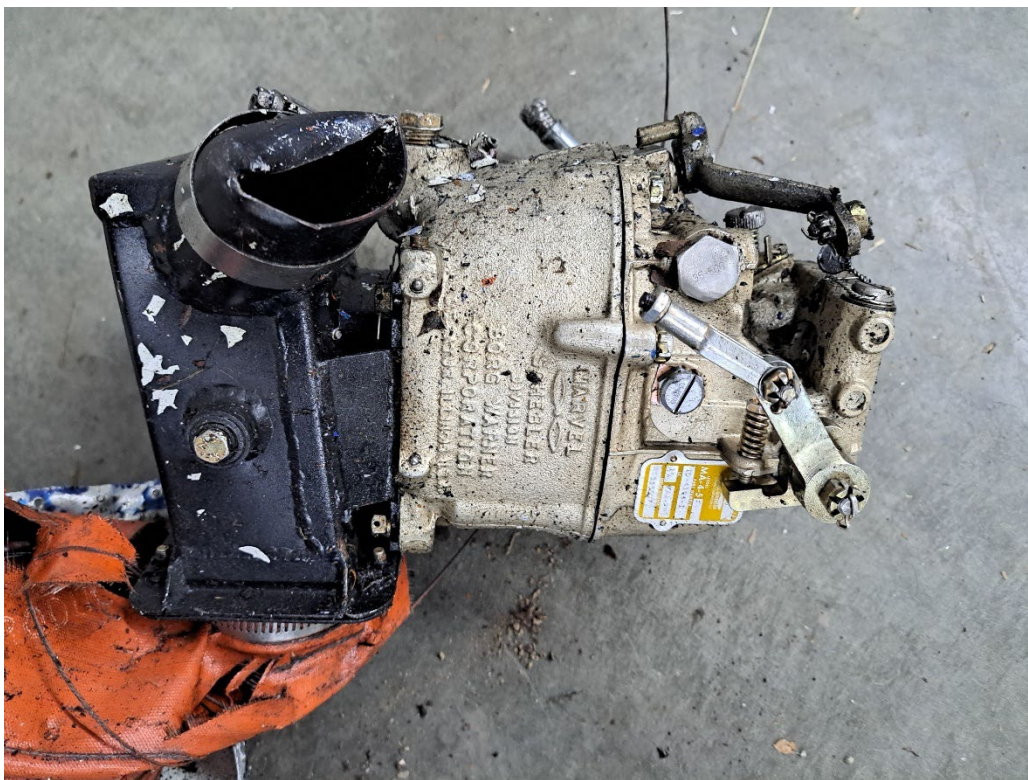
**Figure 16 Carburetor**

The Marvel Schebler carburetor was impact separated from the engine, as were the throttle and mixture controls (Figure 16).

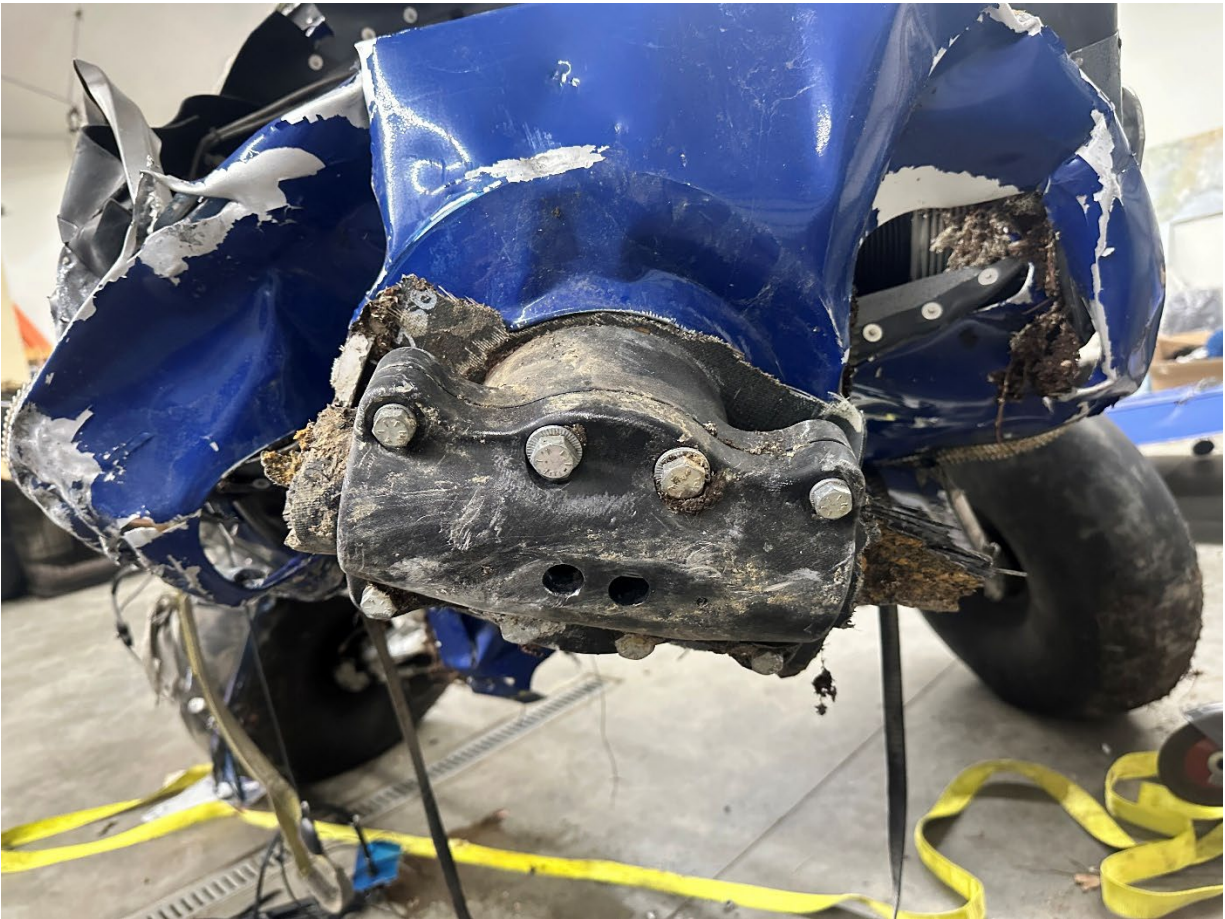
**Figure 17 Propeller hub**

propeller hub remained attached to the crankshaft; however, both propeller blades separated at the hub due to impact (Figure 17). Both blades of the propeller were fractured near the root with a small section of the propeller blades remaining in the hub assembly. One piece of the propeller was found buried at the accident site and was fractured about 30 inches from the root (Figure 18). A small section of a propeller tip section was found, but it could not be determined which propeller blade this piece came from.

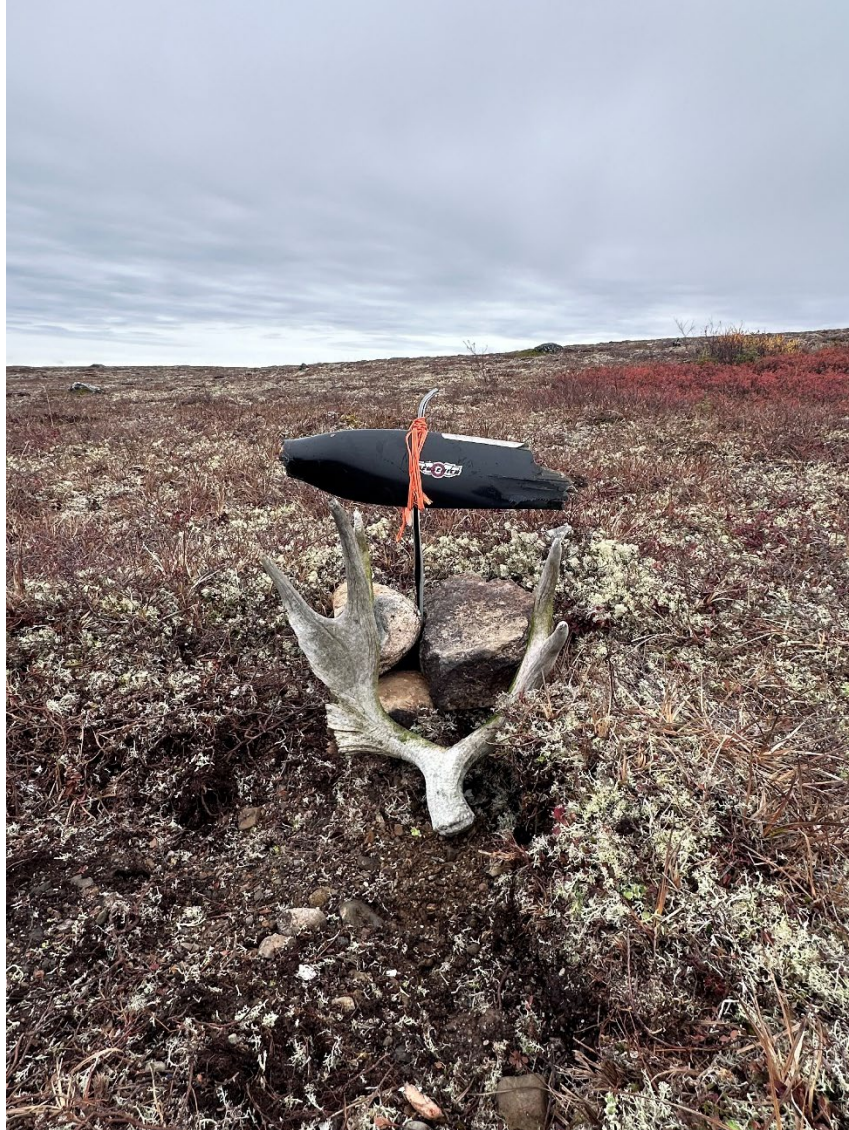
**Figure 19 Propeller blade memorial**

The other propeller blade was left at the accident site where it was used in the construction of a memorial. The witness reported that this propeller blade was found approximately 100 yards west of the wreckage. A photo of this memorial shows the propeller blade fractured at the root with a section missing at the tip of the blade (Figure 19).
