# National Transportation Safety Board

ANC24FA089

## **Wreckage Exam**

Location: King Salmon, AK  
Date: September 7, 2024  
Time: 0924L  
Helicopter: Bell 206B N306FW

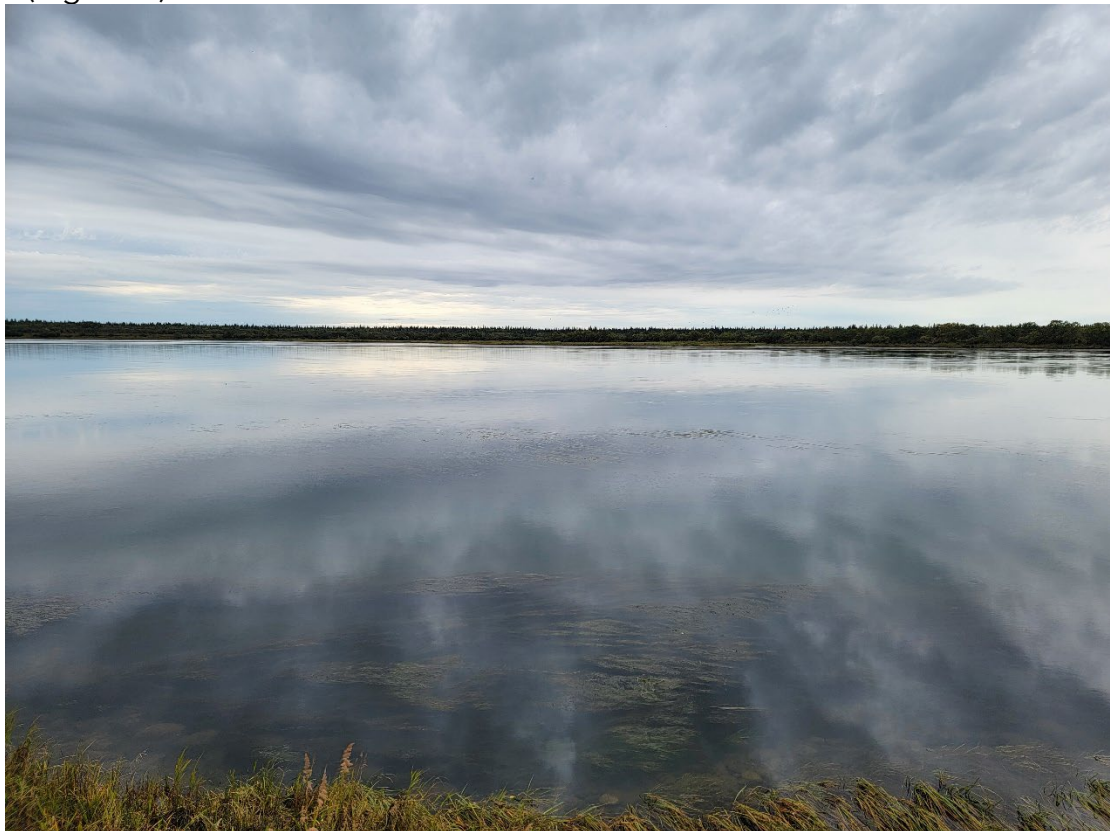
Accident site was in the water of the Naknek River. The river is bordered by featureless terrain. The picture below was taken at the accident site 3 days after the accident. (Figure 1)

**Figure 1 view looking across the river at the accident site on a clear day.**

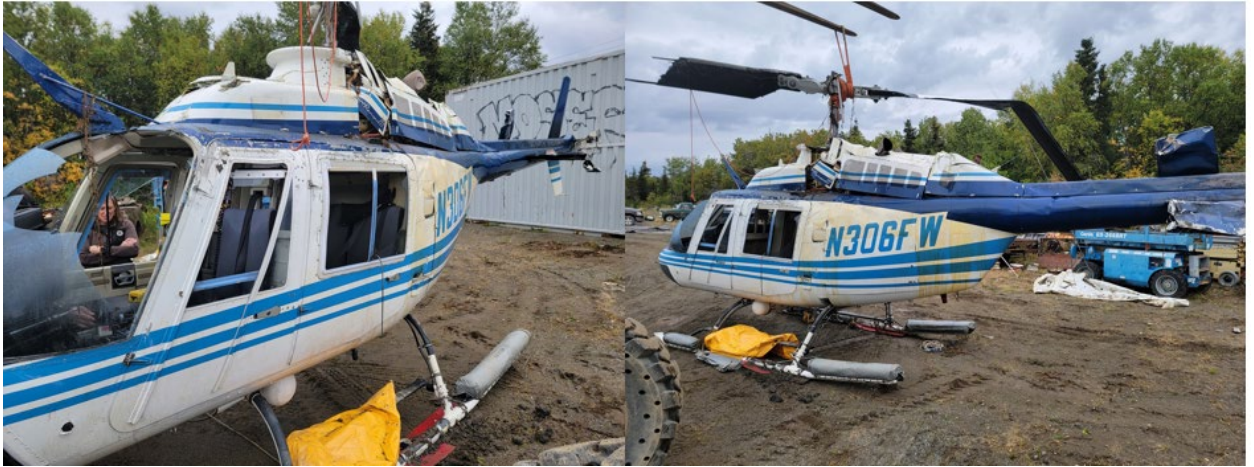
The fuselage was intact with all major components still attached. Figure 2,3,4,5)

**Figure 2 view of the left side of the helicopter.**

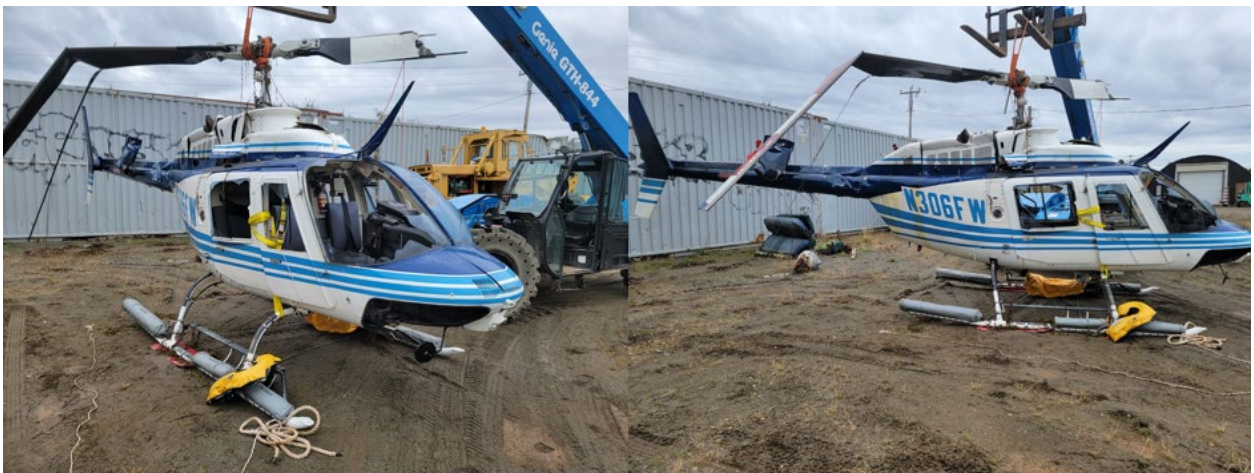
**Figure 3 view of the right side of the helicopter.**

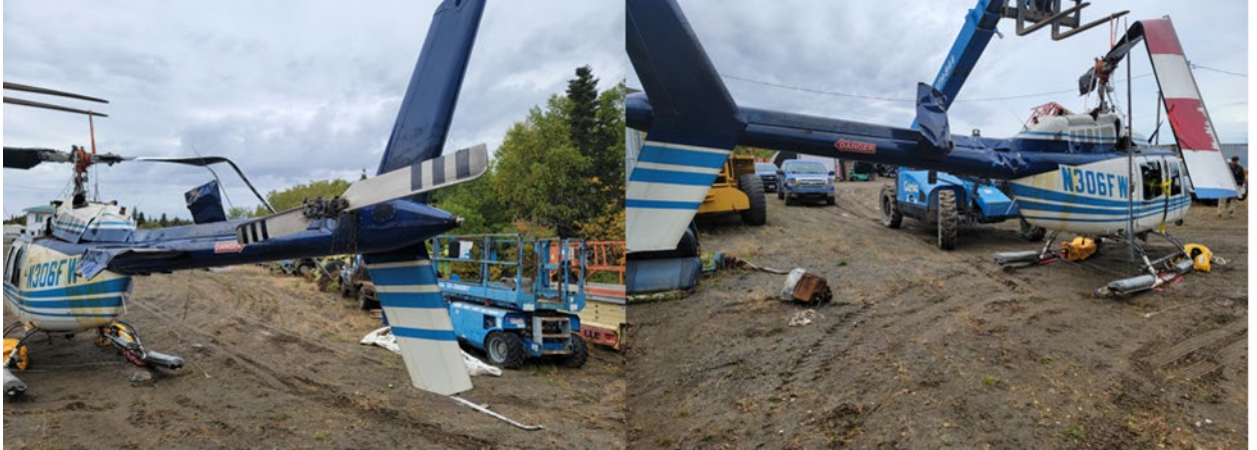
Tail boom was attached to the fuselage. (figure 4,5,6)

**Figure 4 view of the left and right side of the tail boom.**

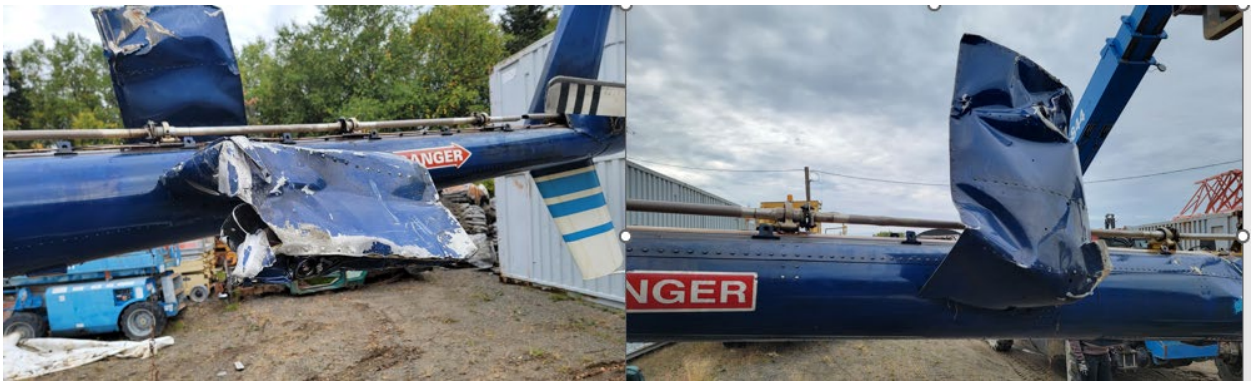
**Figure 5 view of the left and right side of the tail boom.**

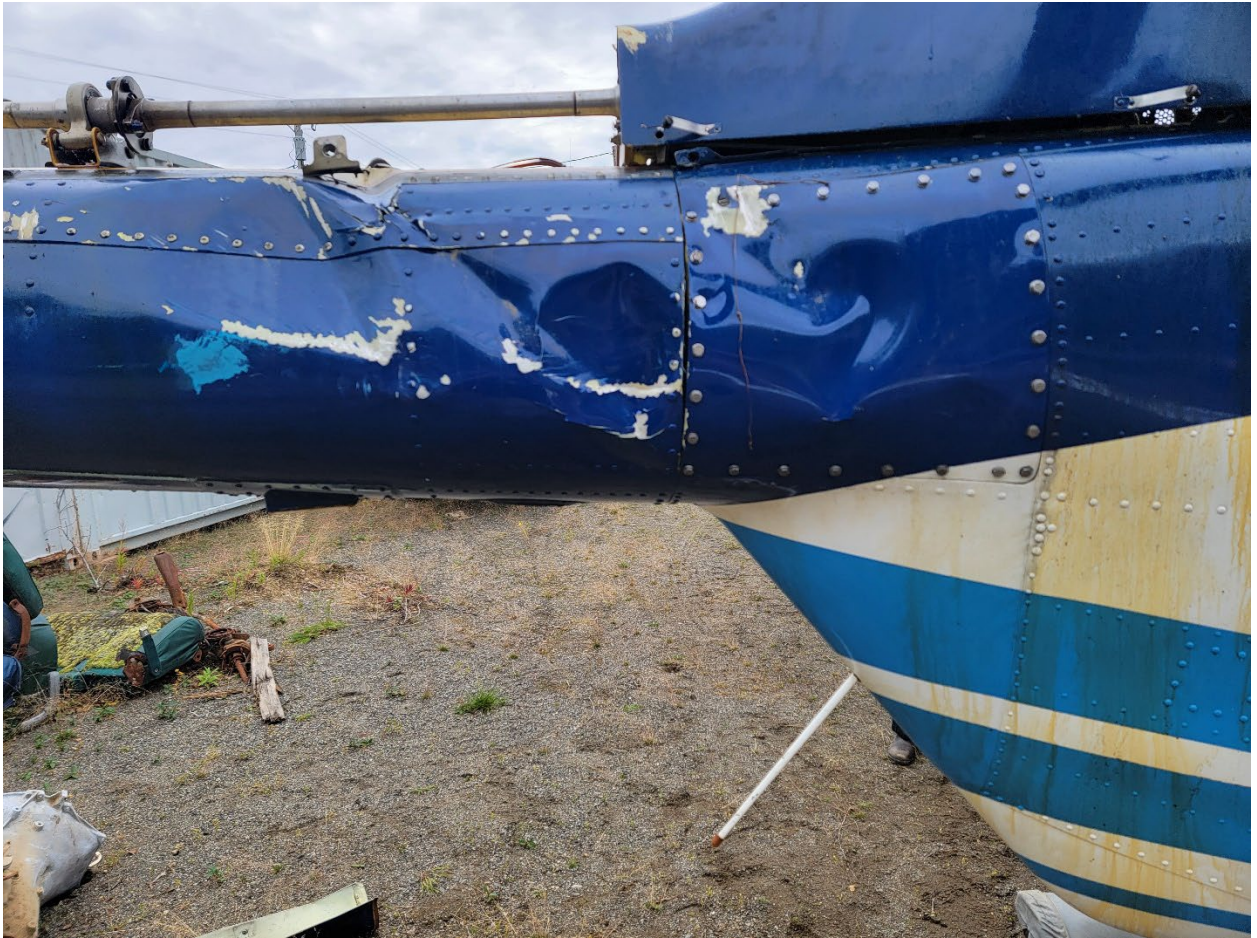
**Figure 6 view of the tail boom attachment to the fuselage.**

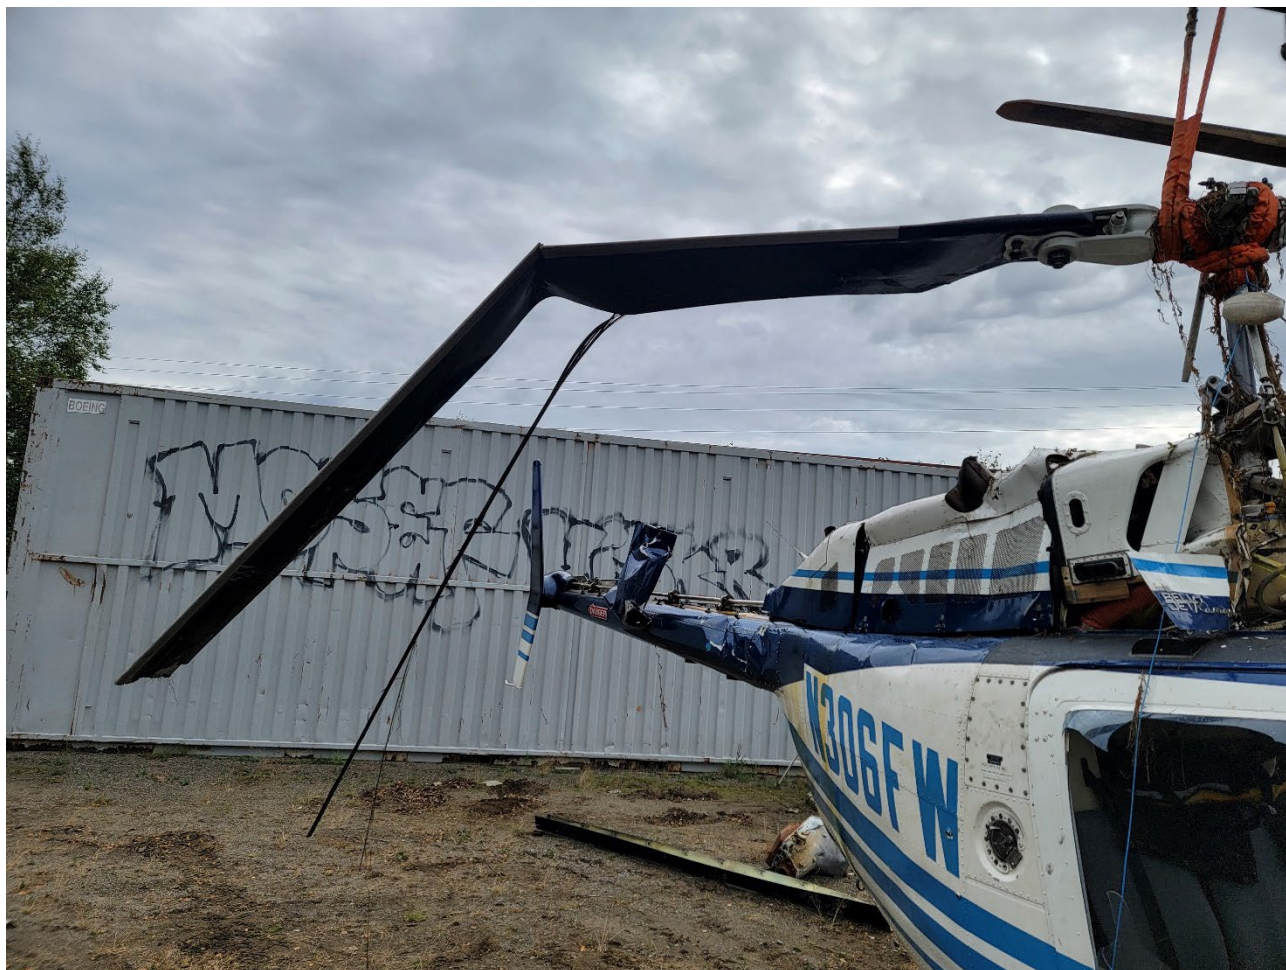
Main rotor blade no.1 (figure 7) was largely intact with a downward bend about mid span, tip area damage and separation of the trailing edge of the rotor blade. Main rotor blade no.2 (figure 8) was impacted separated about three feet from the attachment point to the main rotor hub. (figure 9) The separated section was not recovered. All damage observed was from impact with water/ terrain.

**Figure 7 view of the no.1 main rotor blade.**

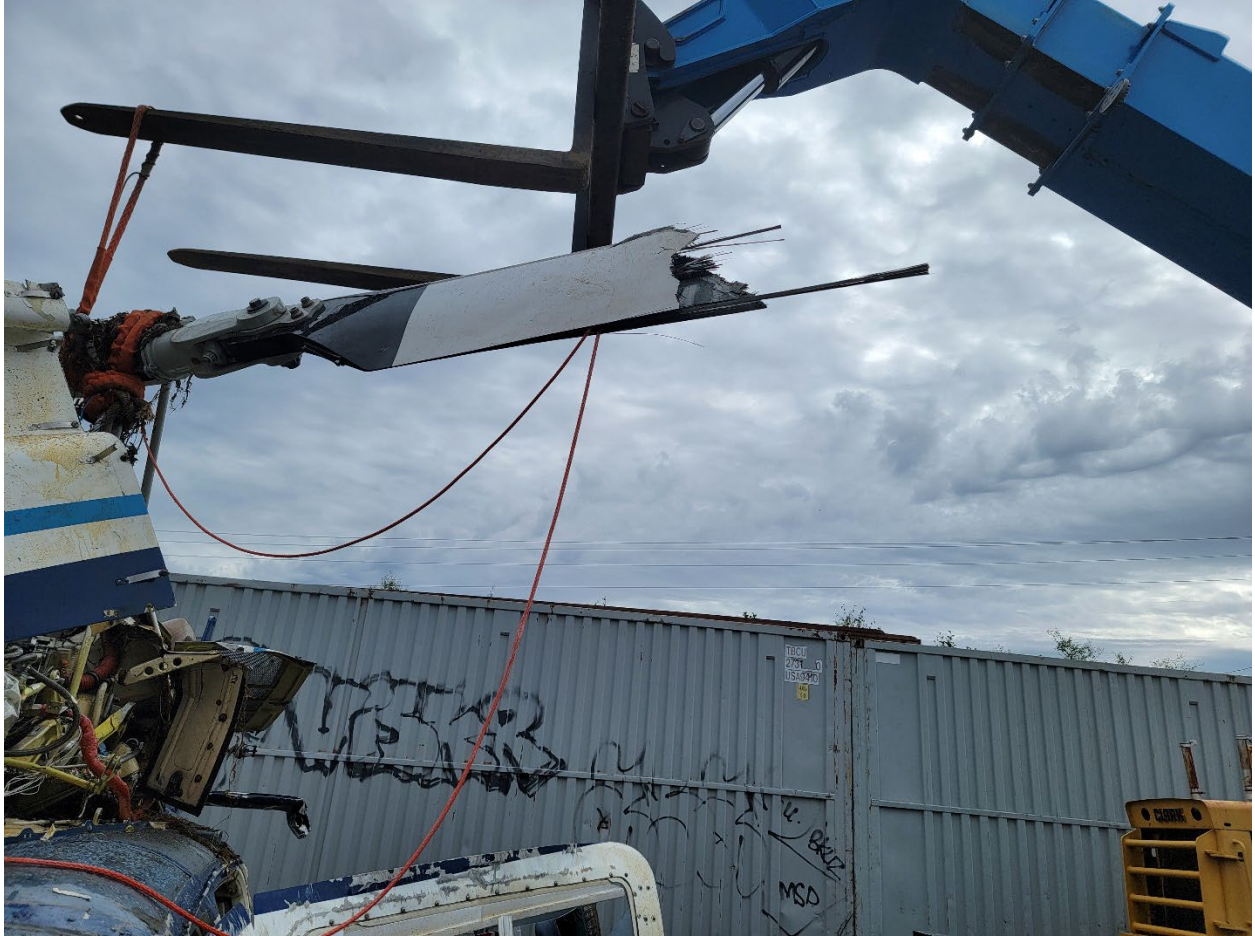
**Figure 8 view of the no.2 main rotor blade.**

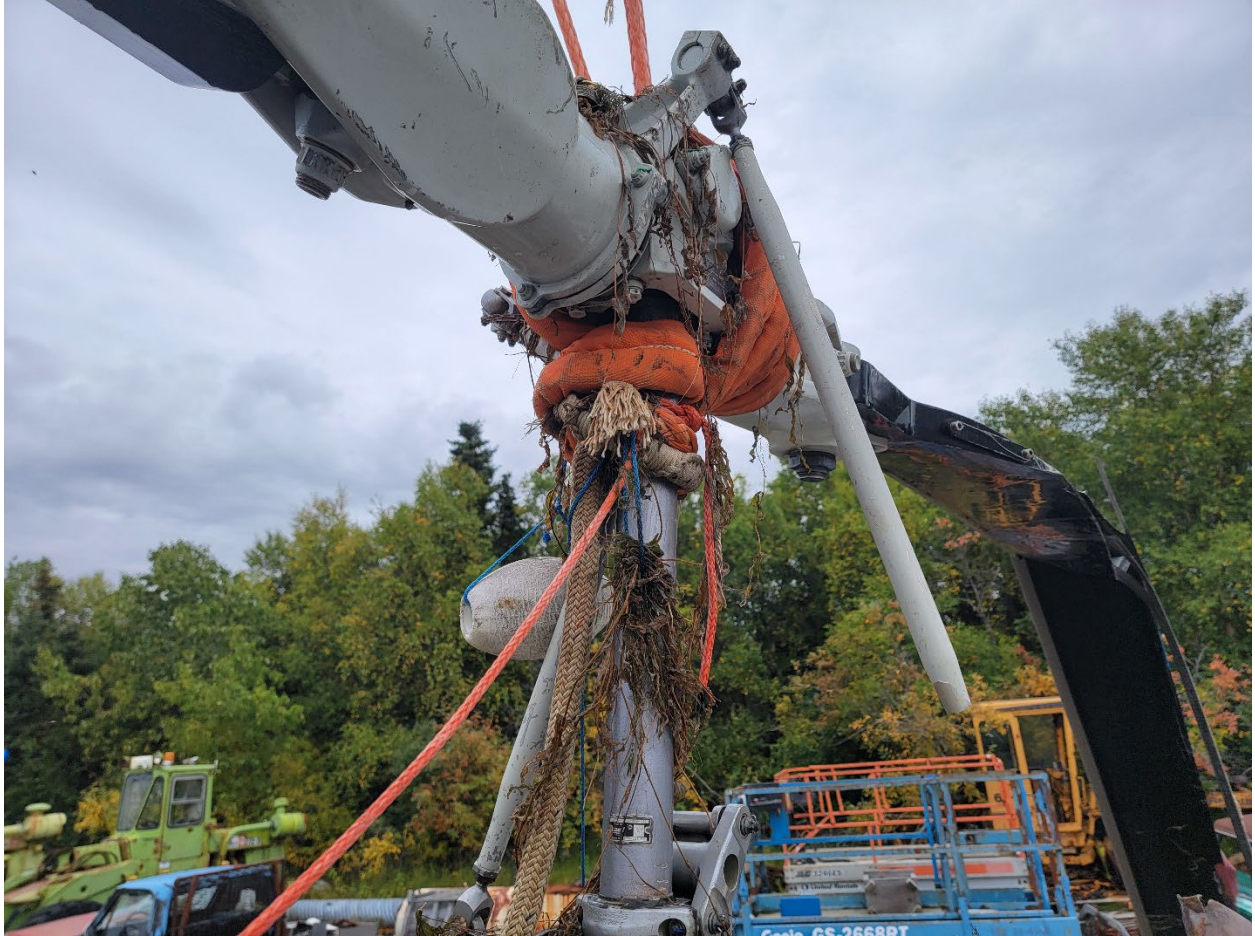
**Figure 9 view of the mast and main rotor hub.**

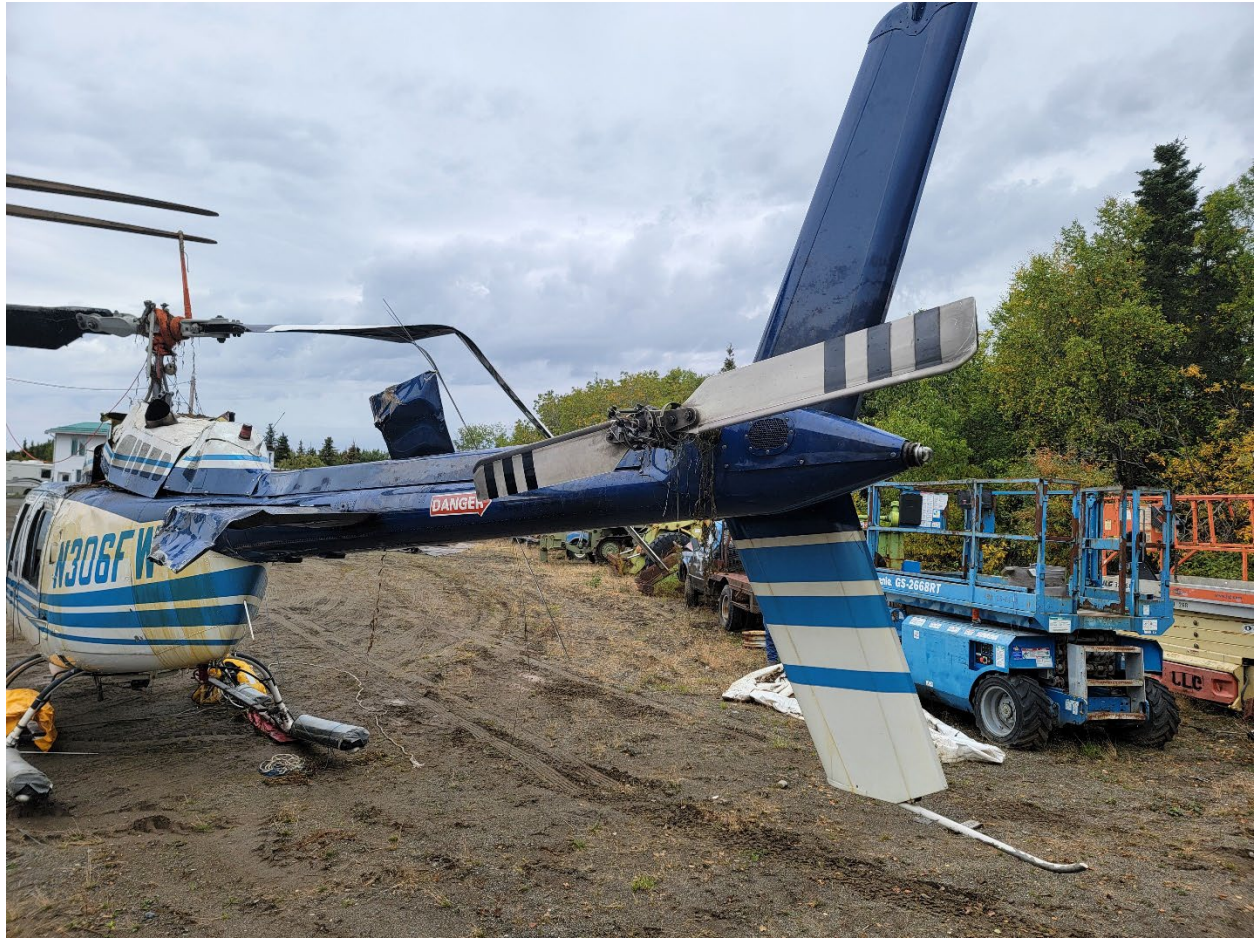
The tail rotor blades, and gear box were undamaged. (figure 10) The tail rotor rotated freely by hand and the drive shaft moved in concert. The drive shaft was connected to the engine with a torsional fracture in the drive shaft into the tail rotor gear box. (figure 11)

**Figure 10 view of the tail rotor blades.**

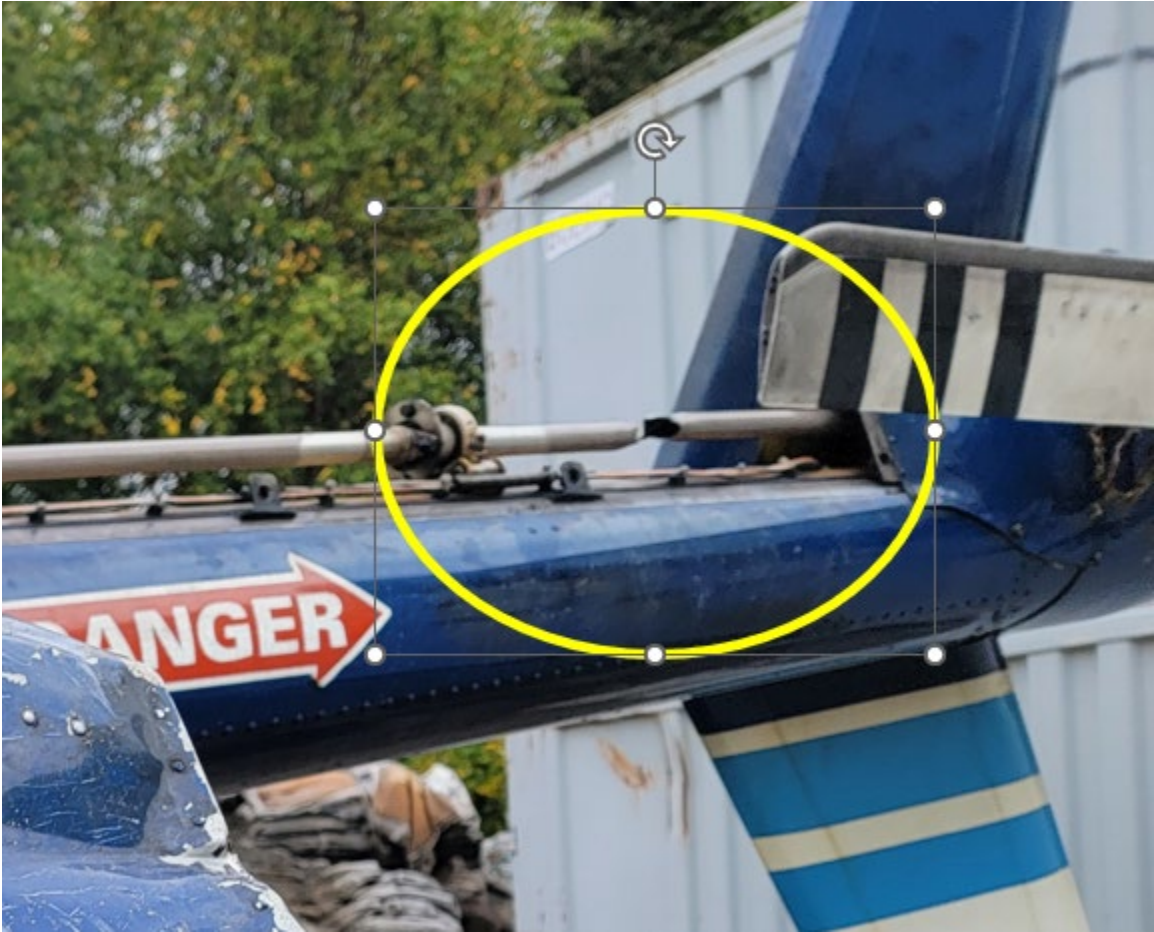
**Figure 11 view of the location of the torsional damage to the tail rotor driveshaft.**

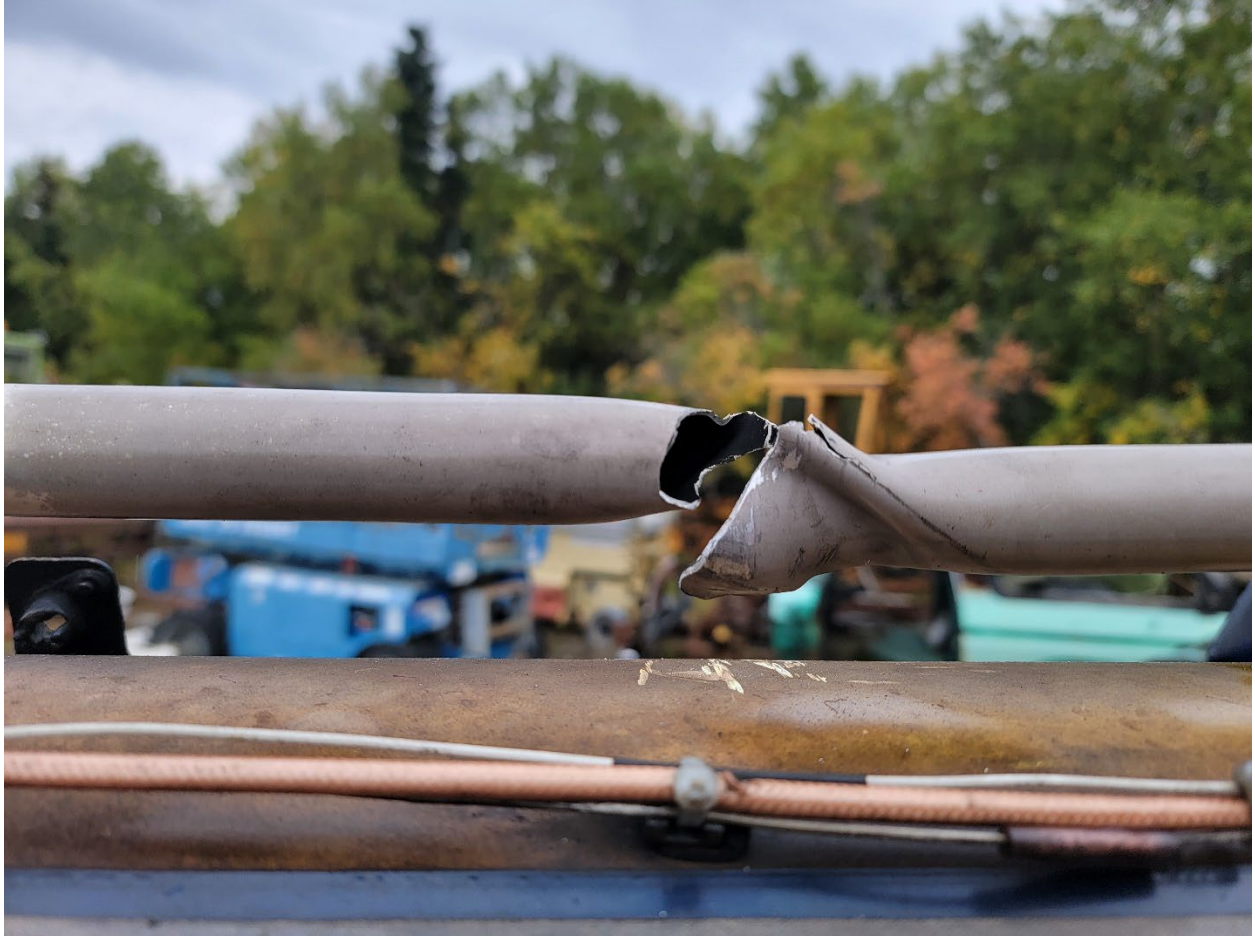
**Figure 12 View of torsional damage to the tail rotor driveshaft.**

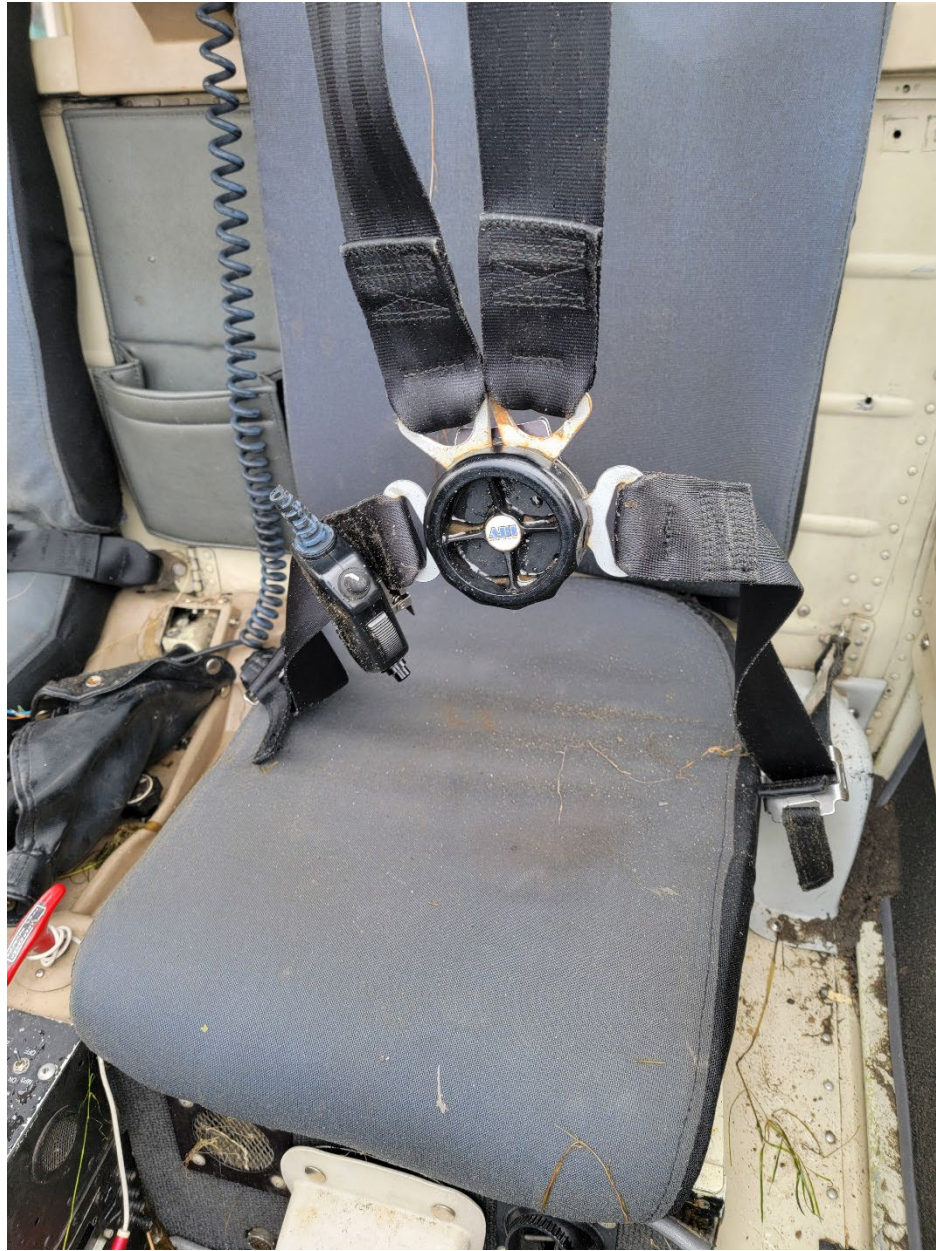
The one fatal was unable to exit the helicopter when the helicopter went under the water. The passenger was in the front left seat using a 4-point seatbelt restraint system. (figure 13) The headset wire connection was pulled apart near the connection for push to talk. (figure 14)

**Figure 13 View of the front left seat.**

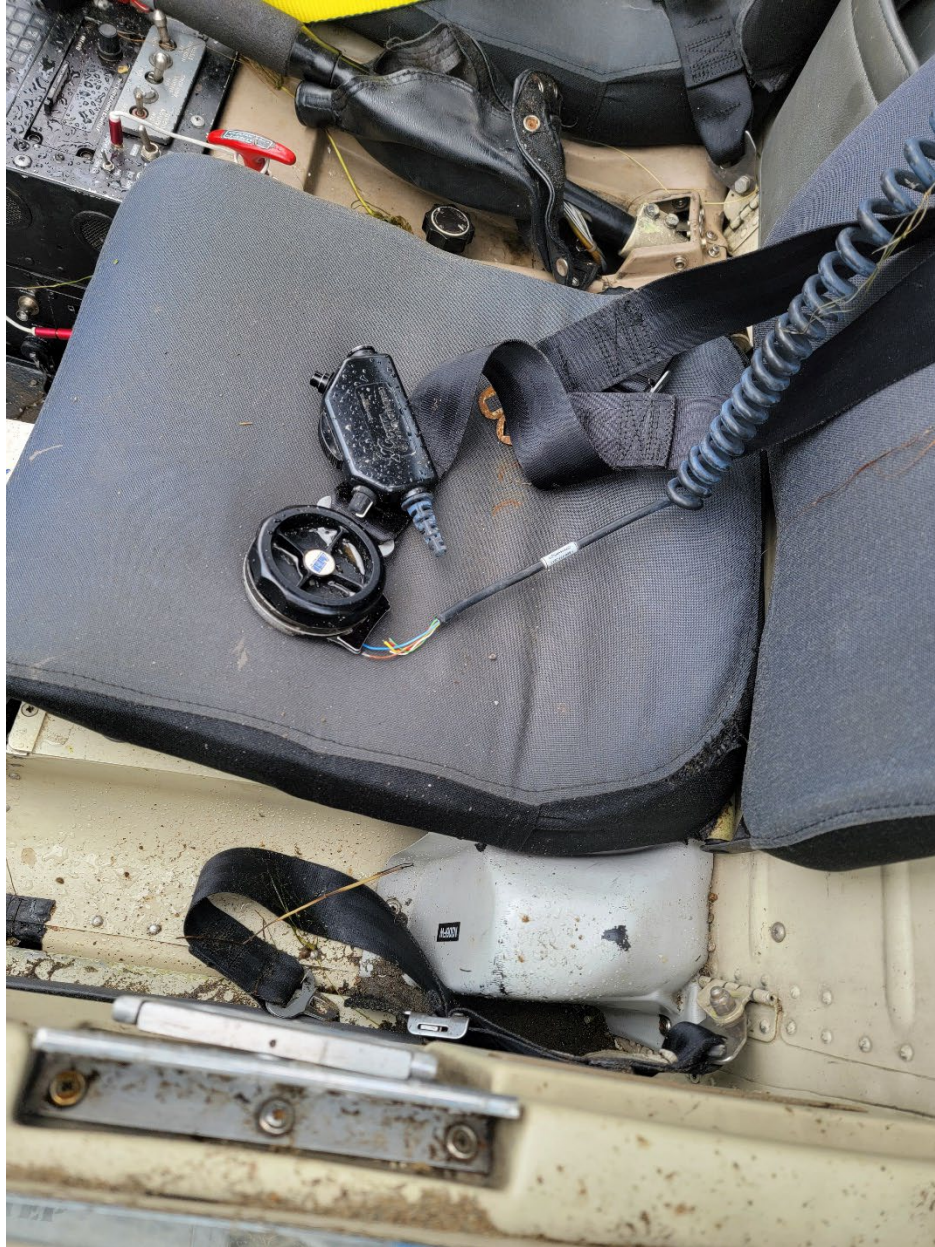
**Figure 14 View of the front left seat.**

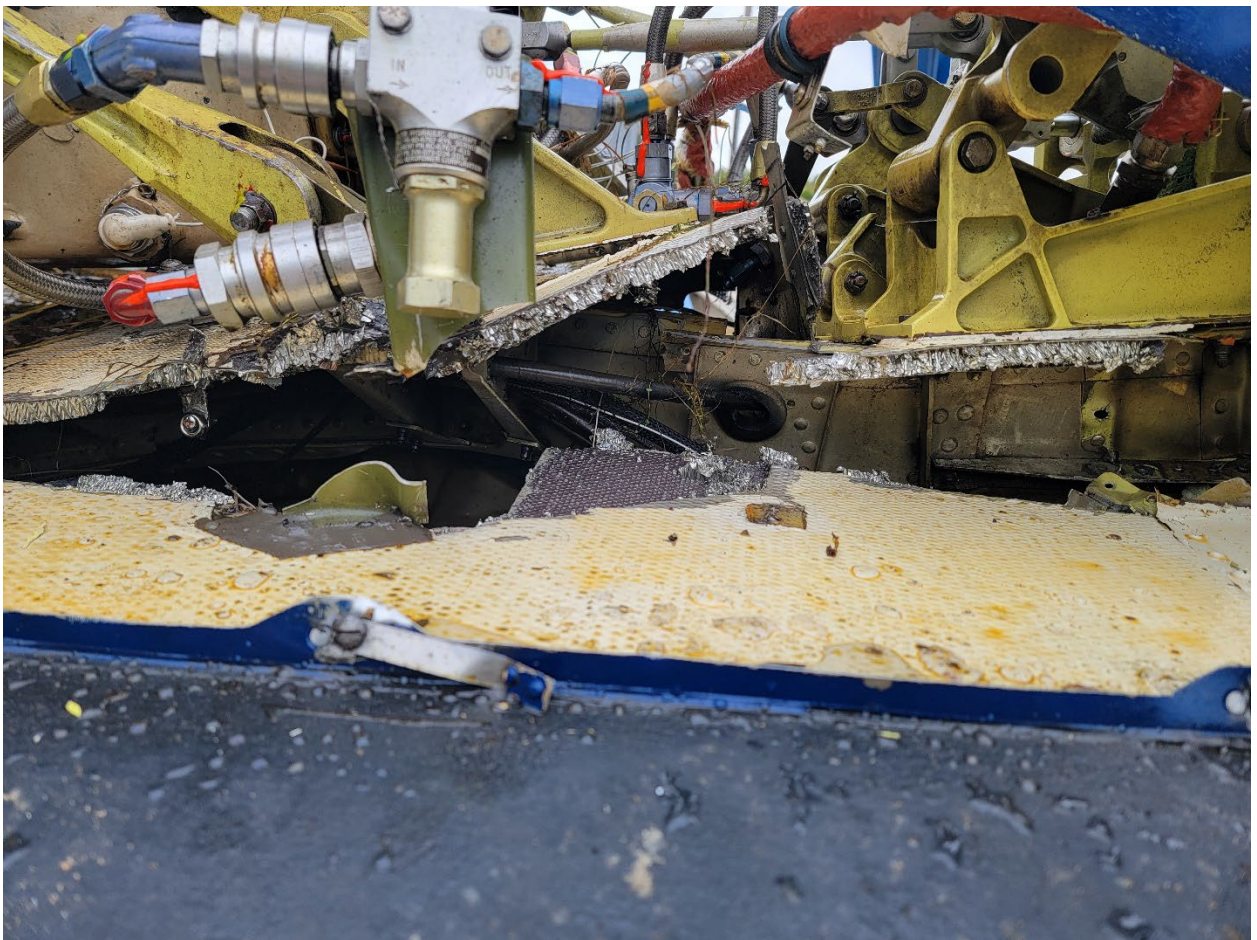
The floor under the flight control hydraulic system and main transmission was heaved upward. (figure 15,16) No damage was observed with the flight control hydraulic servos. All hoses were attached and undamaged.

**Figure 15 View of the right side damage to the floor below the main transmission and flight control servos.**

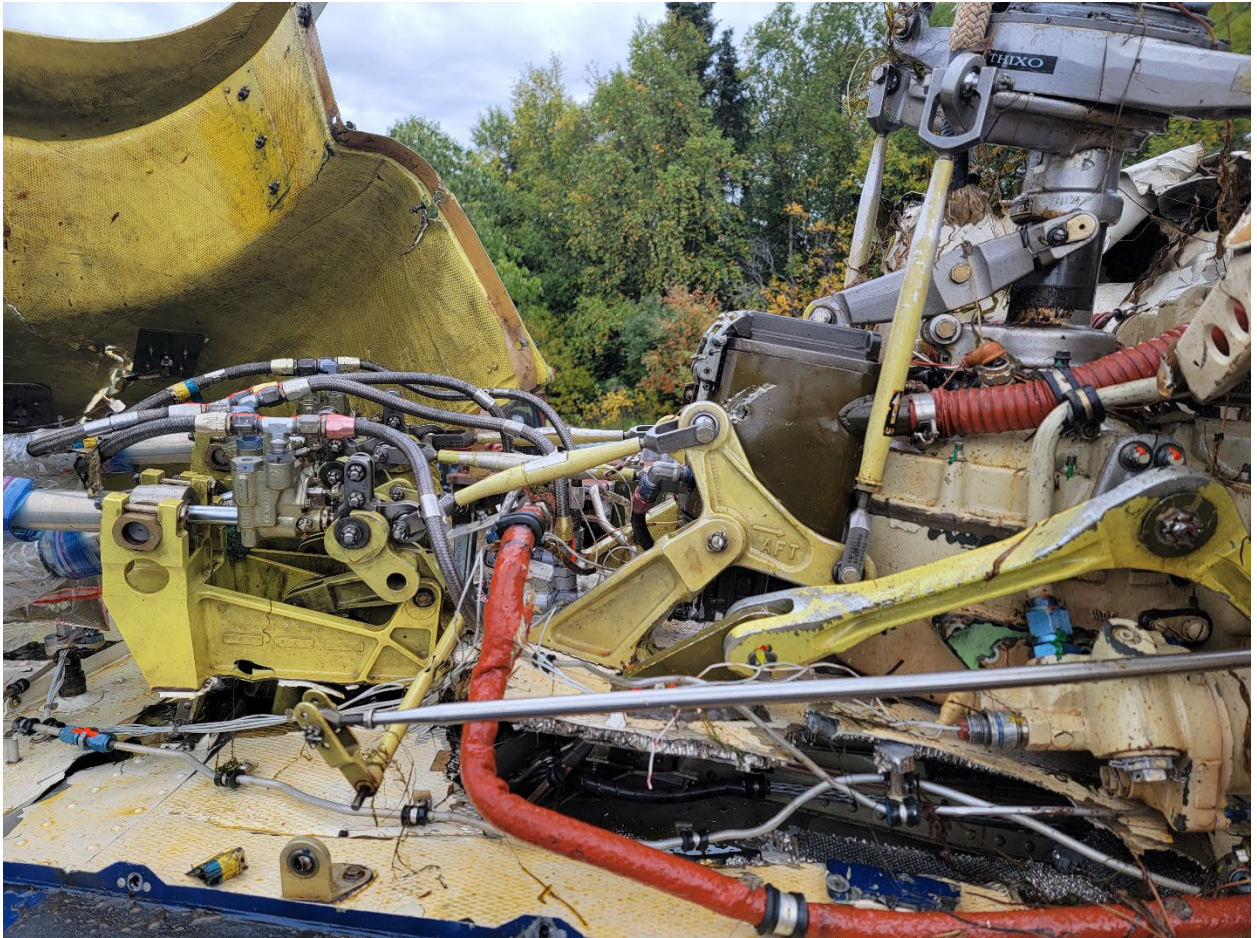
**Figure 16 View of the left side of the hydraulic servos and main transmission.**

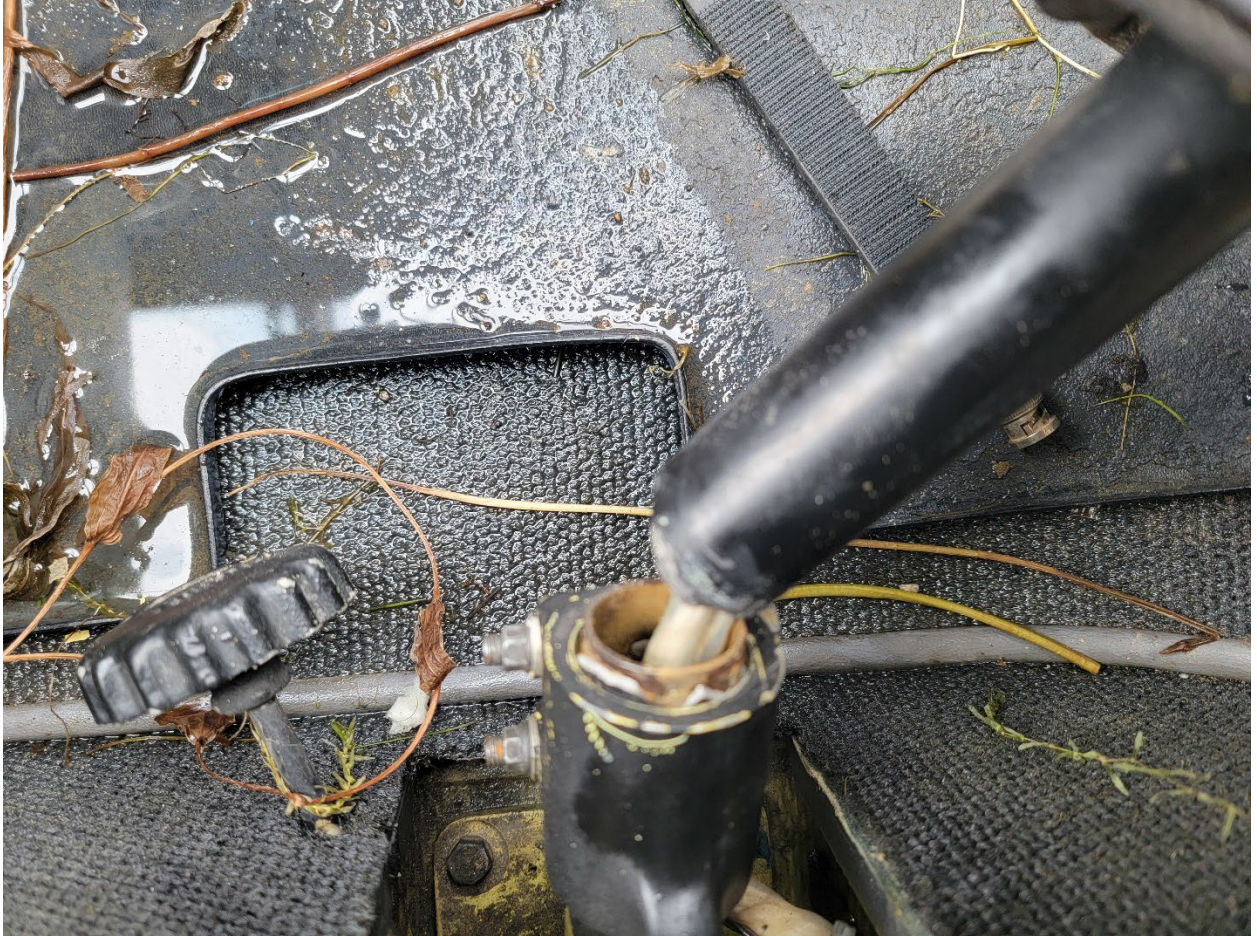
Cyclic and collective flight controls were traced from the cockpit controls to the pitch control rods attached to the main rotor head. One pitch control rod connected to the No.2 main rotor blade was fractured. The cyclic stick and collective were fractured at the base. (figure 17) Anti-torque control (yaw) was traced from the anti-torque pedals to the tail rotor with impact fractures at the bottom of the flight control broom closet and again at the top of the broom closet. Tail rotor pitch control operated smoothly and freely.

**Figure 17 View of the cyclic control fracture.**

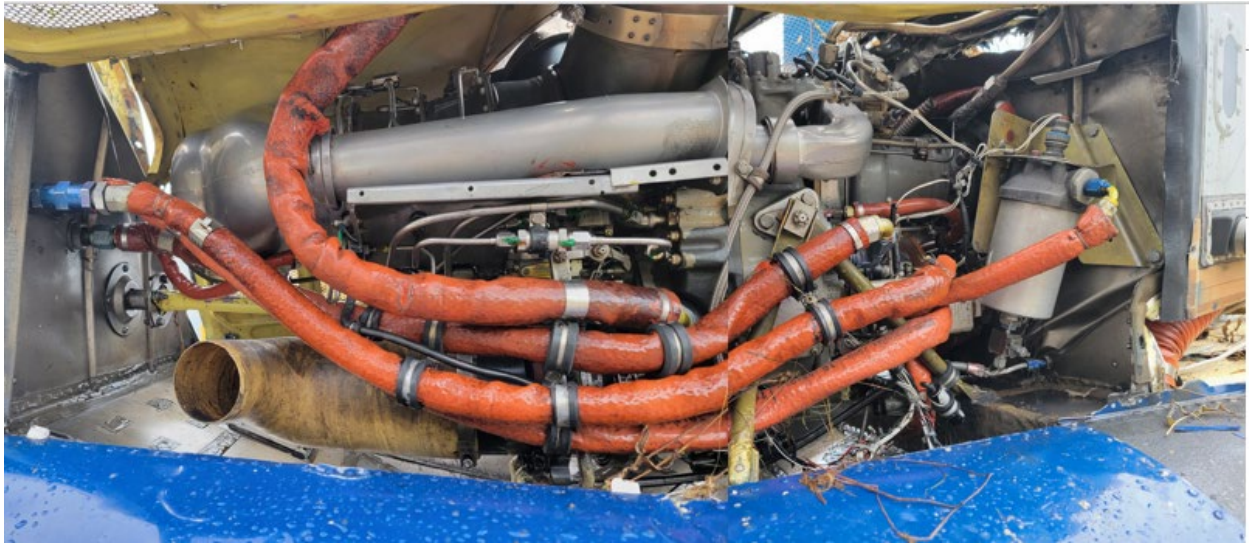
**Figure 18 view of the right side of the engine.**

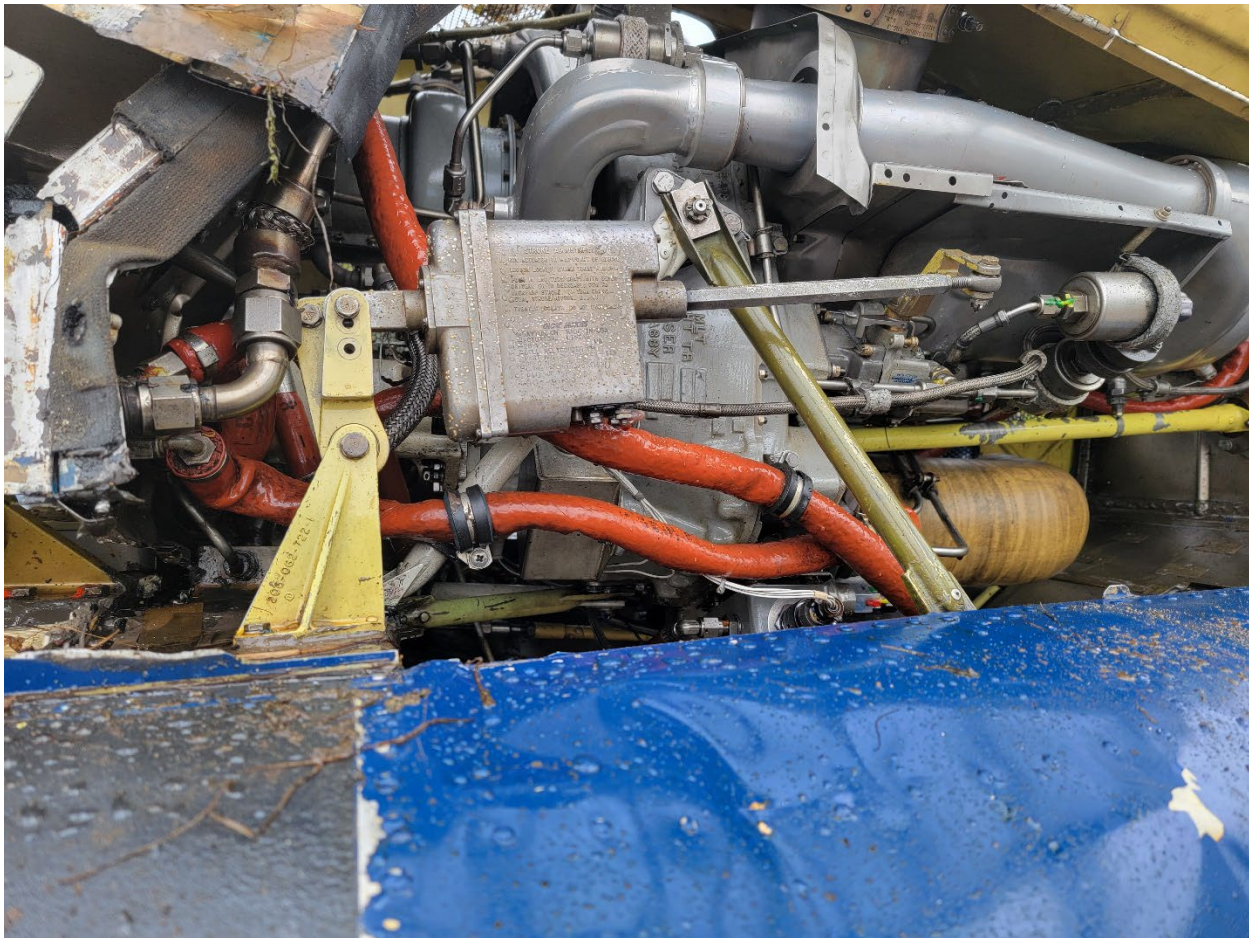
All fuel, oil and electrical lines in the engine compartment were undamaged and connected. Fuel control unit was undamaged. Throttle control from cockpit was traced to the fuel control unit.

**Figure 19 View of the left side of the engine and fuel control unit.**

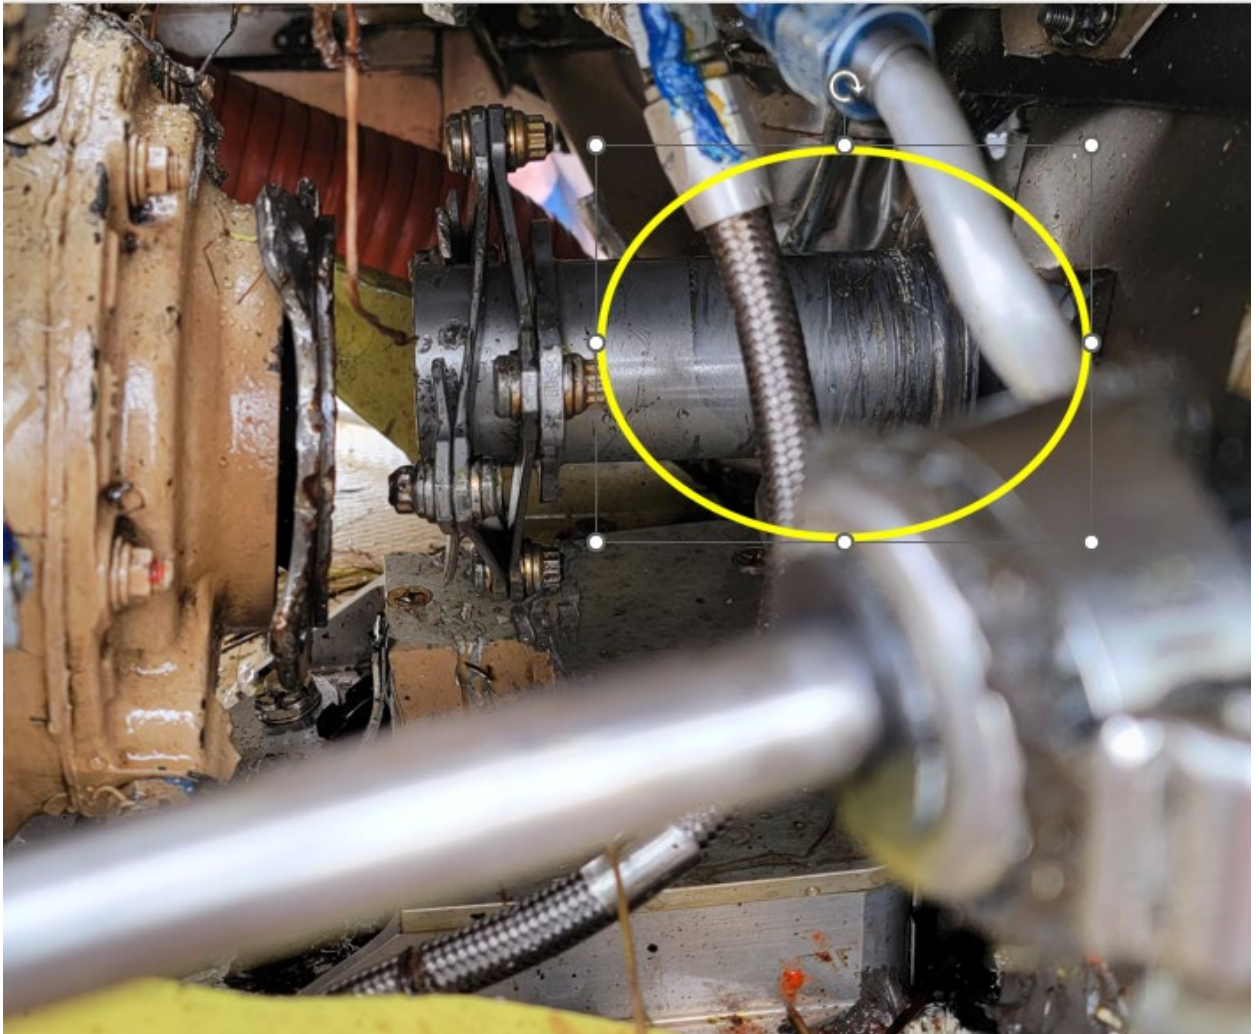
Rotational scoring observed on the tail rotor drive shaft under the engine and on the input shaft to the K-flex. (figure 20,21) The K-flex was fractured separated between the engine and main transmission

**Figure 20 view of rotational scoring on the driveshaft from the engine to the main transmission.**

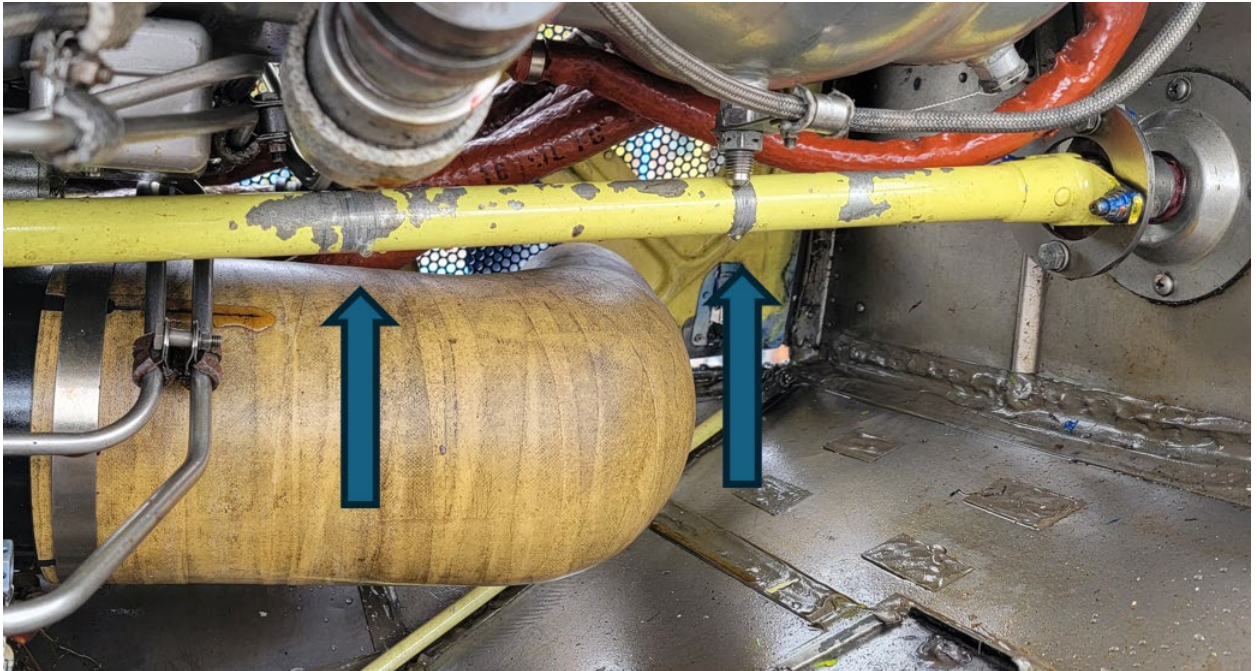
**Figure 21 view of tail rotor driveshaft rotational scoring.**

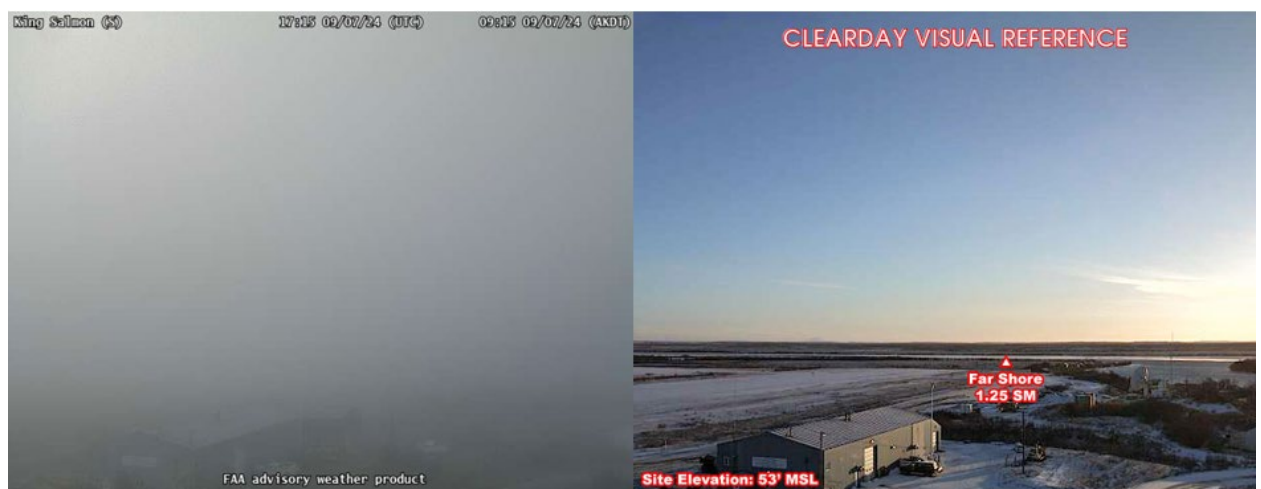
The pilot was informed the weather was wind 170 at 5 knots, one quarter mile visibility with fog, and an indefinite ceiling of 200 feet.

**Figure 22 View of FAA weather cam images near the time of the accident.**
