# National Transportation Safety Board

ANC24FA092

## **AIRFRAME AND ENGINE EXAMINATION**

On September 14, 2024, at 0930 Alaska daylight time, an experimental amateur-built, JP Flyer, N1202Y, was substantially damaged when it was involved in an accident near Wasilla, Alaska. The pilot was fatally injured. The airplane was operated as a Title 14 *Code of Federal Regulation* Part 91 personal flight.

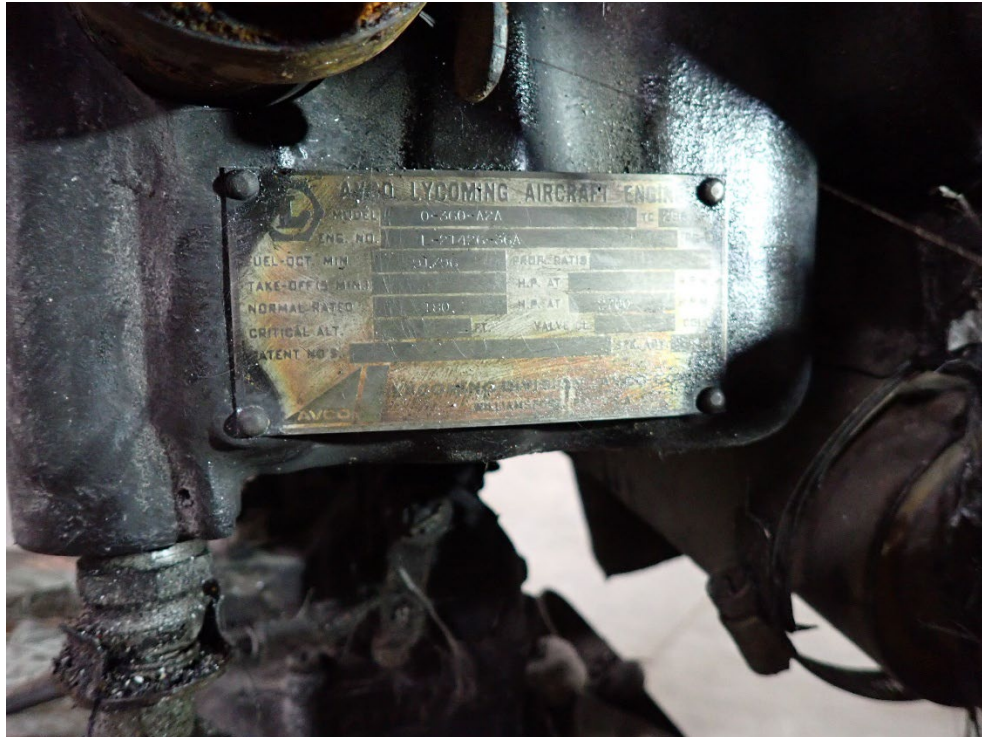
The Lycoming O-360 A2A Serial number L-21426-36A engine was cut from the fuselage for the engine exam. The engine was black in color consistent with a post impact fire and sooty to the touch. Signs of corrosion were observed throughout and consistent with high heat exposure. The logbooks could not be located therefore the total time in service and any historical information concerning the engine is unknown.

**Figure 1 Engine data tag**

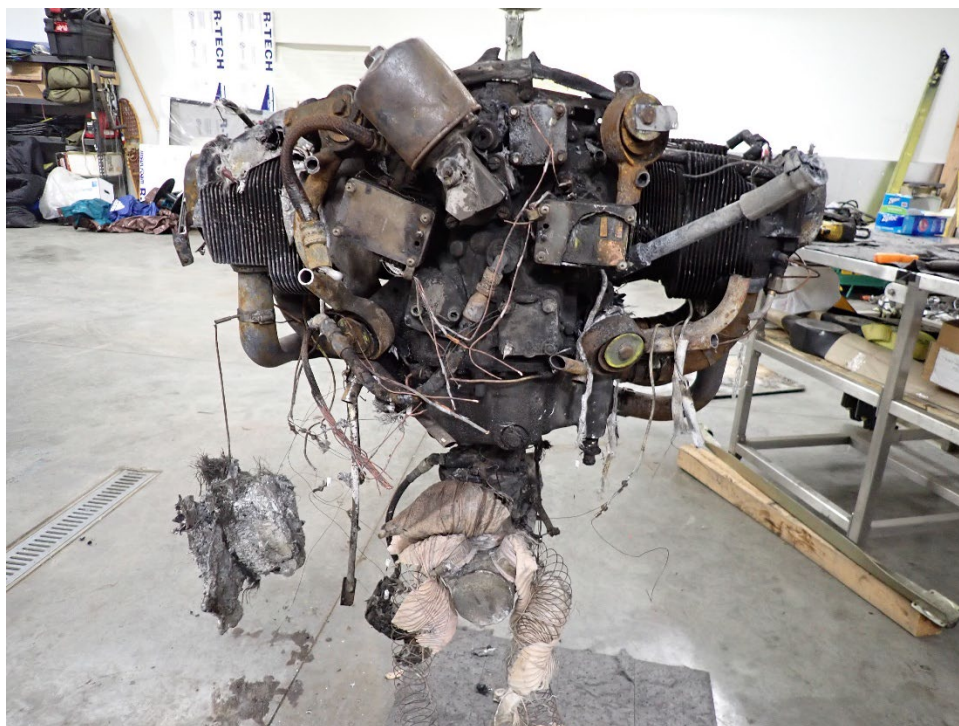
The oil filter was attached to the engine and observed to be safety wired. The filter sustained high thermal damage, no paint was left on the filler can. The filter was impact damaged in the form of crushing to the filter can. The oil filter was not cut open for further examination. The oil cooler was present but mostly consumed by fire, no data tag was visible.

**Figure 2 Engine presented at examination**

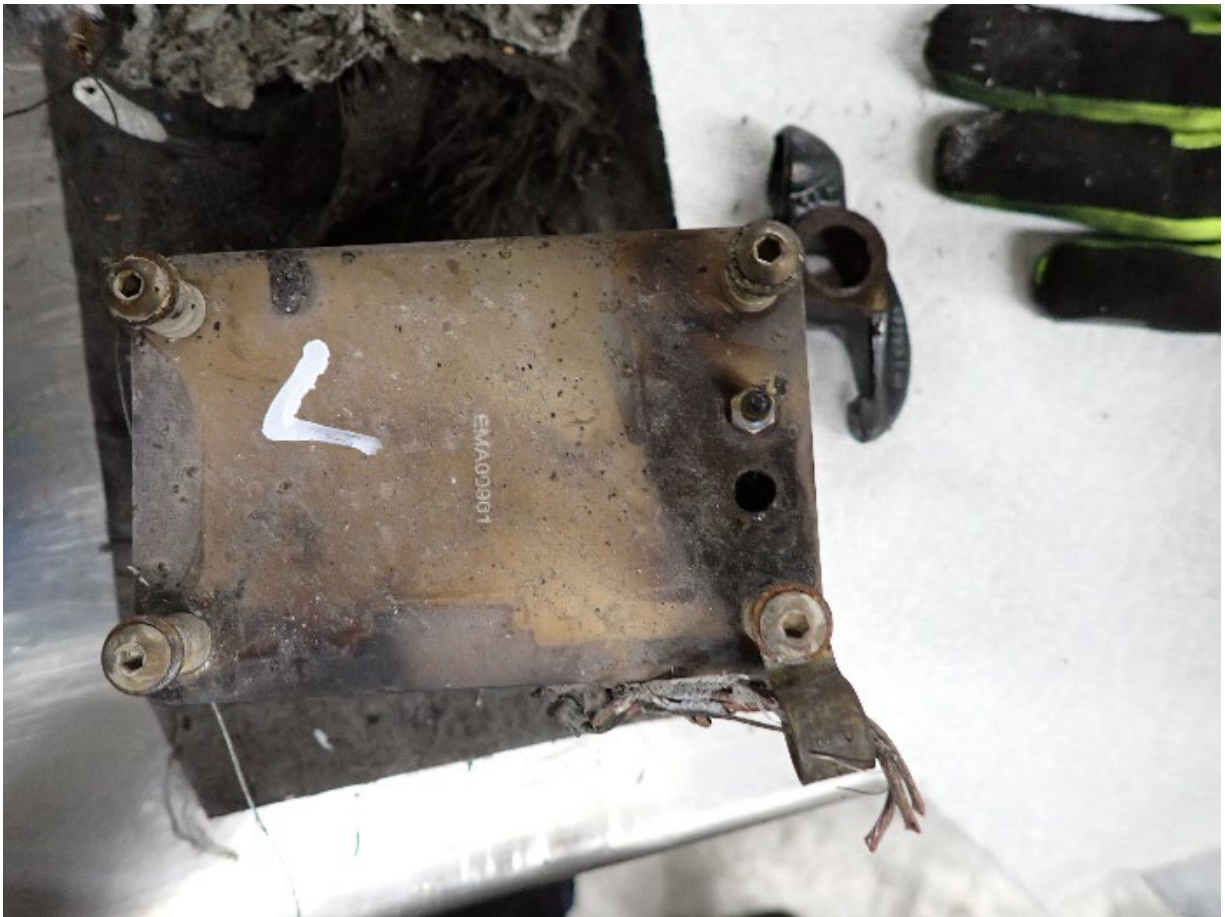
The magneto drive gear was observed to be in good working condition. Both electronic E-Magnetos were firmly attached to the accessory section. Both magnetos were thermally damaged and partially consumed by fire leaving only the drive gear and a portion of the housing attached to the accessory section.

**Figure 3 Left E-Mag**

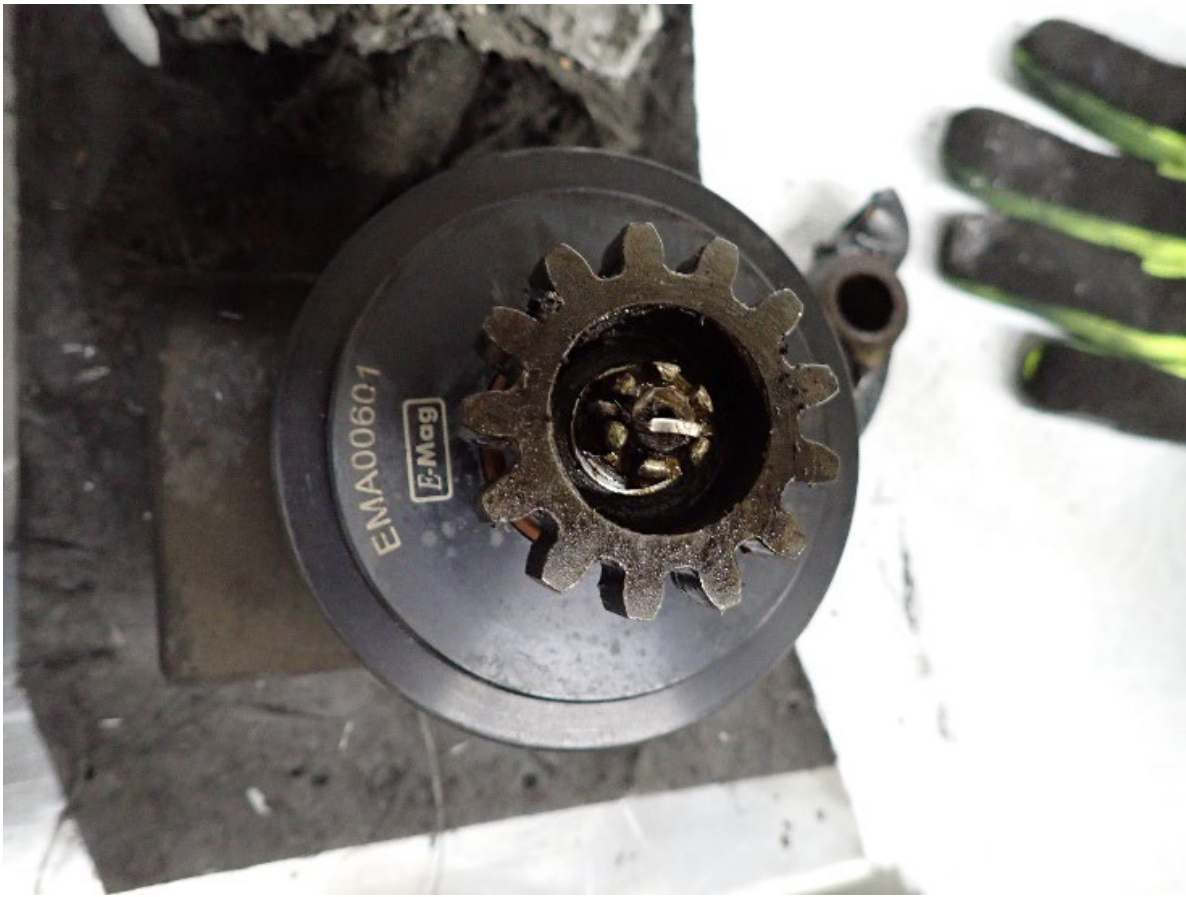
**Figure 4 Left E-Mag gear**

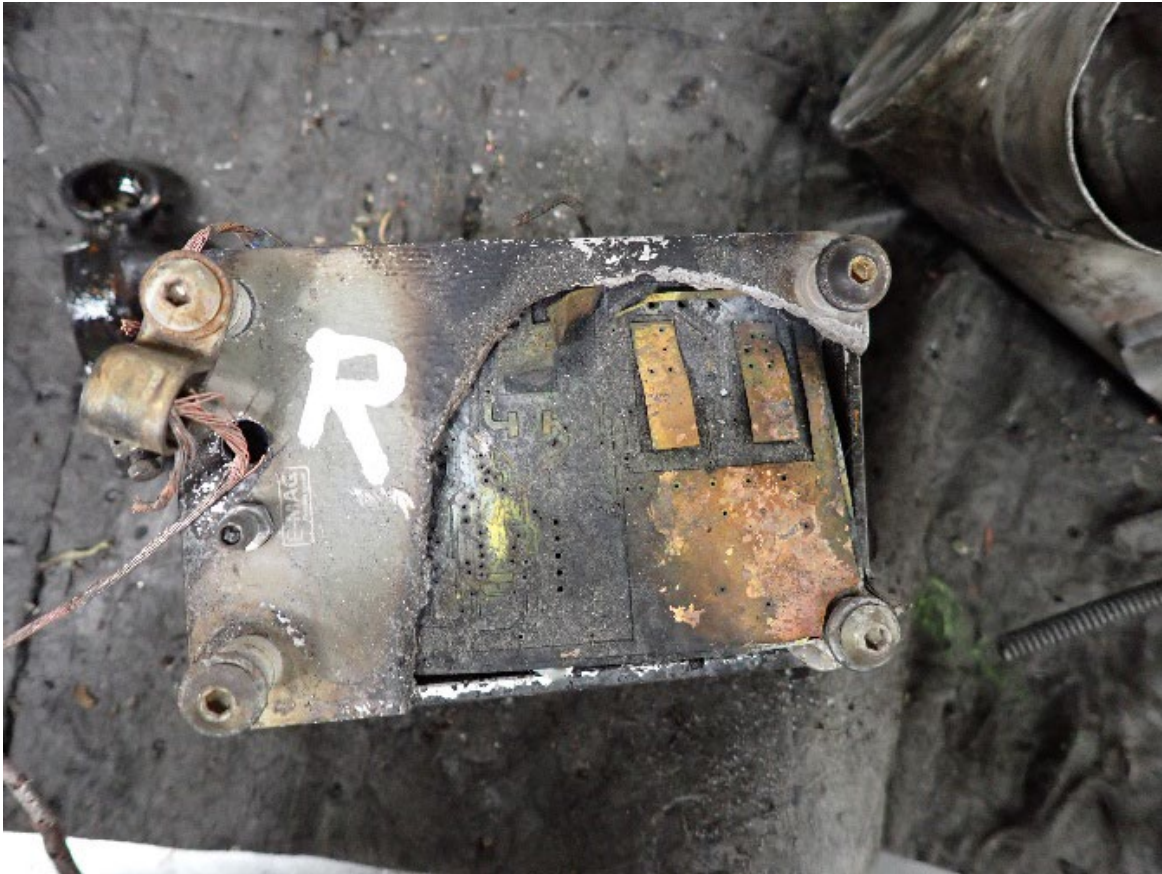
**Figure 5 Right E-Mag**

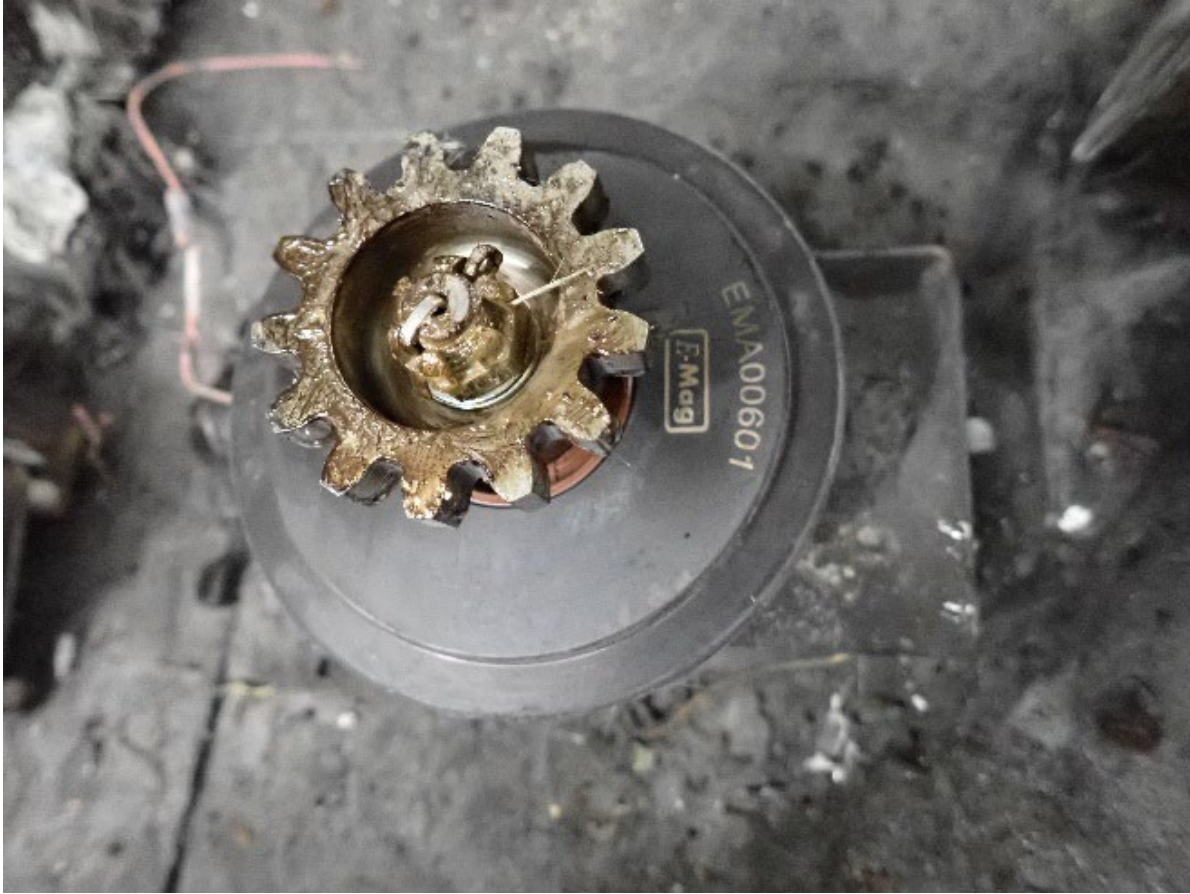
**Figure 6 Right E-Mag gear**

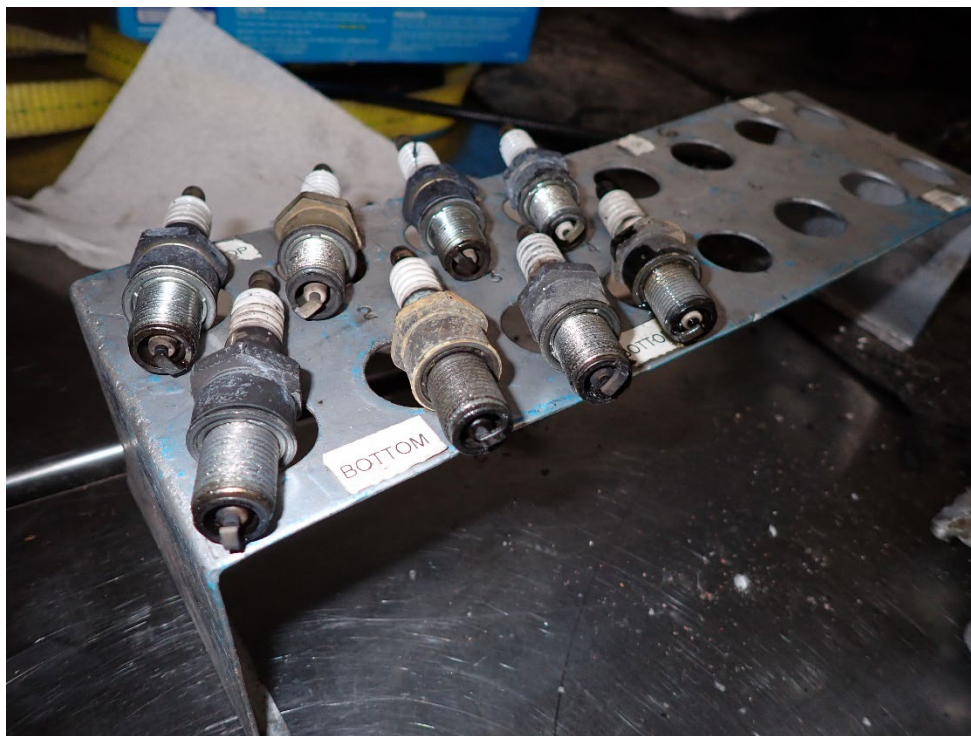
All eight of the NGK BR8ES spark plugs were removed. The electrodes were in good condition, no damage was noted, the ceramic insulator of the No. 3 spark plug was damaged, likely during impact.

**Figure 7 Engine spark plugs**

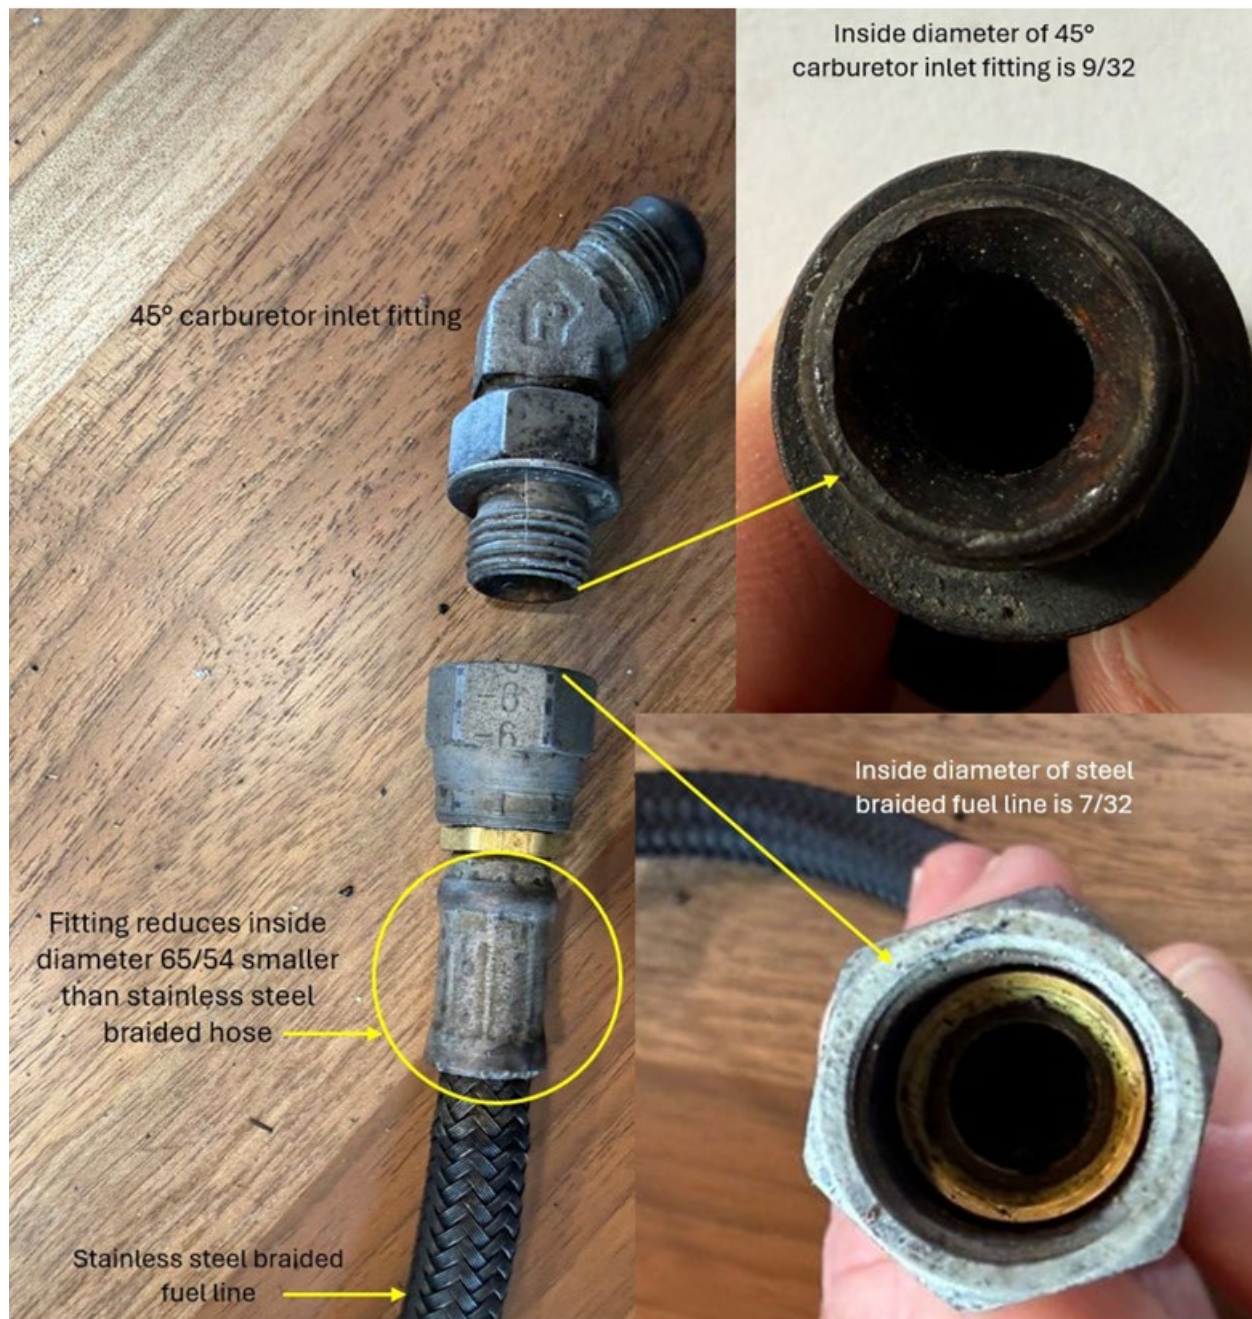
**Figure 8 Inside diameter of inlet fitting and steel braided line**

The inside diameter of the 45° carburetor inlet fuel fitting was 9/32 and the inside diameter of the steel braided fuel line was 7/32. The normal inside diameter of a fuel line and associated fittings is 5/16" or -6 (see figure 8).

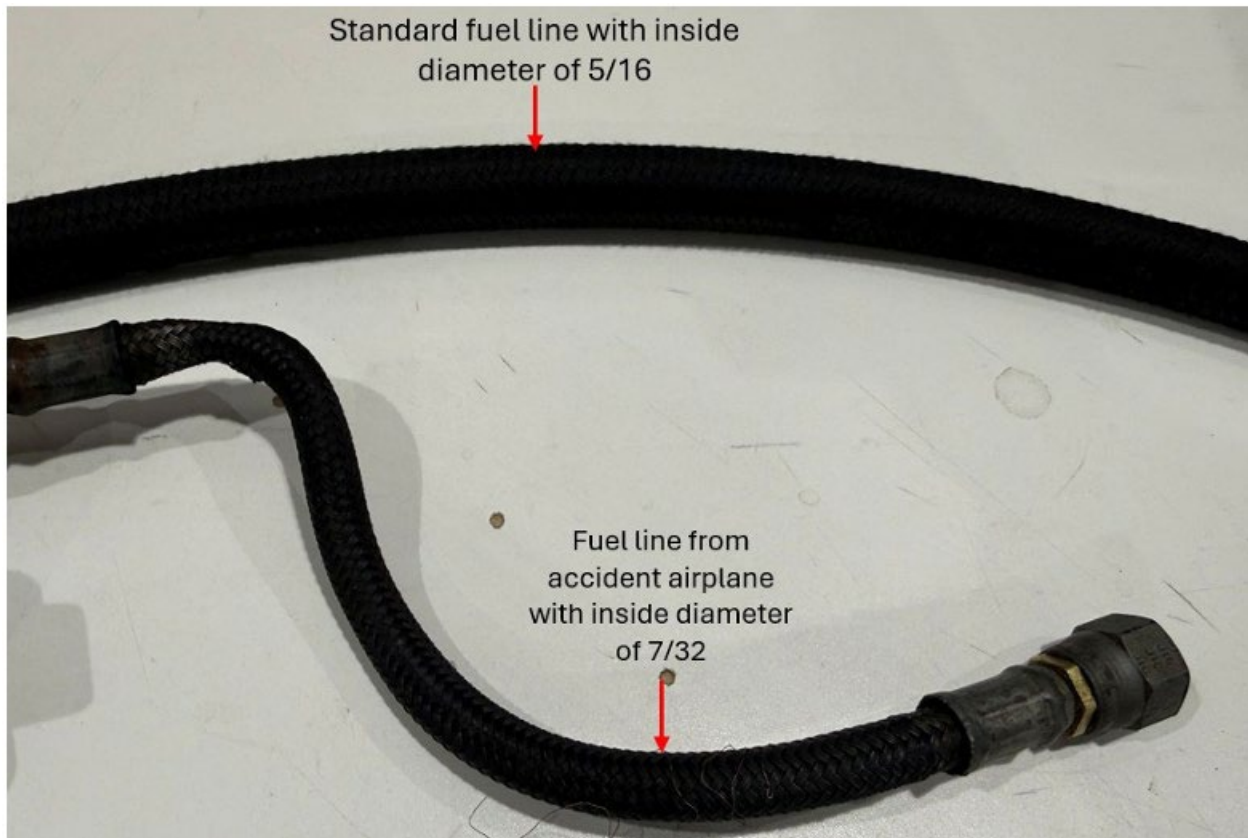
**Figure 9 Standard and non-standard fuel line**

The subject matter expert stated that the steel braided hose that connected the fuel transducer to the carburetor on the accident airplane is considered non standard for this application, smaller in diameter than a standard fuel hose (see figure 9).

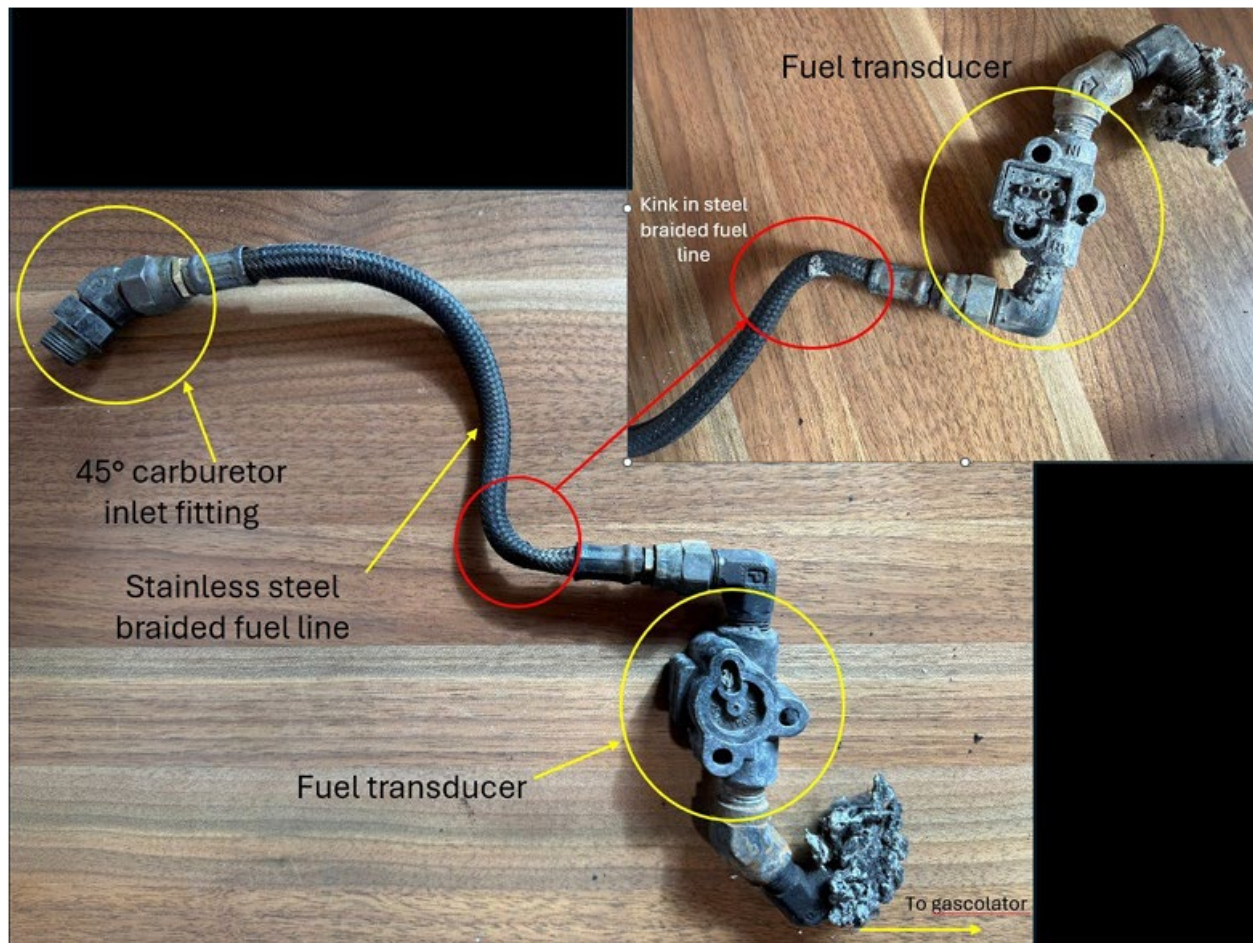
The steel braided hose was observed to have a kink near the output of the fuel transducer (see figure 10).

**Figure 10 Stainless steel braided fuel line with kink**

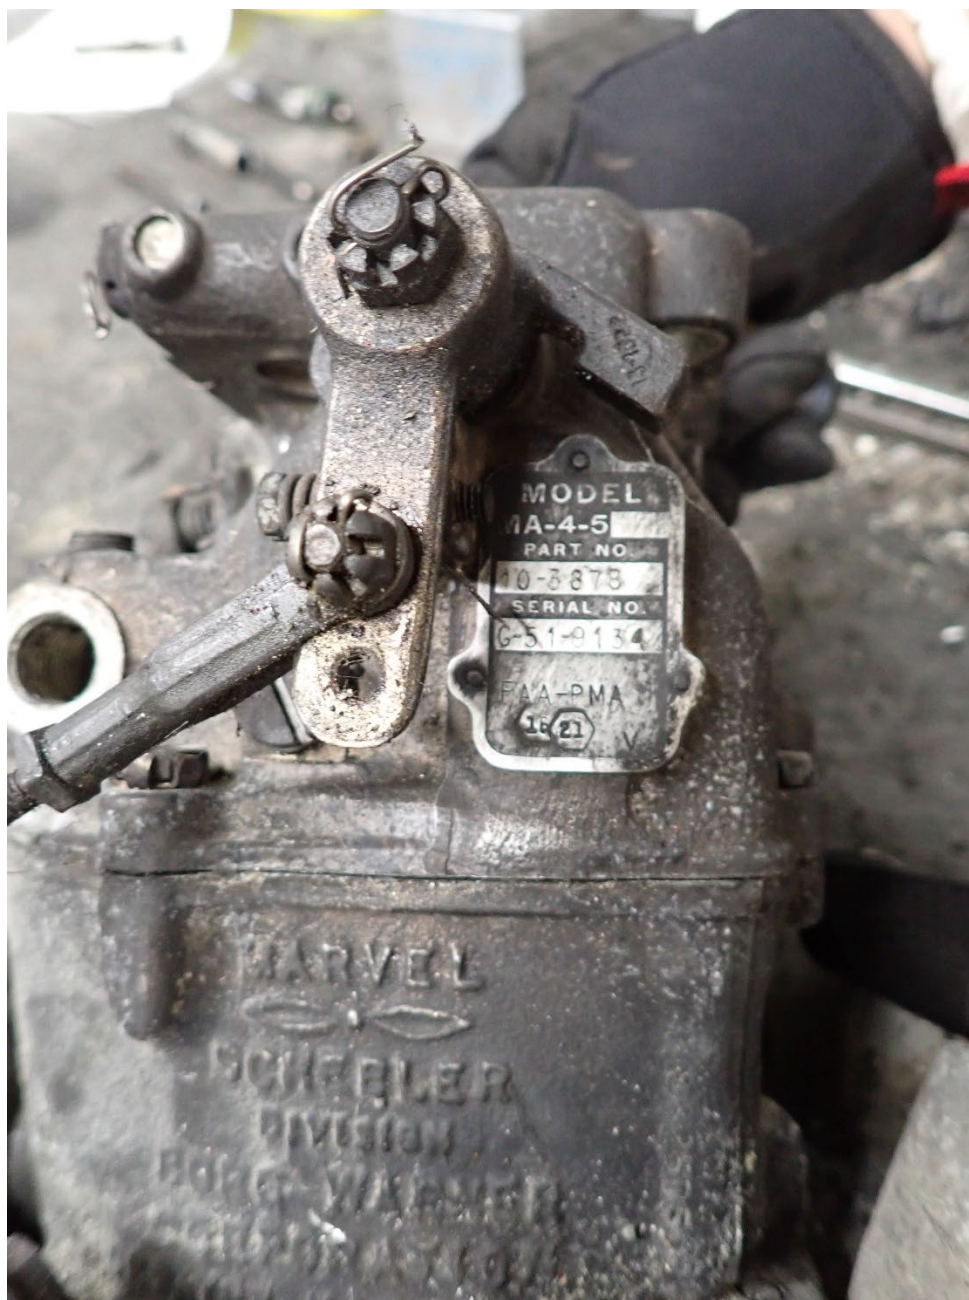
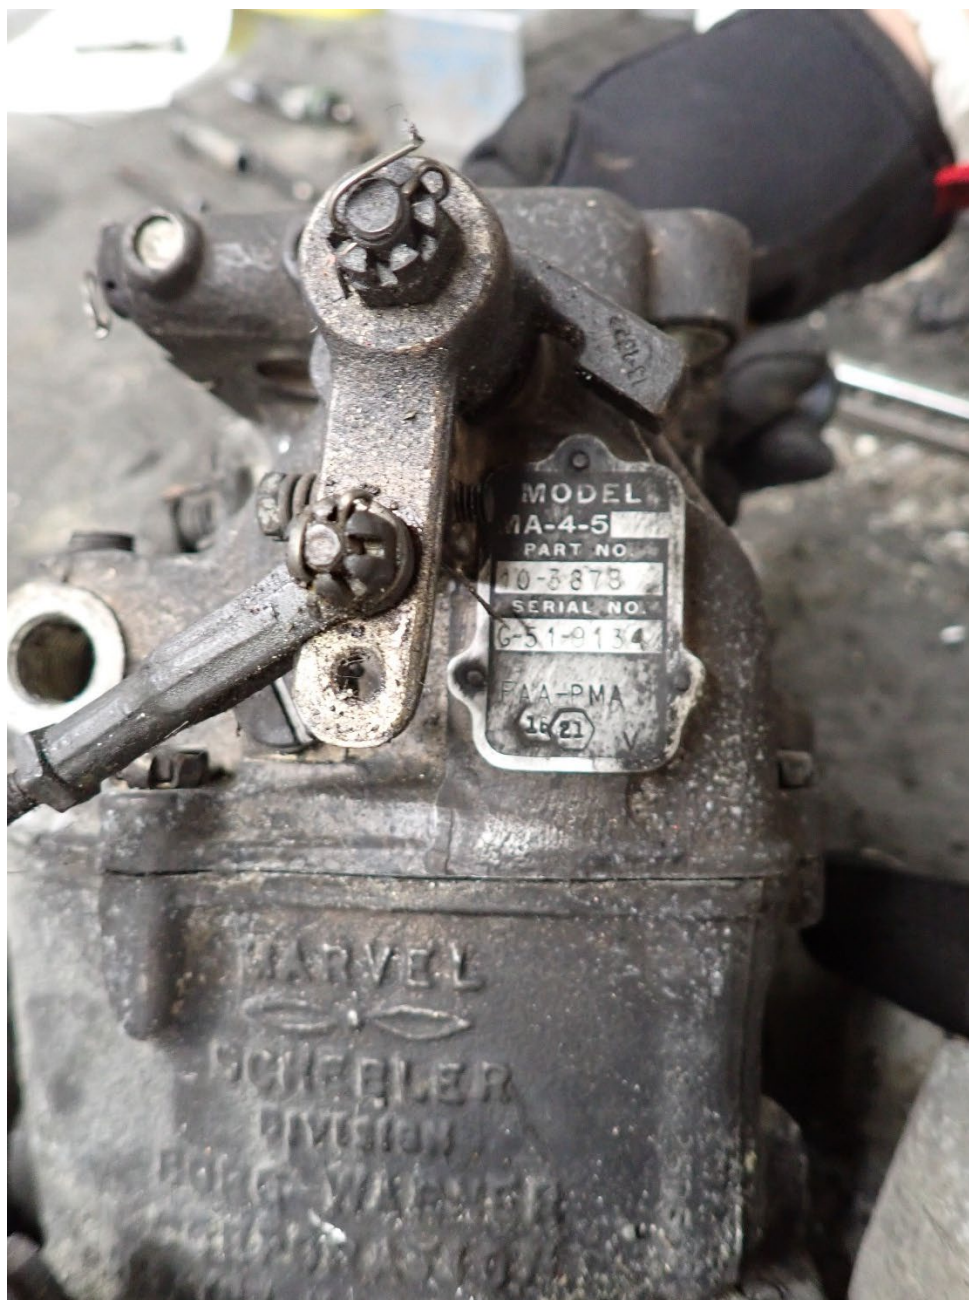
**Figure 11 Engine carburetor**

The Marvel Schebler MA-4-5 carburetor, serial number G-51-9134 was found firmly attached to the oil sump with both the mixture and throttle arms attached in its original condition, with no modifications. The throttle and mixture arms both moved freely through their full range of motion. Both control cables were attached to their respective arms, but impact separated behind each control arm. The fuel inlet screen was present and found to have a small amount of sediment within the screen. The float bowl was removed revealing the remains of the foam floats which were blistered, partially melted and brown in color. The floats were moved up and down, no resistance was observed. The carburetor needle was removed and found to be intact with no damage. The corresponding seat was found to be clean and damage free. A small amount of sediment consistent with impact debris was found in the carburetor bowl. Fluid was present in the carburetor bowl, it had no color and no odor. Water finding paste was used and it was confirmed to be water, likely from the post crash fire and storage condition of the engine since the accident.

**Figure 13 Engine carburetor**

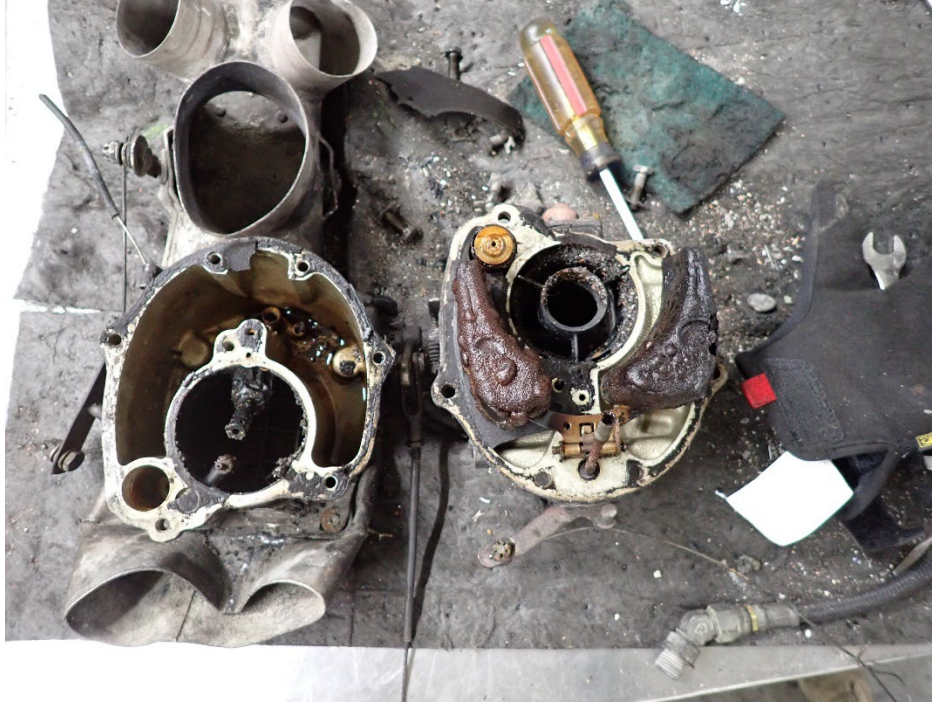
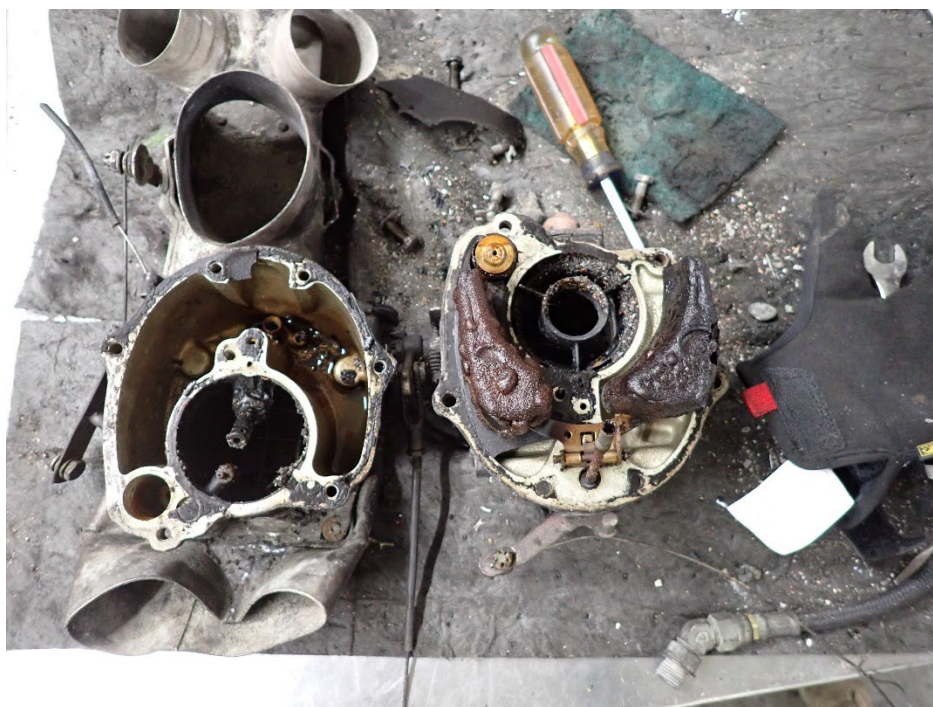
**Figure 12 Carburetor disassembled**

**Figure 14 Carburetor disassembled**

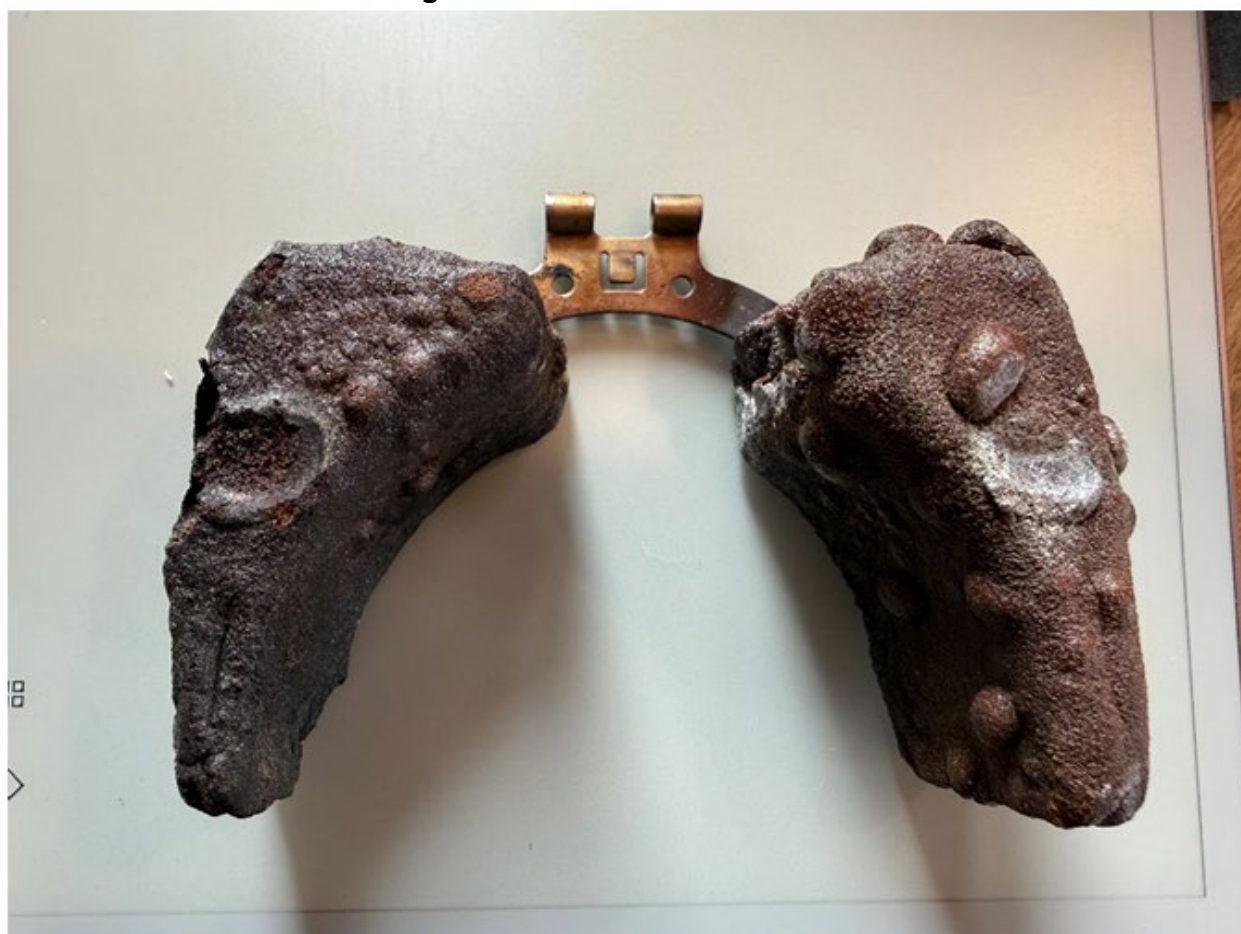
The foam floats were observed to be blistered and thermally damaged (see figure 15). According to the subject matter expert, over time these foam floats are known to absorb fuel which can cause the system to run rich.

**Figure 15 Foam floats from inside the carburetor**

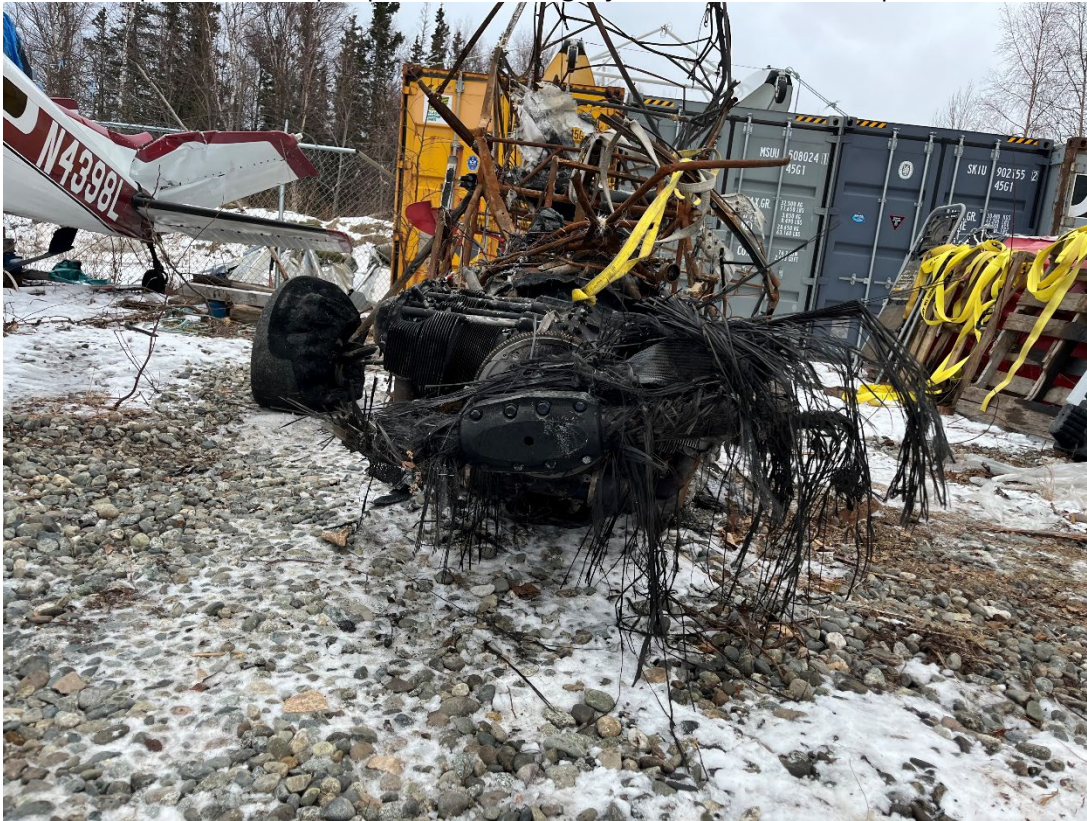
The composite Cato propeller was largely consumed in the postcrash fire.

**Figure 16 View of propeller**
