# National Transportation Safety Board

ANC24LA004

## ENGINE EXAMINATION

Location: Anchorage, AK  
Date: November 12, 2023  
Time: 1615L  
Airplane: Piper PA-22 N8095C

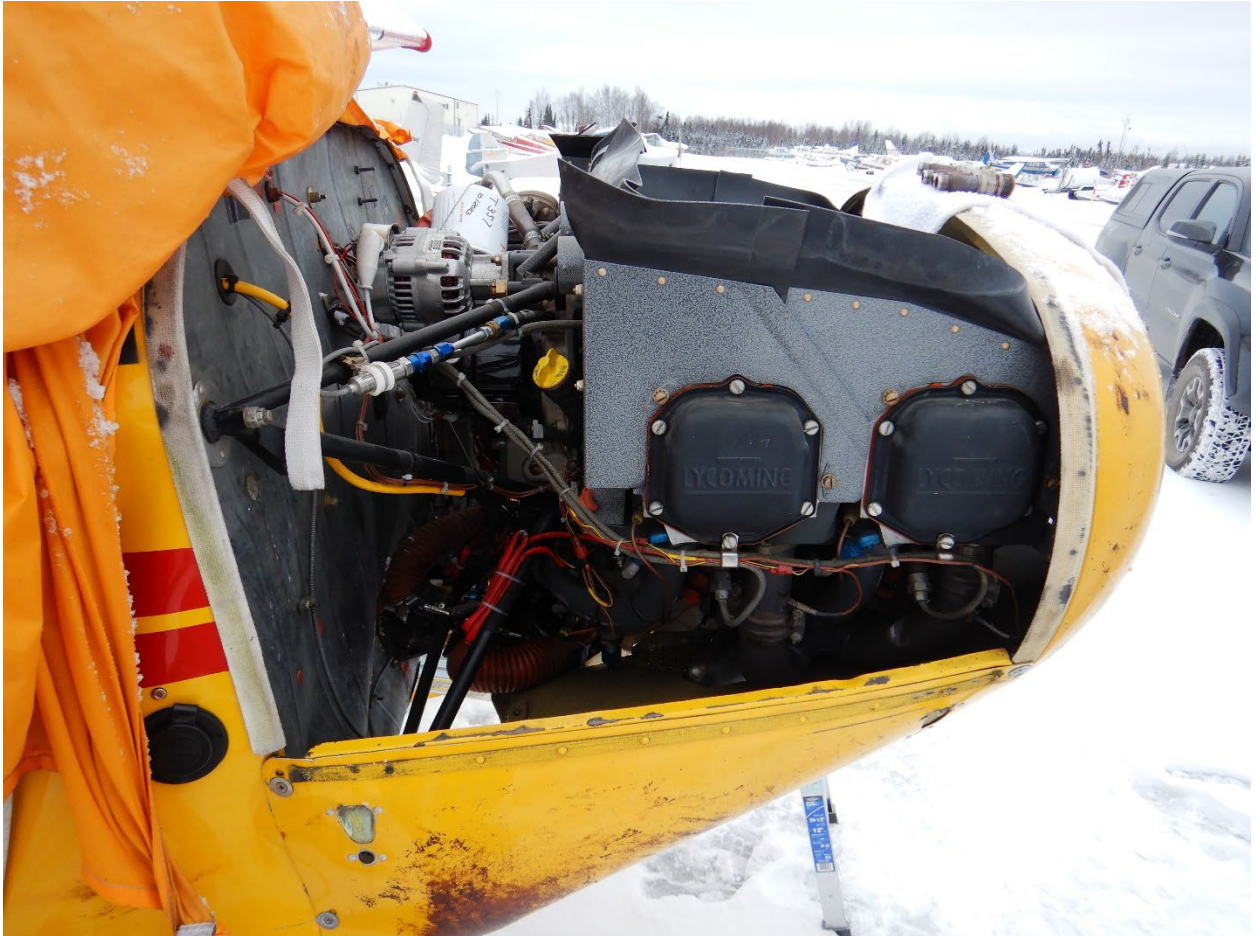
**Figure 1 Right side of engine.**

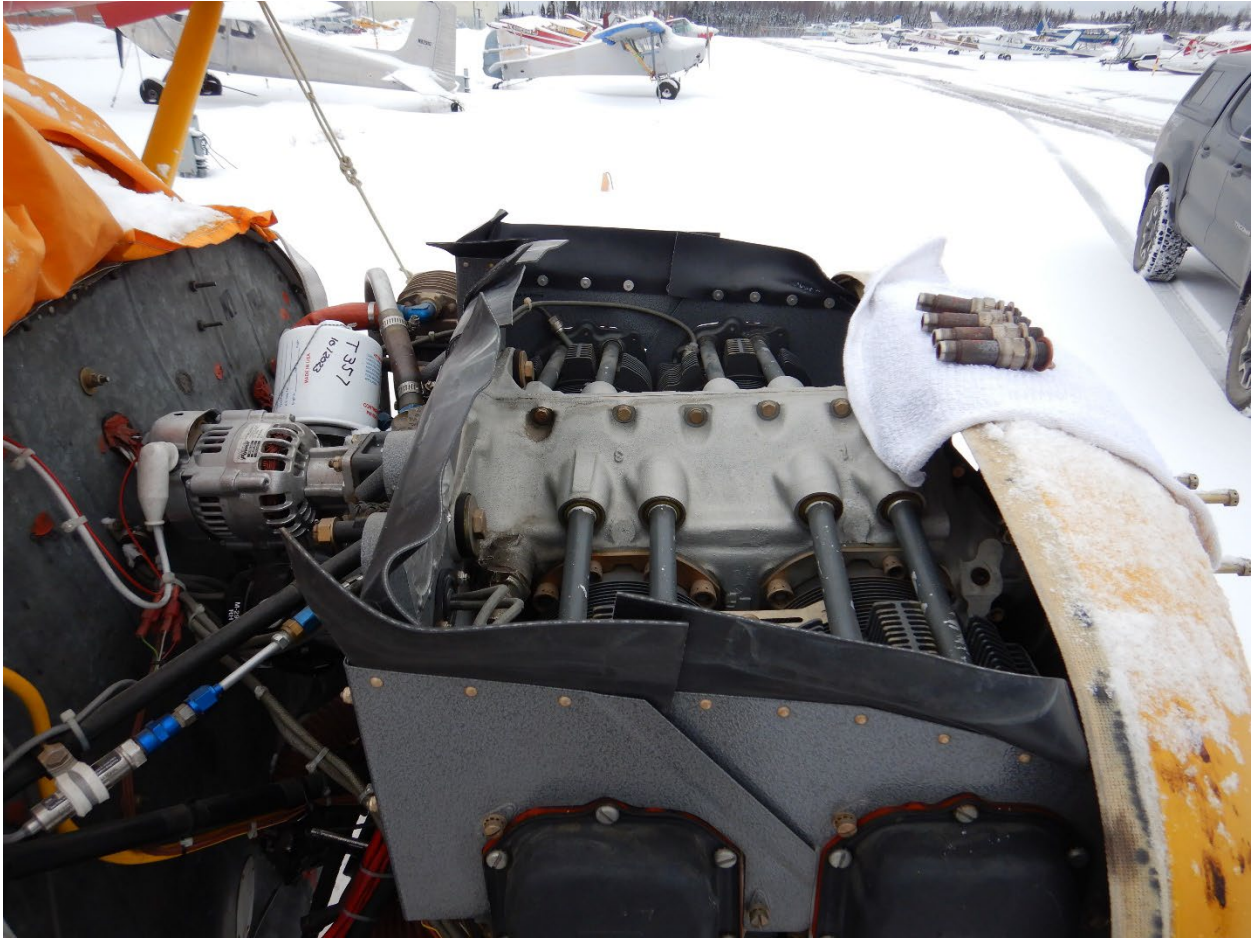
**Figure 2 Right side, top view of engine.**

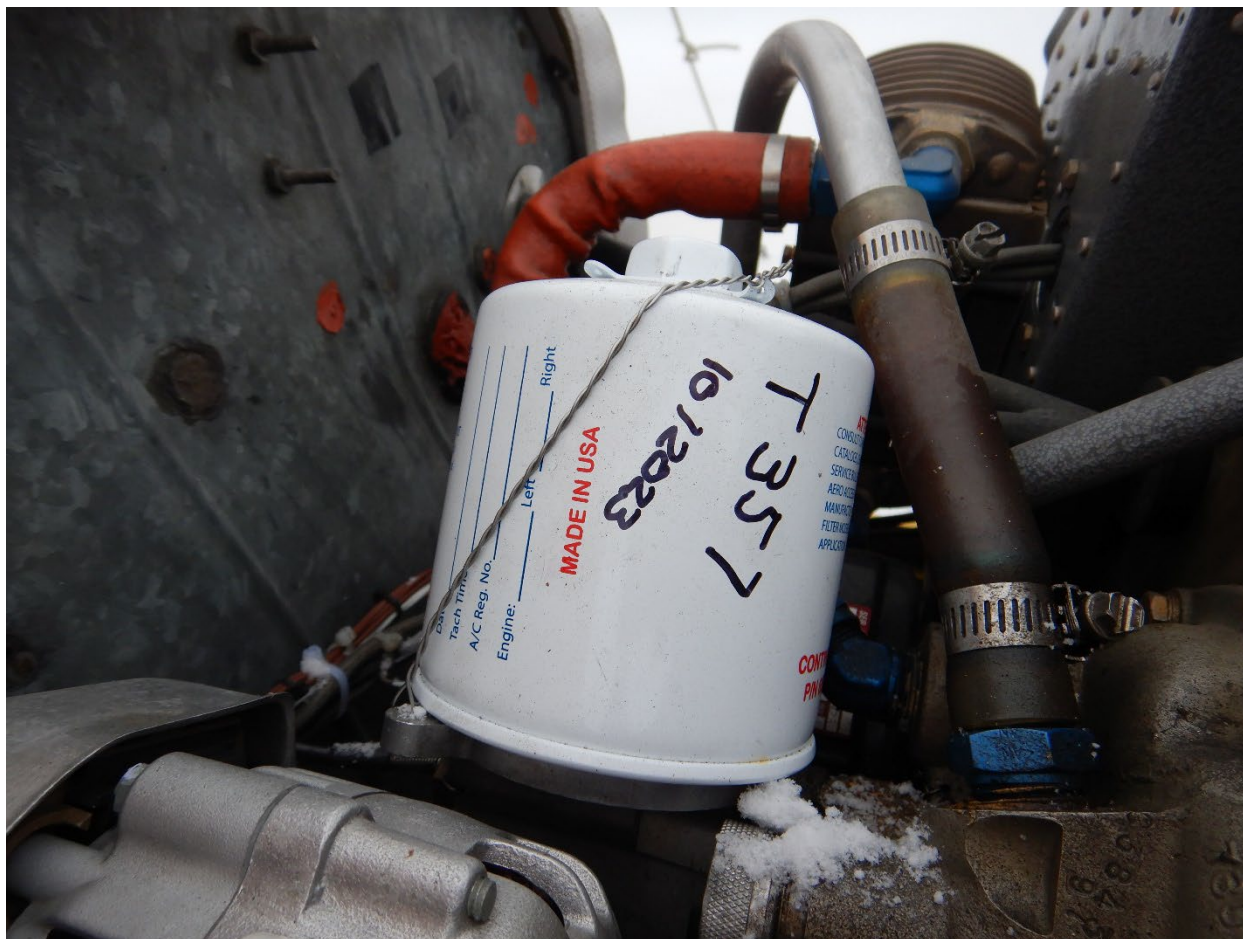
**Figure 3 Engine filter attached to the accessory case.**

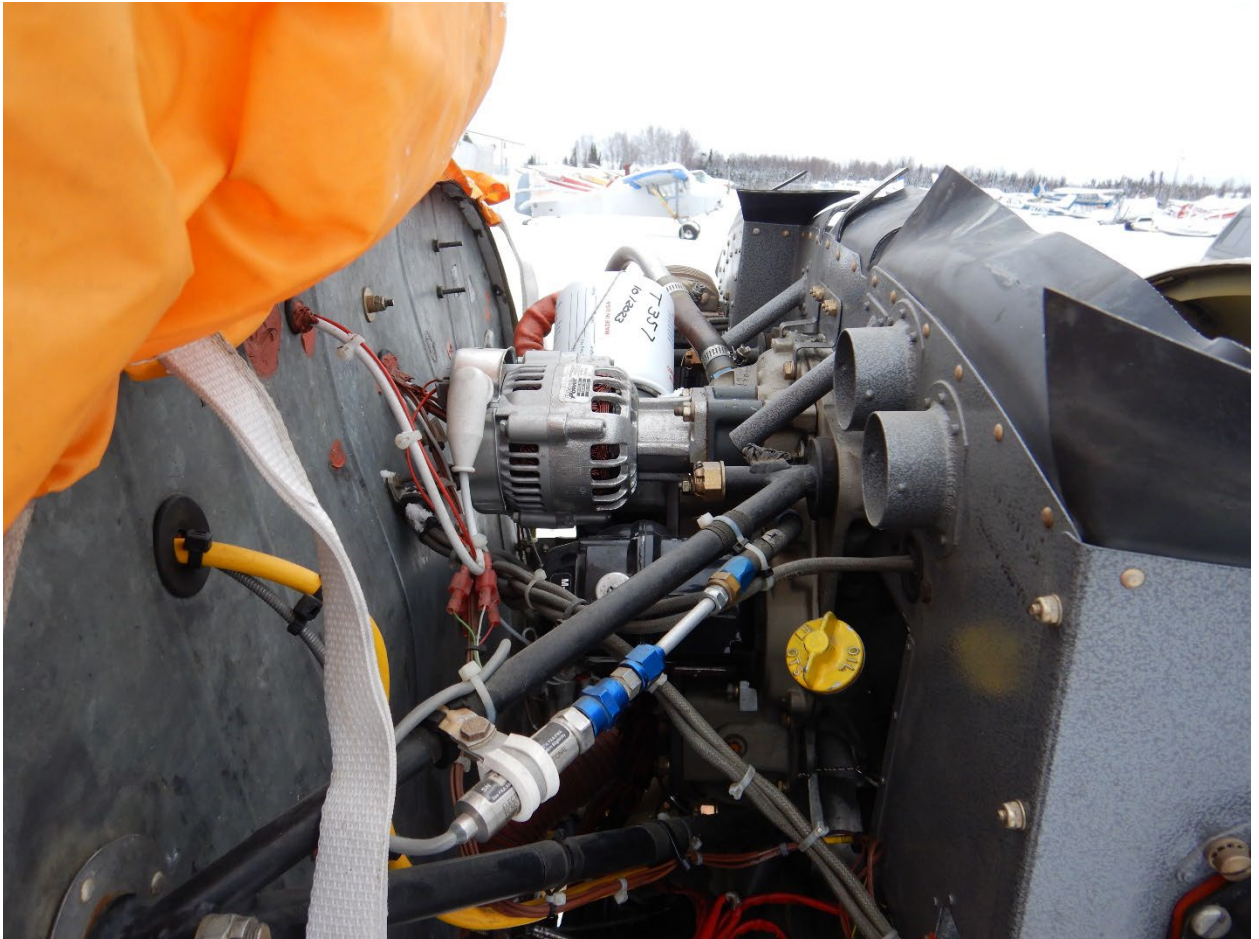
The engine was turned by the propeller flange. Movement was seen in the alternator attached to the accessory case (figure 4), an audio sound of the impulse coupler could be heard from the magneto and thumb compression was obtain from all cylinders which confirm drivetrain continuity from front of the engine to the rear of the engine. The valve covers were removed and all valve rockers moved with similar amount of movement (figure 5,6)

**Figure 4 Right side of the accessory case.**

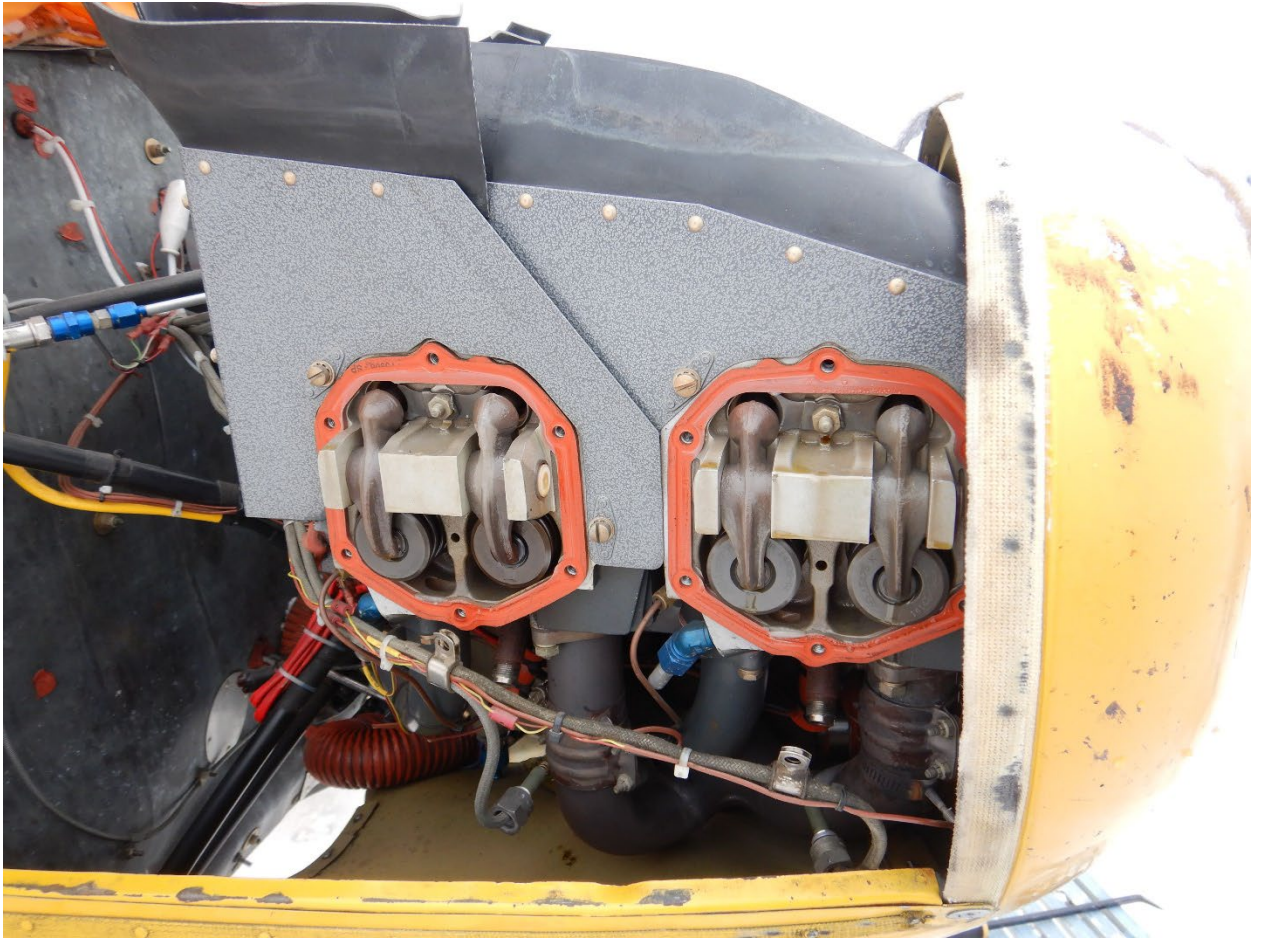
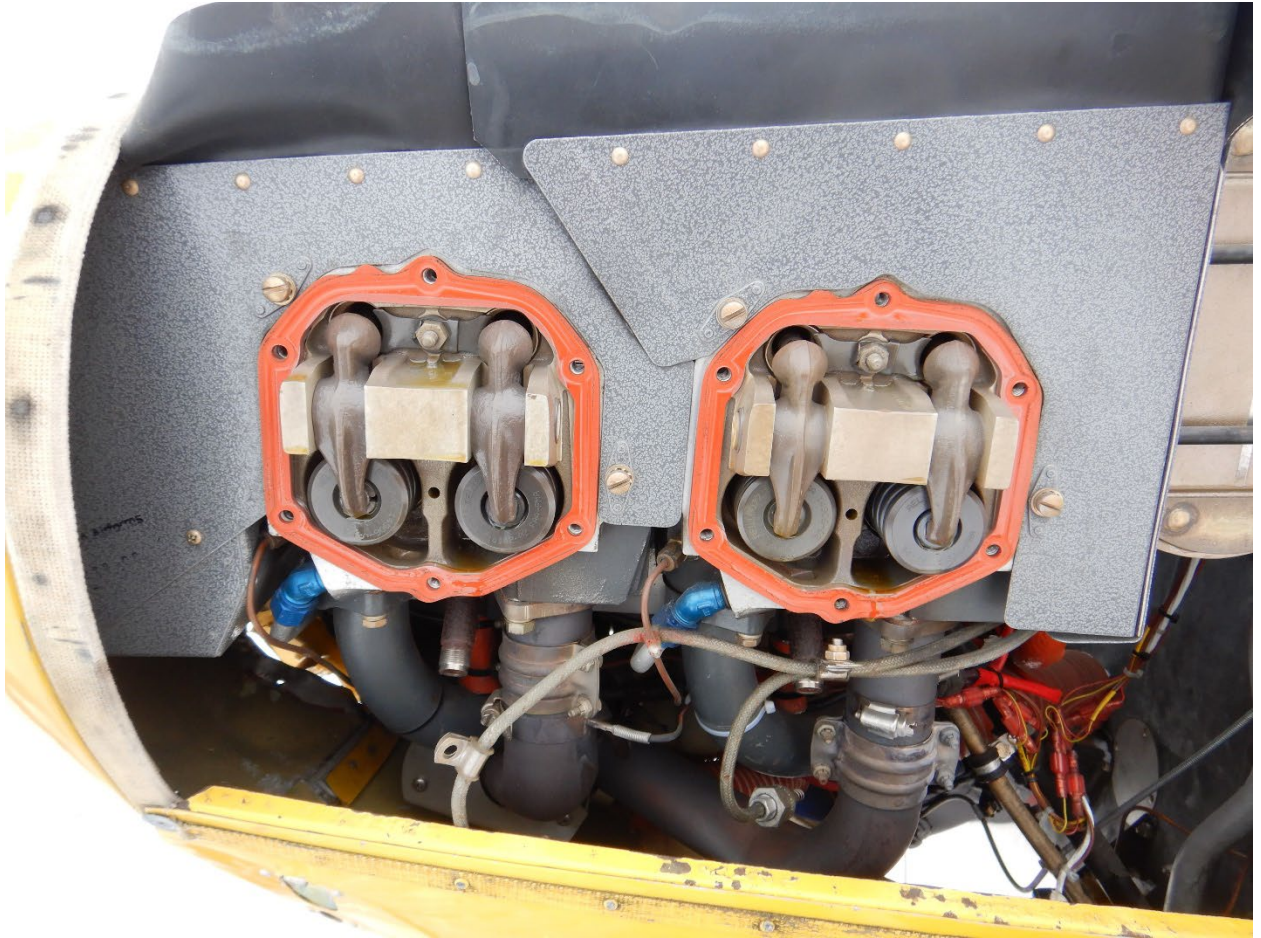
**Figure 5 Right side of the engine with valve covers removed.**

**Figure 6 Left side of the engine with valve covers removed.**

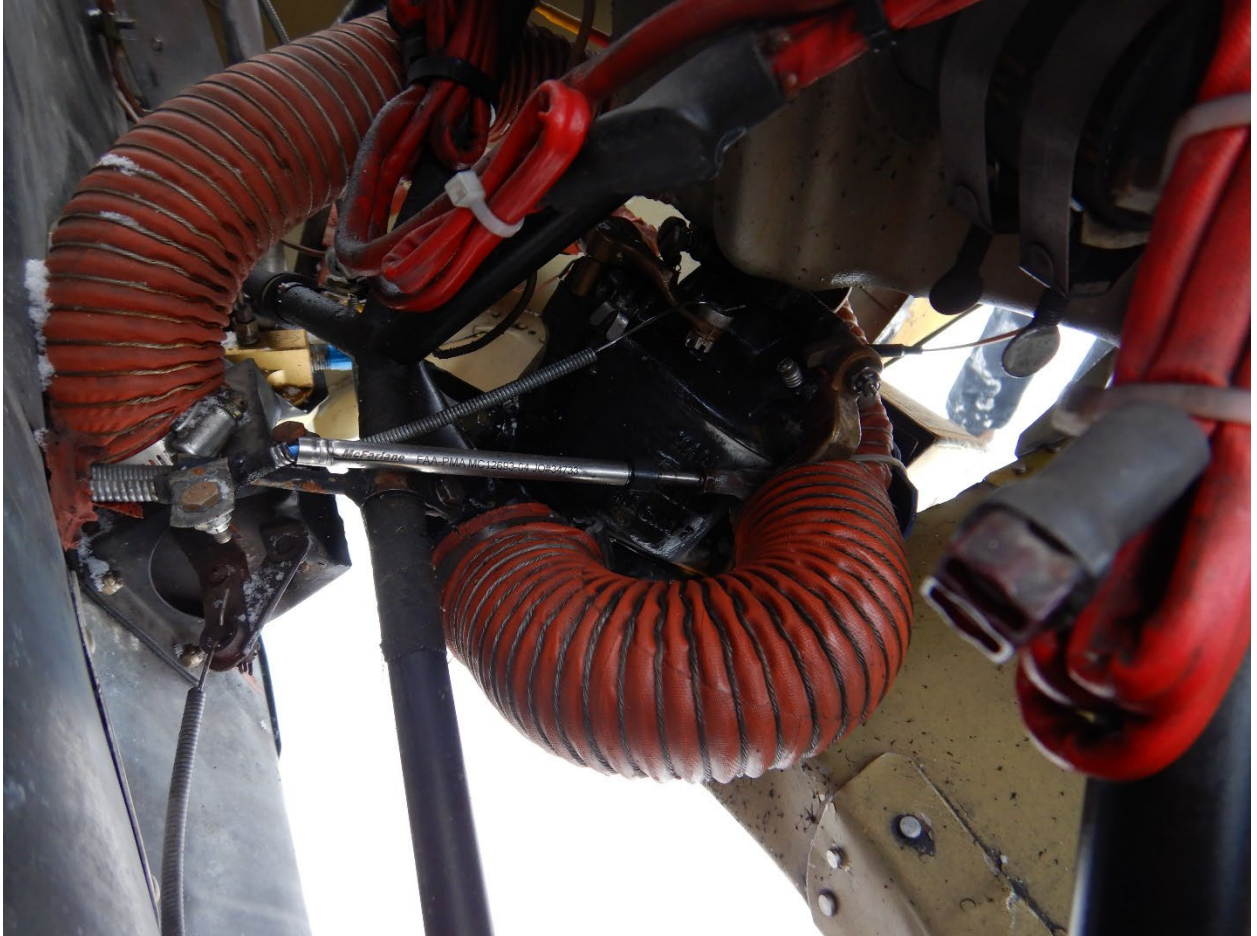
Attempted to drain fuel from the wing tank fuel drain valves but no fuel was present at either drain. The gascolator was removed and blue colored fuel found (figure9). Movement of the fuel selector produced no fuel to the gascolator. No water was observed in the fuel from the gascolator. No fuel was observed in the lines to or in the carburetor. The carburetor was impact separated from the induction system just above the throttle valve (figure 7).

**Figure 7 Right side view of the engine carburetor.**

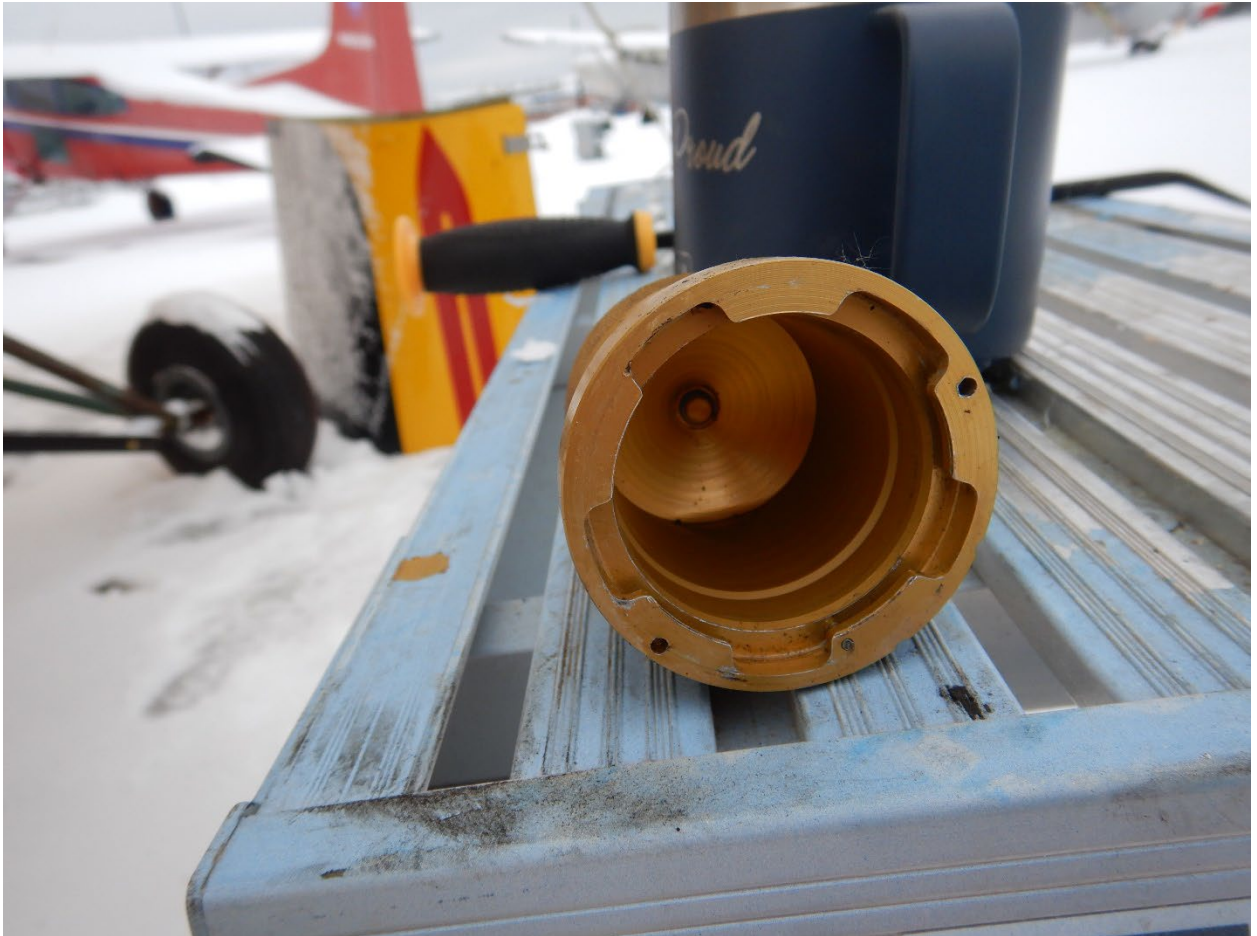
**Figure 8 View inside the gascolator.**

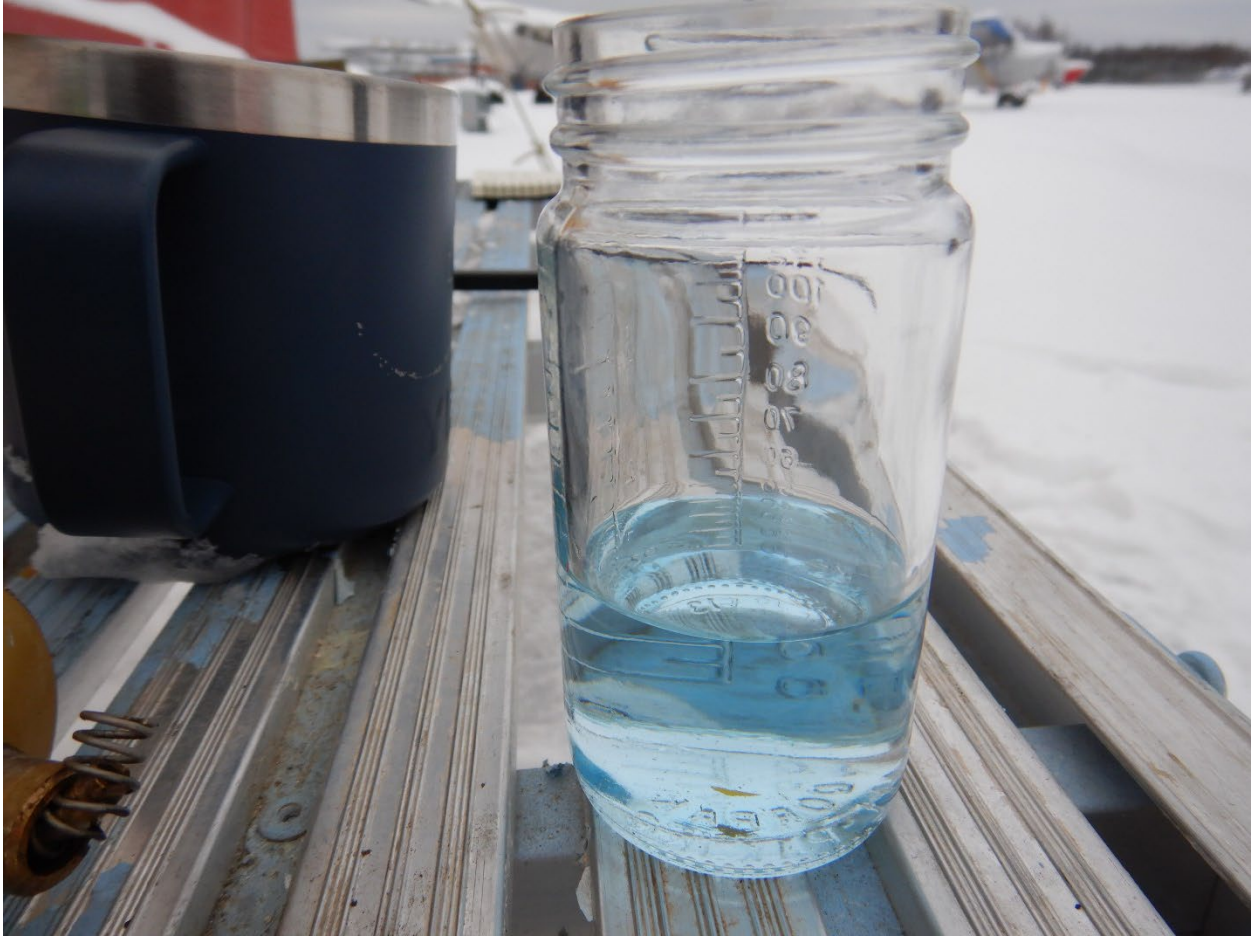
**Figure 9 Fuel removed from the gascolator.**

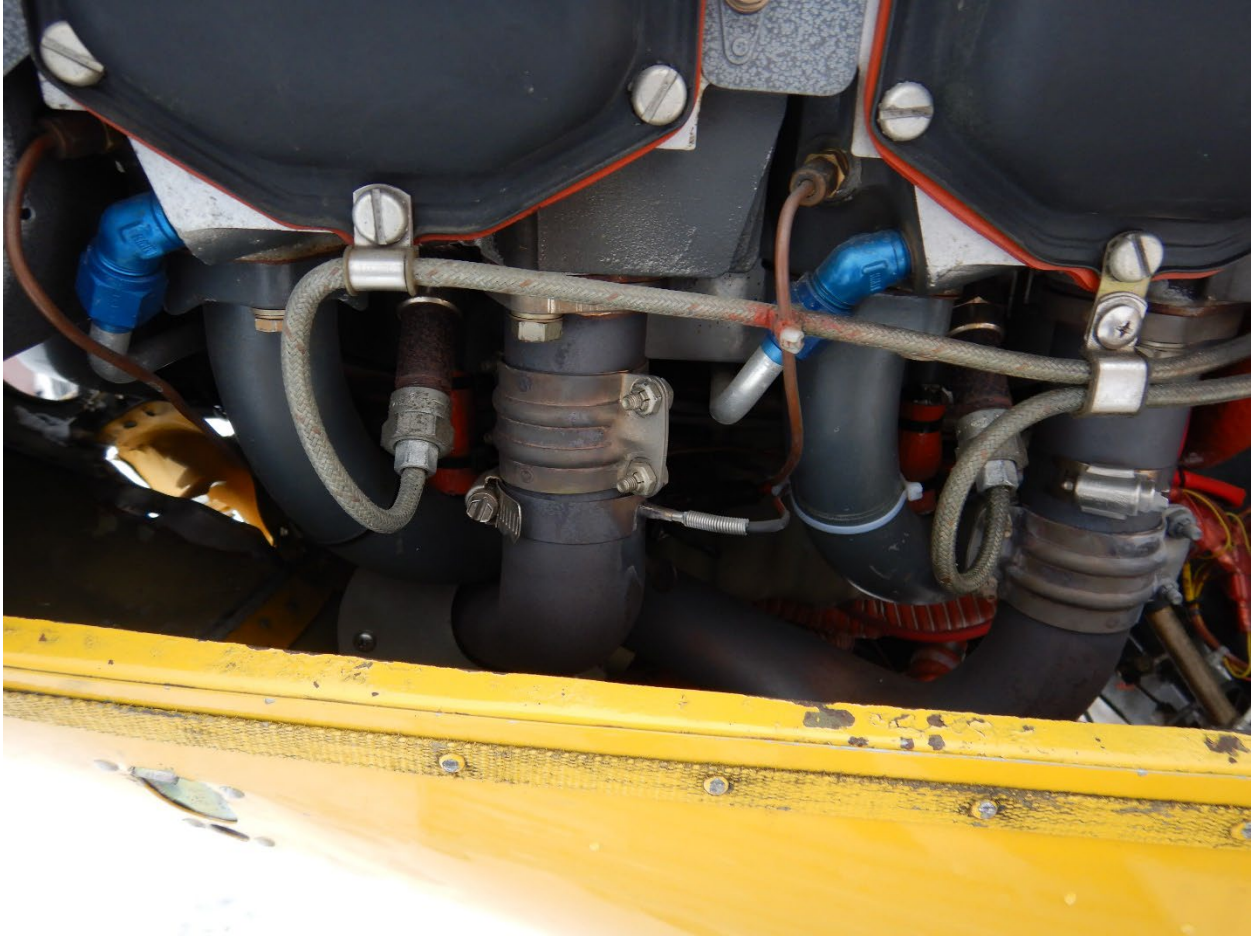
Exhaust system had minor impact damage to two exhaust collectors, the muffler, and muffler shroud with significant impact damage to the exhaust discharge pipes.

**Figure 10 Left side view the engine exhaust collectors and air intake.**

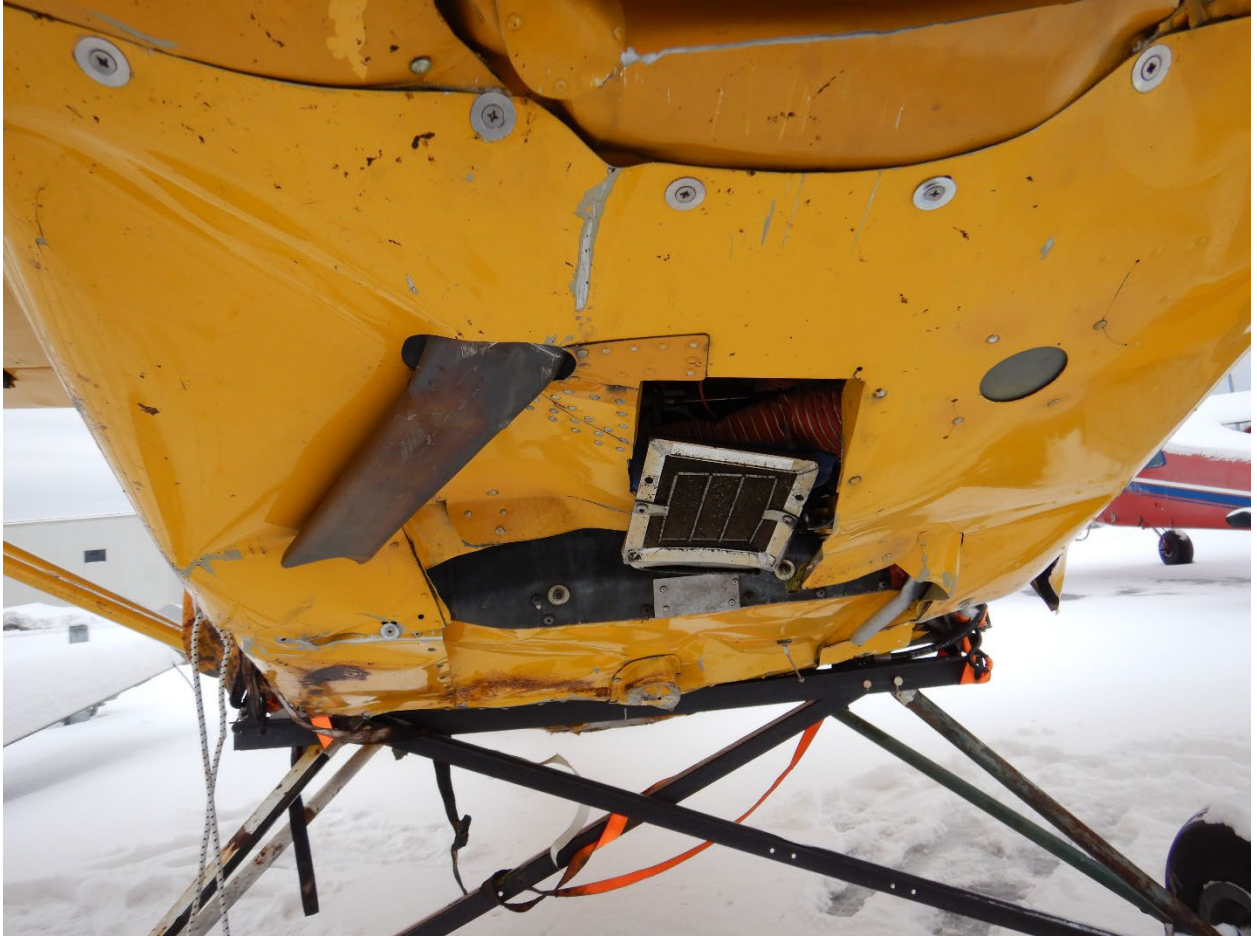
Intake manifold was undamaged. Air intake screen was impact damaged (figure 11) with no observed obstructions.

**Figure 11 View of air intake under engine.**

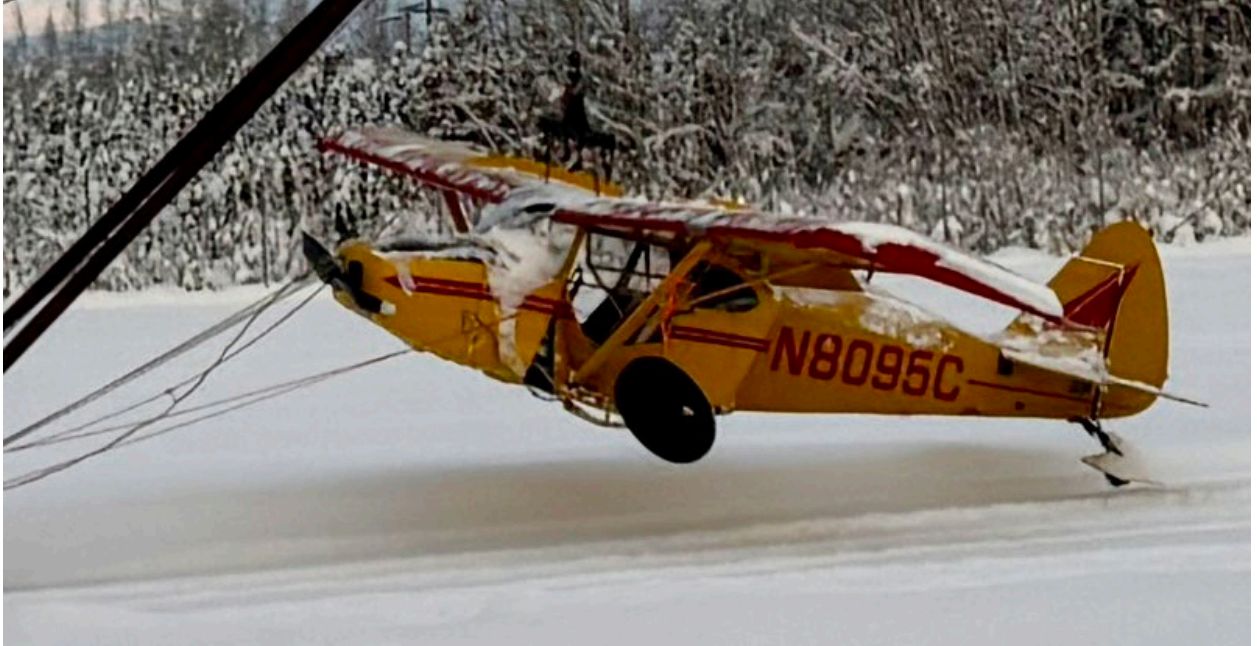
The propeller was removed by the owner and sent to a repair shop before an examination could happen. According to the owner, "Both ends were bent back, but one was more than the other." (Figure 12)

**Figure 12 View of propeller damage, photo provided by owner.**
