ANC24LA011

## INVESTIGATION PHOTOGRAPHS

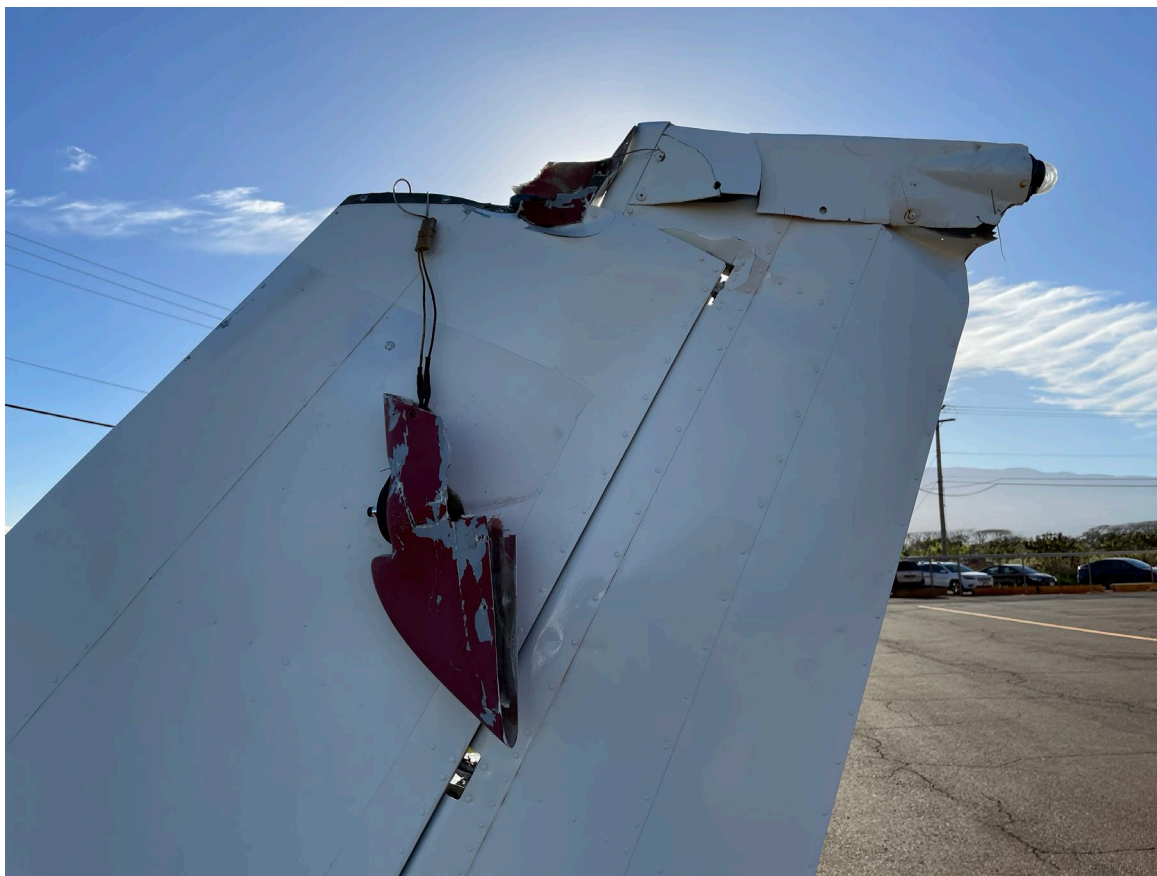
**Photograph 1 - Image of the vertical stabilizer and rudder (Courtesy of FAA)**

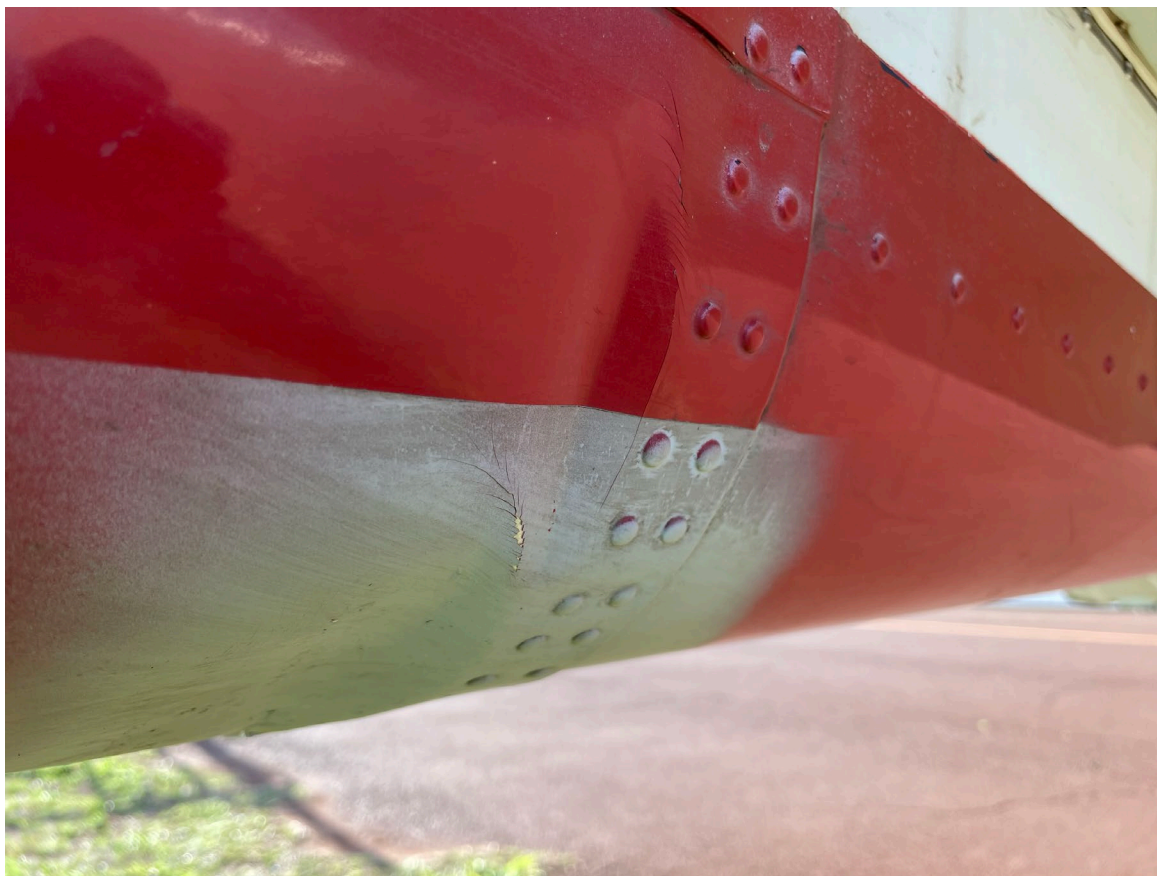
**Photograph 2 -Image of damage to the fuselage (Courtesy of FAA)**
