ANC24LA016

## INVESTIGATION PHOTOGRAPHS

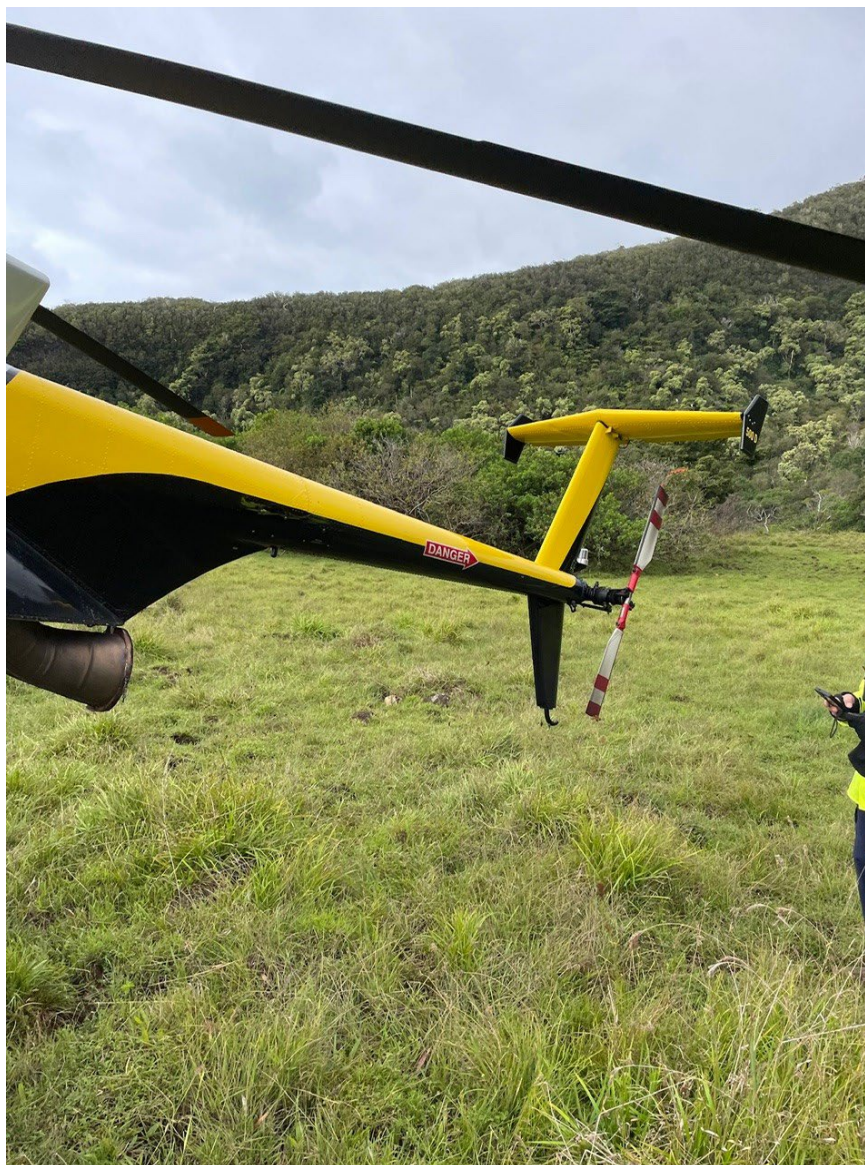
**Photograph 1 - Accident helicopter at accident site (Courtesy of FAA)**

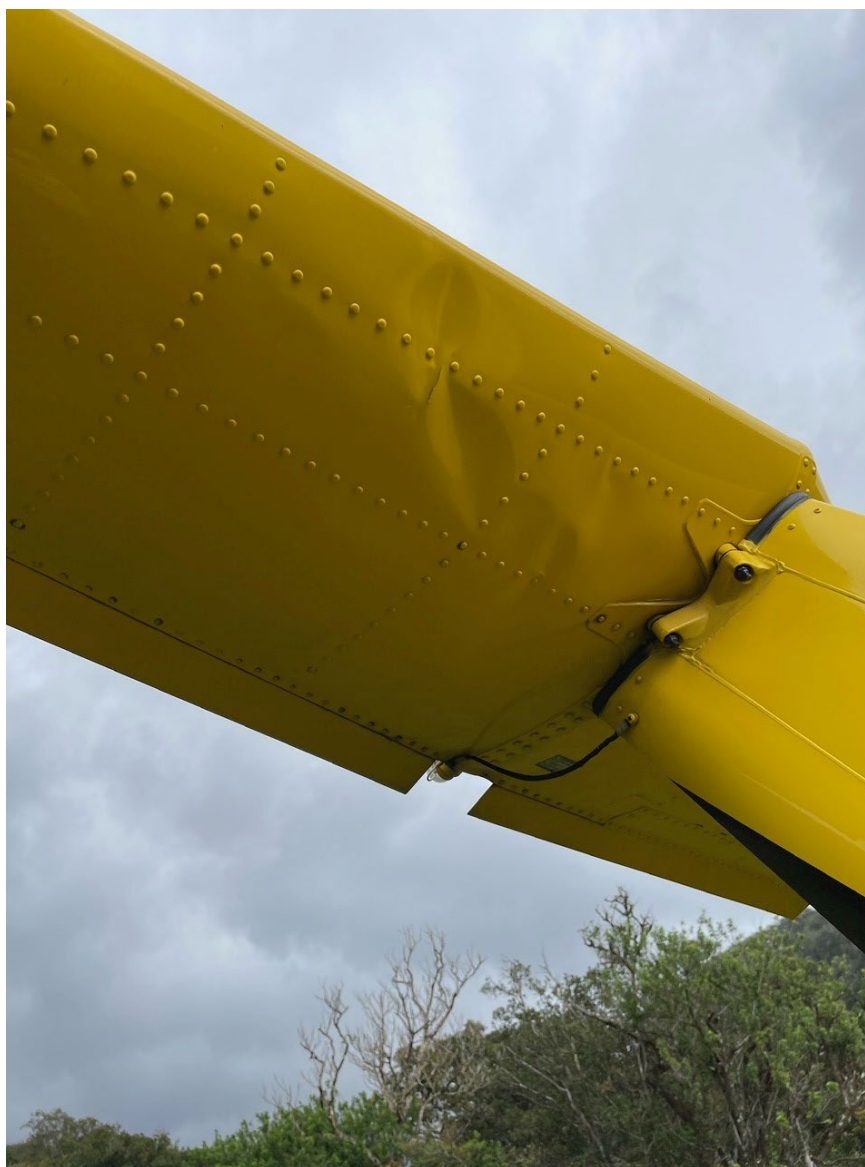
**Photograph 2 - View of the horizontal stabilizer (Courtesy of FAA)**

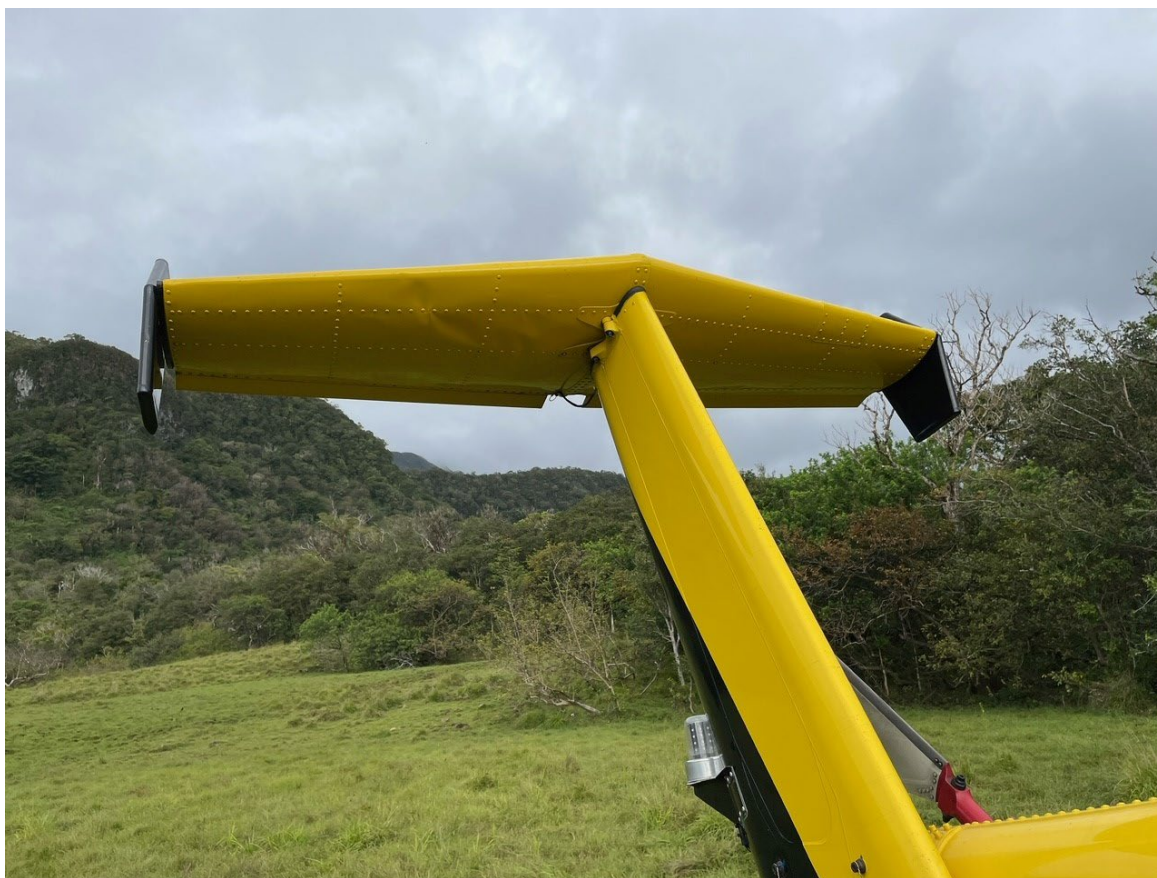
**Photograph 3 - View of the horizontal stabilizer (Courtesy of FAA)**

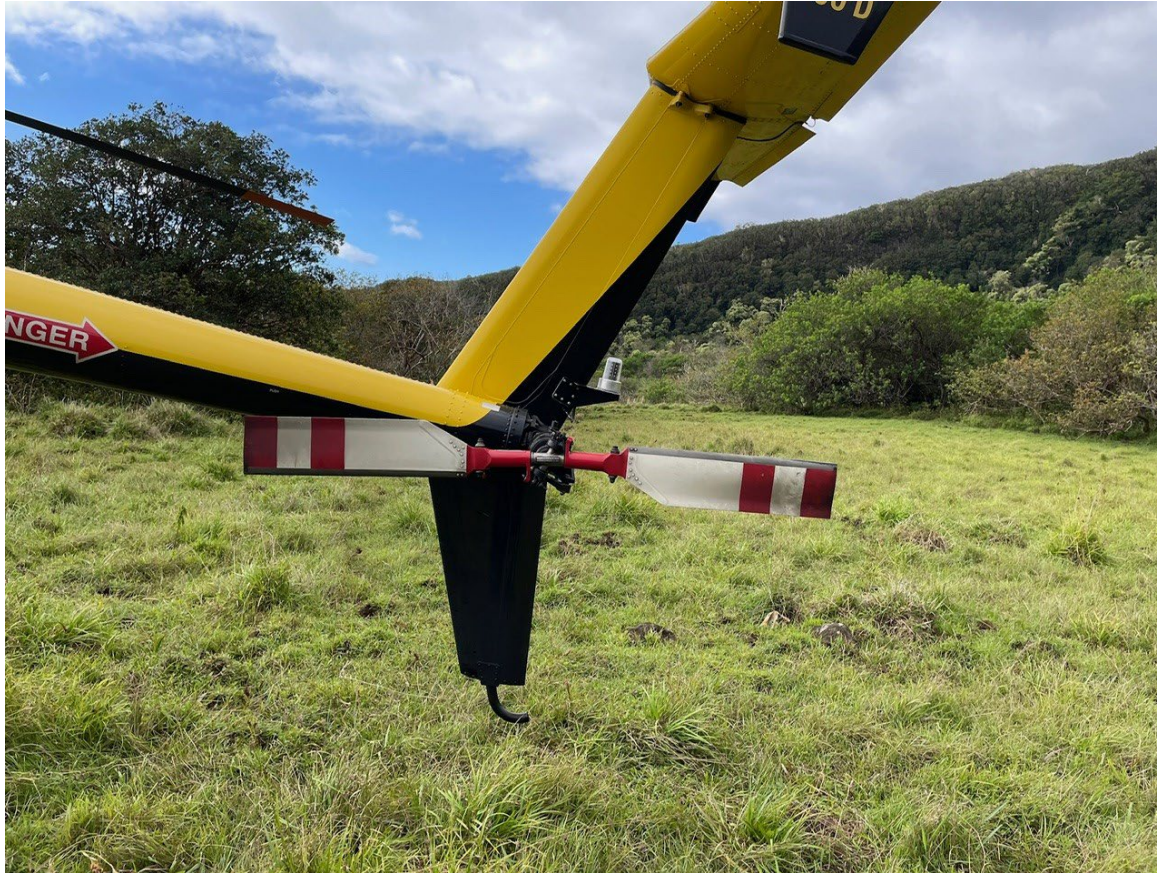
**Photograph 4 - View of the left side of the tail rotor (Courtesy of FAA)**

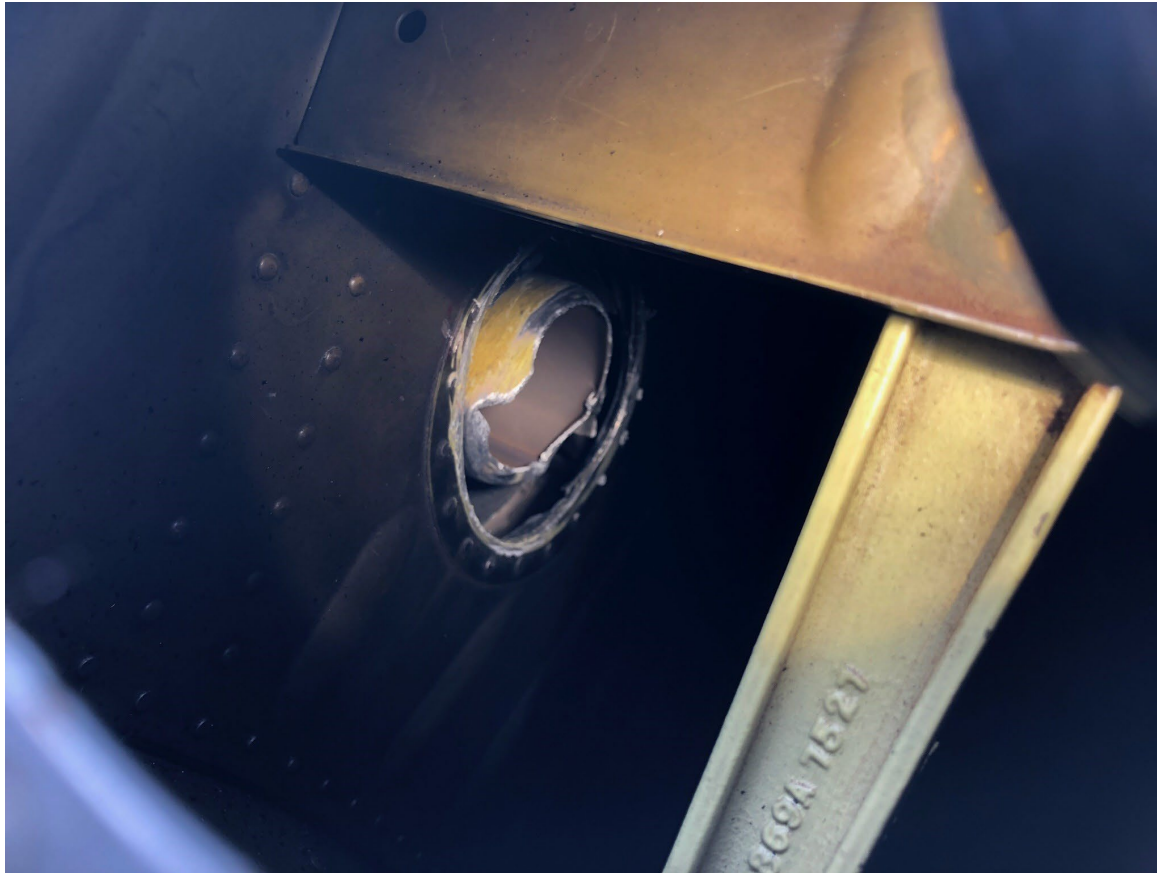
**Photograph 5 - View of the damage to the tail rotor drive shaft (Courtesy of FAA)**
