# National Transportation Safety Board

ANC24LA017

Factual Report 24-062

Location: Kekaha, Hawaii  
Date: February 27, 2024  
Vehicle: MD Helicopter 369E/500E, N633JH  
Investigator: Chihoon Shin, AS-40

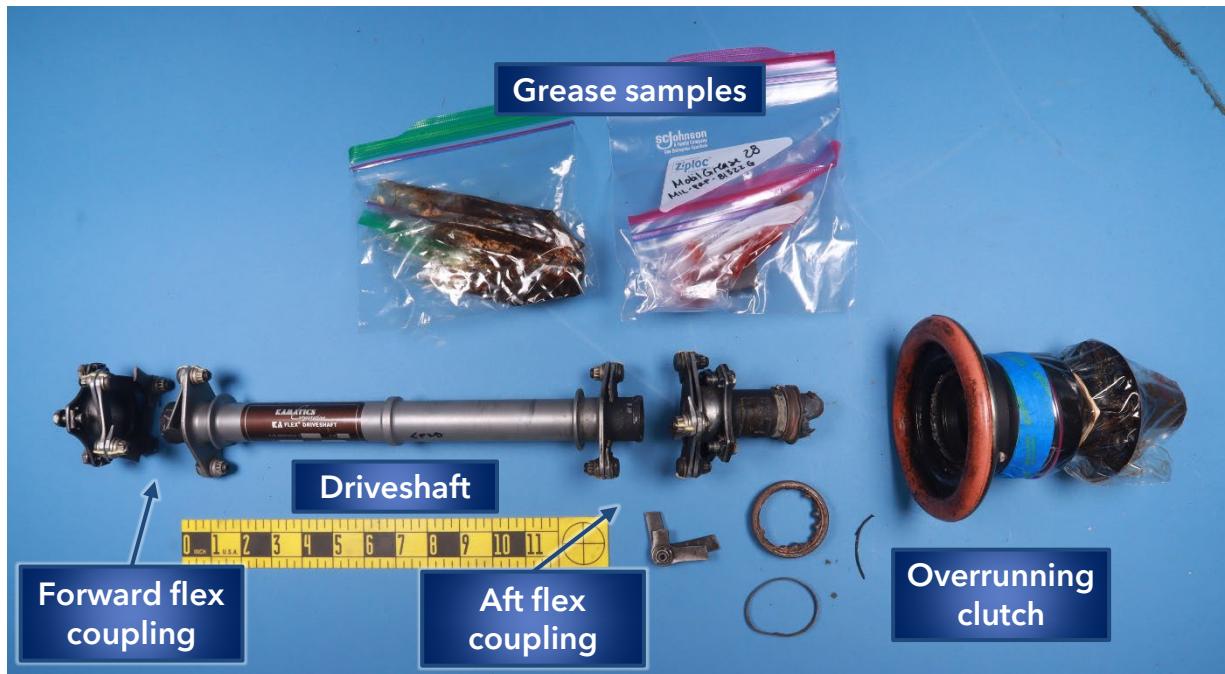
An overall view of the submitted components is shown in figure 1. The flex couplings at each end of the KAflex driveshaft assembly were fractured. Additionally, the overrunning clutch inner race and the output bearing retainer were fractured at the location of the output bearing. The output bearing outer race was separated from the bearing retainer and appeared to be free of grease. The output bearing inner race and most of the balls for the bearing were missing.

One of the bags of grease shown in figure 1 contained a brown colored grease that was collected from the area around the clutch outer race splines at the aft (input) side of the overrunning clutch. The other bag of grease shown in figure 1 contained a sample of Mobil 28 grease that was a brighter red color and was collected from a tube in the operator's consumables cabinet. Using a paper shop towel, a swab of the brown grease was collected from the bag. The towel was then rinsed with acetone while collecting the product of the rinse in a beaker. The beaker was then placed in an ultrasonic cleaner for approximately 5 minutes. A collection of particles was observed at the bottom of the beaker after cleaning.

**Figure 1.** Overall view of the submitted components and grease samples.

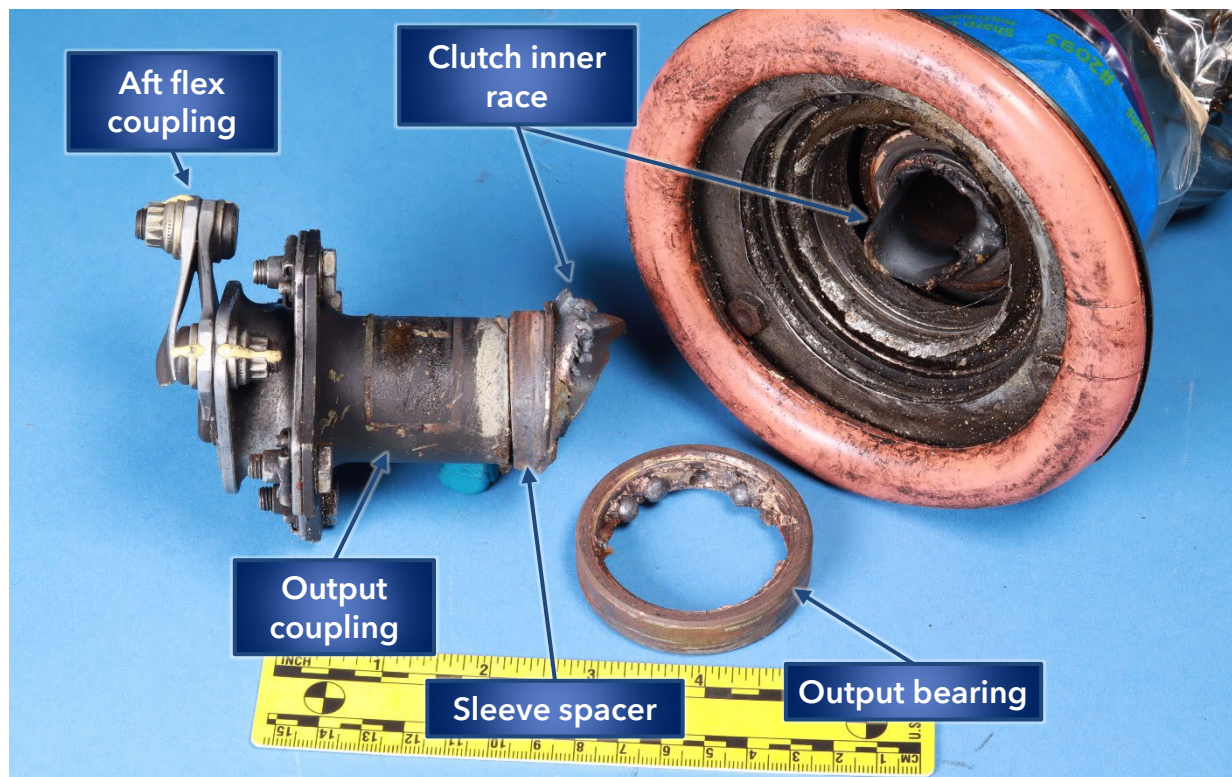
A closer view of the components at the forward end of the overrunning clutch assembly is shown in figure 2. The output coupling, sleeve spacer, output bearing, and clutch inner race showed heat tinting, oxidation, and deformation consistent with high heat exposure. A rectangular area that appeared to be carbonized adhesive was observed on the side of the output coupling.

**Figure 2.** Closer view of components at the forward end of the overrunning clutch assembly.

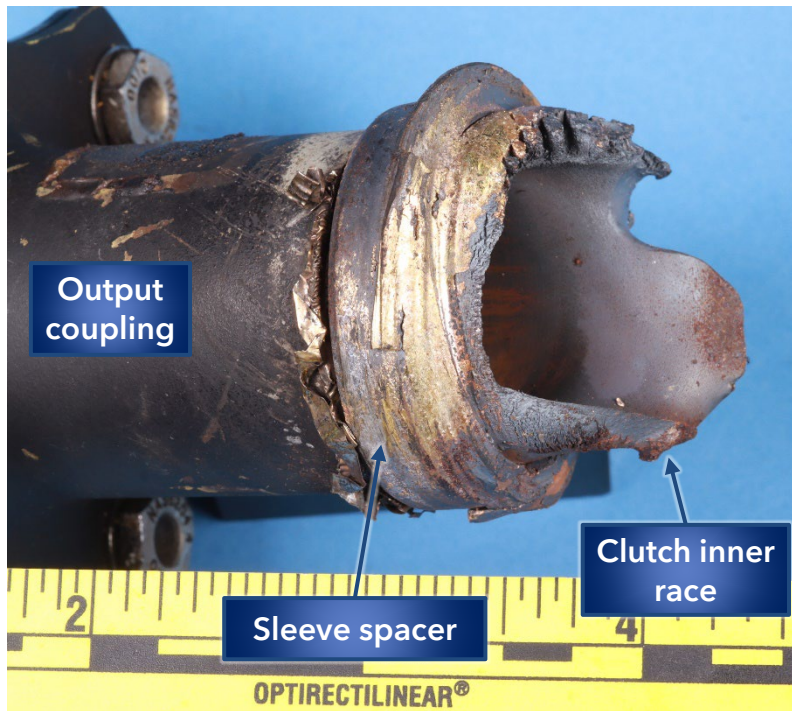
A closer view of the forward fracture surface on the clutch inner race is shown in figure 3. The forward sleeve spacer adjacent to the output coupling was intact on the inner race, but the surfaces were oxidized, and the flange at the aft side of the spacer was heavily deformed and rubbed circumferentially on one side. The aft sleeve spacer appeared intact within the overrunning clutch assembly and was not

examined in detail. The clutch inner race fracture was located between the sleeve spacers, a location corresponding to the position of the output bearing. The fracture surfaces and adjacent areas were tinted to a bluish black color consistent with oxidation at high temperatures. The same areas showed extensive deformation consistent with ductile fracture at high temperatures.

**Figure 3.** Forward side of the clutch inner race fracture.

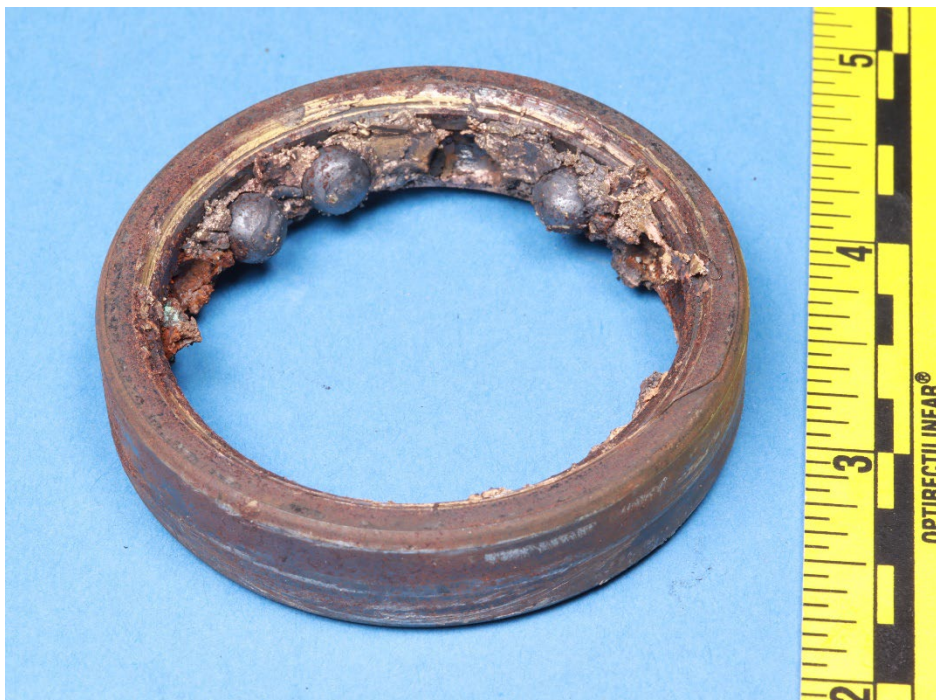
The output bearing outer race and remaining balls and bearing cage material are shown in figure 4. The outer race was oxidized and heat tinted consistent with high heat exposure. The balls also showed heat tinting and deformation consistent with high heat exposure. The bearing cage was destroyed, and molten and resolidified remnants of cage material were fused to the bearing outer race and around the remaining balls.

**Figure 4.** Output bearing outer race with cage and ball remnants.

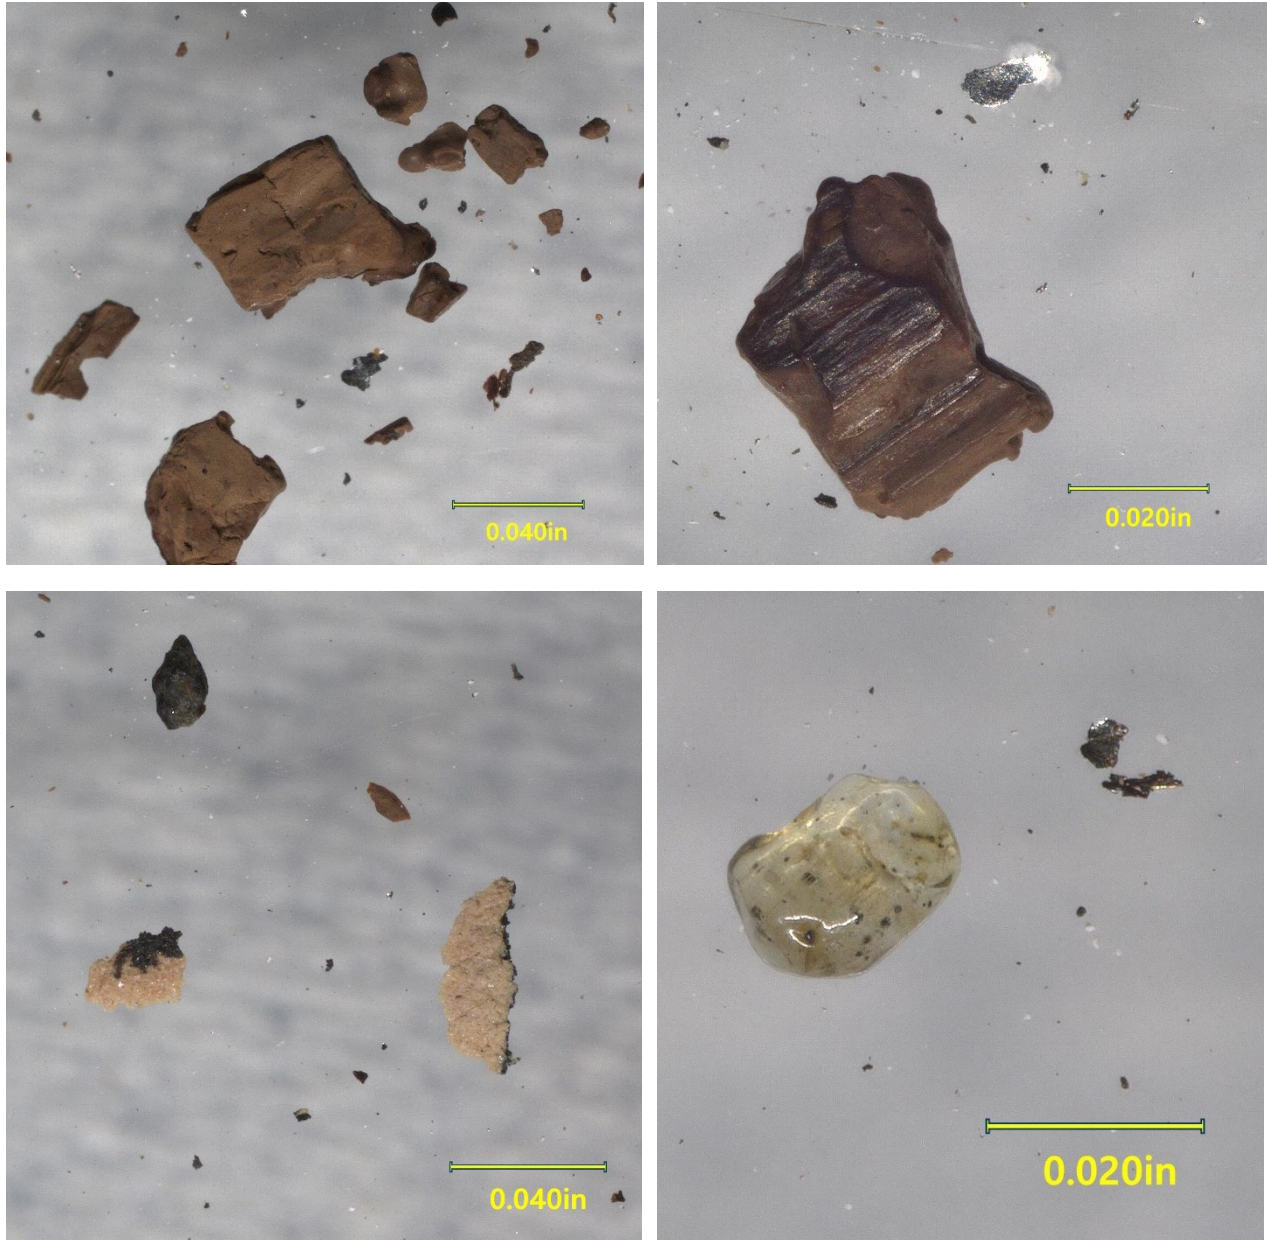
The acetone and grease solution was drained away from the particles, and the particles were collected onto a glass plate for further examination. Representative images of the particles are shown in figure 5. The largest particles were brown and had a textured appearance such as those shown in the upper left image in figure 5. Many of these brown textured particles had a black surface on one side such as the particle shown at the upper right image in figure 5. Other particles appeared as flat metallic flakes such as the smaller particles shown in the upper right and lower right images in figure 5. Some translucent particles with smooth rounded surfaces consistent with sand particles were observed such as the larger particle in the lower right image in figure 5. A few light-colored particles with a rough speckled surface and a black surface on one side were also observed as shown in the lower left image in figure 5.

The helicopter had experienced a forced landing and came to rest on its side at a beach known as Honopu Beach. Sand particles were observed on the exterior of the overrunning clutch housing. A sample of the sand particles were collected from an area around the forward seal, and the particles had an appearance similar to the rounded particles extracted from the brown grease.

**Figure 5.** Particles extracted from the brown grease sample including brown clay-like textured particles with a black surface (upper images), shiny flattened metallic flakes (right images), translucent particles with smooth rounded surfaces consistent with sand (lower right image) and rough light-colored accretions with a black surface (lower left image).

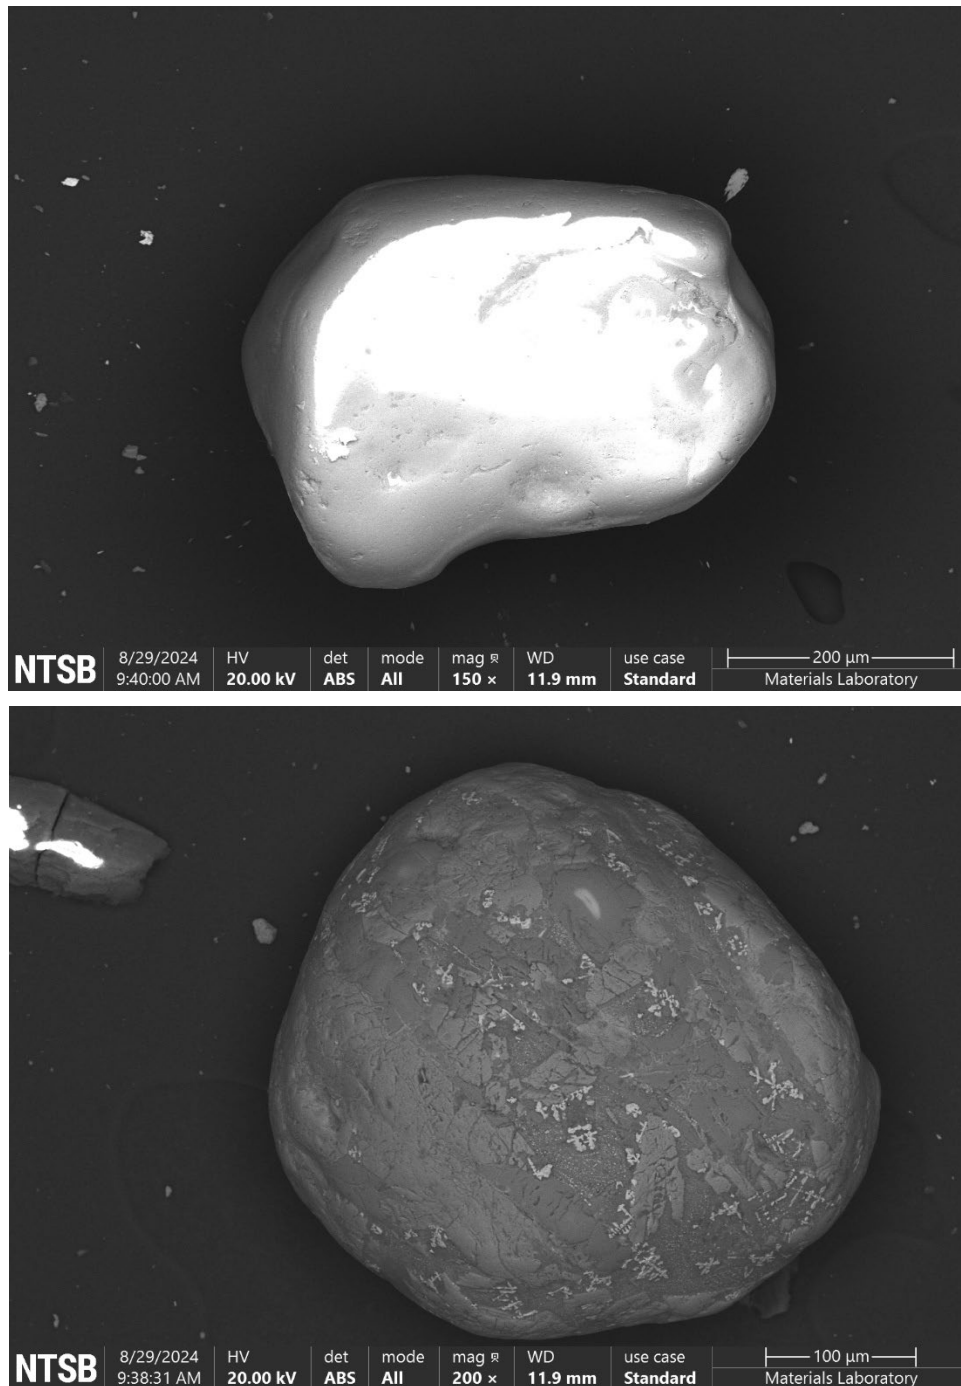
dispersive spectroscopy (EDS). SEM images of several particles extracted from the brown grease as viewed using the backscattered electron detector in composition mode are shown in figures 6 through 8.<sup>1</sup> Some of the rounded particles had a relatively uniform light gray appearance such as the particle shown in the upper image in figure 6. These particles exhibited widespread charging in response to the electron beam as shown by the overexposed areas in the image.<sup>2</sup> Other rounded particles had a more variable appearance with dendritic structures and less overall charging such as the particle shown in the lower image in figure 6. Smaller particles with a somewhat spongy surface appearance were also observed such as the particle shown in figure 7. An SEM image of a rough light-colored particle shown in the lower left image in figure 5 is shown in figure 8. These particles appeared to be an accumulation of fine angular particles that had been formed together into a larger particle.

**Figure 6.** SEM images of rounded particles extracted from the brown grease sample as viewed using the backscattered electron detector in composition mode.

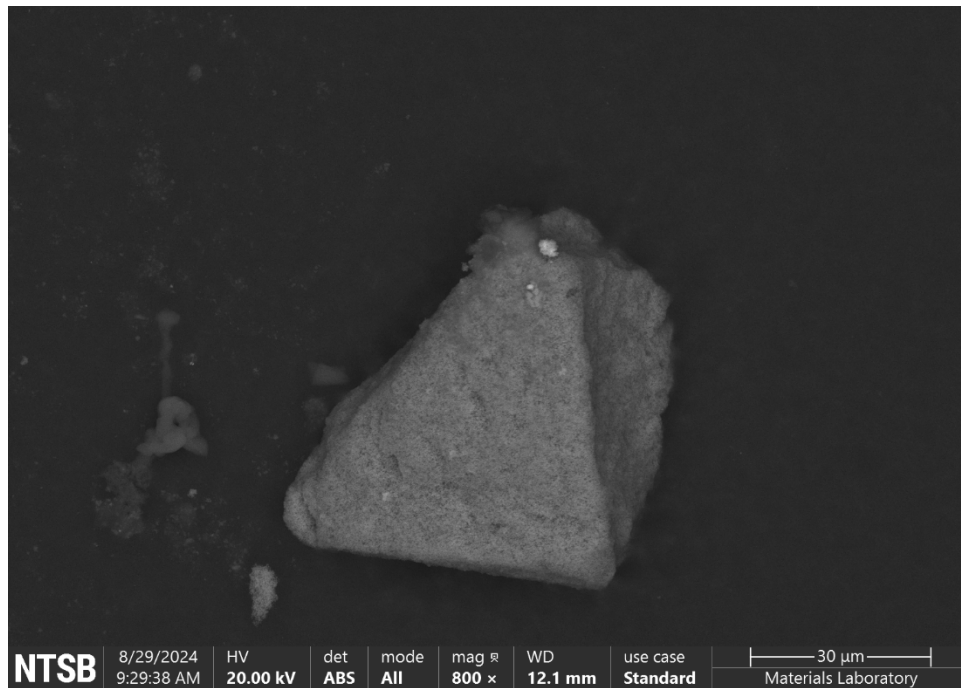
**Figure 7.** SEM image of a titanium-rich particle extracted from the brown grease sample as viewed using the backscattered electron detector in composition mode.

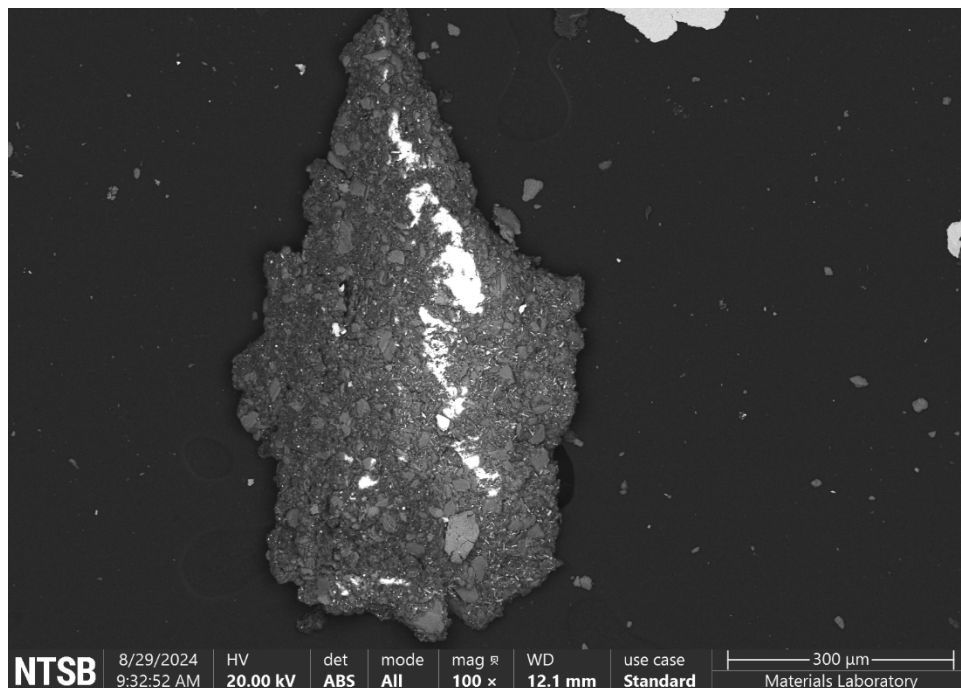
**Figure 8.** SEM image of a rough accretion extracted from the brown grease sample as viewed using the backscattered electron detector in composition mode.

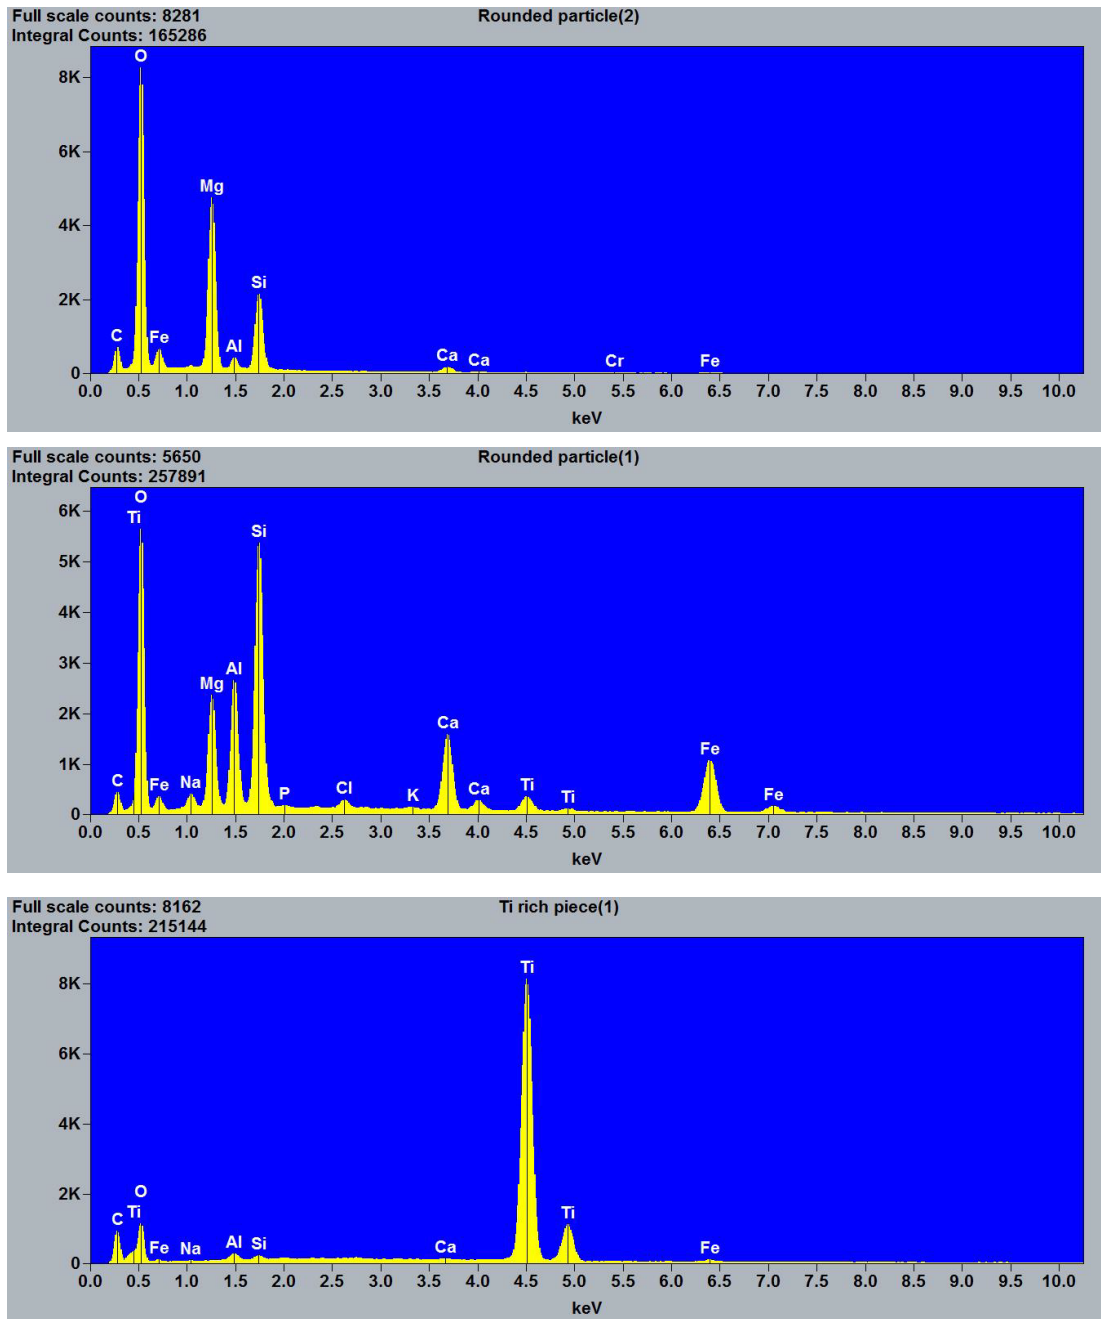
Representative EDS spectra for particles extracted from the brown grease are shown in figures 9 through 11. Particles such as the larger rounded particle shown in the lower right image in figure 5 and the particles shown in figures 6 and 7 had typical spectra as shown in figure 9. Spectra similar to those shown in figure 9 were also obtained from the sand particles collected from the exterior surface of the clutch housing.

The relatively larger rounded particles shown in the upper and lower images in figure 6 corresponded to the upper and middle spectra shown in figure 9, respectively. The rounded particles had high peaks of silicon, magnesium and oxygen as shown in the upper two spectra in figure 6. Substantial peaks of aluminum, calcium, titanium, and iron were also observed associated with some of the particles as shown in the middle spectrum. The relatively smaller particles with a spongy surface appearance such as the particle shown in figure 7 corresponded to the lower spectrum shown in figure 9. These particles were characterized by spectra with a high peak of titanium and smaller peaks of carbon and oxygen.

**Figure 9.** EDS spectra obtained from rounded particles extracted from the brown grease sample. The upper and middle spectra show typical analysis results associated with rounded particles showing high peaks that included silicon, magnesium, and oxygen, and the lower spectrum was typical of smaller particles with a high titanium peak.

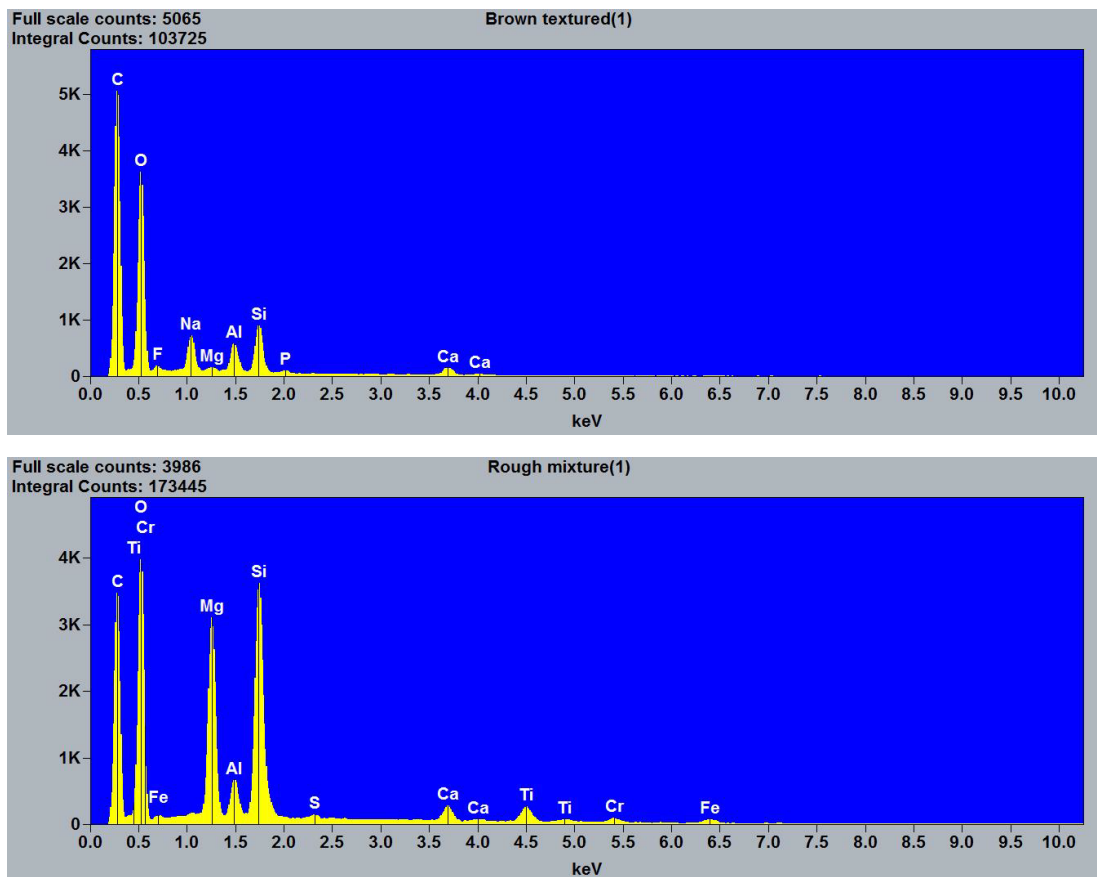
A typical EDS spectrum for the brown textured particles is shown in the upper spectrum in figure 10. High peaks of carbon and oxygen with smaller peaks of sodium, aluminum, silicon, and calcium were observed. While a magnesium peak was also detected, the relative size of the magnesium peak was considerably smaller than both the aluminum and silicon peaks. By comparison, the magnesium peak in spectra obtained from the sampled sand particles generally was either higher than

A typical EDS spectrum for the rough speckled accretions (see lower left image in figure 5 and image in figure 8) is shown in the lower spectrum in figure 10. High peaks of carbon, oxygen, magnesium and silicon with smaller peaks of aluminum, calcium, titanium, chromium, and iron were observed.

**Figure 10.** Typical EDS spectra associated with the brown textured particles (upper spectrum) and the rough light-colored accretions (lower spectrum) extracted from the brown grease sample.

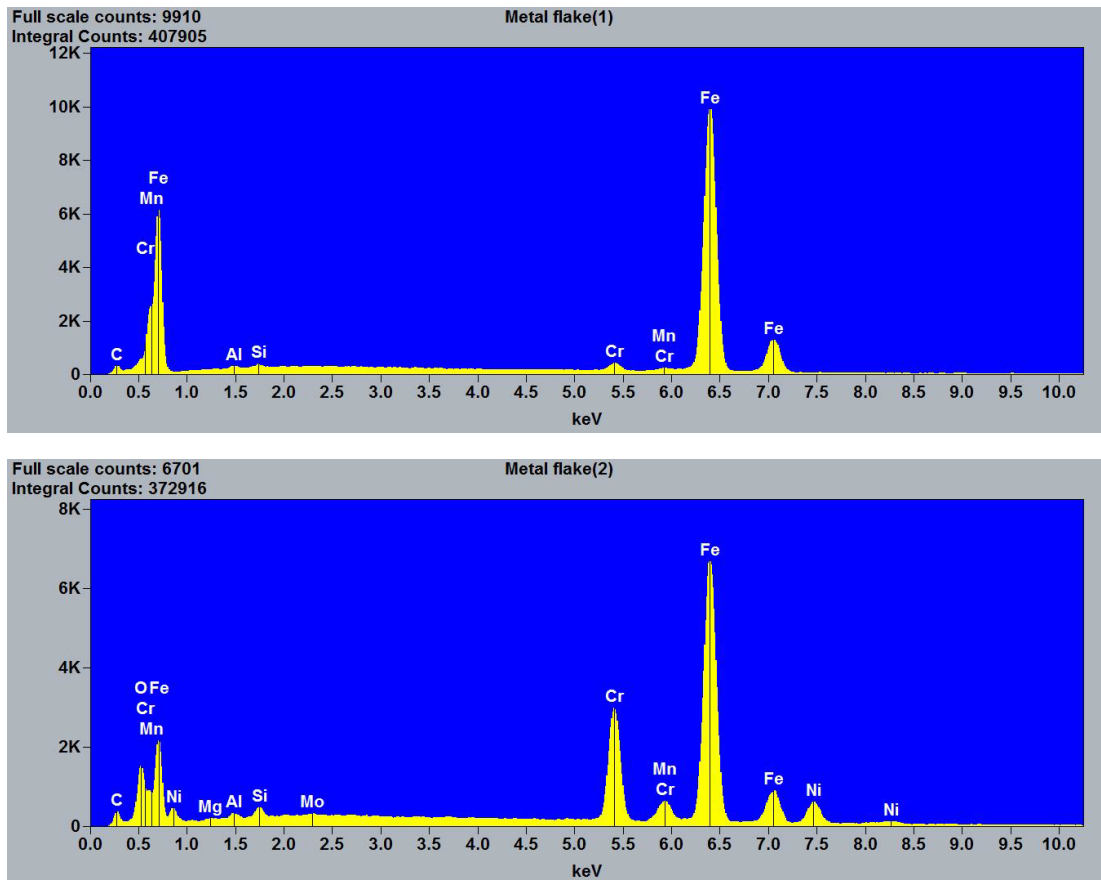
Typical EDS spectra obtained from metal flakes extracted from the brown grease sample are shown in figure 11. The spectra for some flakes had a high peak of iron with relatively small peaks of chromium and manganese, a spectrum consistent with low alloy steel. Spectra for other metal flakes had a high peak of iron with a substantial peak of chromium and a smaller peak of nickel, a spectrum consistent with a stainless steel.

**Figure 11.** EDS spectra obtained from metal flakes extracted from the brown grease sample. The spectra were consistent with a low alloy steel (upper spectrum) and a stainless steel (lower spectrum).
