# National Transportation Safety Board

ANC24LA017

Group Chair's Factual Report

Location:      Kekaha, HI  
Date:          February 27, 2024  
Time:          1330 Hawaii-Aleutian standard time  
Helicopter:    MD Helicopters 369E, registration N633JH

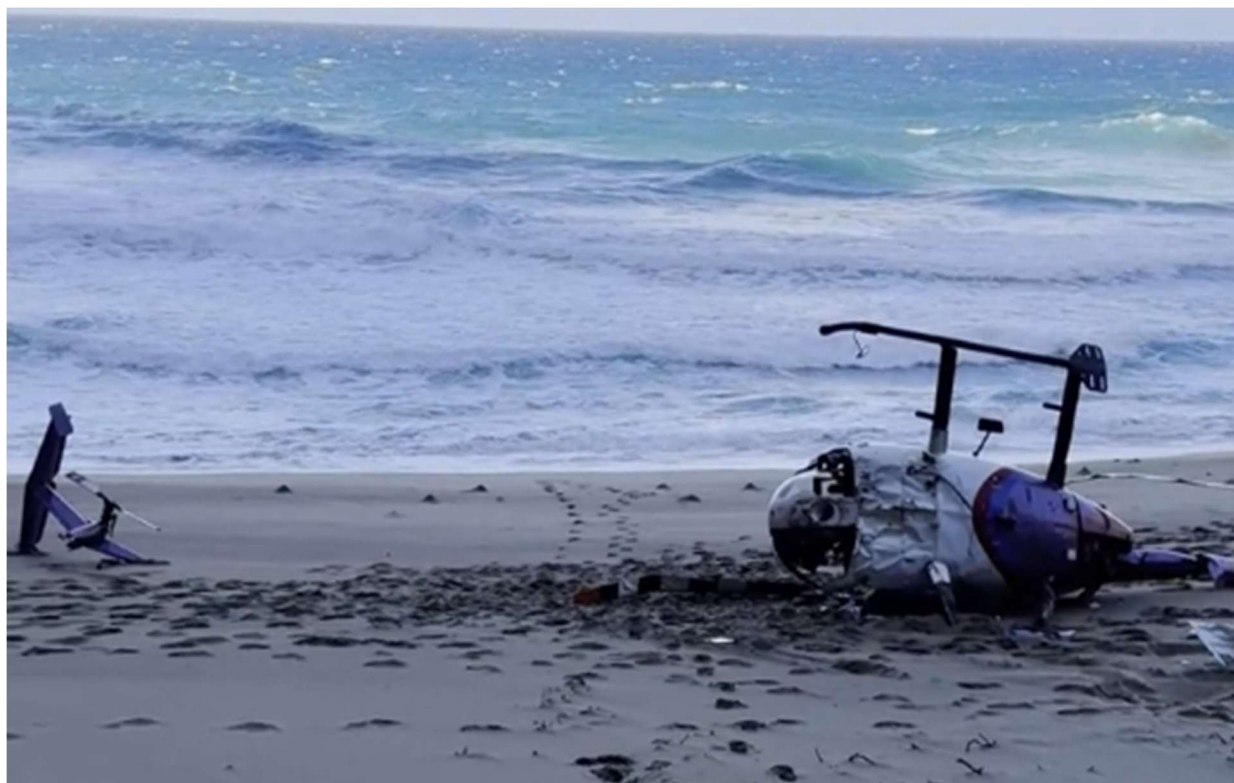
The operator took videos documenting the accident site prior to recovery of the wreckage. The helicopter came to rest on its right side. The right skid tube had separated from the landing gear and was upright in the sand behind the fuselage. The empennage, containing the vertical fin, horizontal stabilizer, and tail rotor, was found about 25 feet ahead of the fuselage (**figure 2**).

**Figure 2.** The main fuselage and the separated empennage containing the vertical fin, horizontal stabilizer, and tail rotor. (Image courtesy of Jack Harter Helicopter)

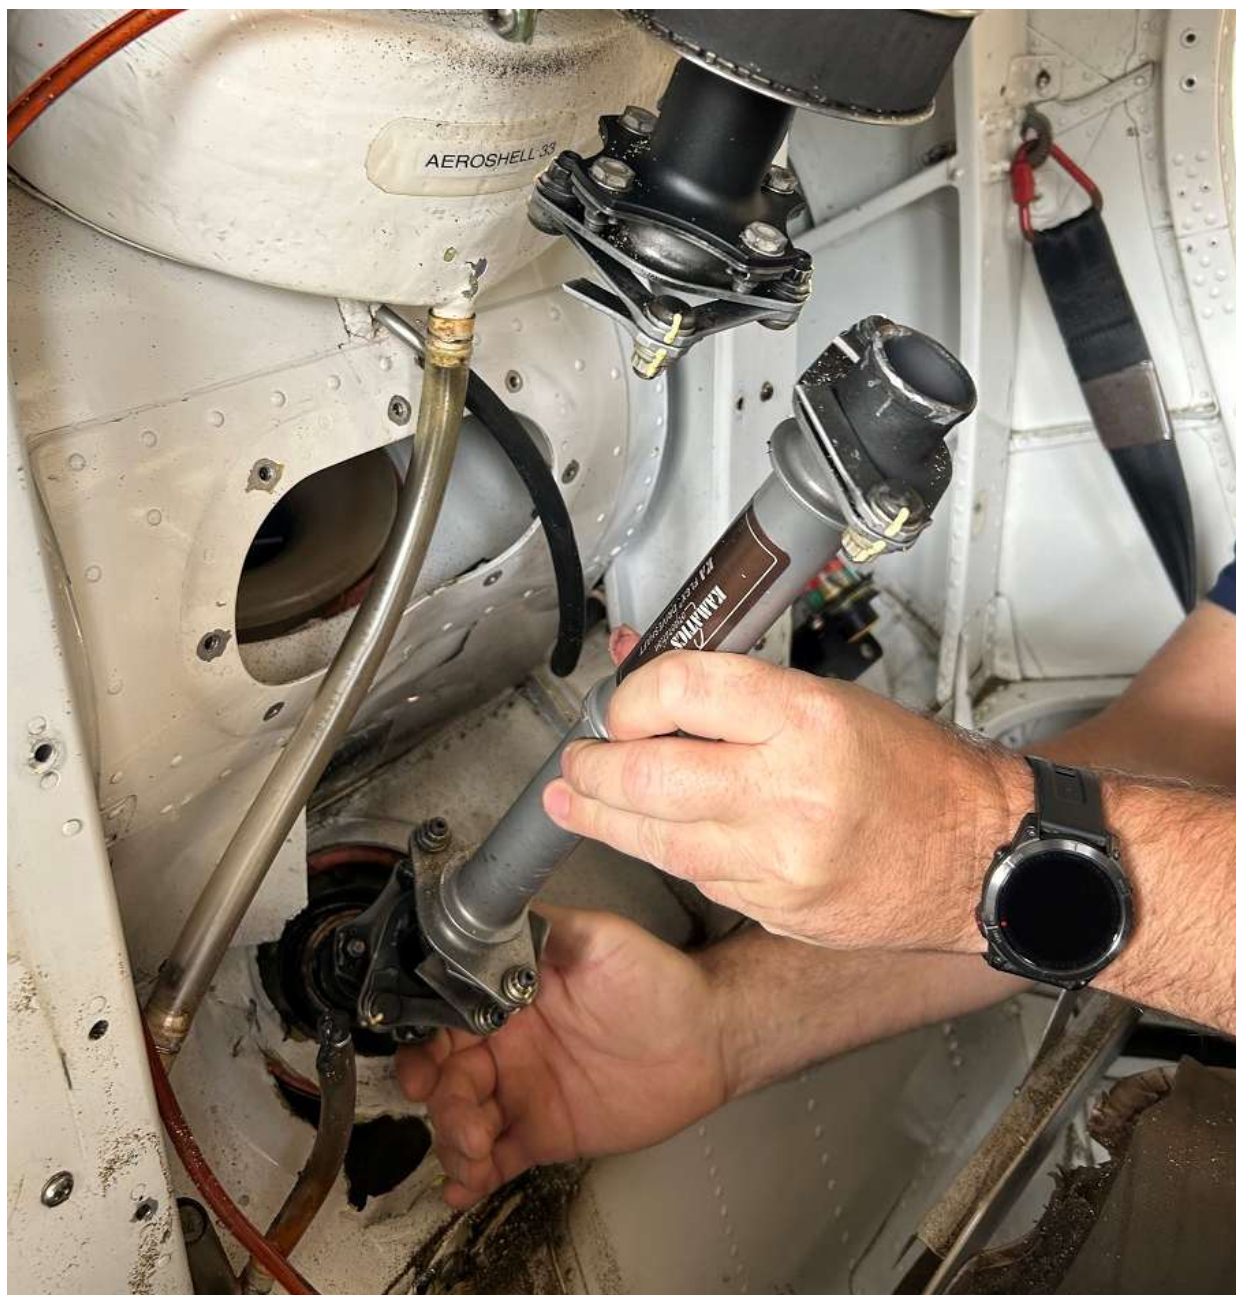
The wreckage was recovered and subsequently stored in a secured hangar in Lihue, HI. After recovery of the helicopter, the NTSB investigator-in-charge authorized removal of the Kaflex driveshaft cover. Once the Kaflex driveshaft cover was removed, the flex plates on both ends of the Kaflex driveshaft were found fractured (**figure 3**). Additionally, the clutch inner race's splined shaft had fractured aft of the splines and exhibited thermal deformation.

**Figure 3.** The Kaflex driveshaft as found in the wreckage after removal of the driveshaft cover. (Image courtesy of the FAA)

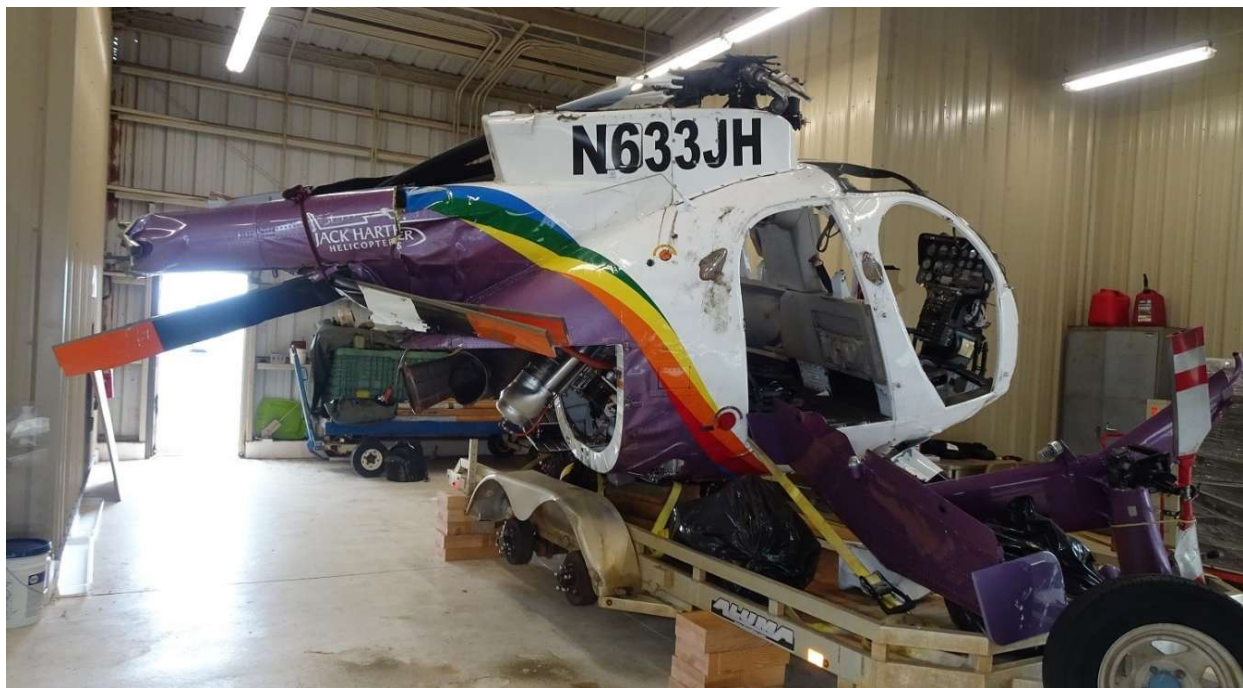
The helicopter fuselage exhibited impact damage from the hard landing (**figure 4**). The right skid tube was separated from the skid struts. The left skid tube remained attached to the fuselage via its struts, the latter of which remained attached to the fuselage. The tail boom was fractured and separated about 28 inches forward of the tail gearbox mounting face. The remainder of the tail boom was attached to the fuselage and exhibited a left-ward deformation.

**Figure 4.** The recovered wreckage at a hangar in Lihue.

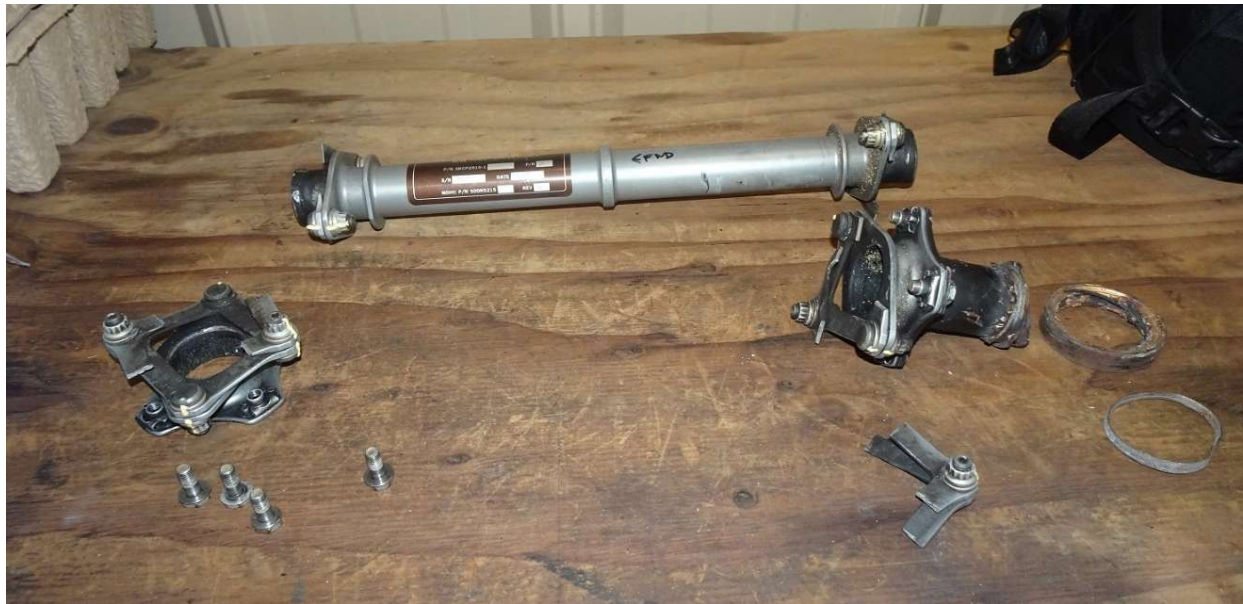
The Kaflex driveshaft had fractured and separated at both ends of its flex plates (**figure 5**). The Kaflex driveshaft tube was continuous and did not exhibit torsional deformation or fractures. The forward flex plate assembly had fractured at its aft plate. The aft flex plate assembly had fractured at its forward plate. All fasteners for the Kaflex driveshaft installation remained installed and their torque stripes were present with no evidence of torque stripe misalignments. The Kaflex driveshaft was P/N SKCP2910-1 and S/N 0197. The forward splined flange, attaching to the main gearbox input pinion, and the aft splined flange, attaching to the splined output shaft of the overrunning clutch, did not exhibit cracks, fractures, or deformation.

**Figure 5.** The Kaflex driveshaft after removal from the wreckage.

Examination of the fracture surfaces on the flex plates of the Kaflex driveshaft showed signatures consistent with overload. No evidence of fatigue was observed on these fracture surfaces.

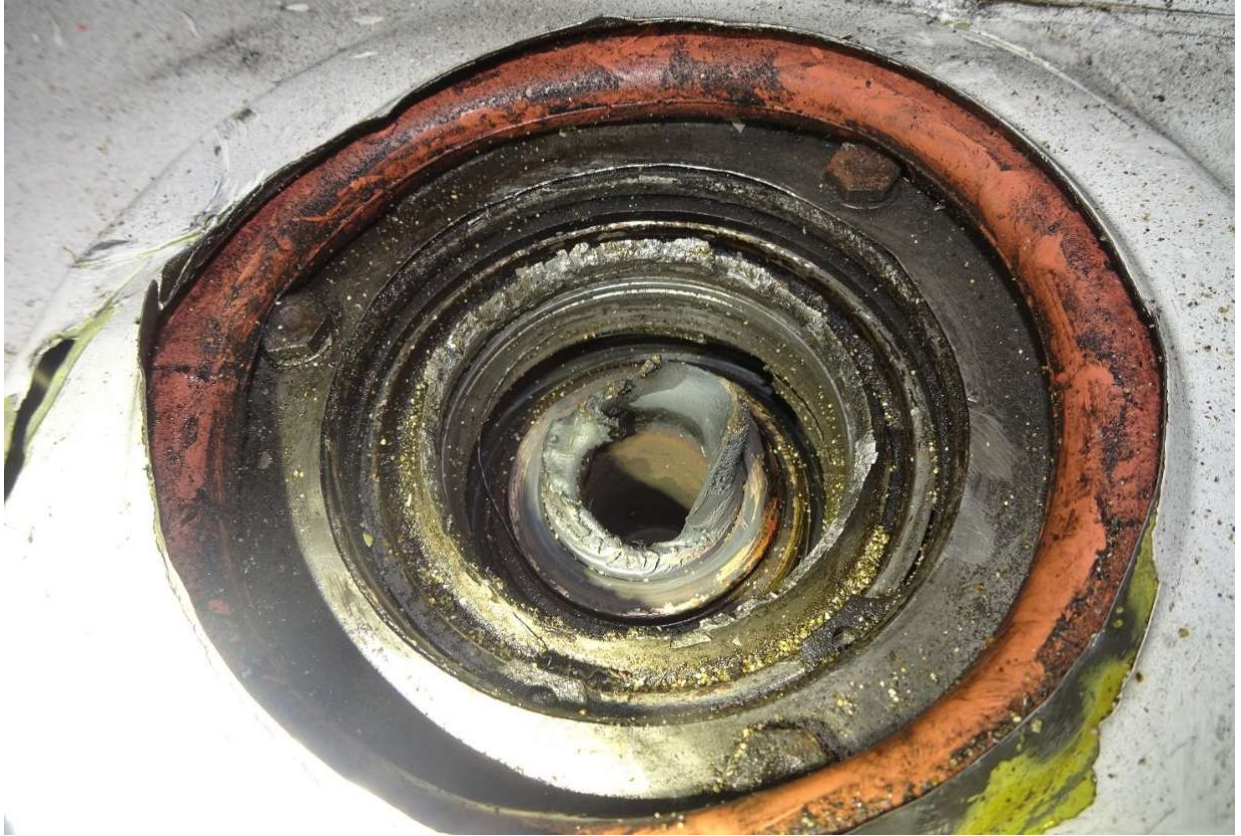
The overrunning clutch subassembly and the clutch housing remained installed on the engine gearbox housing but the clutch inner race splined shaft had fractured aft of the splines, with the fracture exhibiting a spiral and partially melted appearance (**figure 6**). The overrunning clutch assembly was P/N 369A5350-605. The forward portion of the fractured clutch inner race splined shaft remained attached to the aft splined flange that was attached to the aft end of the Kaflex driveshaft (**figure 7**). A portion of the clutch output bearing (P/N 369A5361, see **figure 1**), normally installed immediately adjacent to the clutch inner race's splines, was found in its normally installed location but had separated from the clutch. However, the clutch output bearing found was composed only of the bearing outer race with three roller (ball) elements adhered to the outer race and exhibited thermal damage (**figure 8**). A circular metal piece, which exhibited thermal damage and deformation, was found with the output bearing.

**Figure 6.** The fractured and thermally deformed clutch inner race.

Examination of the damage to the components at the forward end of the overrunning clutch assembly showed heat tinting, oxidation, and deformation consistent with high heat exposure. The output bearing outer race contained remnant balls (roller elements) and cage pieces that had melted and resolidified to the outer race.

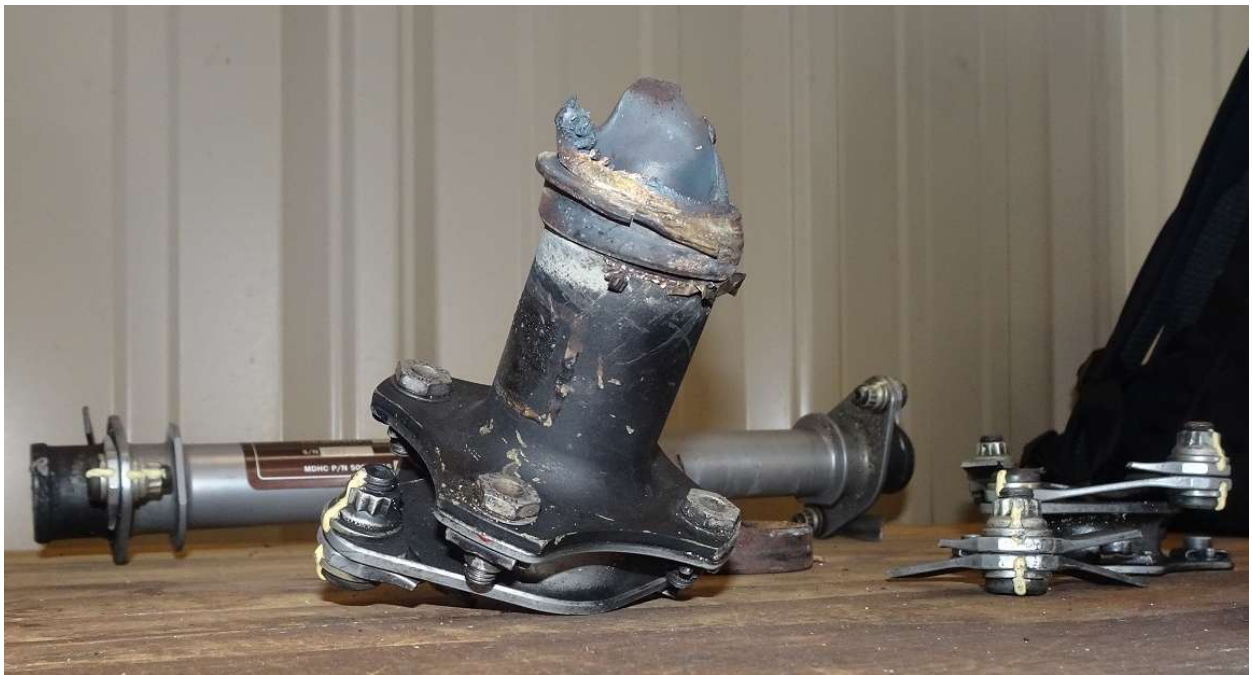
**Figure 7.** The forward portion of the clutch inner race still within the flanged connection attached to the aft flex plates of the Kaflex driveshaft.

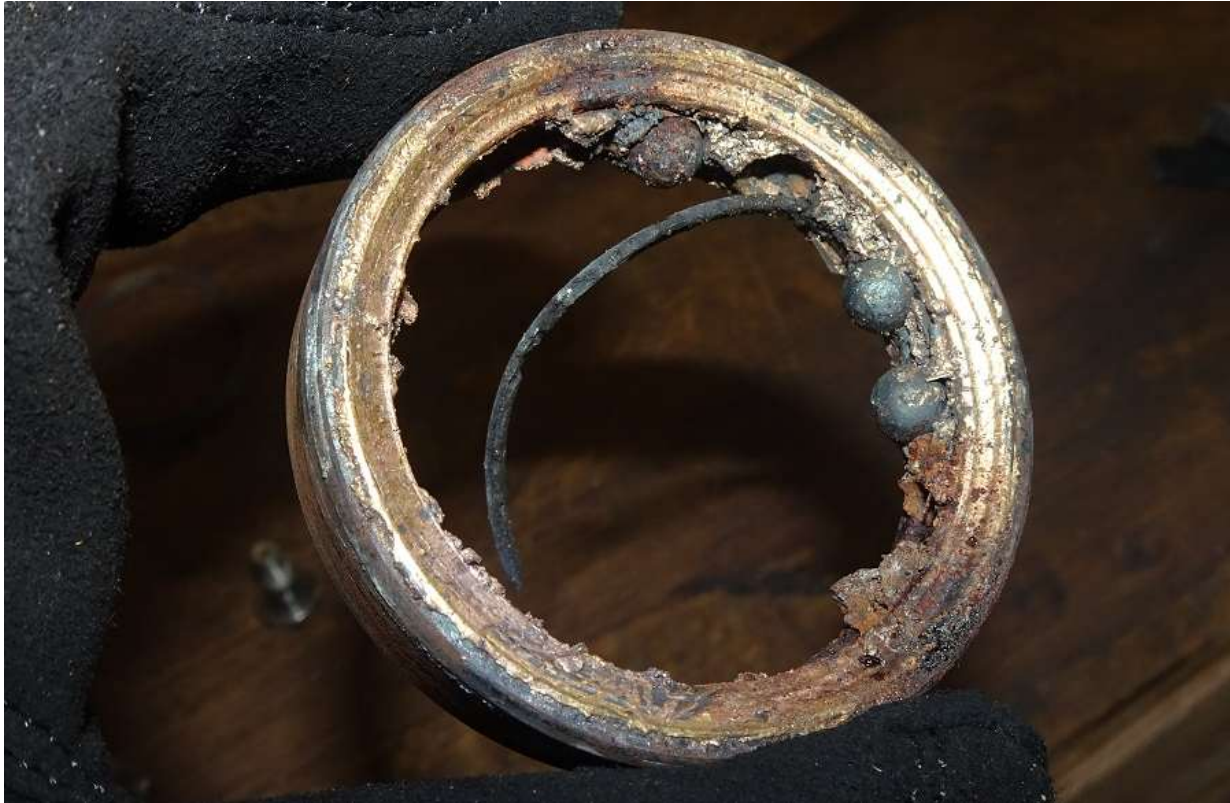
**Figure 8.** The clutch output bearing outer race with the three roller (ball) elements adhered.

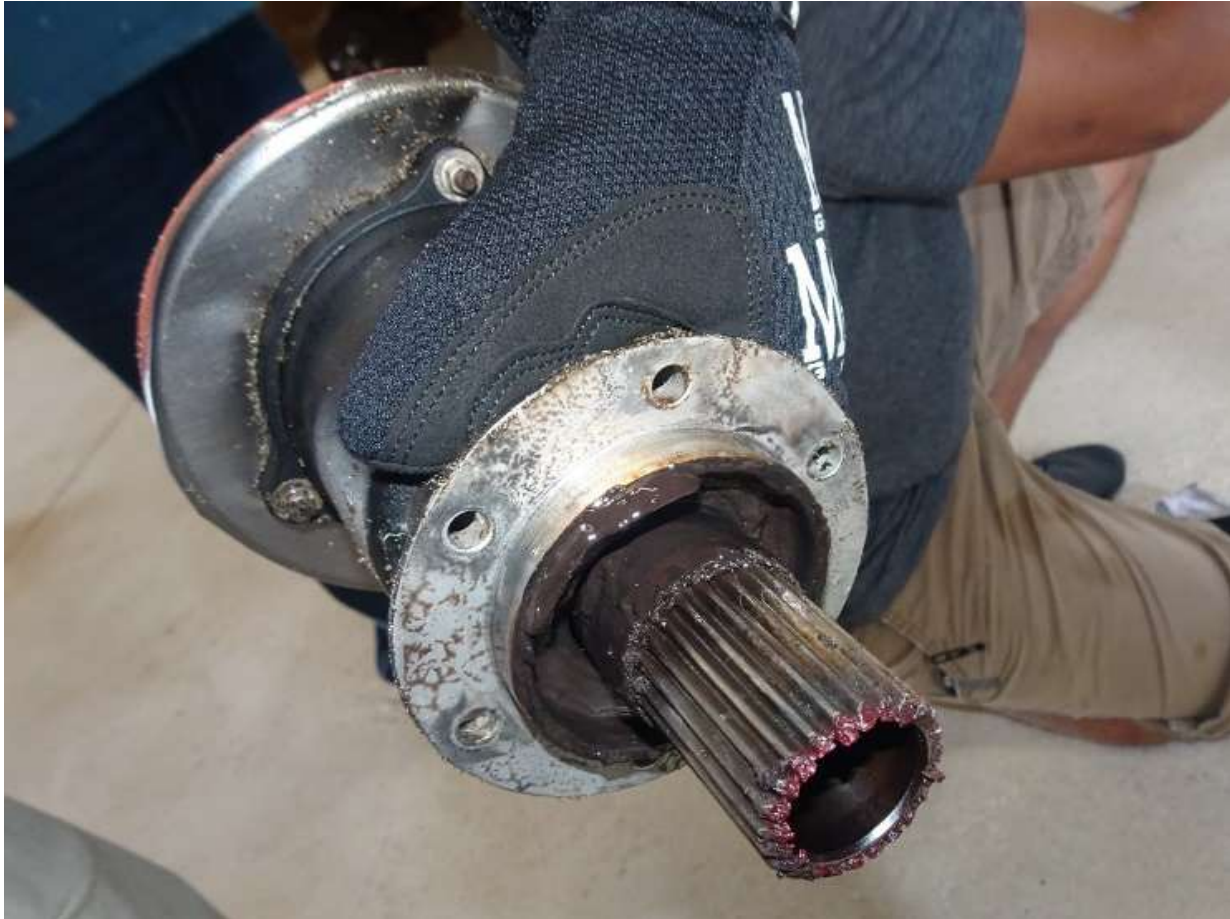
After the engine was removed from the airframe, the overrunning clutch was observed to be installed normally on its engine gearbox mounting studs. The overrunning clutch assembly was removed from the engine gearbox, revealing the clutch outer race splines which did not exhibit anomalous wear (**figure 9**). Dark brown-colored material, similar in consistency to grease mixed with oil, was present on the forward face of the clutch mounting pad of the engine gearbox. The dark brown-colored material had metallic-colored specks within the mixture. A sample of the dark brown-colored material was retained by the NTSB for further evaluation. Functionality of the clutch's sprags was confirmed upon manual rotation of the clutch's input splines: in the drive direction, the sprags engaged, and in the freewheeling direction, the sprags disengaged; rotation of the clutch shaft was difficult to accomplish.

**Figure 9.** The clutch outer race splines after removal of the overrunning clutch assembly from the engine.
