ANC24LA017

## INVESTIGATION PHOTOGRAPHS

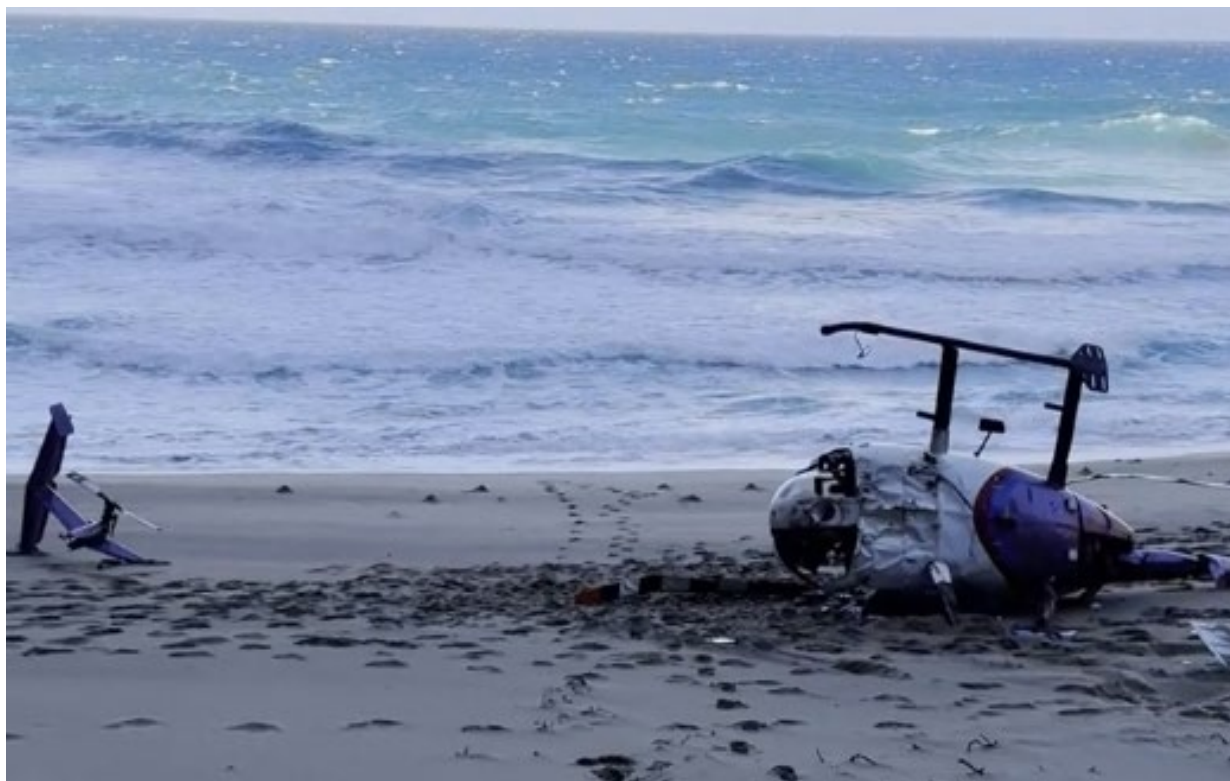
**Photograph 1 - Image of fuselage and the separated empennage containing the vertical fin, horizontal stabilizer, and tail rotor (Courtesy of Operator)**

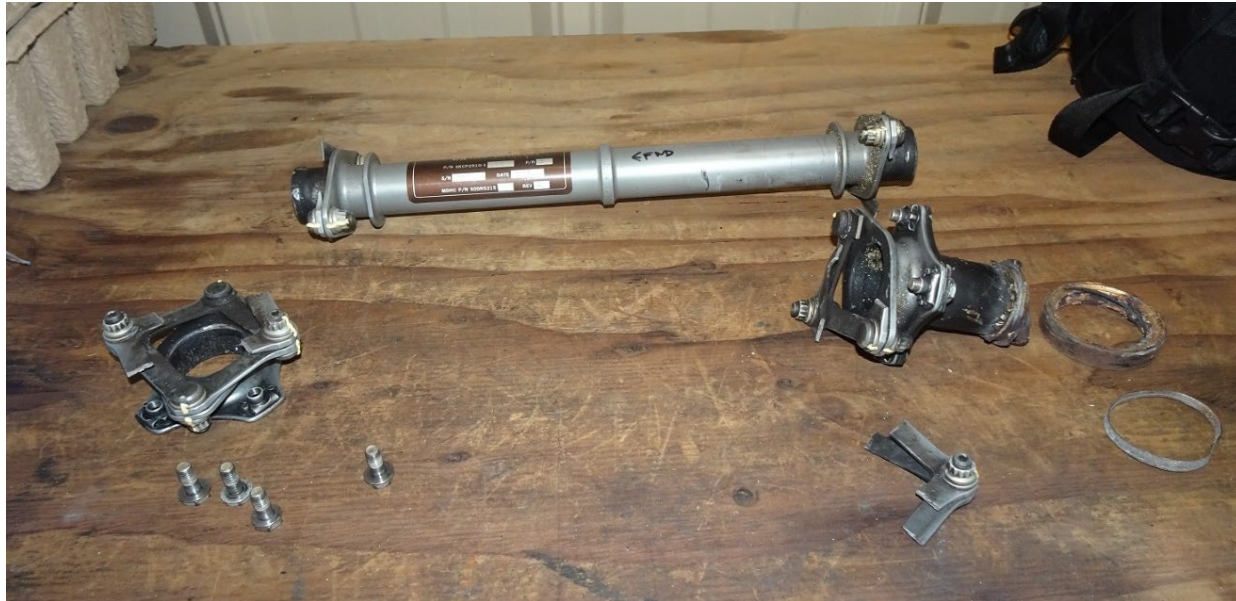
**Photograph 2 - Image of Kaflex driveshaft after removal from wreckage (NTSB Photo)**

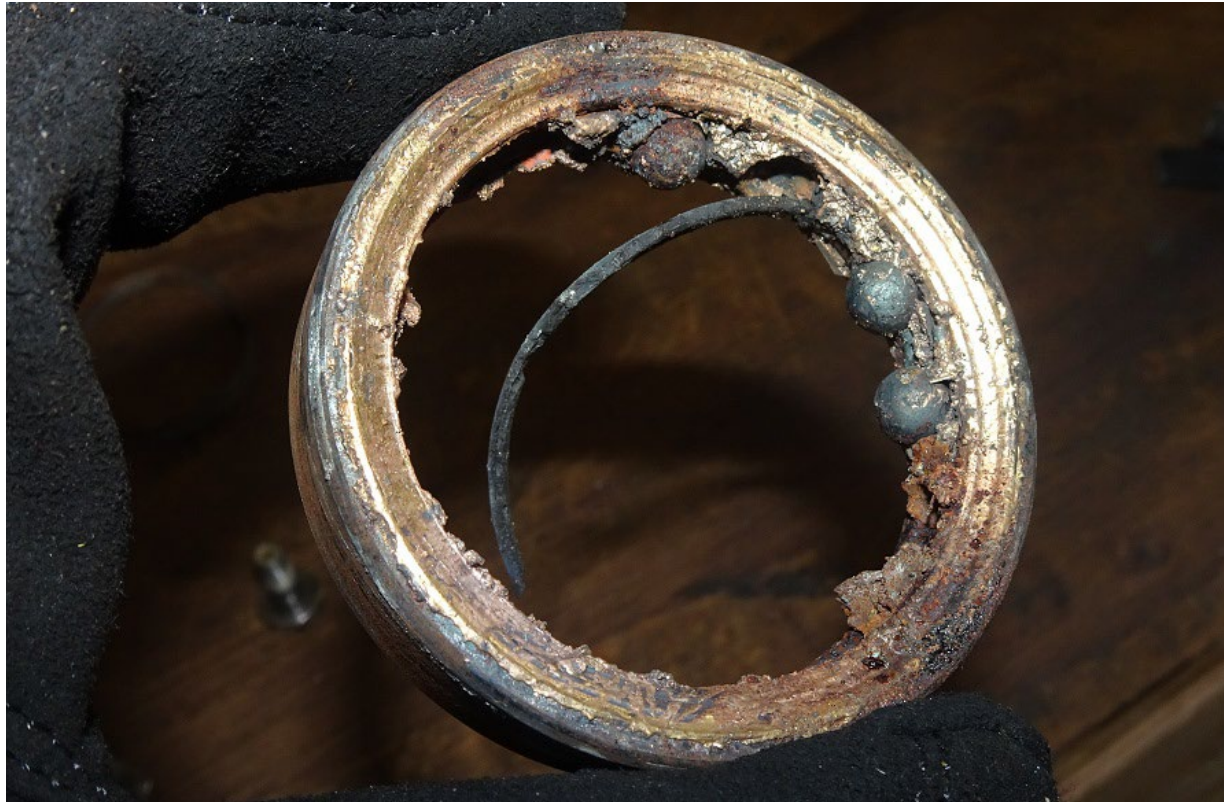
**Photograph 3 - Image of clutch output bearing outer race with three roller elements adhered (NTSB Photo)**
