Re: Jack Harter Helicopters' Party Submission re: MD Helicopter 369E/500E Accident; February 27, 2024; Kekaha, Hawaii; NTSB Investigation No. ANC24LA017

## EXAMINATION REPORT

### HUGHES 369D OVERRUNNING CLUTCH EXAMINATION

Report Date 3 September 2024

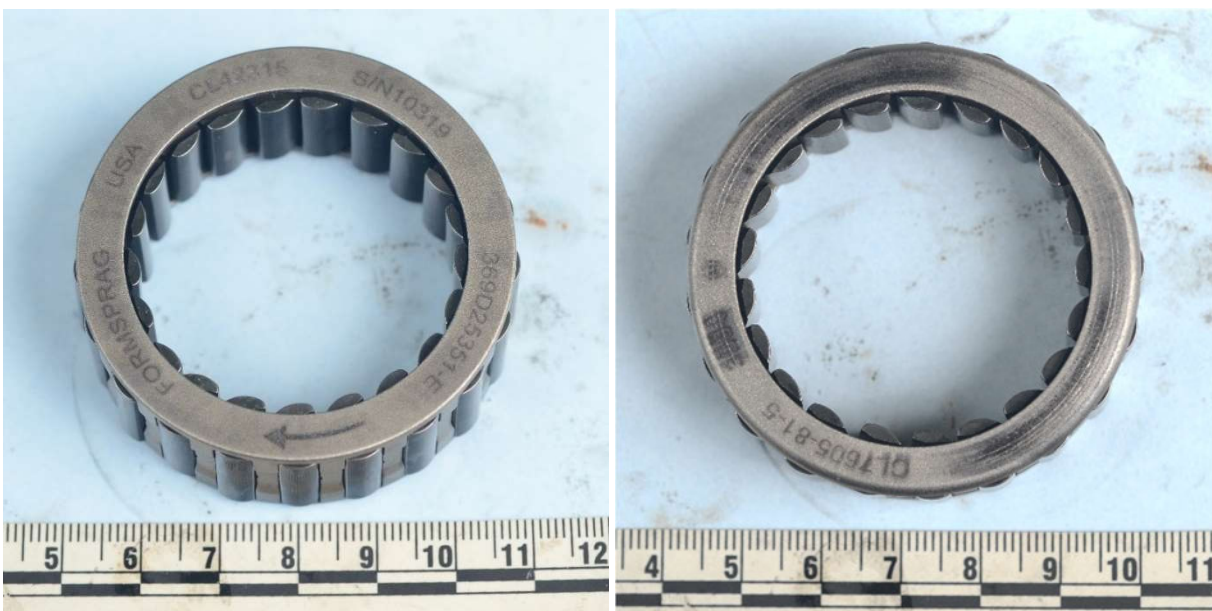
Figure 5 - Sprag Assembly, part number 369D25351-E (BSC)

#### 4.2 Visual examination of the sprag clutch assembly revealed wear that was beyond the allowable limits in the overhaul manual.

The sprags showed wear, especially noticeable on their inner load surfaces. One sprag showed flaking of the Formchrome surface treatment. See Figure 9.

The sprags had freedom of movement and there was no binding. No corrosion was observed. The retainer springs were sound and there were no chips or cracks in the components. However, the assembly was worn beyond serviceable limits.

- The sprag assembly (PN 369D25351-BSC, SN 10319) showed wear beyond serviceable limits. Wear was greatest on the sprag cage.
- The spacer/washer separating the sprag assembly and the face of the sprag cage were scored, consistent with relative movement in the presence of debris.

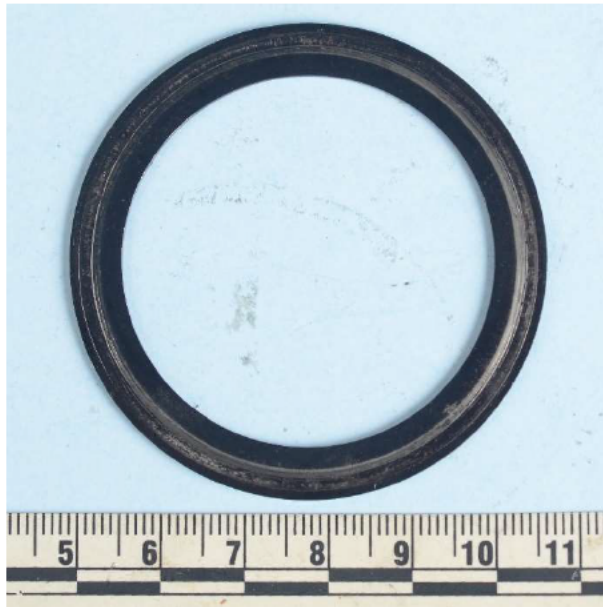
The spacer/washer – item 19 in Figure 3, 369A5360-BSC – was scored on its surface (see Figure 6). Similar scoring was observed on the contacting face of the sprag cage (see Figure 5). This was consistent with relative movement between the parts in the presence of wear debris.

*Figure 6 – Spacer/washer, part number 369A5360-BSC*

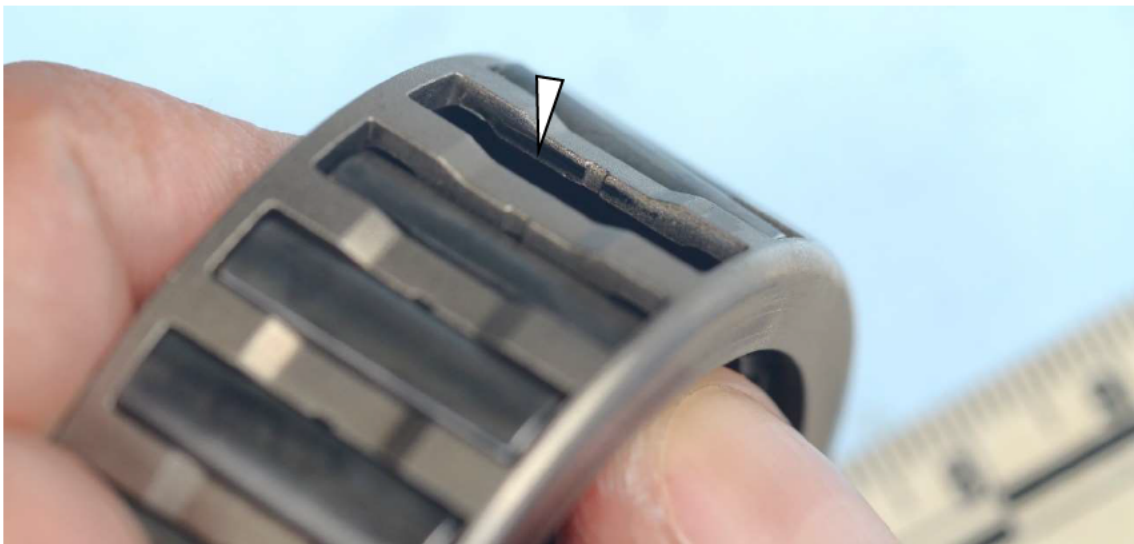
Closer examination of the sprag assembly showed heavy wear on the cage, well beyond the 0.102 mm or 0.004 in maximum depth stated in Table 503 of the overhaul manual. Figure 7 and Figure 8 show a photograph and an optical microscope image of the wear on the cage.

*Figure 7 - Wear on sprag cage*

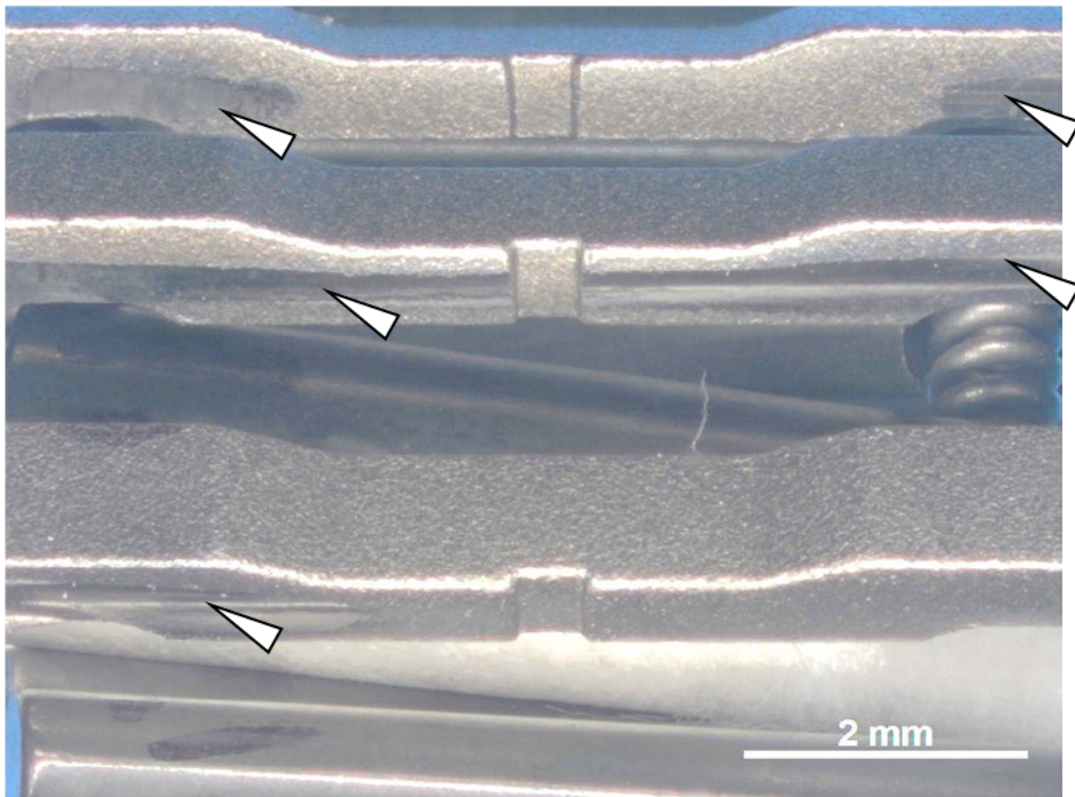
*Figure 8 - Optical microscope image of wear on sprag clutch cage (indicated)*

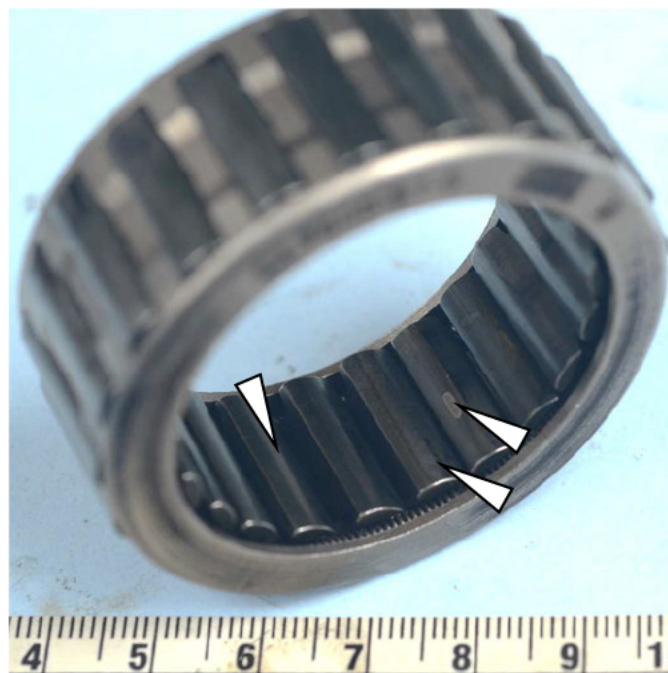
*Figure 9 - Sprag assembly, showing flaking of the Formchrome surface treatment on one of the sprags, and wear on sprag load areas.*

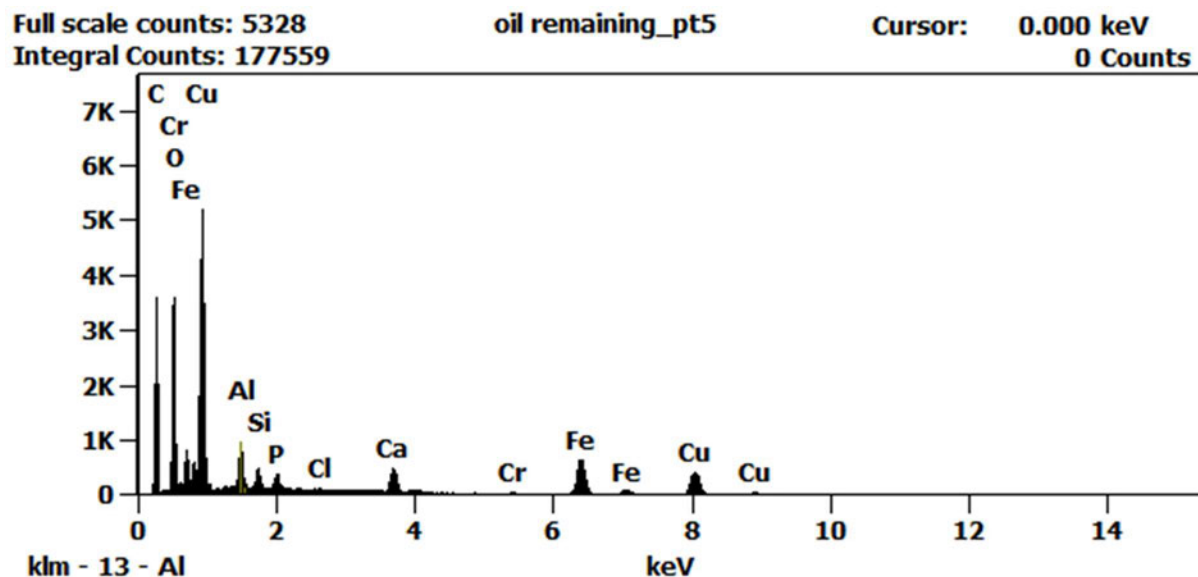
The samples of used sprag clutch oil extracted by JHH were passed through a fine filter and washed with acetone. The washed debris were then analyzed using Energy Dispersive X-ray Spectroscopy (EDS) in a scanning electron microscope (EDS) for elemental composition. A representative X-ray energy spectrum is shown in Figure 10. The micron-scale debris consisted of copper, iron, and chromium. These elements were present in the bearing components. Other elements detected included calcium, silicon, and aluminum, which were likely present as dust (contamination).

It was concluded that the metallic debris were wear particles from the sprag clutch components.

Figure 10 - Representative X-ray energy spectrum for debris found in sprag clutch oil

- Metallic debris was present in the sprag clutch oil. EDS analysis showed that it was wear debris from the sprag clutch components as well as external contamination (dust).

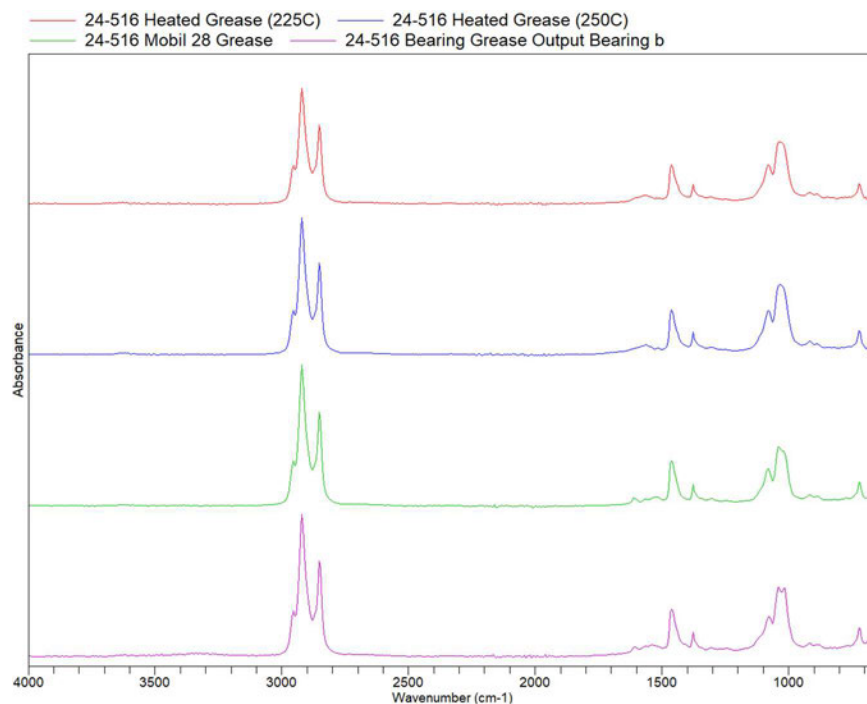
Figure 11 – FTIR analysis results (IR absorbance spectra)

#### 4.5 FTIR analysis of the darkened grease from the overrunning clutch output ball bearing did not indicate overheating of the lubricant

Over-heating and consequent oxidation of the grease would be expected to produce changes to the IR absorbance spectrum in the 1500 cm<sup>-1</sup> to 1750 cm<sup>-1</sup> wavenumber range. These changes can be observed in Figure 11, in the spectra for the samples of grease heated to 225 °C and 250 °C – compare these to the spectra for the fresh grease. There was no similar change in the spectra for the sample of used grease collected from the overrunning clutch output bearing. The FTIR analysis results did not indicate oxidation of the used grease from the overrunning clutch bearing.

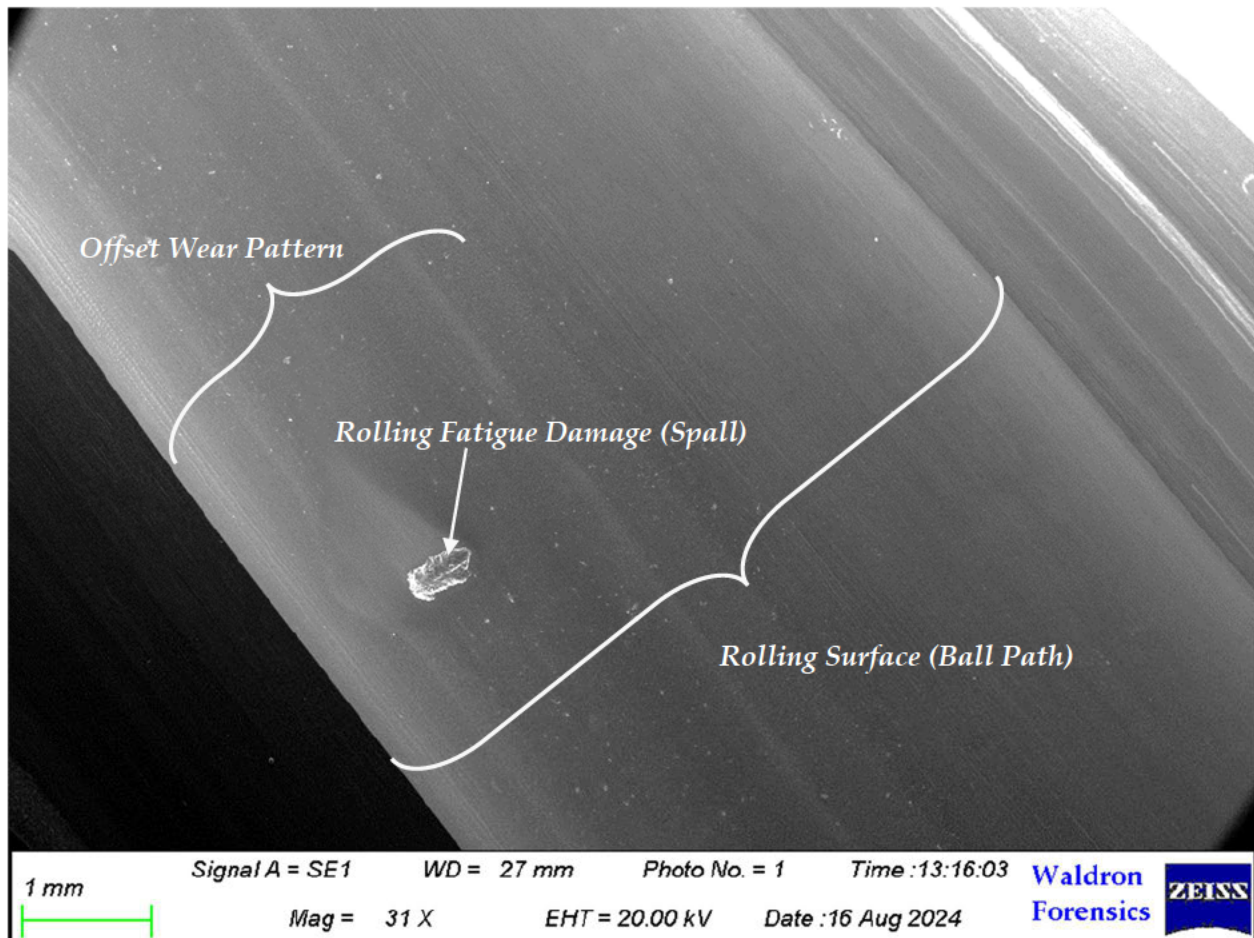
The bearing rolling surfaces showed wear patterns showing “pear skinning” and flaking/spalling. The flaking remained in its initial stage. Figure 12 through Figure 14 show scanning electron microscope images of the rolling surface on the outer ring of the outer bearing. The appearance of the worn surface and the flaking were typical of rolling contact fatigue. Rolling contact fatigue often appears at the end of the bearing life but can occur prematurely under excessive loads.

It was further observed that the bearing wear pattern was axially offset to one side of the ball path on the outer rings. This indicated the presence of an axial load on the bearing.

*Figure 12 – Scanning Electron Microscope of Outer Bearing Outer Ring Running Surface*

- Visual and microscopic examination of the output bearing running surfaces (balls, inner and outer rings) showed evidence of rolling fatigue, including “pear skinning” flaking/spalling.

- The wear pattern on the output bearing outer ring was offset to one side, indicating the presence of an axial load.

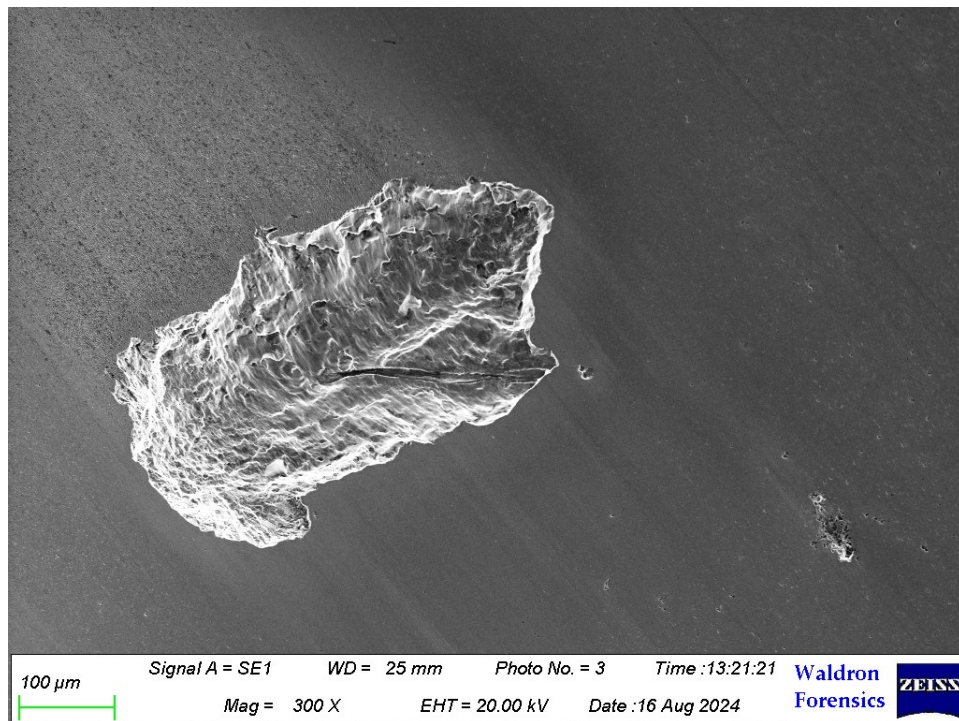
Figure 13 – Higher magnification of rolling fatigue flake/spall found on the outer ring ball path of the output bearing

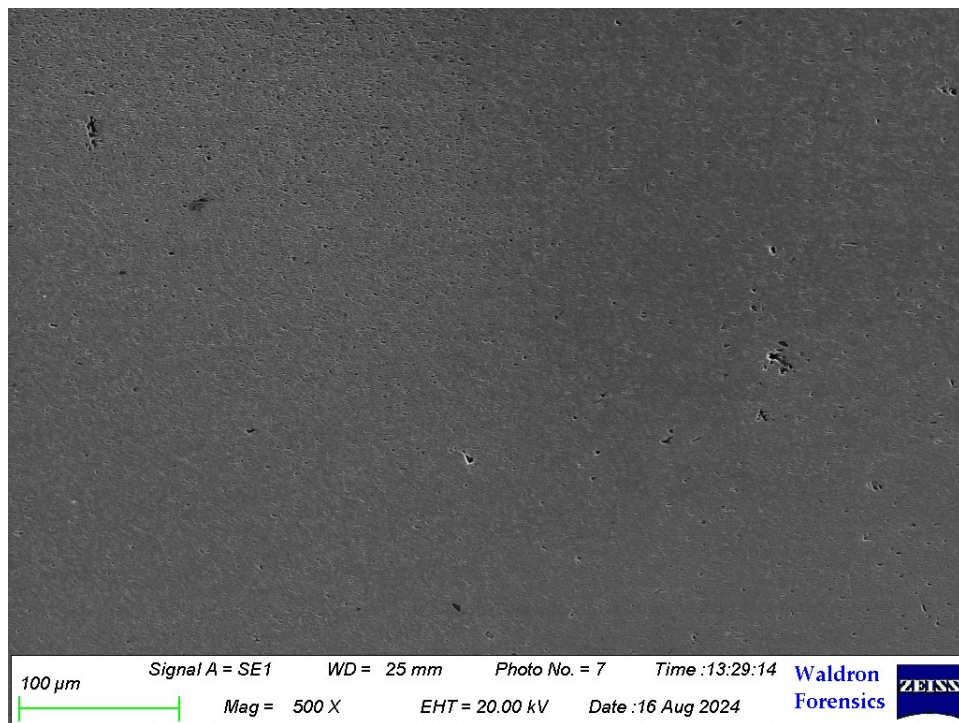
Figure 14 – High magnification image of the surface in the worn area of the outer ring ball path of the output bearing
