ANC24LA019

## INVESTIGATION PHOTOGRAPHS

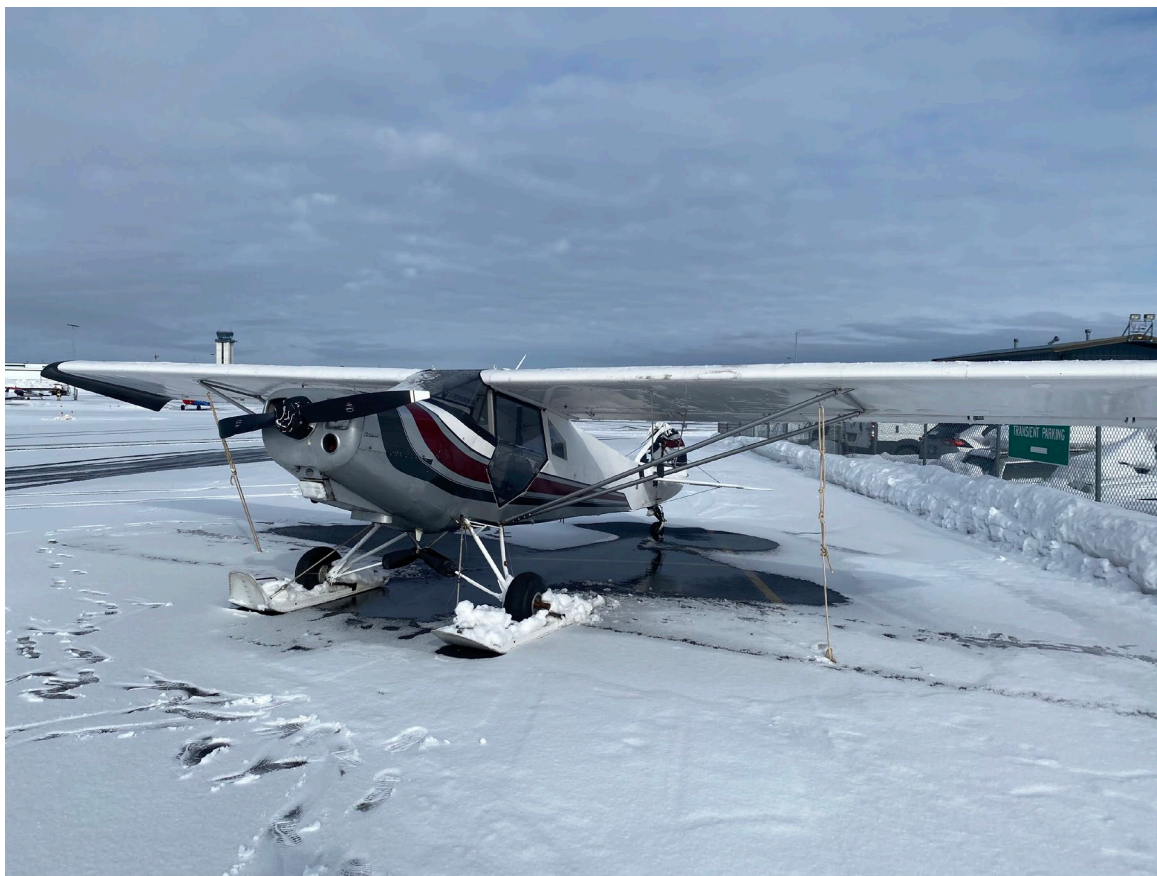
**Photograph 1 - View of aircraft post recovery (Courtesy of owner)**

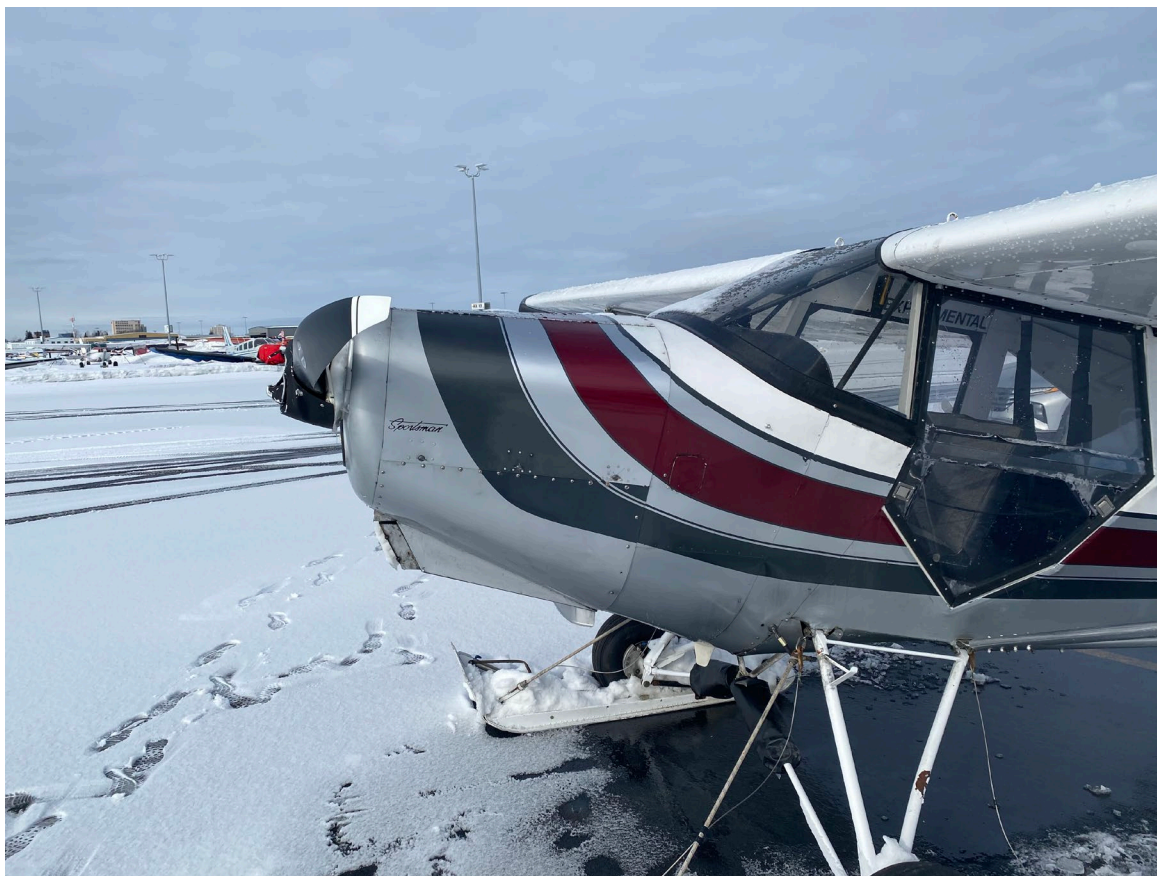
**Photograph 2 - Left hand view of accident aircraft after recovery (Courtesy of owner)**

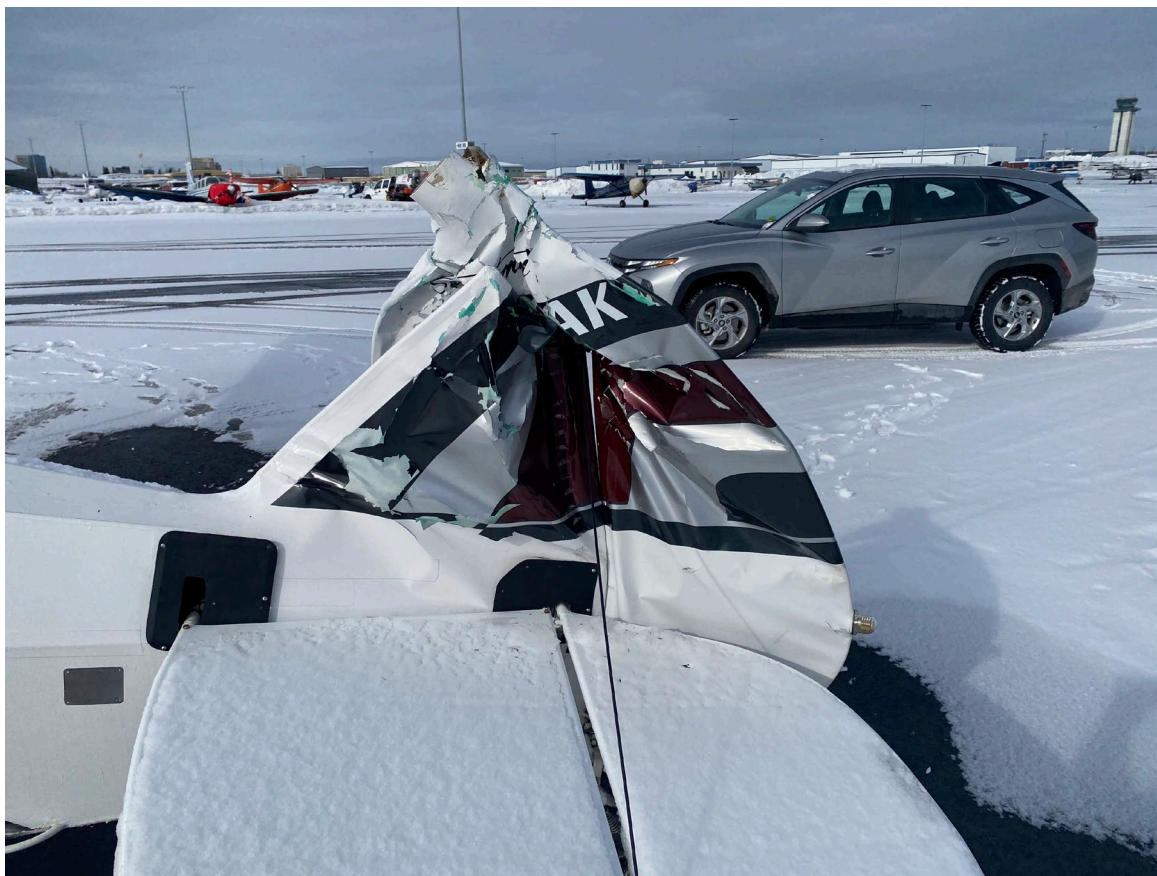
**Photograph 4 - Left side of Tail of aircraft after recovery (Courtesy of Owner)**
