# National Transportation Safety Board

ANC24LA025

## **ENGINE EXAMINATION**

Airplane: Cessna 120 N77032

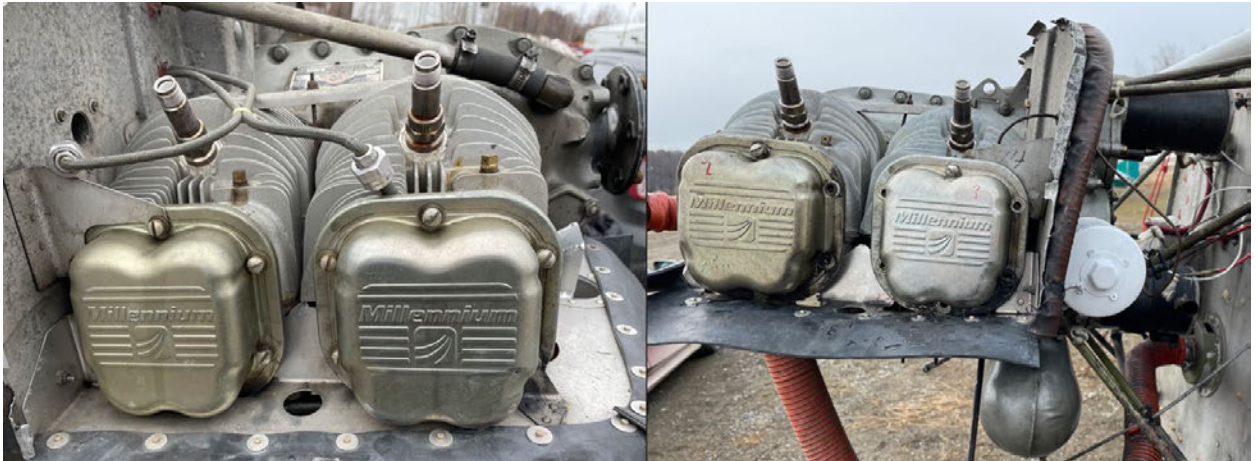
**Figure 1 Left and right side of the engine.**

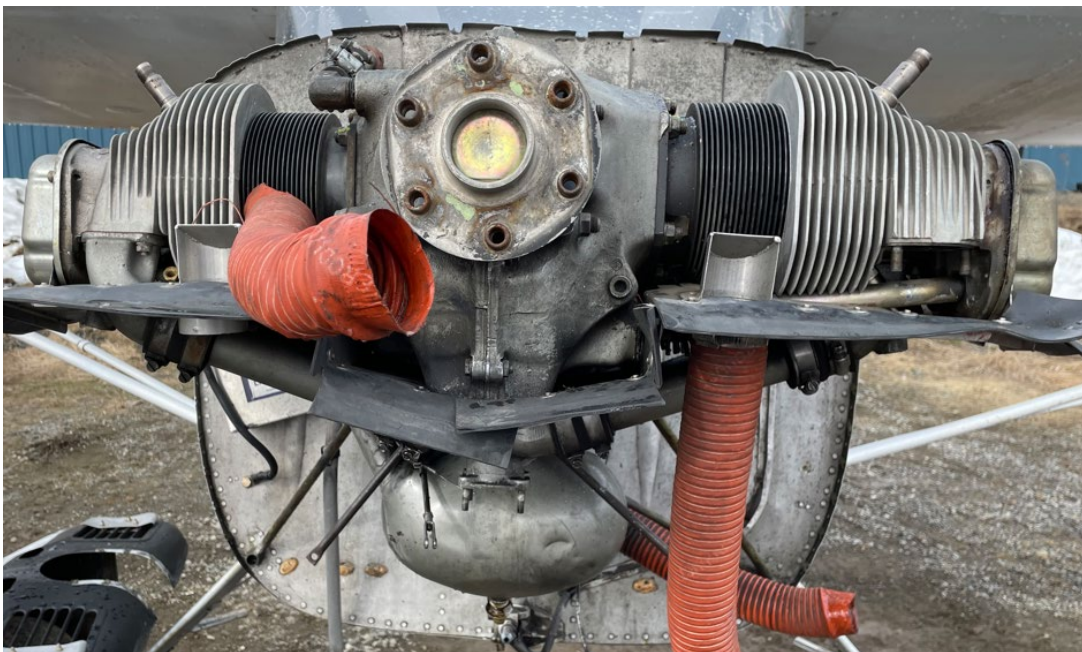
**Figure 2 Front view of the engine.**

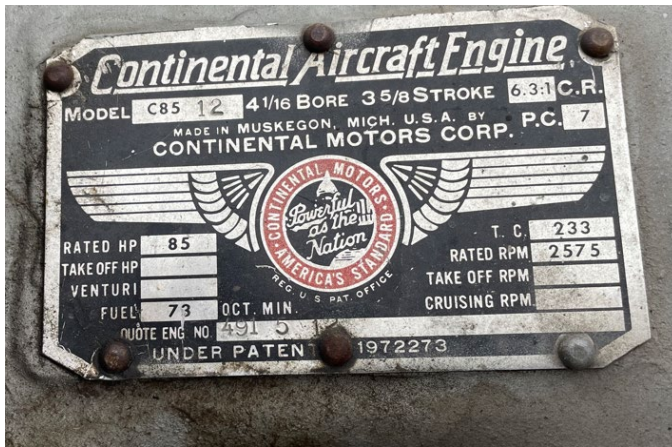
The engine is a Continental Aircraft engine, Model C85, S/N 4915-12 (Figure 3)

**Figure 3 View of data tag on top of the engine.**

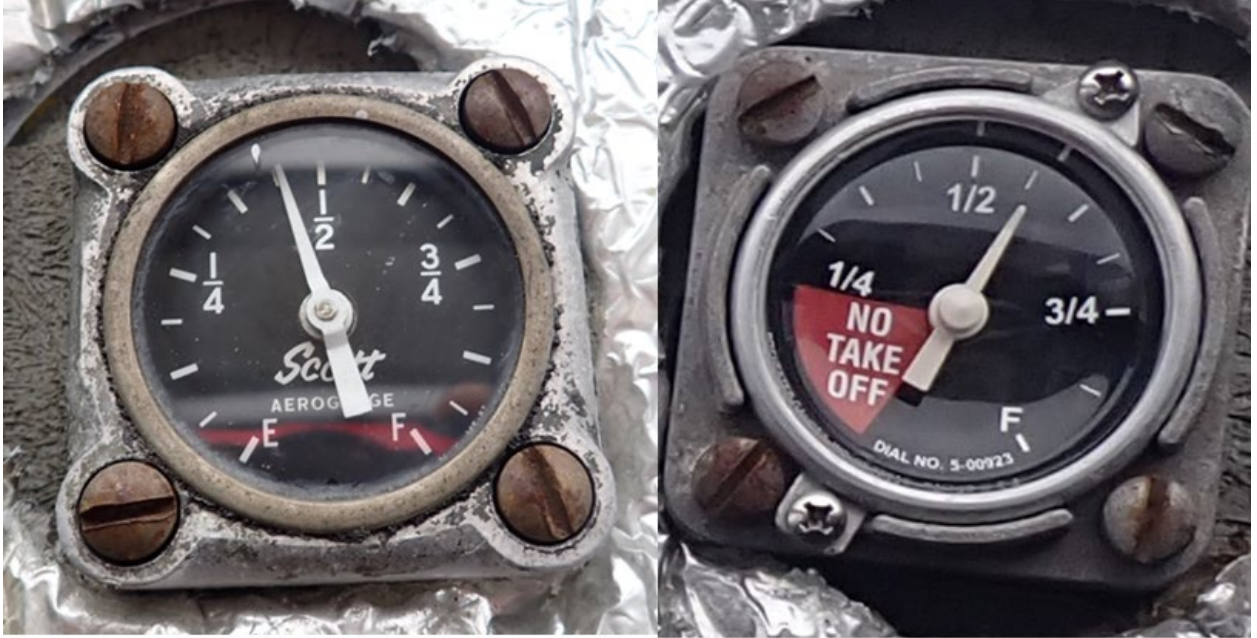
The owner verified that the airplane had 6 gallons of fuel in each wing before takeoff. During the engine examination the left wing fuel tank indicated just under a half tank and the right wing fuel tank was just over a half of tank (Figure 5).

**Figure 5 View of the left and right fuel level indicator from inside the cockpit.**

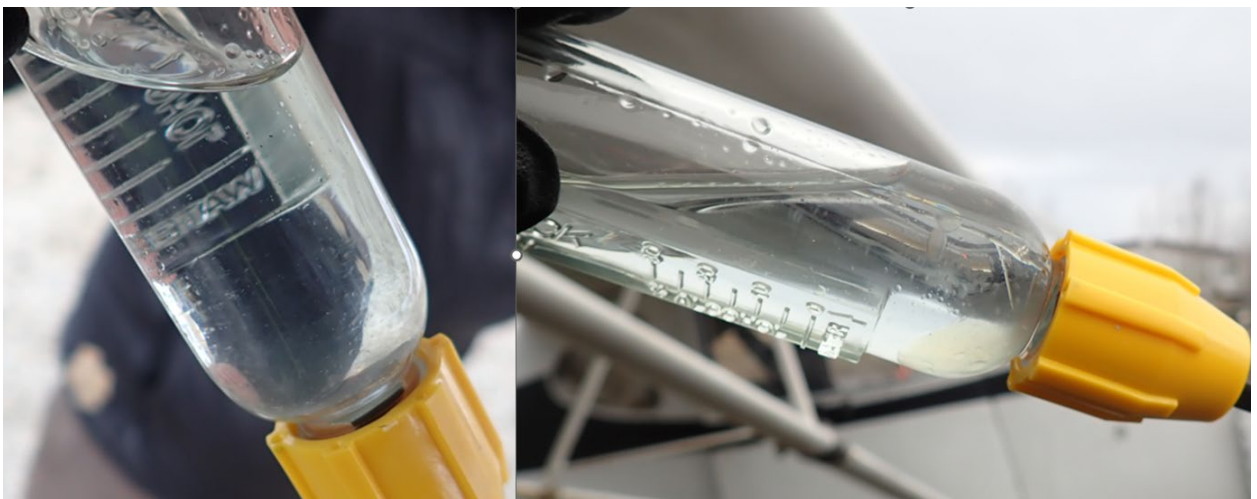
Fuel was collected from each wing tank's fuel sump drain valve. No water was observed in the fuel drained from the left fuel tank. A small amount of water was observed in the fuel drained from the right fuel tank (Figure 6). Before the engine examination the owner retold the events leading up to the accident. He stated he had found a small amount of water when sumping the right side wing fuel tank and that it was typical for this airplane to collect a small amount after sitting outside.

**Figure 6 view of fuel collected from the left and right fuel tank.**

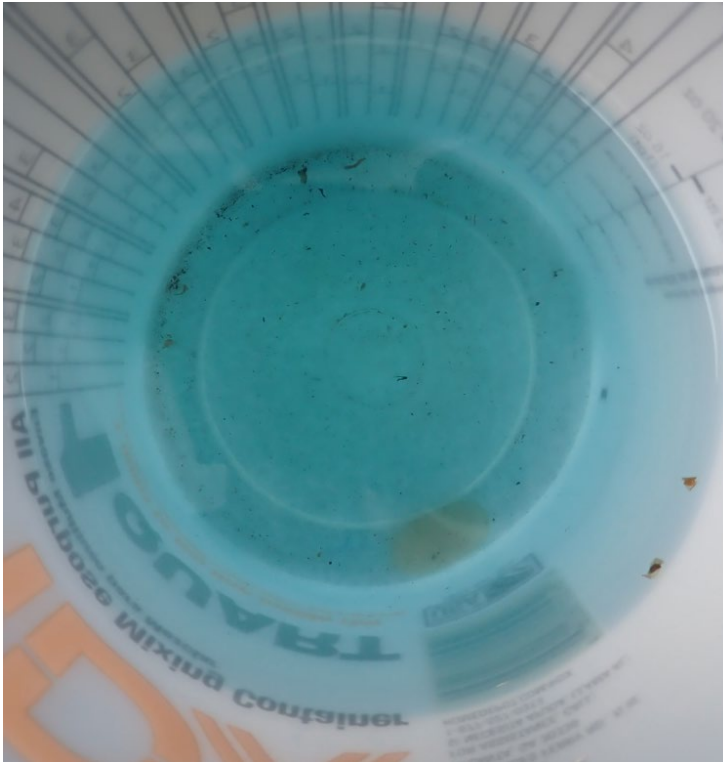
The gascolator was drained of fuel. A small amount of water was observed with a few particles of dirt (Figure 7). The gascolator screen was free of obstructions (Figure 8).

**Figure 7 View of fuel collected from the gascolator.**

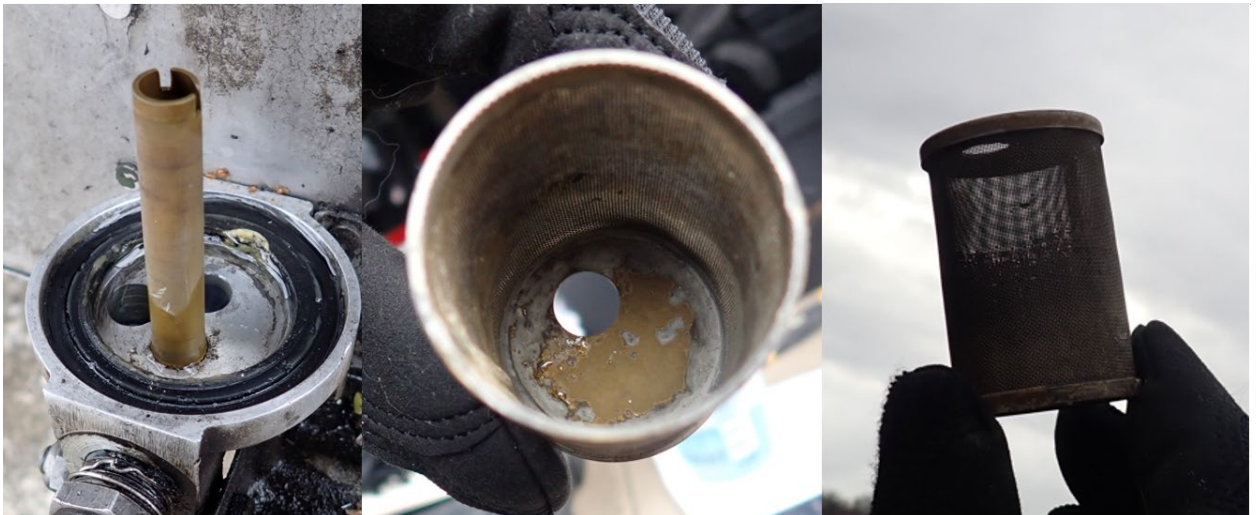
**Figure 8 View of the gascolator mount and screen.**

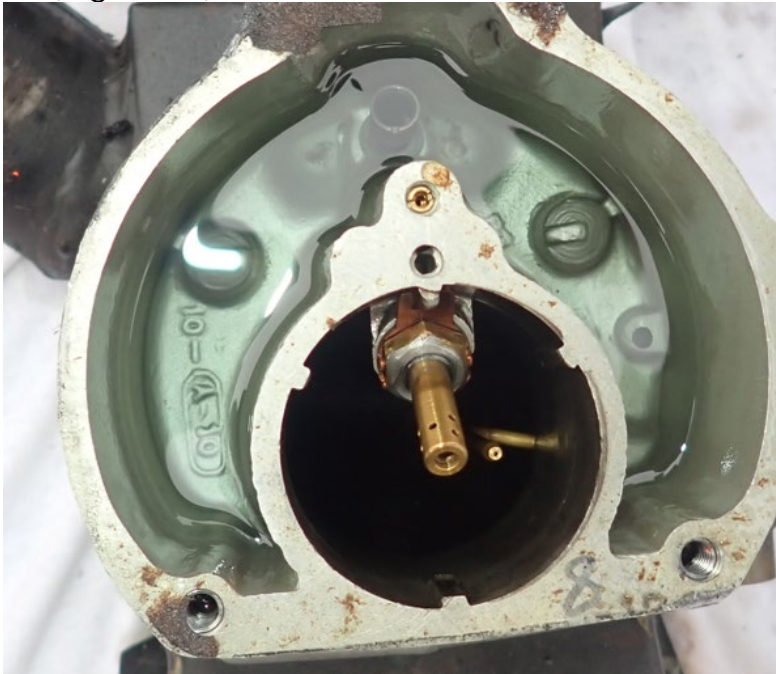
**Figure 9 View looking down into the carburetor bowl.**

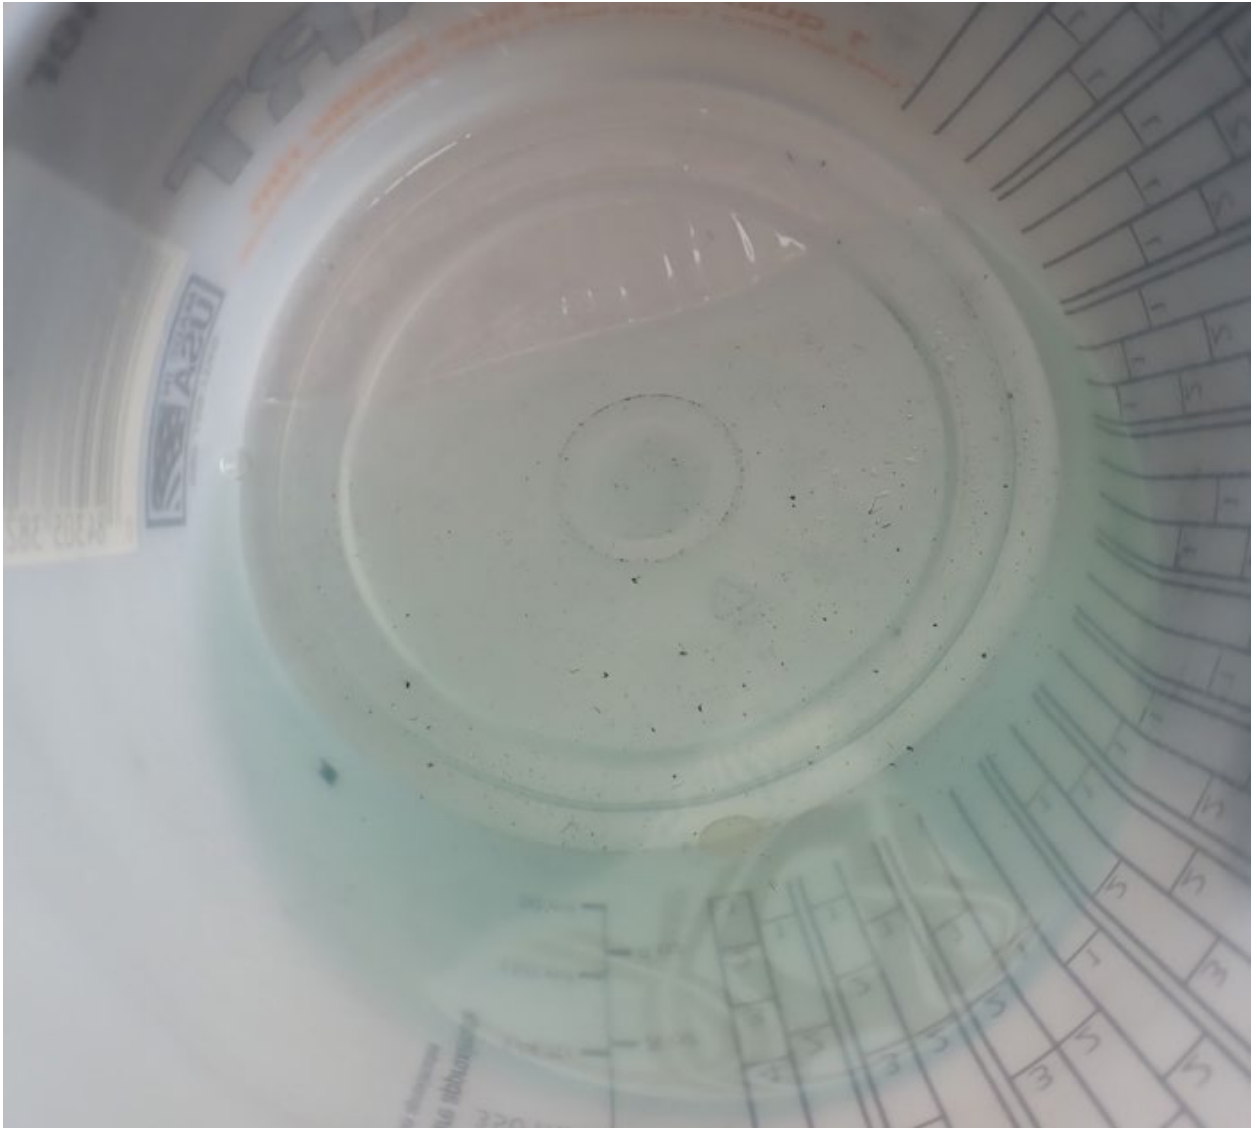
A very small amount of water was observed in the carburetor bowl (Figure 10). The last chance inline fuel filter screen was clean, and no obstructions were observed (Figure 11). The carburetor float was in good condition, no damage to the float was observed (Figure 12).

**Figure 10 Fuel collected from the carburetor bowl.**

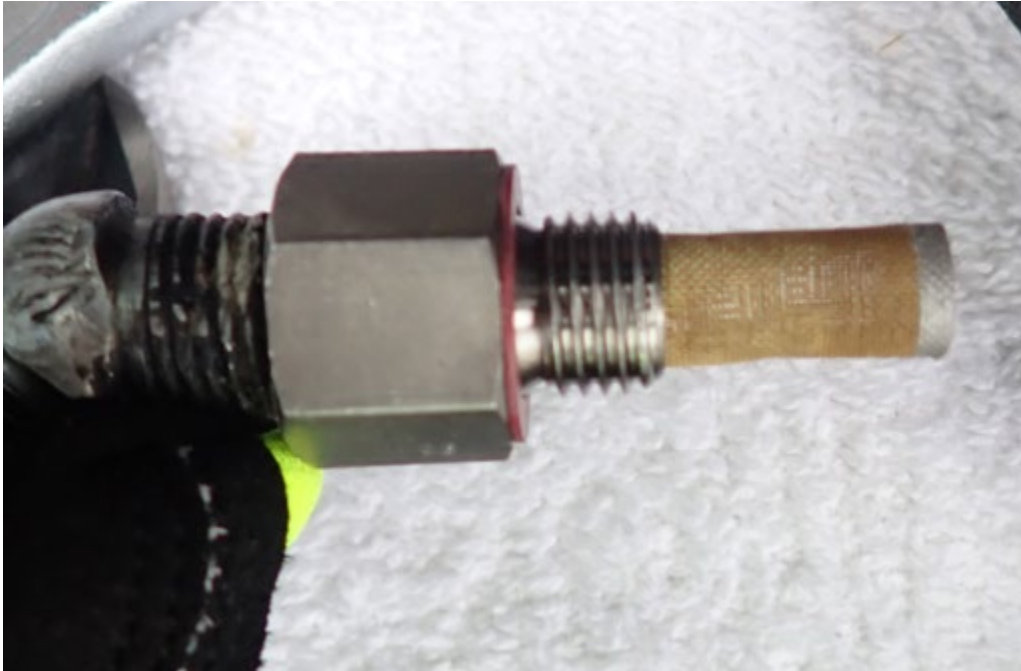
**Figure 11 View of the last chance fuel screen into the carburetor.**

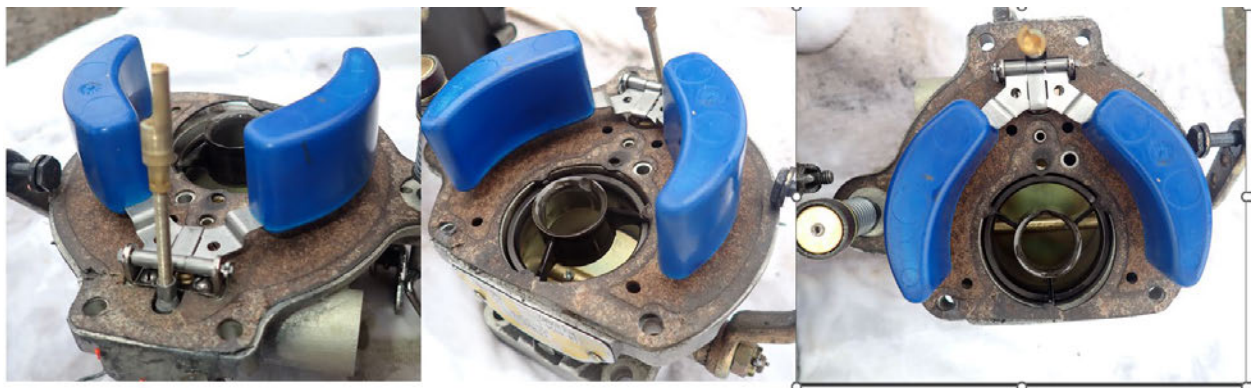
**Figure 12 View of the carburetor float assembly.**

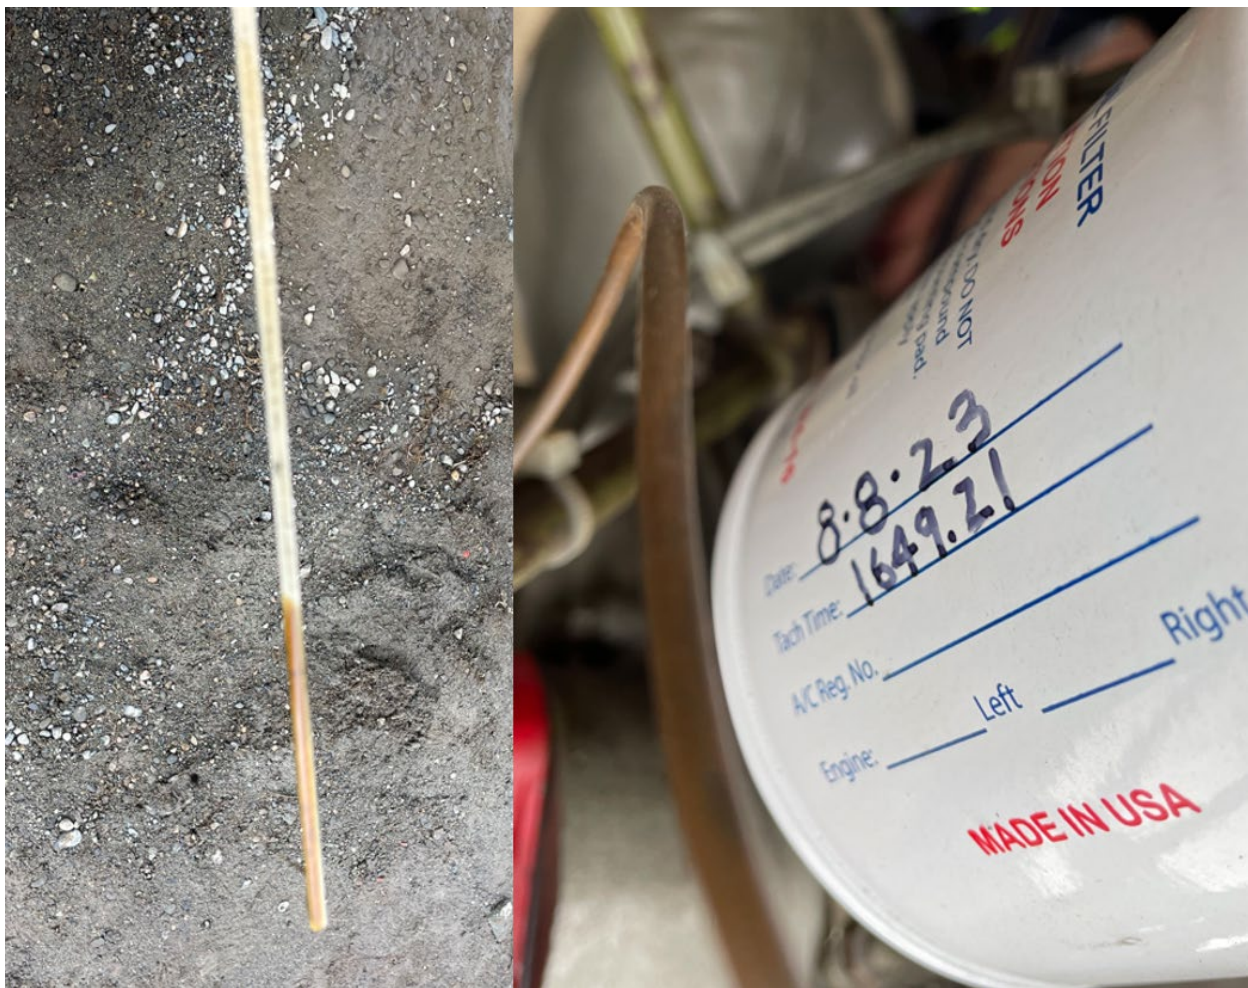
Engine oil level was good (Figure 13), the total time of the airplane is 1695.01. The last oil filter change was performed at 1649.21 aircraft hours (Figure 13).

**Figure 13 View of the engine dip stick and remote oil filter.**

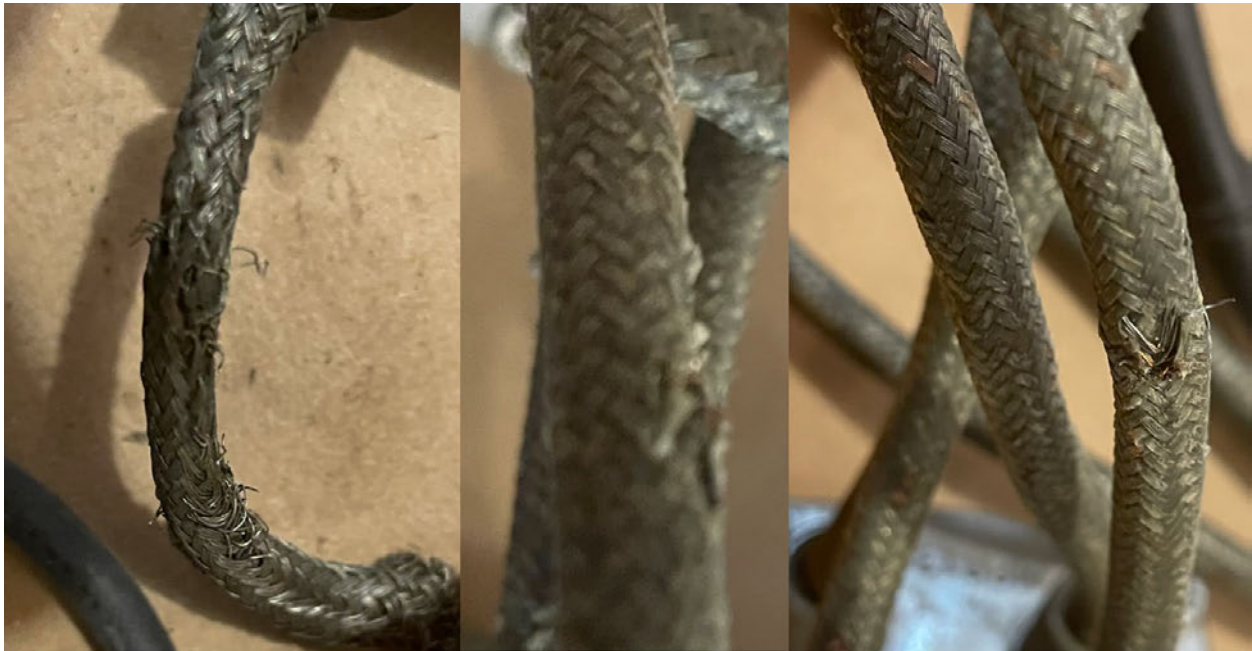
All high-tension sparkplug wires were securely fastened from the magnetos to the sparkplugs. The high-tension sparkplug wires had numerous spots along the shielding of excessive wear (Figure 14). Wire resistance was the same on all high-tension wires except for the wires going to the top number two and four sparkplugs, those wires had a higher resistance. The wires were tested in a cable tester. All high-tension sparkplug wires tested good except for the wires to the bottom number two and four cylinders. The number two tested good only after moving the wires around. When testing the number four wire you could hear a wire shorting out in or near the magneto.

**Figure 14 View of damage to the high-tension sparkplug lead wires.**

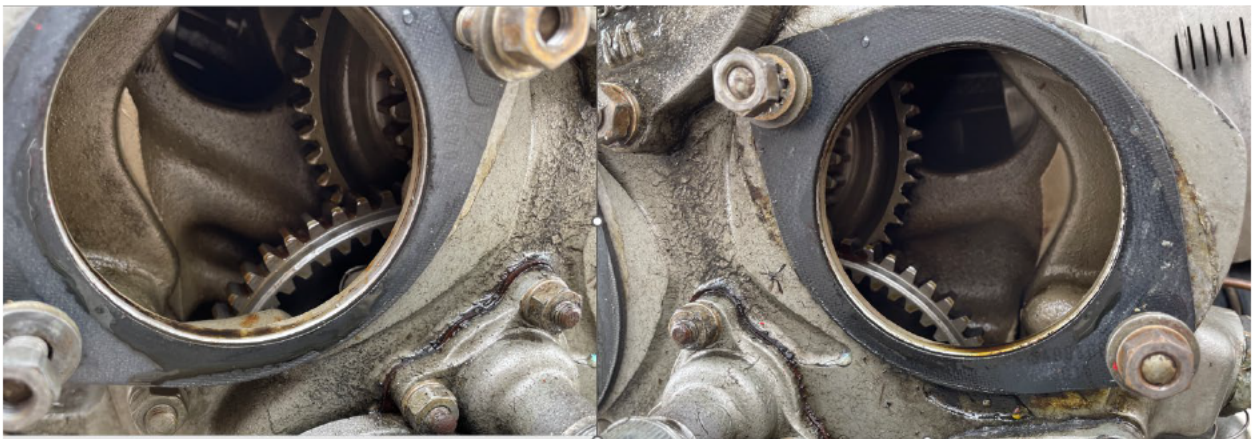
**Figure 18 View into the accessory case after the removal of the magnetos.**

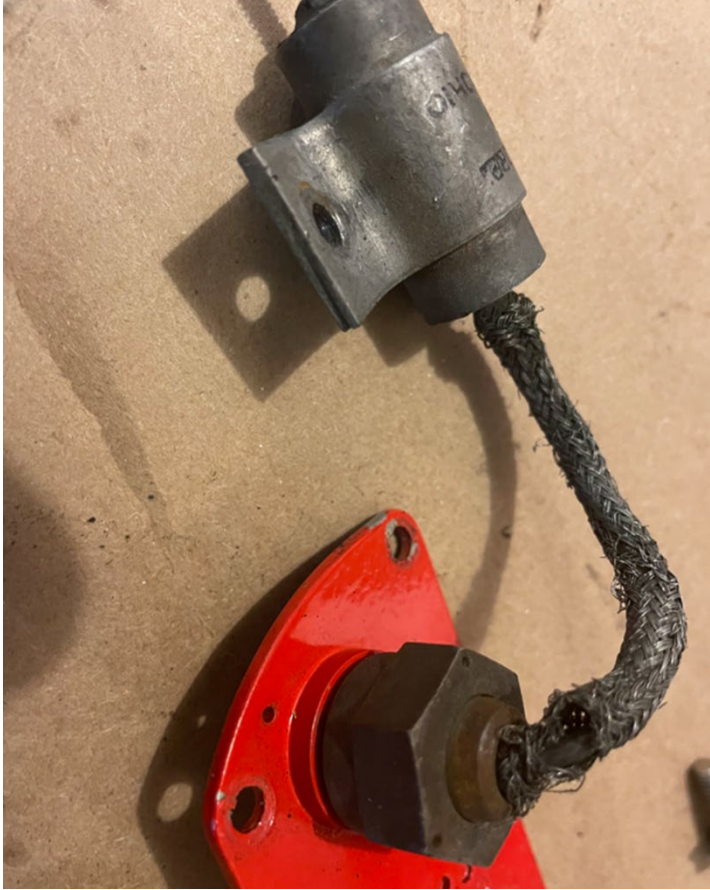
Both magnetos were securely fastened, and timing was about 30° before TDC. The P-lead connection into the back of the left side magneto was loose and had backed out about four full turns, the right magneto connection had backed out about a half a turn. The p-lead grounds were disconnected from both magnetos and the main crank shaft was rotated and only one sparkplug lead on the top left side would intermittently produce a weak spark. The magnetos were removed and benched tested. When directly spinning the magnetos, all leads produced strong spark except for wire leads to the top sparkplug in cylinder four(T4) and to the bottom leads in cylinder two(B2) and four(B4). The spark produced to T4, B2 and B4 was very weak and difficult to see.

**Figure 19 view of wire damage to the P-lead connection into the back of the left magneto.**

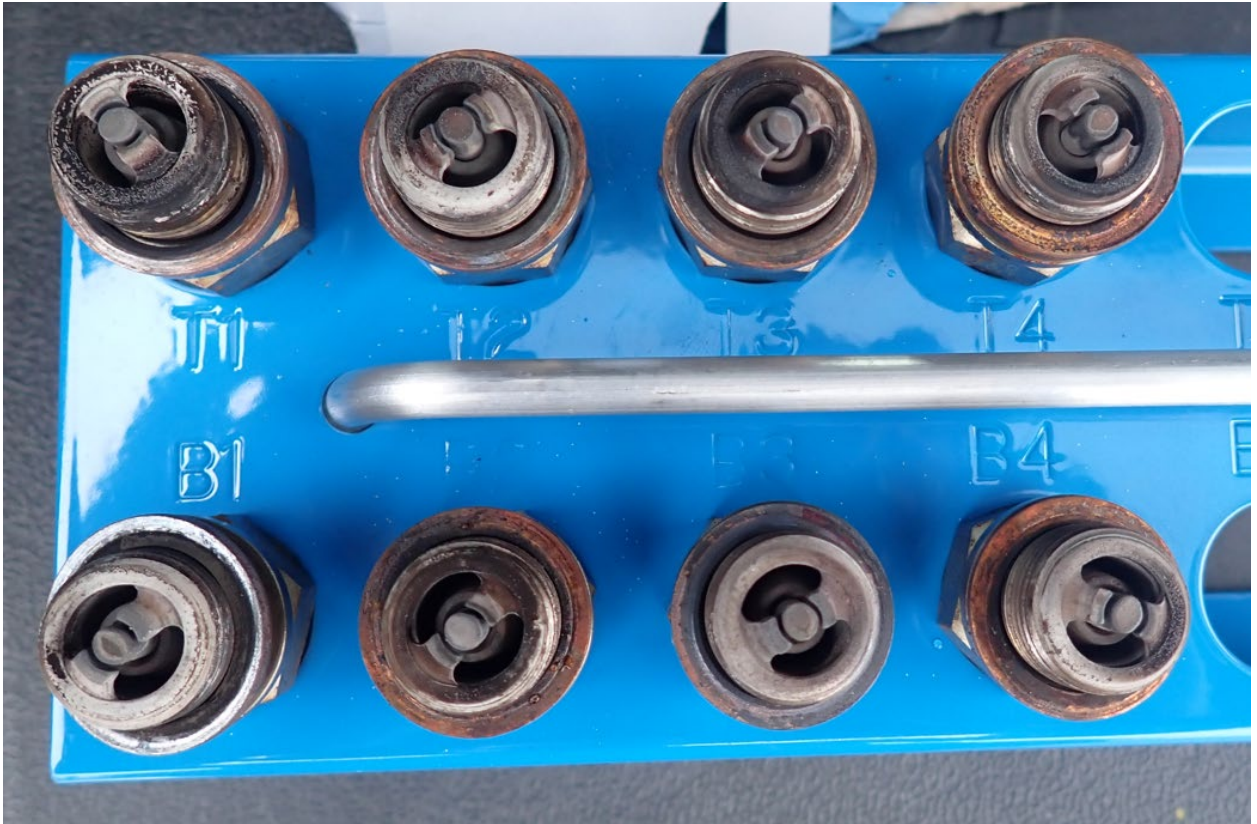
All sparkplugs except the bottom sparkplug to the number 4 cylinder were securely installed. The number four sparkplug was about halfway backed out of the cylinder. The sparkplugs were removed. Using the Champion aviation check-a-plug guide. The sparkplugs were in worn out - normal condition (Figure 20). Electrodes showed normal erosion, ground electrodes about half original thickness. The bottom sparkplugs to cylinders one and four had excessive gaps between the ground electrode and the center electrode and top sparkplugs to cylinders one, three and four had excessive gaps between the ground electrode and the center electrode.

**Figure 20 View of sparkplugs removed from the engine.**

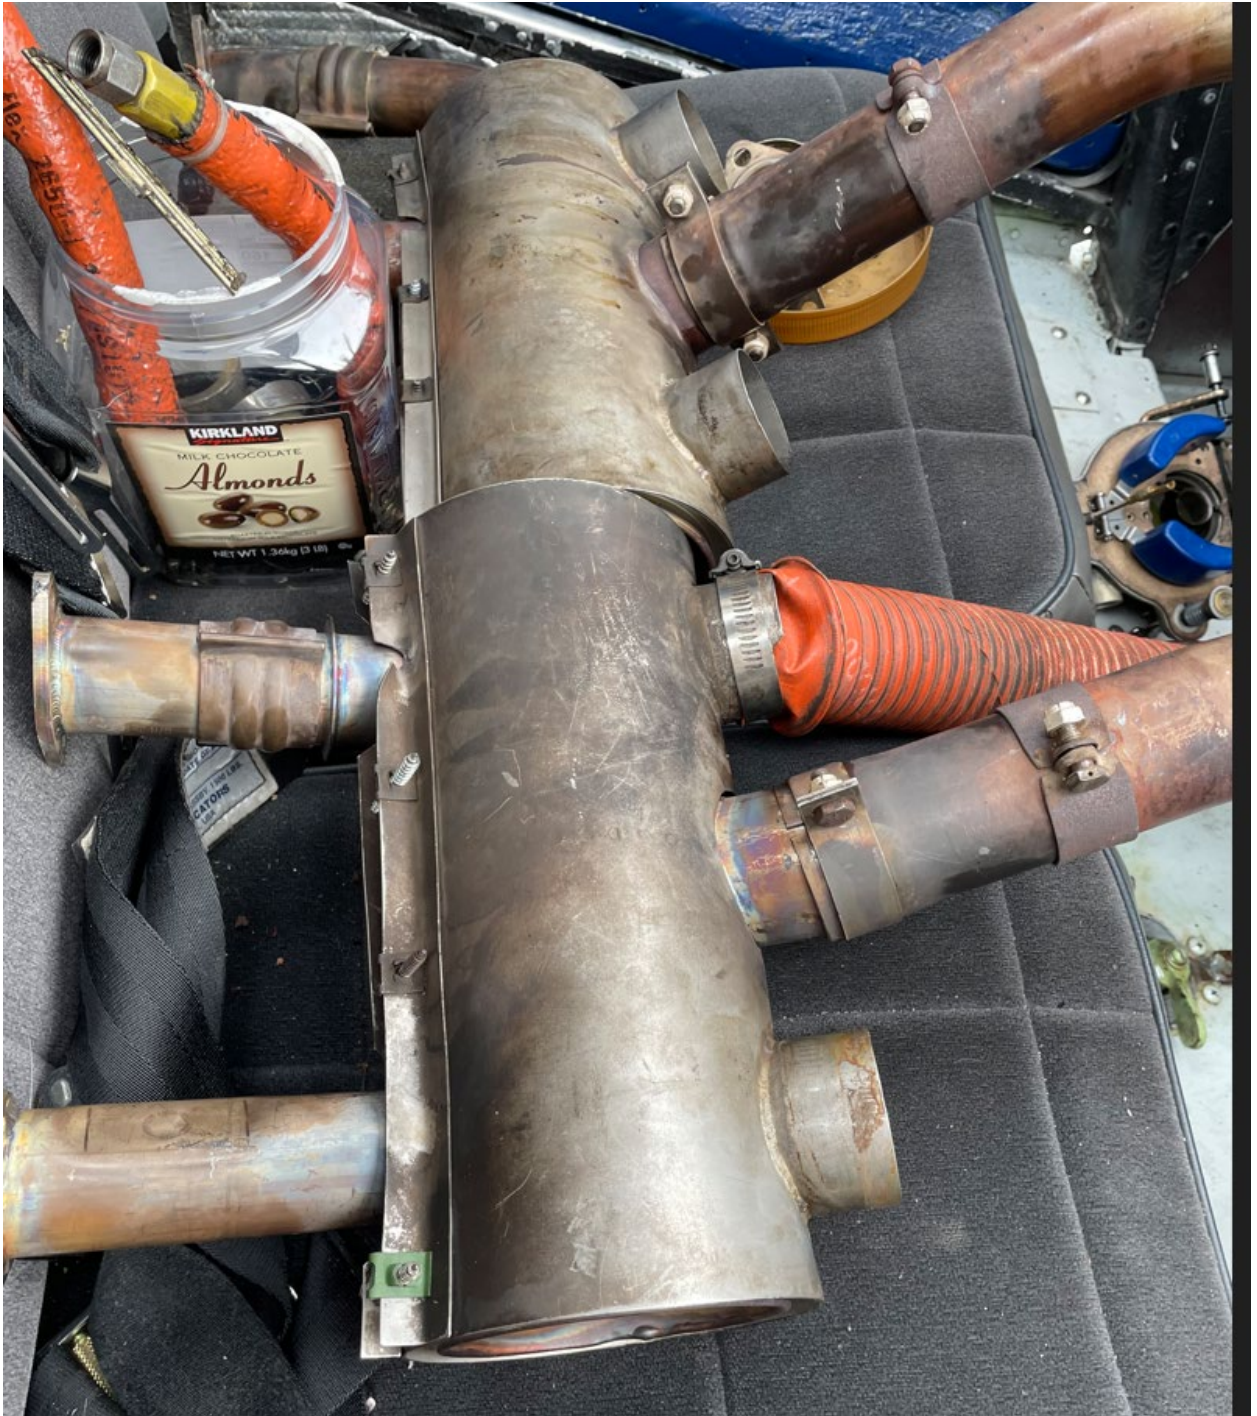
Air inlet screen to the carburetor heat box was removed and no obstruction in the screen or air intake to the carburetor were observed. The exhaust collectors were removed, and no obstructions were observed in the exhaust collectors or mufflers (figure 21).

**Figure 21 Left and right exhaust collectors and mufflers.**

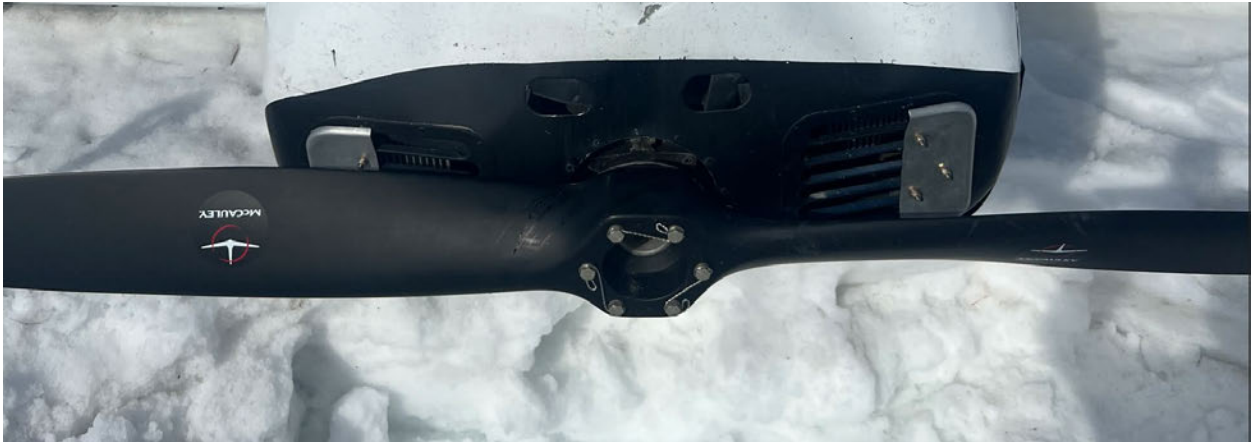
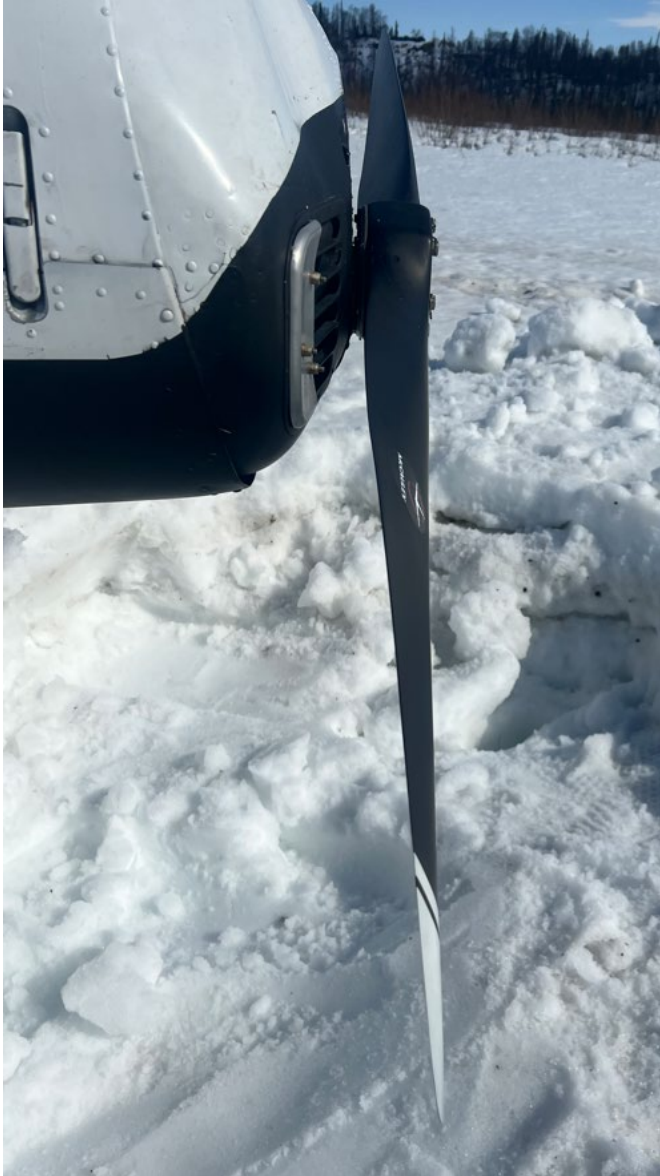
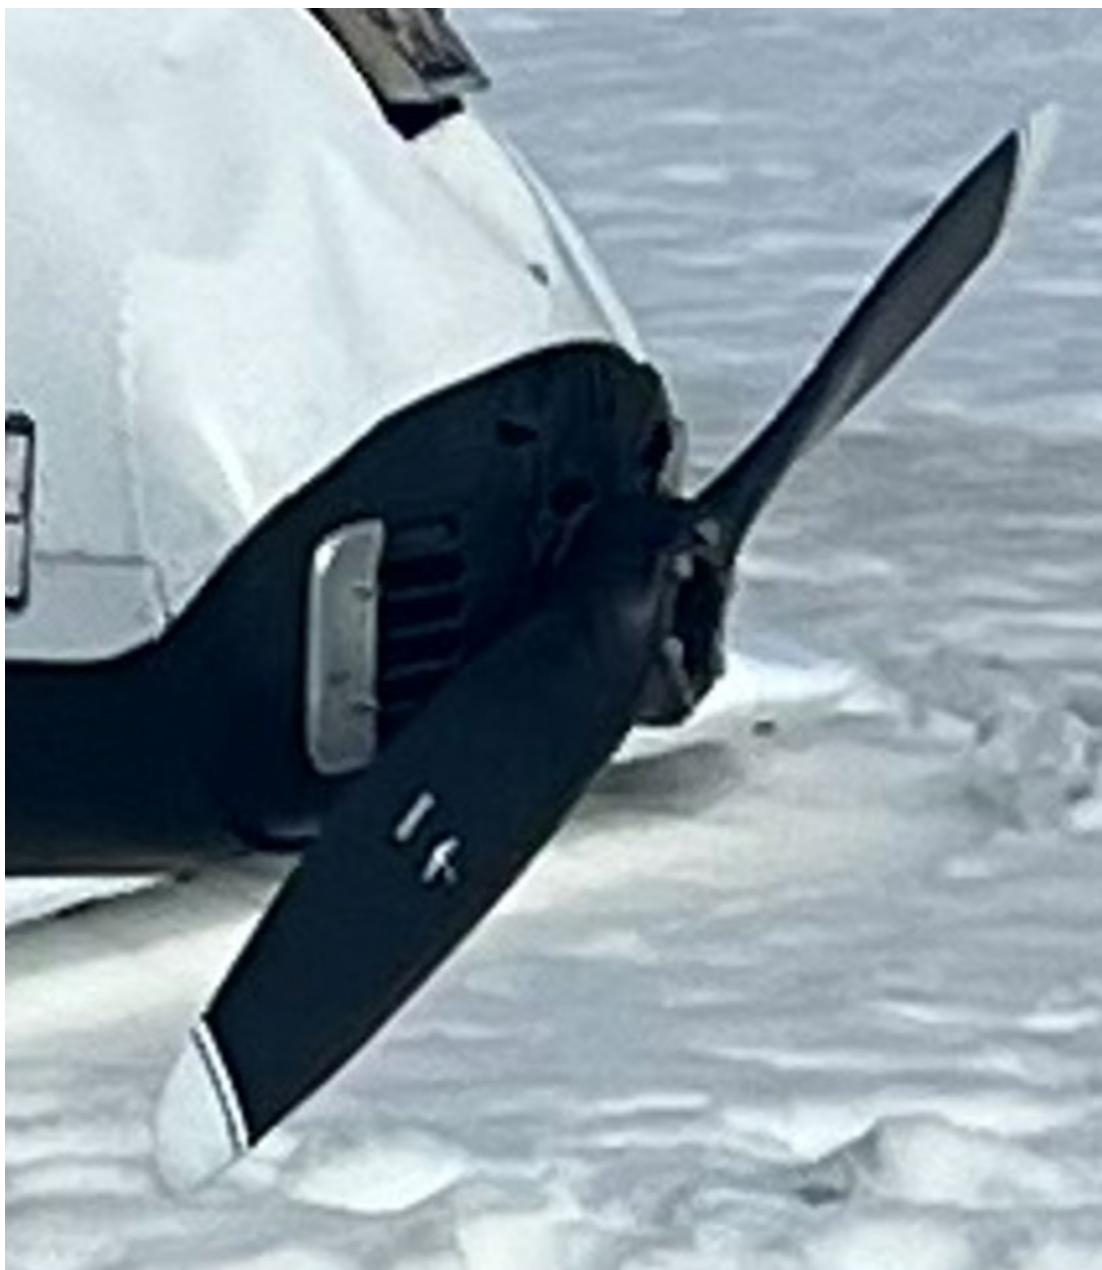
The propeller was removed to prevent damage during recovery. The mechanic and owner provided the below pictures of the propeller before removal. The propeller was not available during the engine examination. The owner's mechanic during the engine examination stated that the propeller was undamaged with no signs of rotational damage and believes the engine had quit before the airplane nosed over in the snow (Figure 22-24).

**Figure 22 View of propeller at the accident site, photo provided by owner's mechanic.**

**Figure 23 View of propeller at the accident site, photo provided by owner's mechanic.**

**Figure 24 View of propeller at the accident site, photo provided by owner's mechanic.**

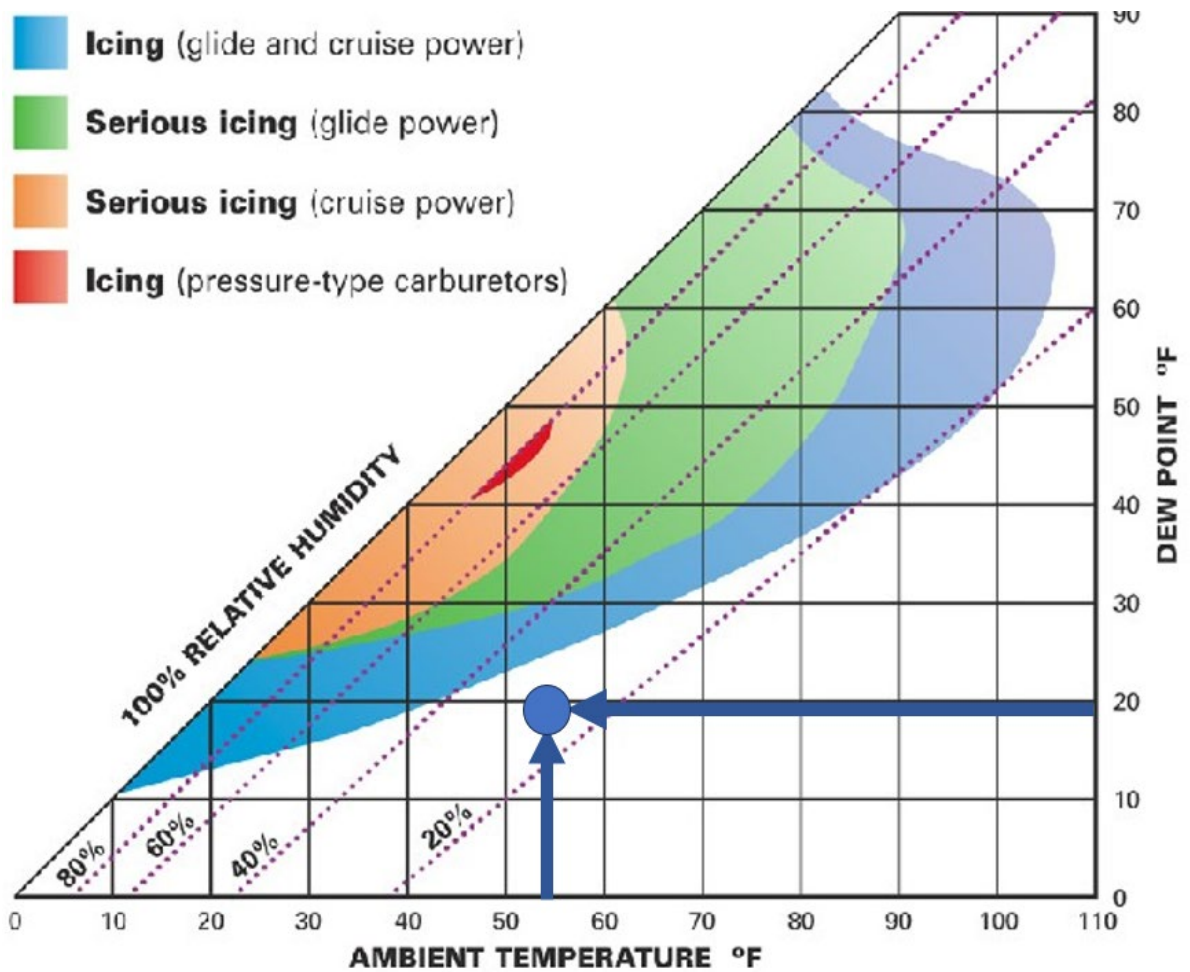
Talkeetna weather facility reported at 14:53 local time temperature of 53.6F with a dew point of 19.4F. Talkeetna METAR PATK 212253Z 28003KT 10SM CLR 12/M07 A2983 RMK AO2 SLP105 T01171067. The environment conditions were outside the carburetor icing probability chart for carburetor icing (Figure 25).

**Figure 25 Carburetor icing probability chart**
