# National Transportation Safety Board

ANC24LA027

## **ENGINE EXAM**

Location: Marana, AZ  
Date: April 19th, 2024  
Time: 12:30 Local  
Airplane: Piper PA 28-151, N4399X

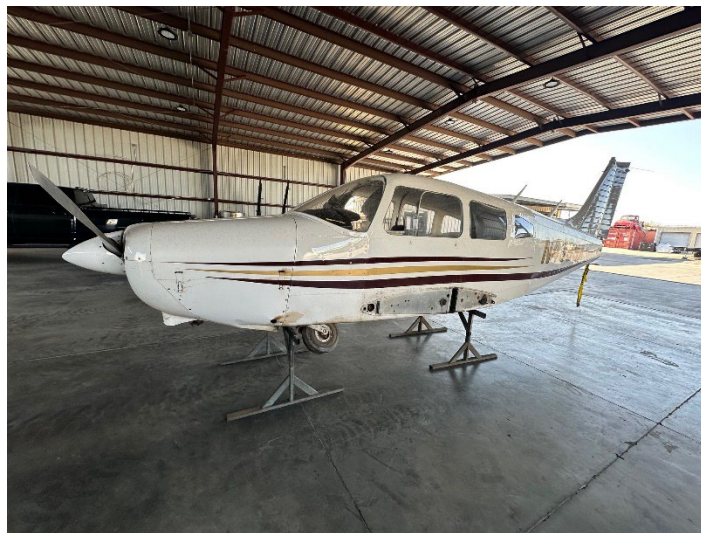
The airplane was presented without the wings and mounted on a stand (figure 1). The airframe was intact, the nose wheel had collapsed causing damage to the underbelly. An oil sheen on the belly and leading edge of right step was observed.

**Figure 1** Accident Airplane

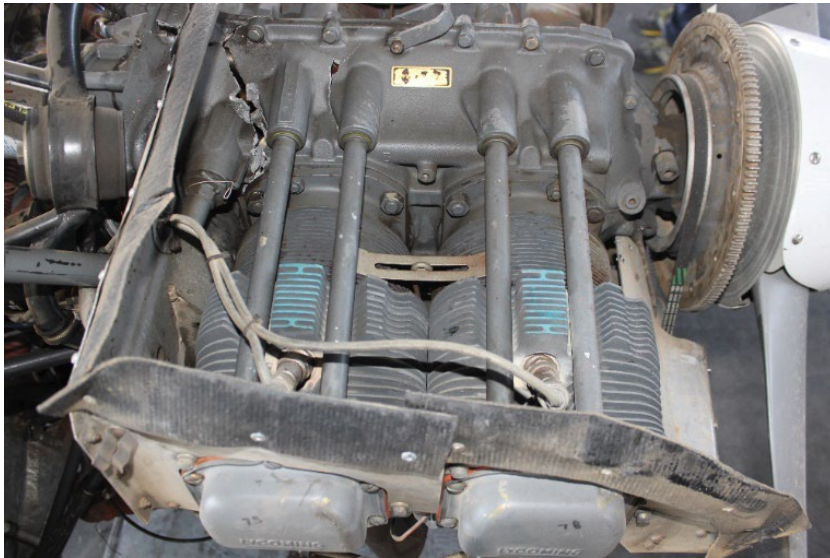
A continuous crack was observed above the number three intake valve tappet casting through the engine case and down through to the sump (figure 2). The right magneto was detached from its mounting flange on the accessory case, and a portion of the mounting flange remained securely clamped to the case.

**Figure 2** Crack in crank case beginning near the top of cylinder #3

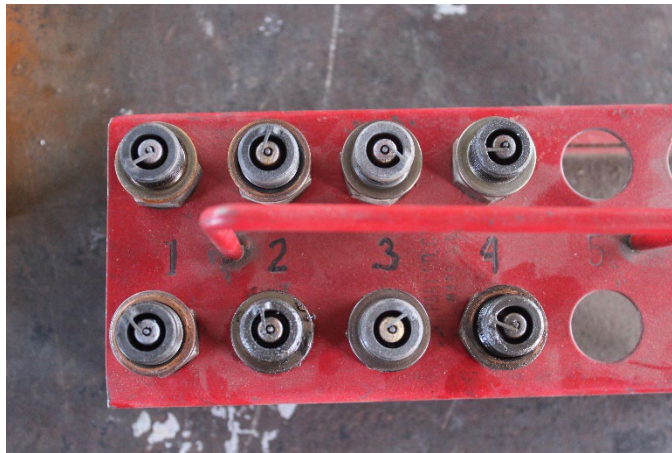
The Tempest (UREM38S) fine wire spark plugs were removed (the number four top spark plug could be loosened by hand); the plugs were mechanically intact. All electrodes were covered in grey deposits and had normal wear signatures when compared to the Champion Check-A-Plug AV-27 chart. The lower number two and four spark plugs were oil wet (figure 3).

**Figure 3** Spark Plugs from accident airplane

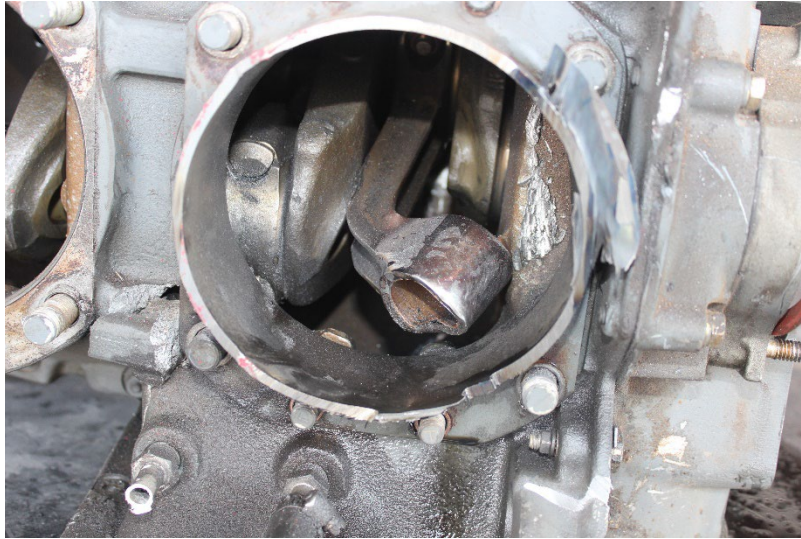
The number four cylinder connecting rod was bent approximately 45 degrees at the wrist pin end (figure 4). The connecting rod was continuous. The wrist pin had detached and had become embedded in the lower section of the crankcase (figure 5). The upper portion of the number four cylinder assembly was cut from the crank case. The piston head appeared to be in its full compression stroke travel limit. The entire piston skirt was fragmented down to the piston rings and exhibited gouging damage with remnants of the piston ring boss remaining (figure 6). A section of the wrist pin boss remained, and one side exhibited dull and even granular separation

**Figure 4** Bent Connecting Rod #4 Cylinder

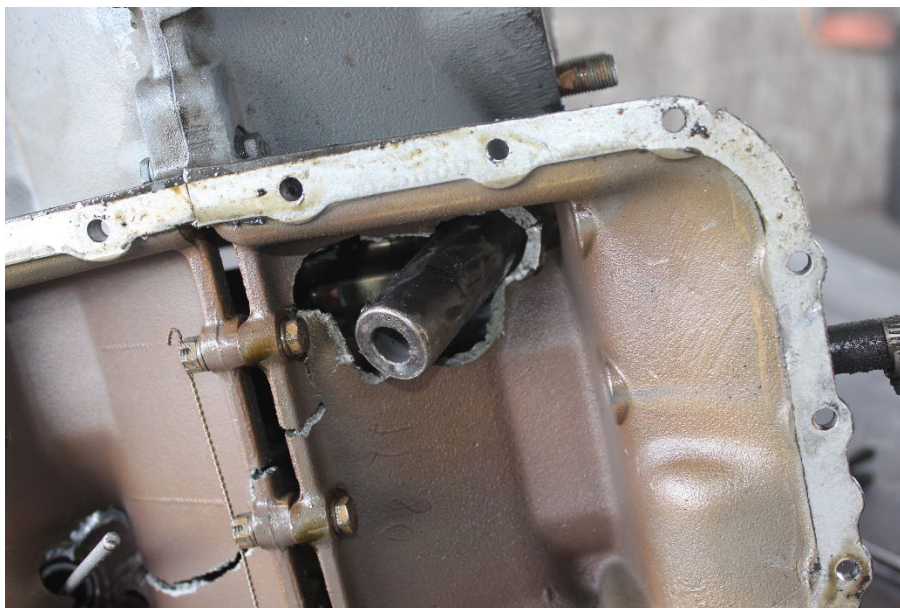
**Figure 5** Wrist pin embedded in lower crank case

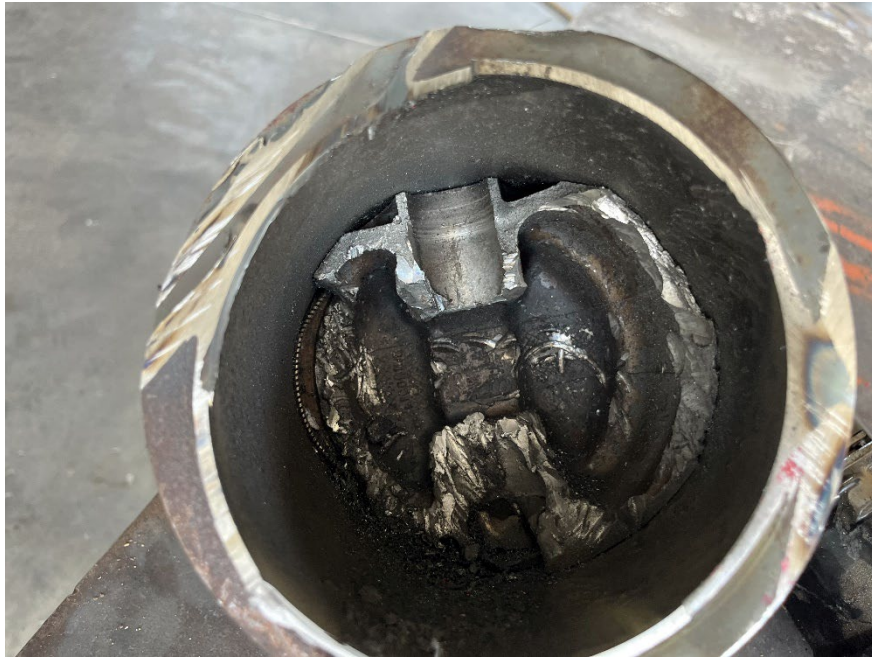
**Figure 6** Cylinder #4 piston skirt and wrist pin boss damage

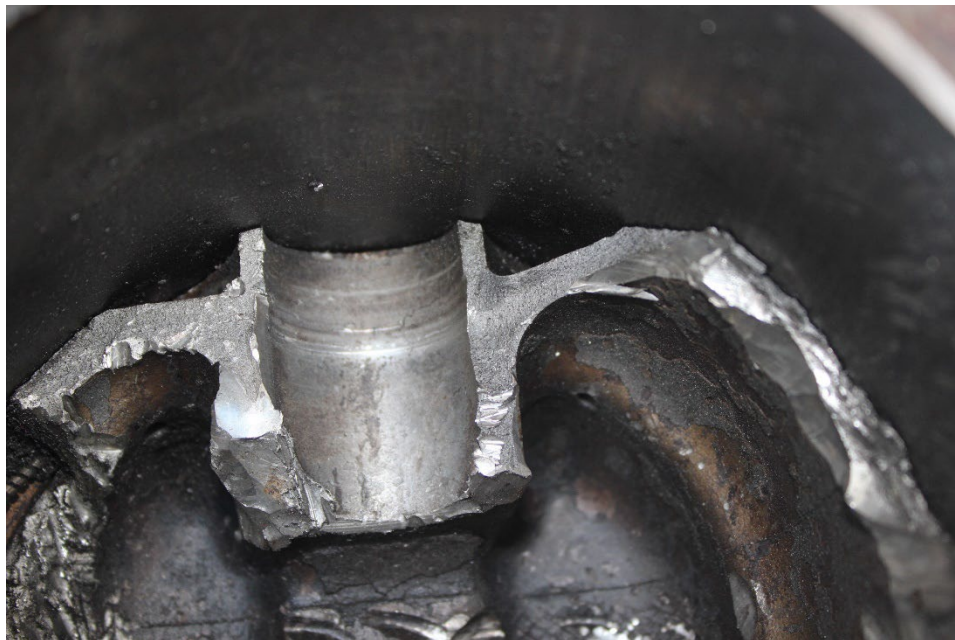
surface features. The other side of the wrist boss exhibited darker discoloration with concentric semicircular granular pattern (figure 7).

The appearance and coloration of the rod was consistent with the other rods in the engine. According to the engine manufacturer representative, the observed bearing surfaces, bushings and subject wrist pin did not exhibit any abnormal wear or heat distress.

**Figure 7** Wrist Pin Boss #4 Cylinder
