# National Transportation Safety Board

ANC24LA027

## **MATERIALS LABORATORY**

Factual Report 24-055

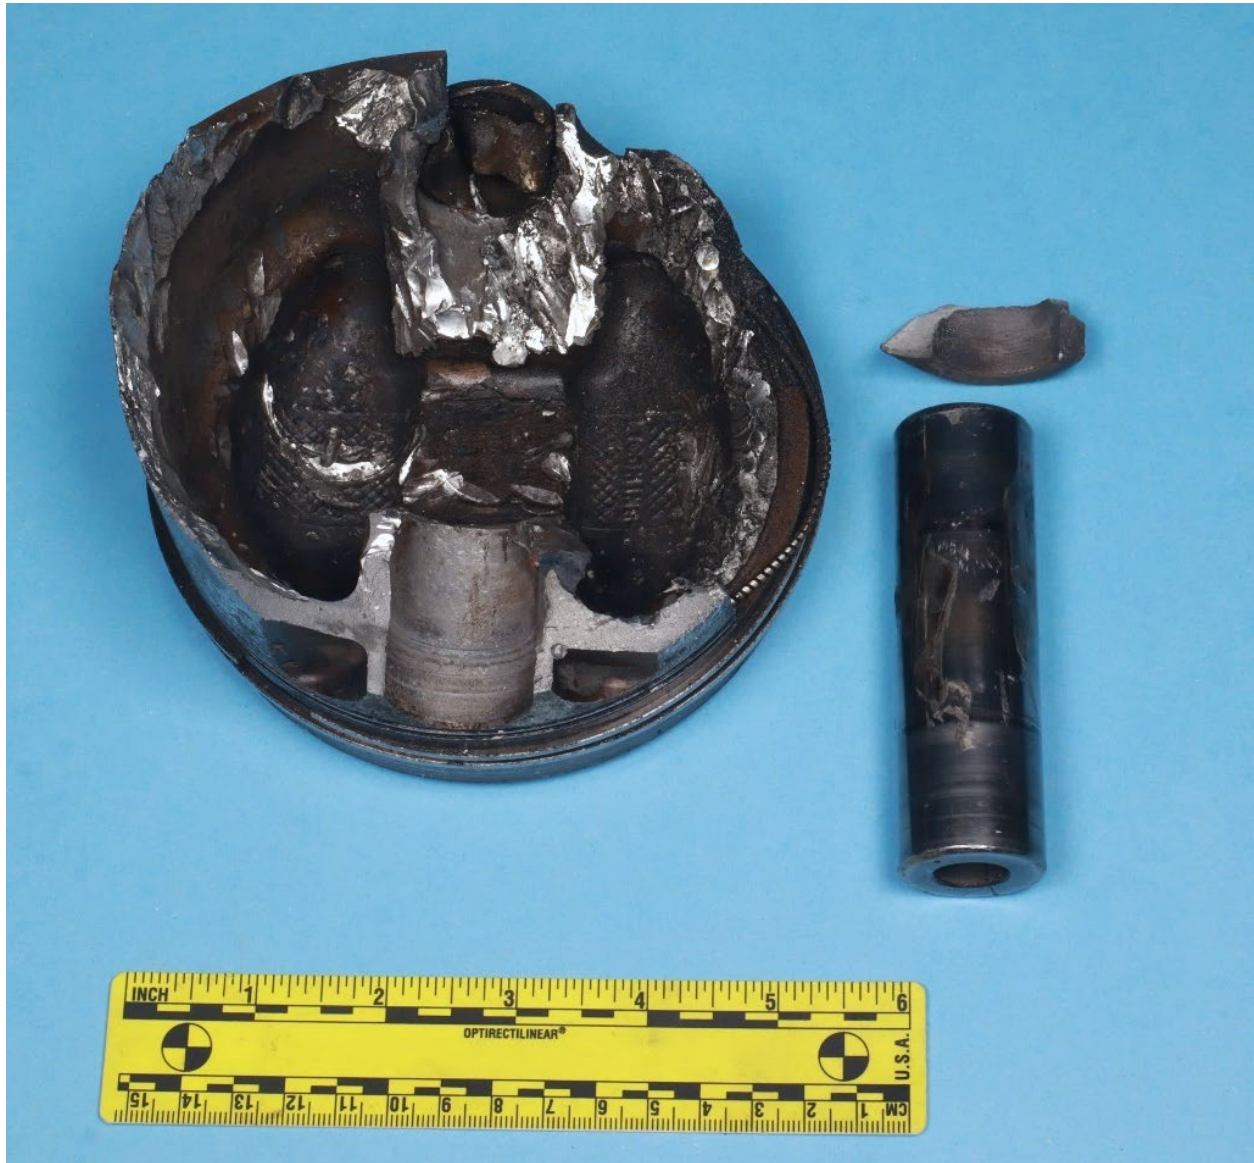
Figure 1 shows the fractured remnants of the piston and pin as received. As described in more detail below, all the components received exhibited features consistent with overstress fracture or cracking.

**Figure 1.** The pieces submitted from the accident, the piston remnants and the piston pin.

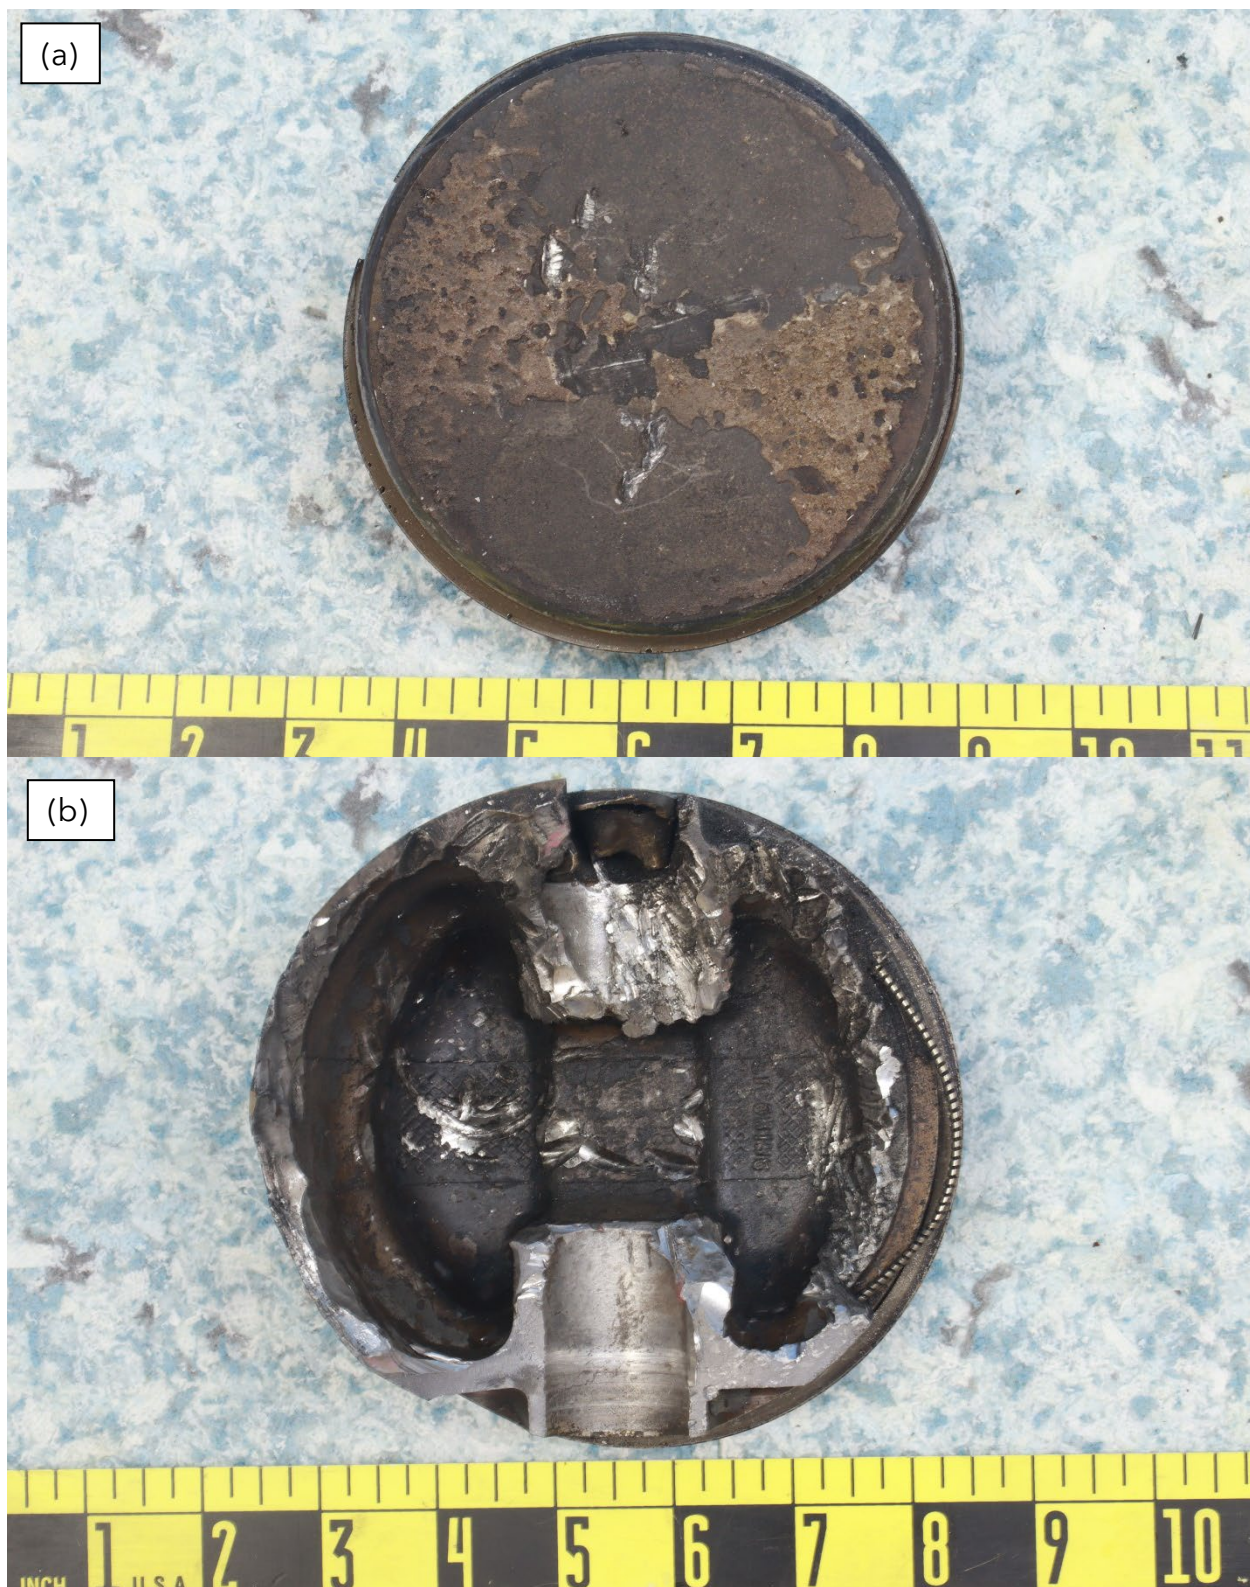
The piston is shown from both the top of the crown and the underside of the skirt in Figure 2. The top of the crown was intact and contained two major areas of tannish-yellow waxy and flaky regions, consistent with the buildup of tetraethyl lead-derived combustion products, typical of avgas fuel.

The skirt on the piston underside exhibited the most damage, with the fracture surfaces demonstrated in Figure 2b, and the damage along the skirt shown from the sides in Figures 3 and 4. Approximately half of the skirt material was missing, with the demarcation of fracture located along the bore containing the pin. The lower third of the fracture surfaces of the piston exhibited discernible fracture features, while the rest exhibited reflective lusters with erratic streaks—these areas were consistent with post-fracture smearing damage from impact or rubbing against adjacent parts. In addition, circular impact witness marks were present on the interior surface of the piston remnant (Figure 2b).

**Figure 2.** Views of the piston remnant from (a) the crown and (b) the underside and skirt, as received.

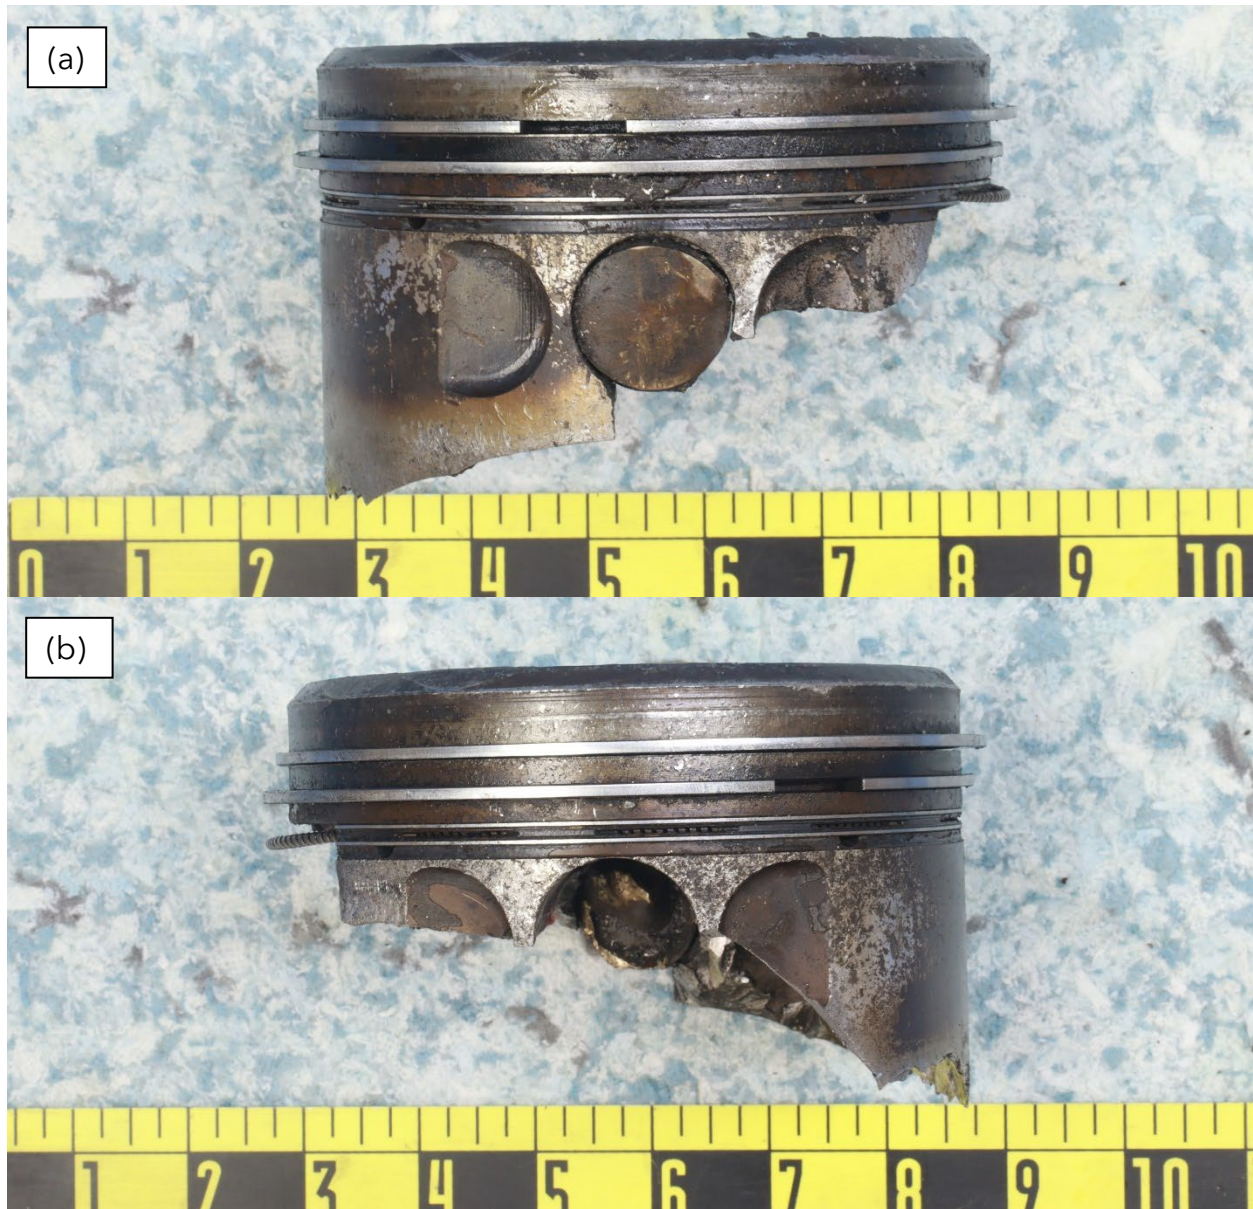
**Figure 3.** Side views of the piston from the pin boss sides showing (a) the side with the cap still in place and (b) the reverse side.

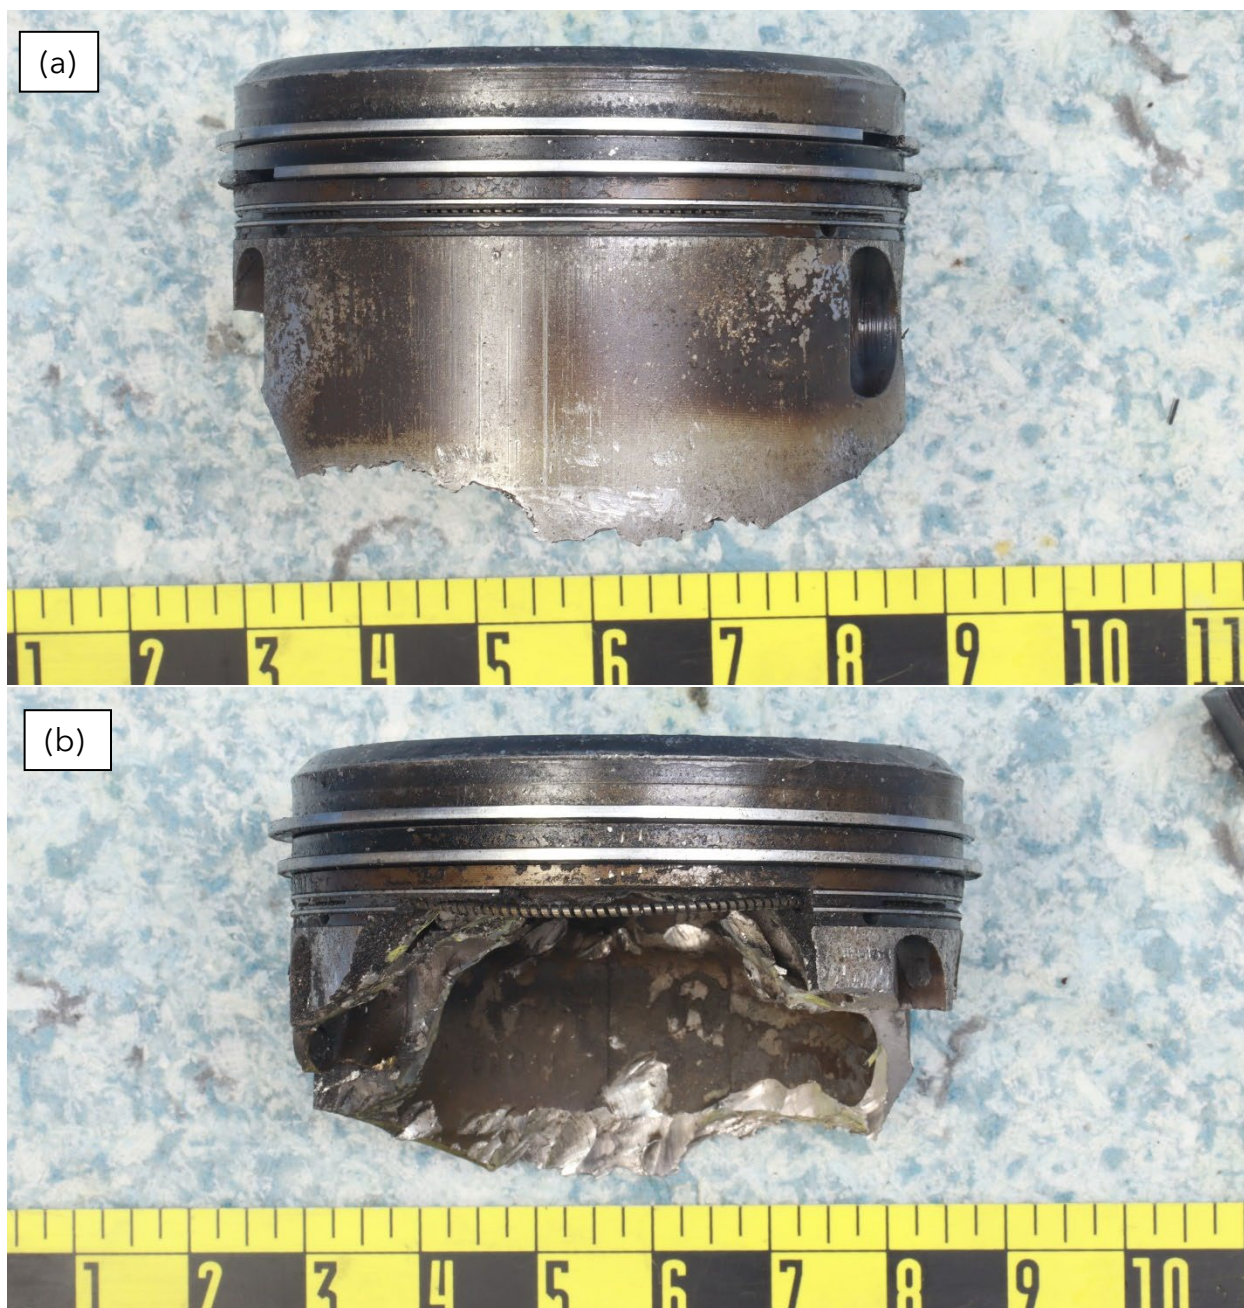
**Figure 4.** Side views of the piston remnant from (a) the longer skirt remnant side and (b) the short side, as received.

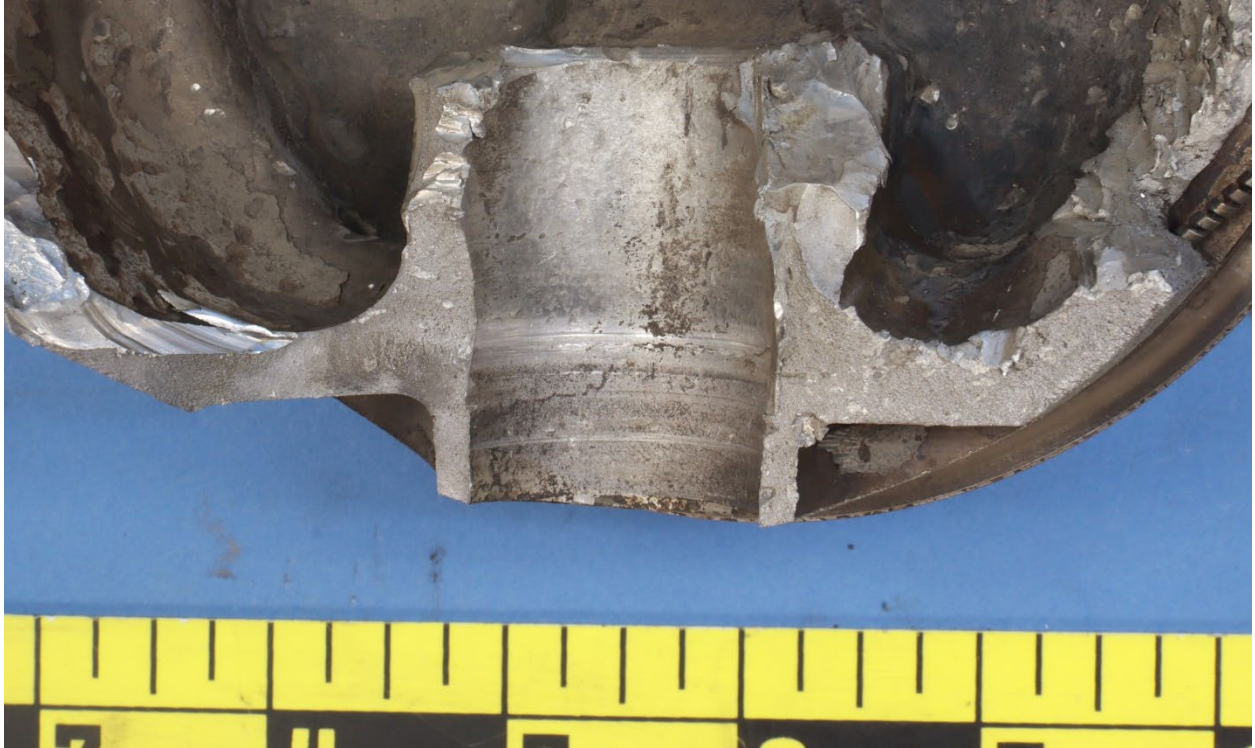
The undamaged areas of the piston fracture surface are highlighted in Figures 5 and 6. As shown from the oblique lighting, the fracture surface in the region in Figure 6 exhibited river patterns consistent with fracture from the outer edges inward on the left side, and from the smeared area along the pin bore on the right side.

**Figure 5.** View of the fracture surface near the pin on the piston.

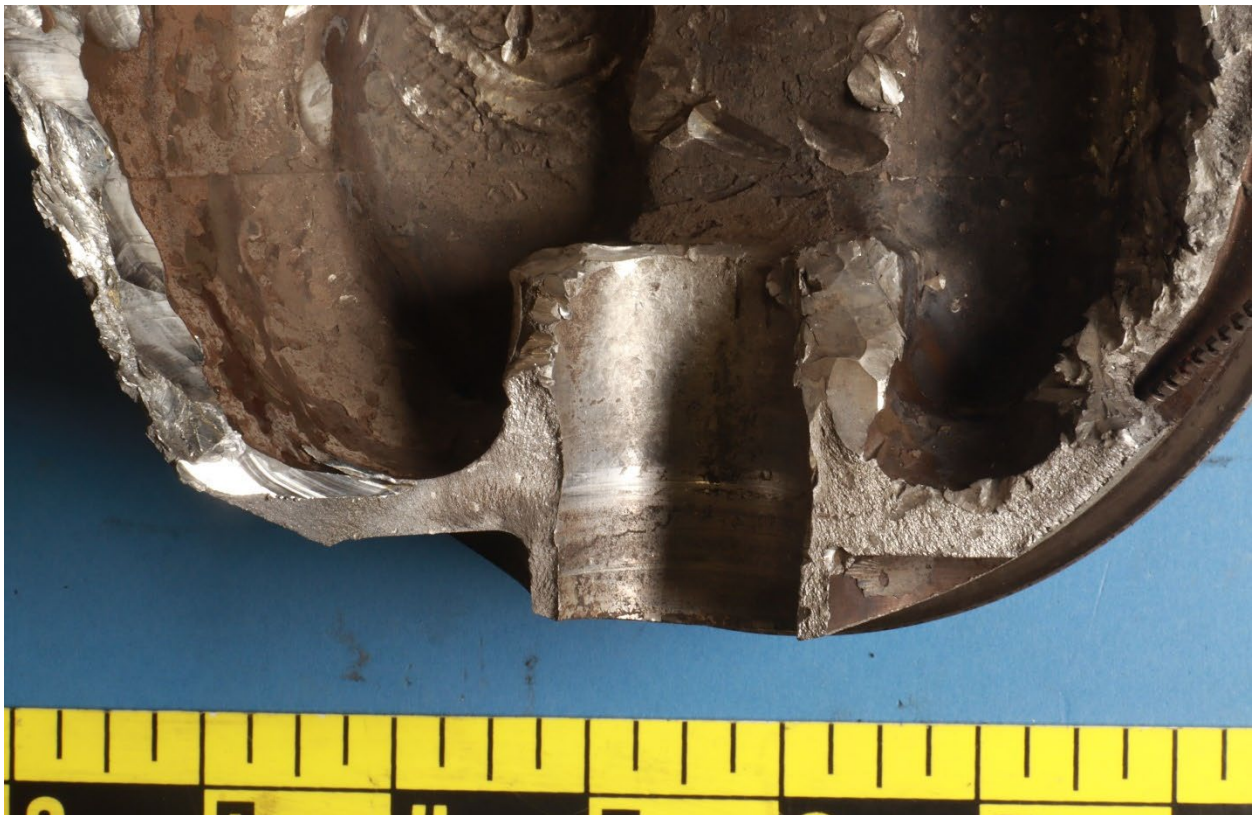
**Figure 6.** Oblique lighting view of the piston fracture surface in Figure 5.

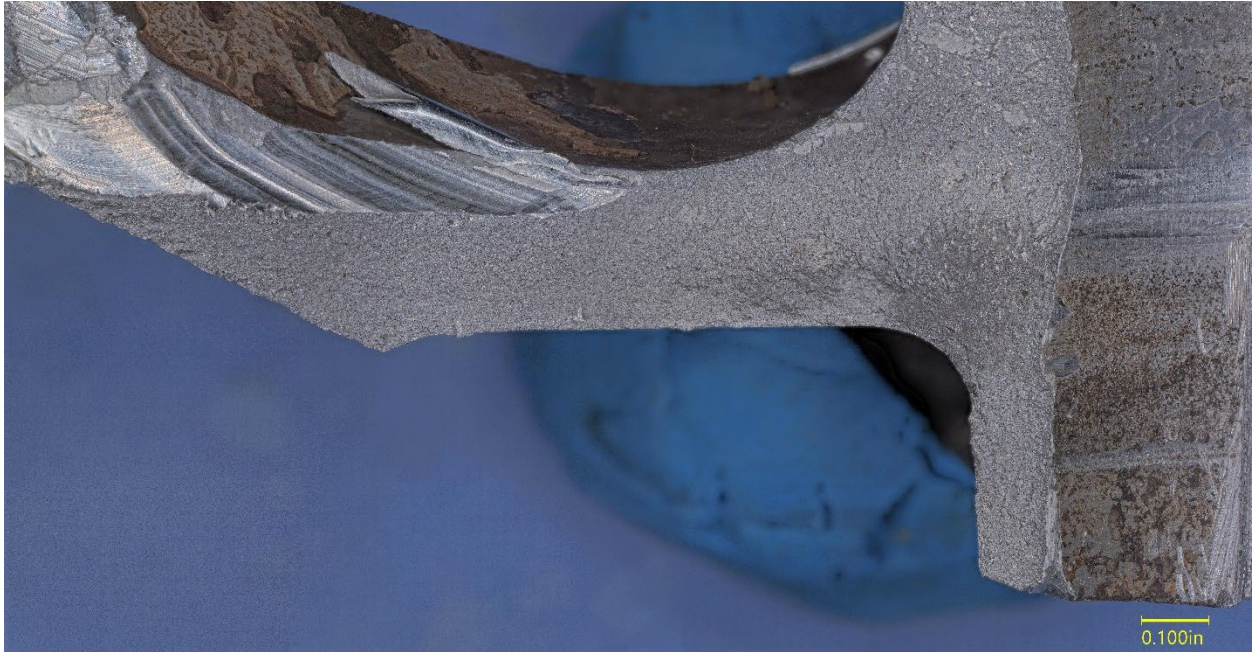
Figure 7 shows a closer view of the left fracture surface from Figure 6. Figure 8 shows an annotated view illustrating the general fracture direction from the outside piston corner opposite the pin bore. The river patterns in Figure 9 show the direction of the fracture, as illustrated in Figure 10. Figure 10 shows the corner of the fracture surface facing the machine bore that faced the piston pin. This corner exhibited some wear or rubbing marks on the left towards the machine surface, small impact marks, or depressions along the outboard face (Figure 11).

**Figure 7.** Montage of the piston fracture surface, after sectioning and cleaning.

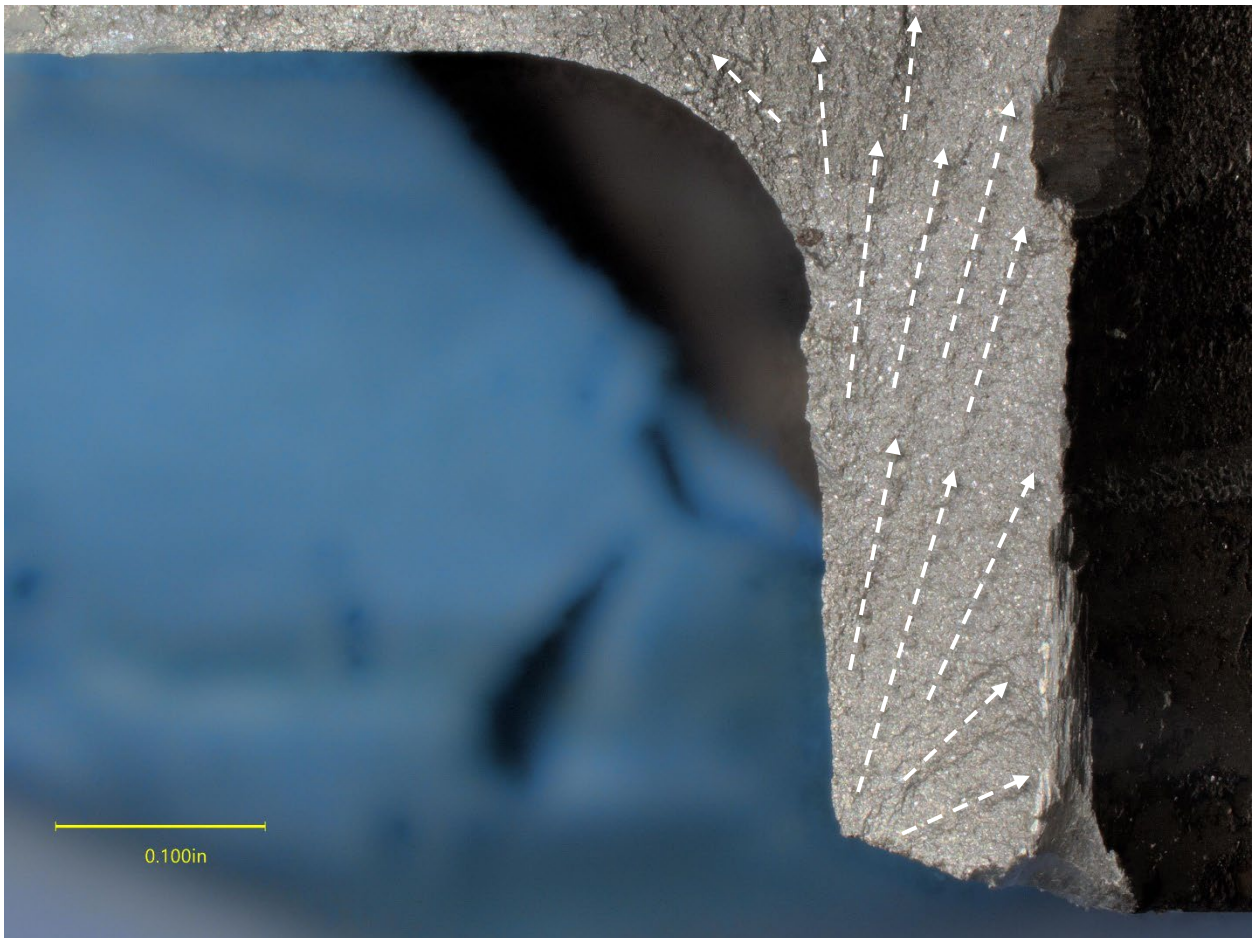
**Figure 8.** The initial area of the piston fracture surface, after sectioning and cleaning.

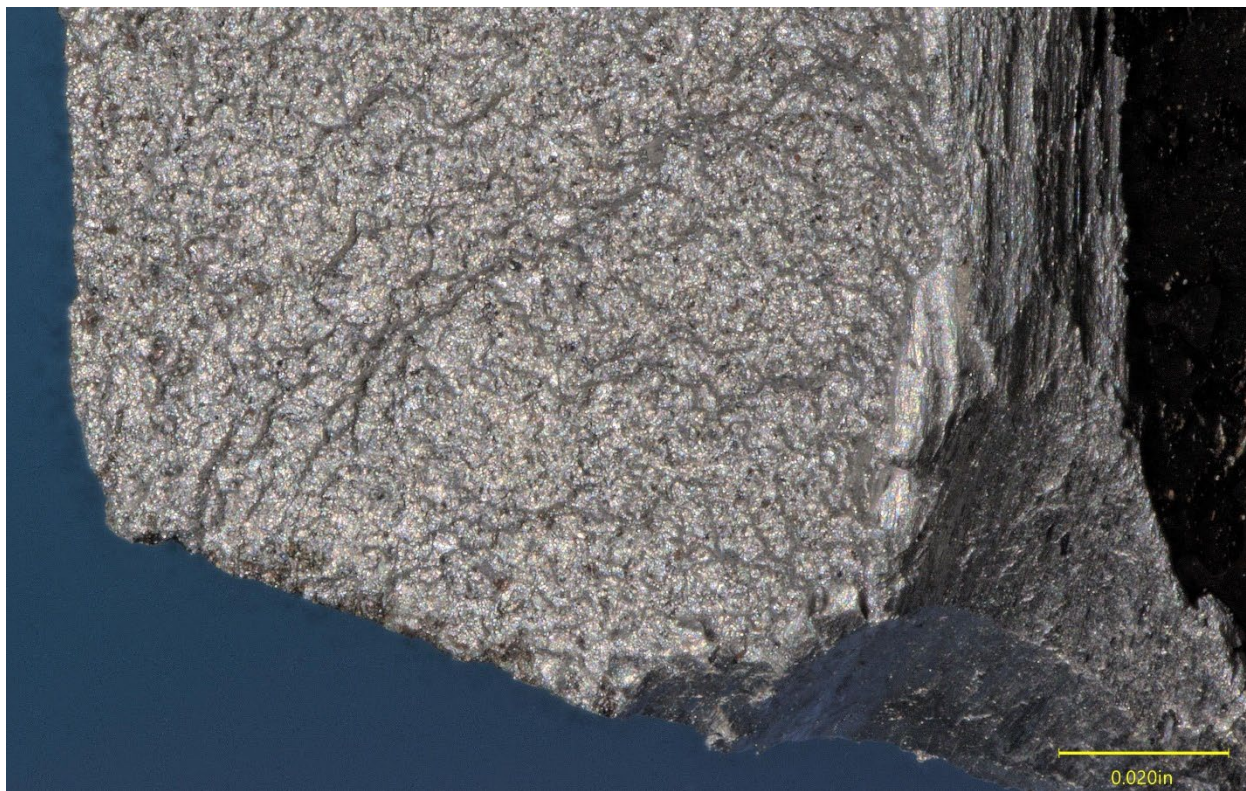
**Figure 9.** The initial fracture region on the outboard pin corner of the piston surface.

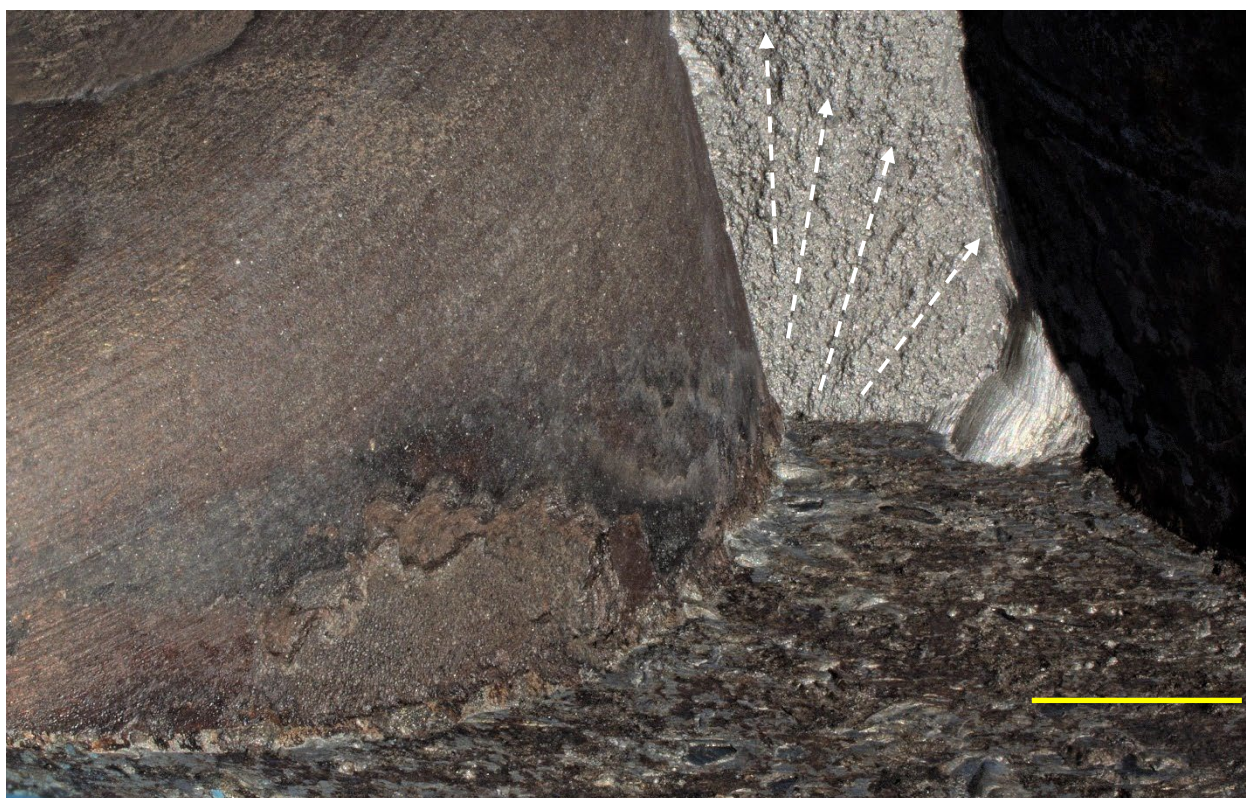
**Figure 10.** Angled view of the piston initiation area, annotated to show the fracture direction.

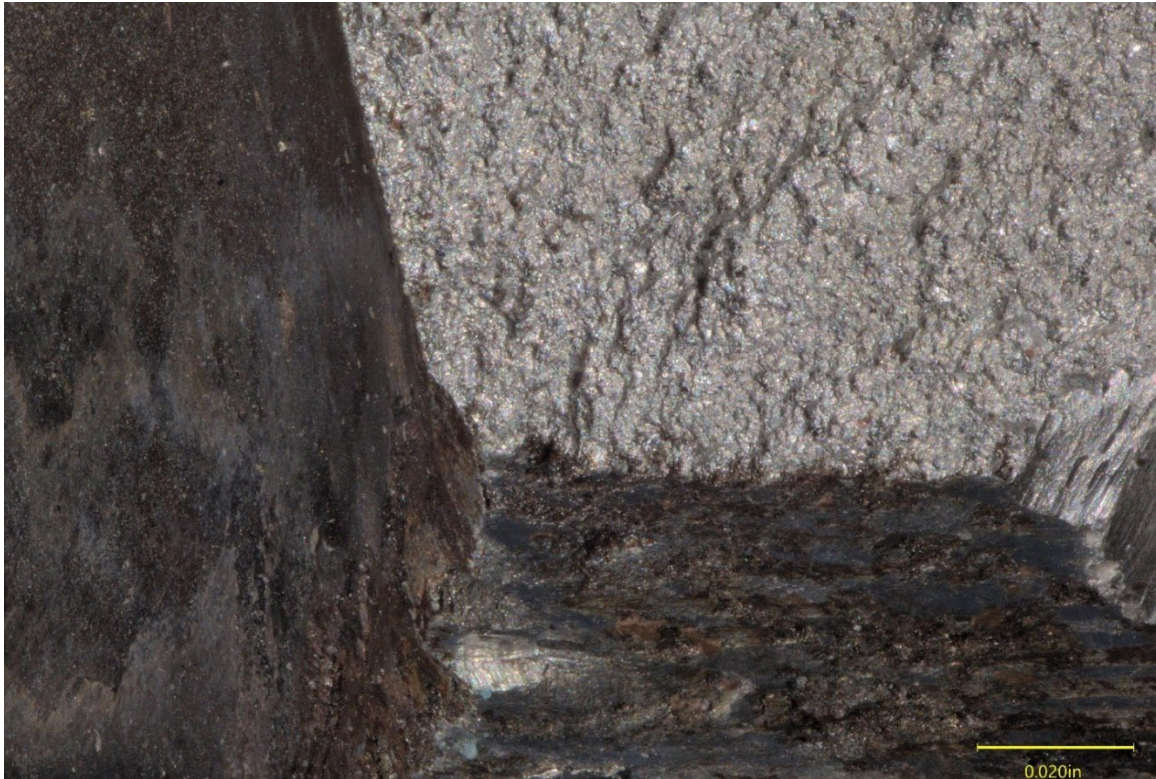
**Figure 11.** Angled view of the piston initiation area.

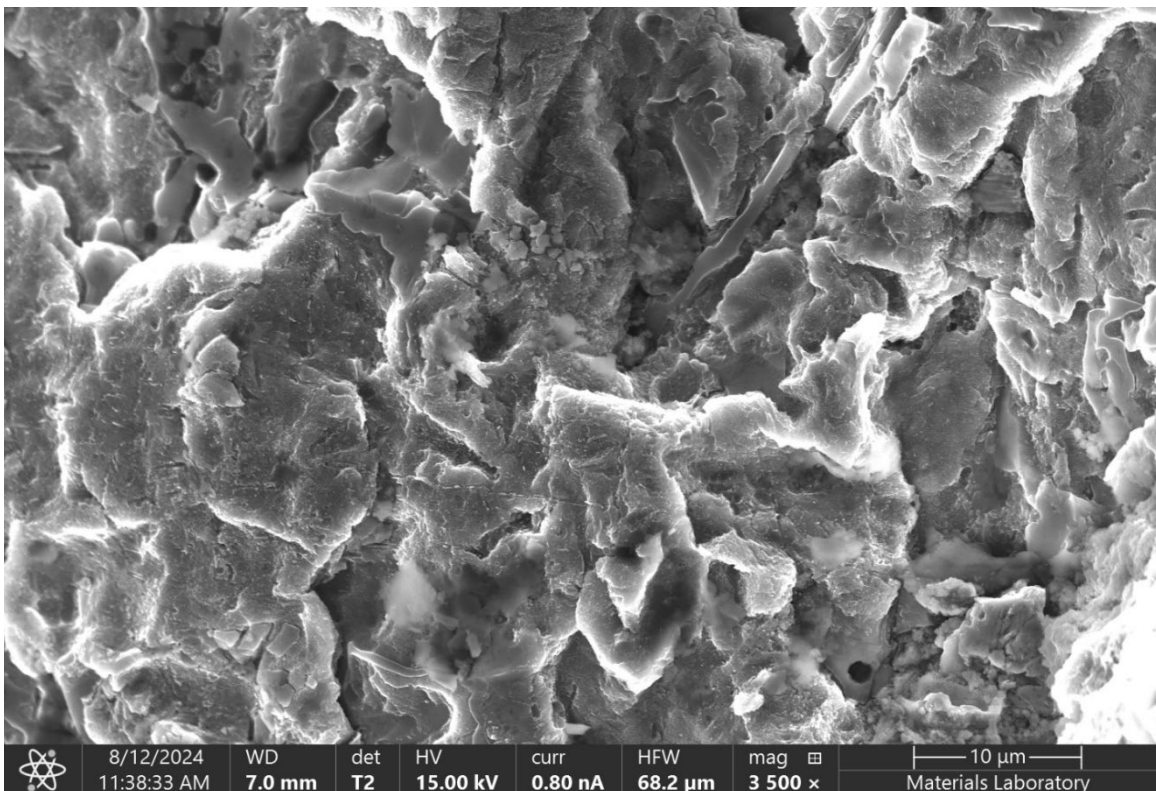
This portion of the fracture surface was excised, cleaned with acetone, and examined using a field emission scanning electron microscope (SEM). Figure 12 shows a typical area of the fracture surface near the edge in Figures 11 and 12. The fracture surface was rough and tortuous, with intermediate areas exhibiting smoother or flatter features. On most of the rougher portions of the fracture surface, illustrated in Figures 13 and 14, the part exhibited fine dimpled rupture, consistent with overstress fracture.

**Figure 12.** Secondary electron (SE) micrograph of an area near the outboard edge of the piston fracture surface.

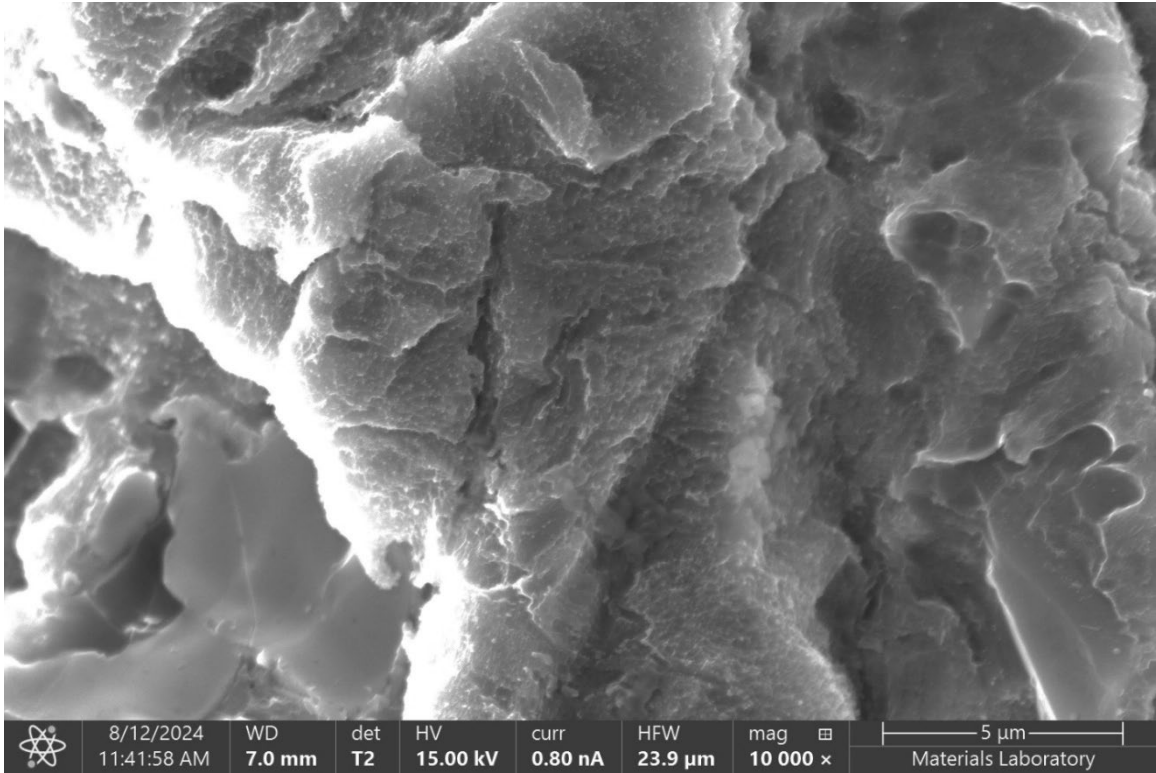
**Figure 13.** SE micrograph of the upper central area in Figure 12.

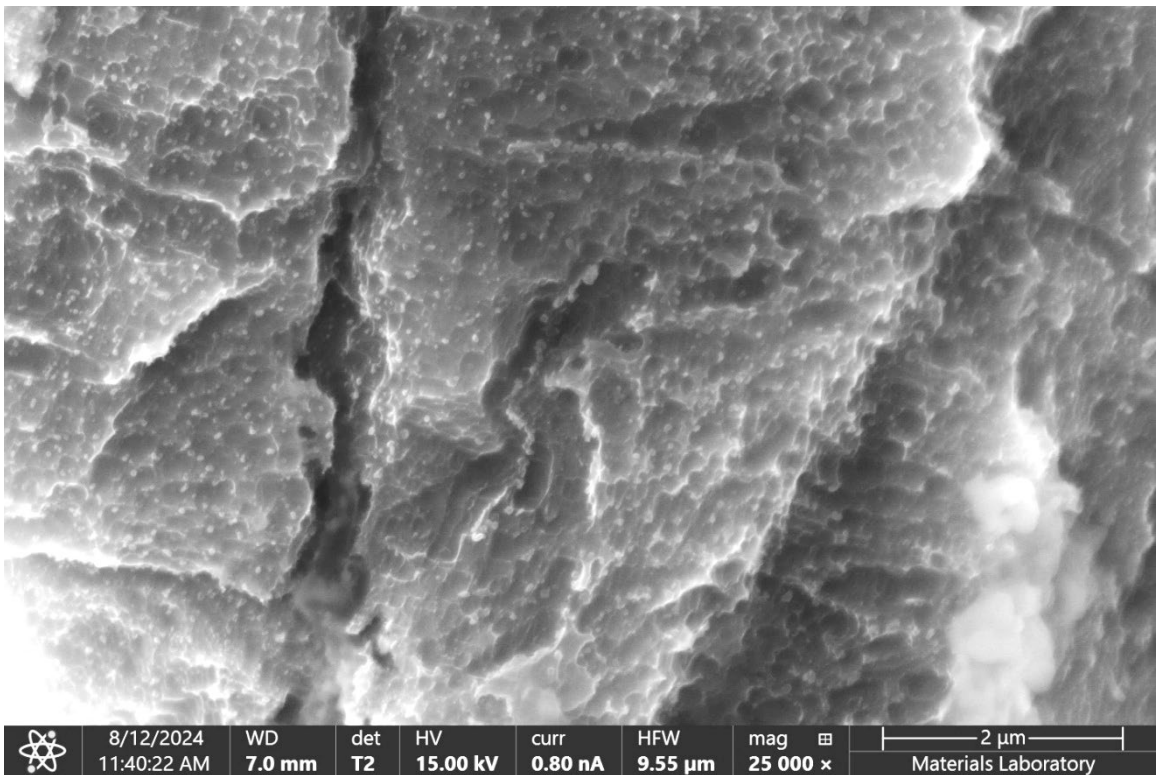
**Figure 14.** SE micrograph of dimpled rupture from the area in Figure 13.

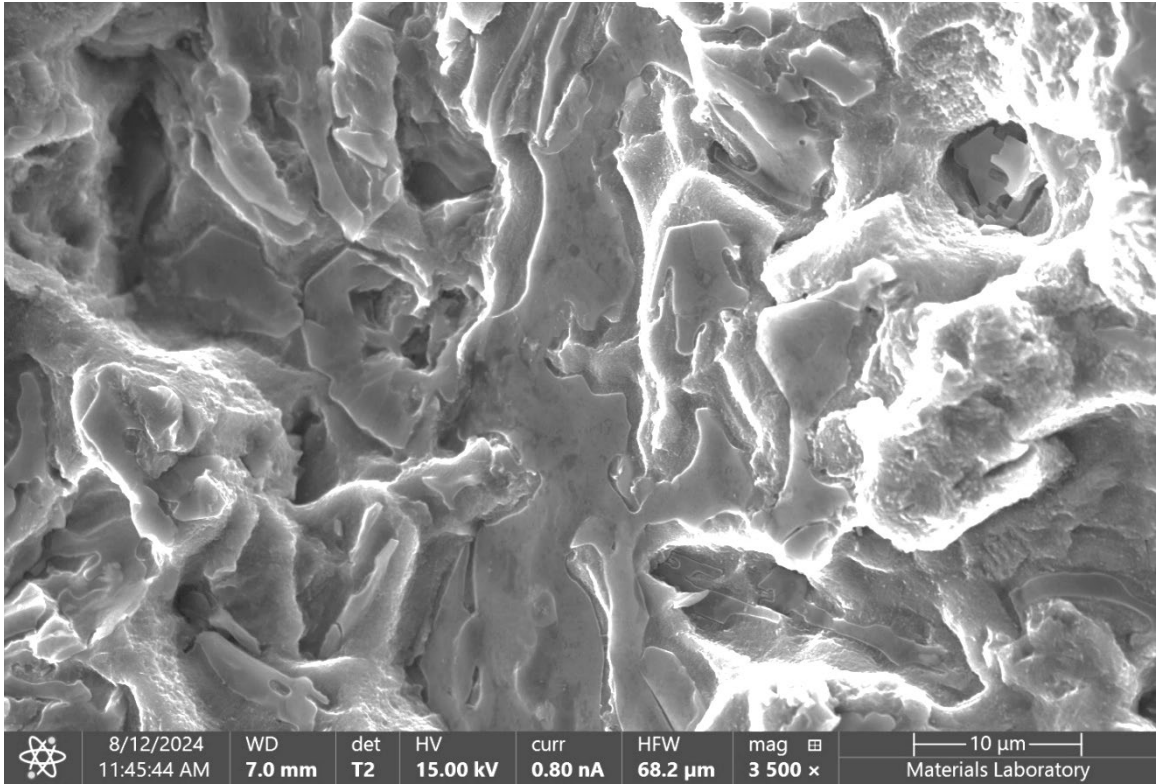
The smoother features on the fracture surface, as typified in Figure 15, were examined using energy dispersive x-ray spectroscopy (EDS) and were rich in silicon. The surrounding area, which exhibited fine dimpled rupture, was mostly aluminum (Figure 16). These chemical characteristics were consistent with an aluminum-silicon casting, and the fracture features were consistent with overstress fracture typical of such casting alloys.

**Figure 15.** SE micrograph of a flat fracture feature consistent with fracture of a Si-rich phase.

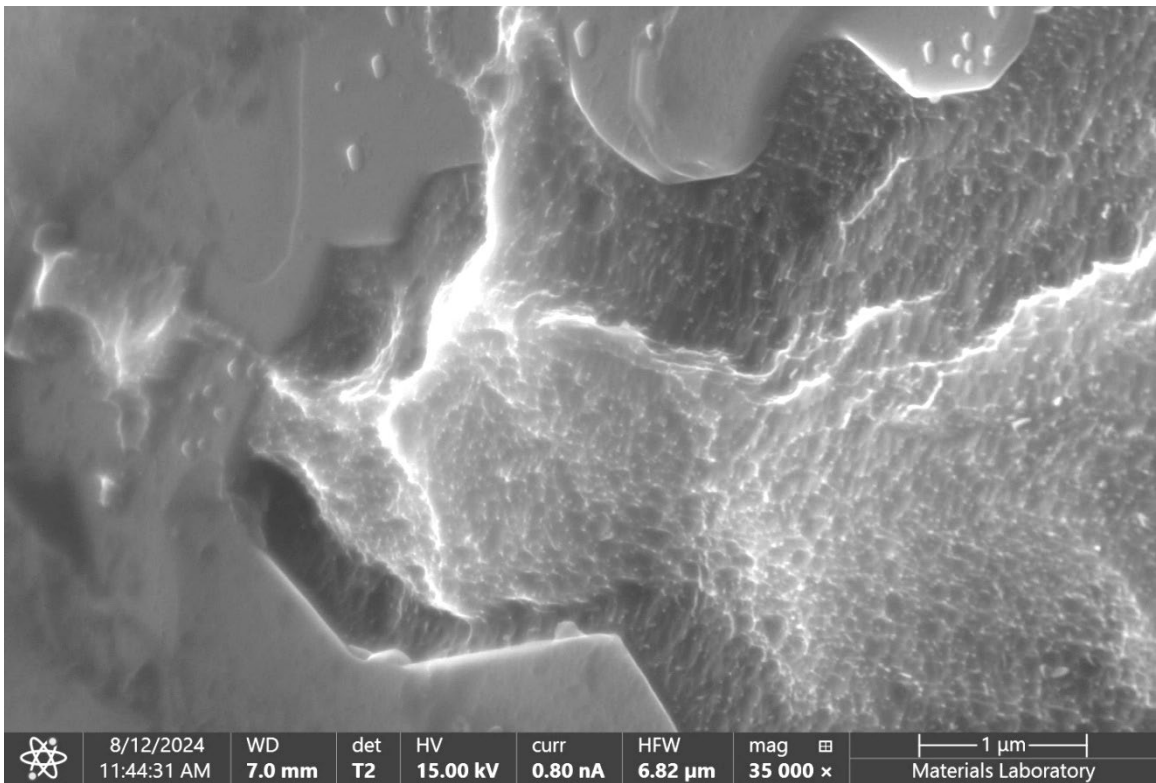
**Figure 16.** SE micrograph of fine dimpled rupture near the Si-rich phase in Figure 15.

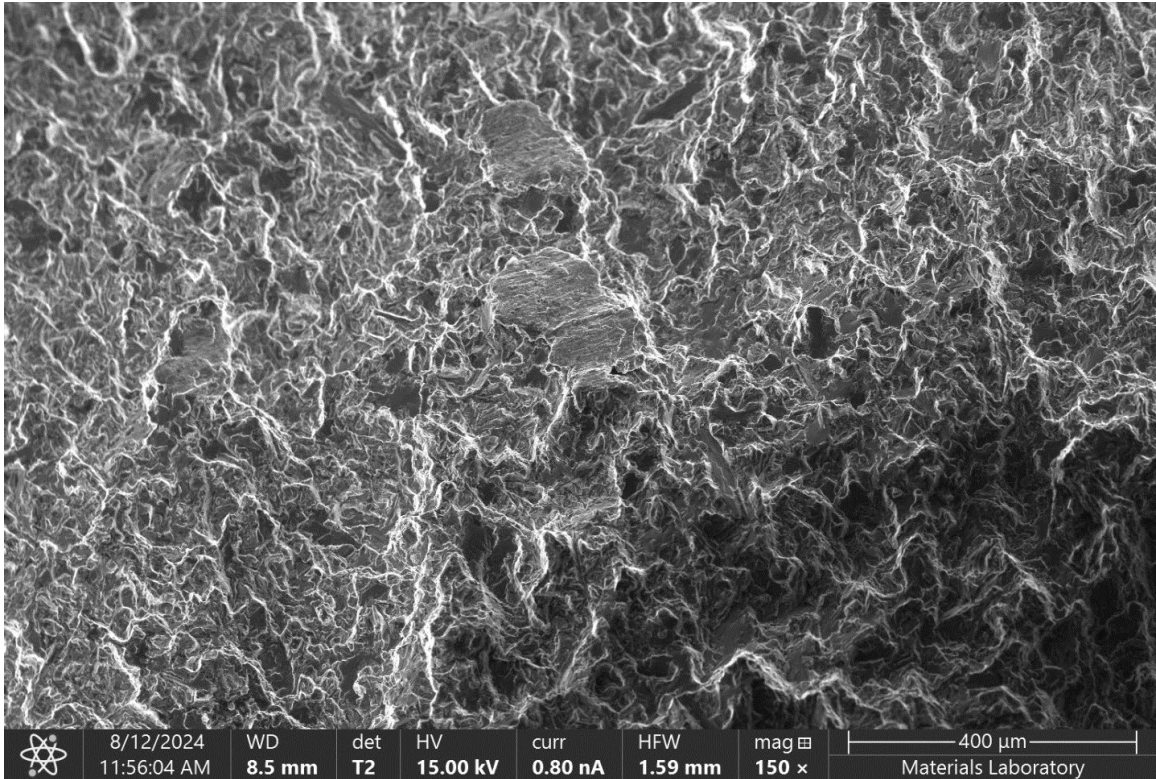
Figure 17 shows isolated areas with parallel linear features on the fracture surface. The features outside these regions were consistent with overstress fracture. A closer view of the areas with streaks showed the linear features to be erratic, inconsistent, and layered (Figures 18 and 19). A closer examination found dimpled rupture in these areas (Figure 20). These regions were consistent with post-fracture smearing damage of the fracture surface rather than other failure modes, such as those

**Figure 17.** SE micrograph of isolated areas of smearing damage on the piston fracture surface.

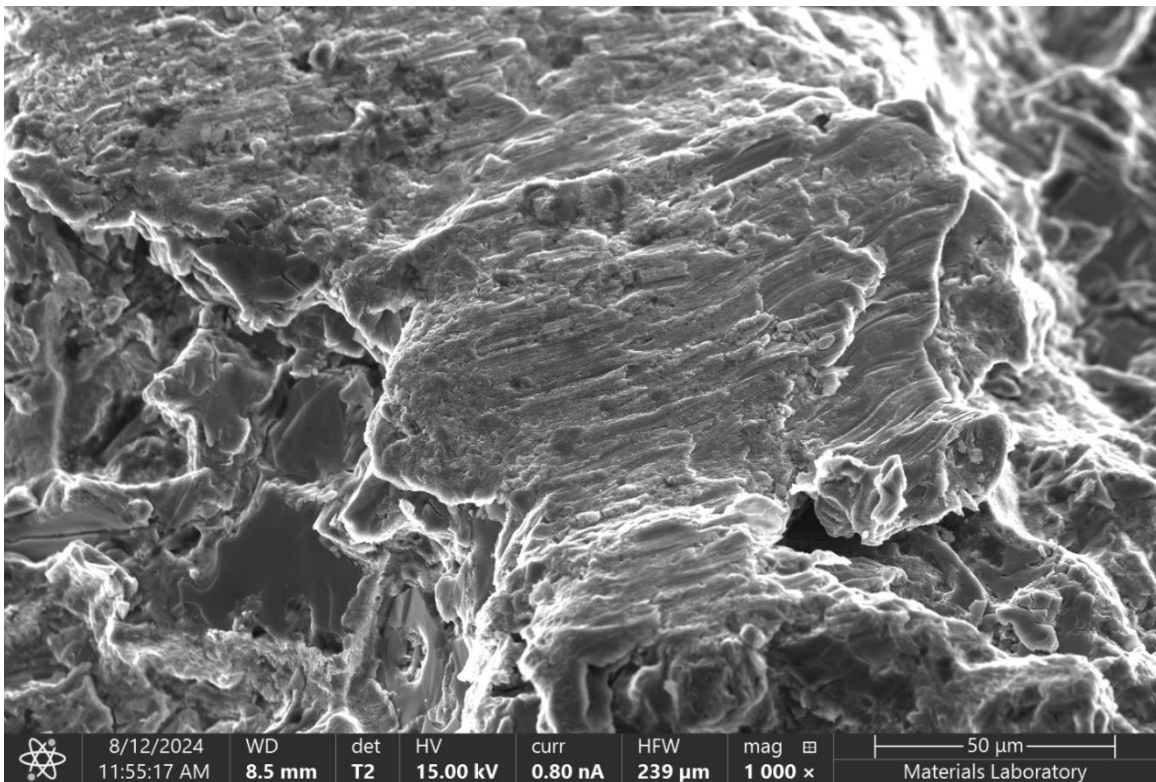
**Figure 18.** SE micrograph of the smeared region in Figure 17.

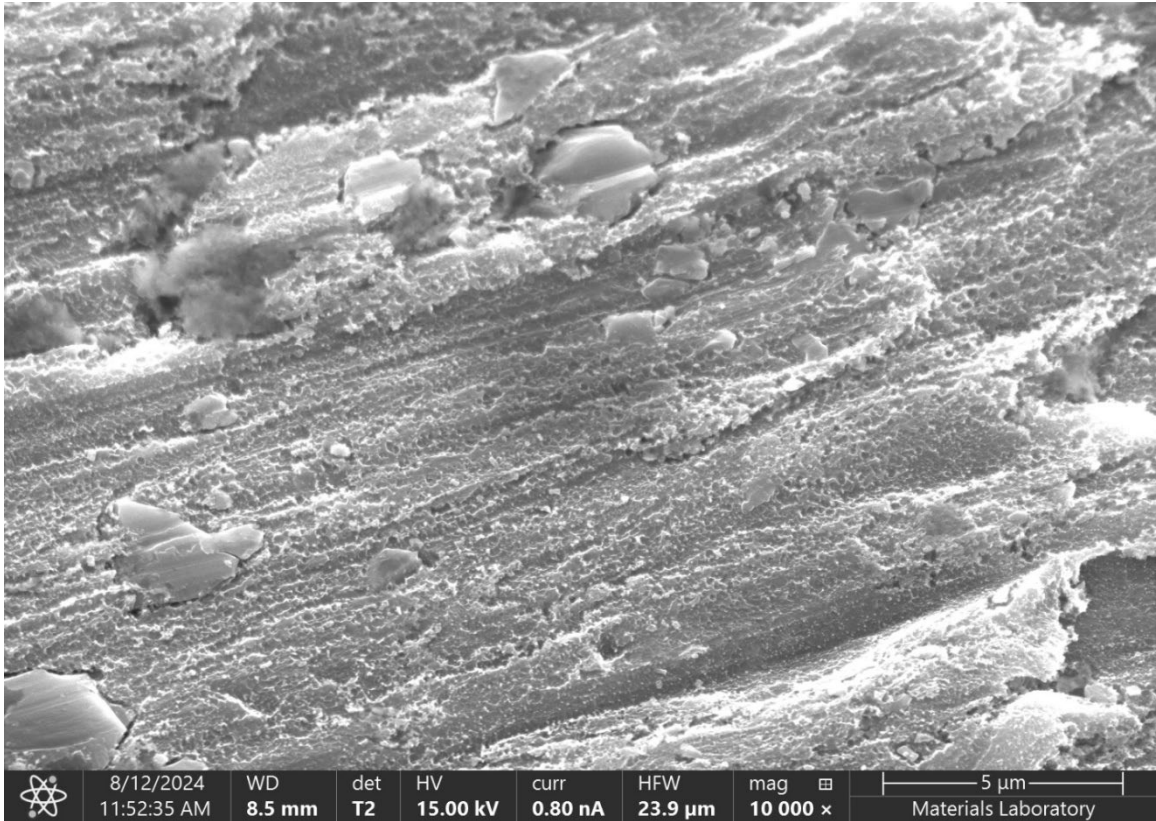
**Figure 19.** SE micrograph of the smeared streaks in Figure 18.

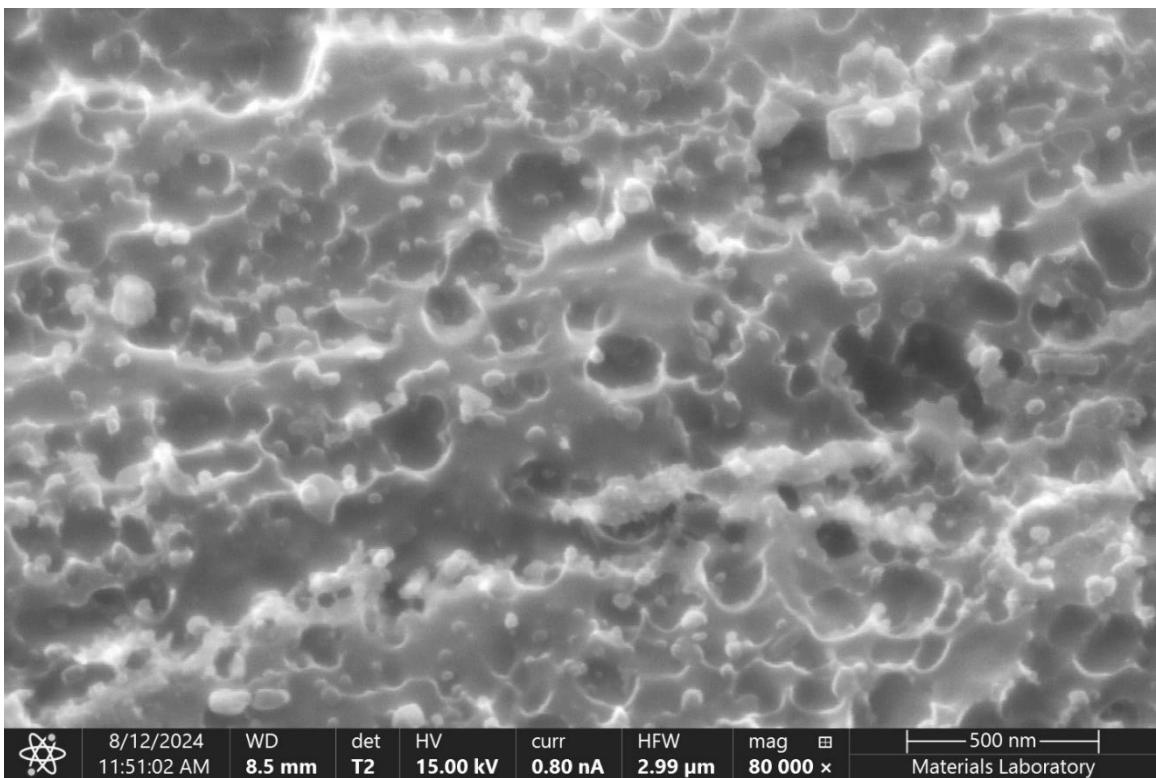
consistent with crack propagation. No features consistent with failure modes other than dimpled rupture were observed on the piston fracture surfaces.

**Figure 20.** SE micrograph of dimpled rupture in the streaks in Figure 19.
