# National Transportation Safety Board

ANC24LA027

## **MATERIALS LABORATORY**

Factual Report 24-055

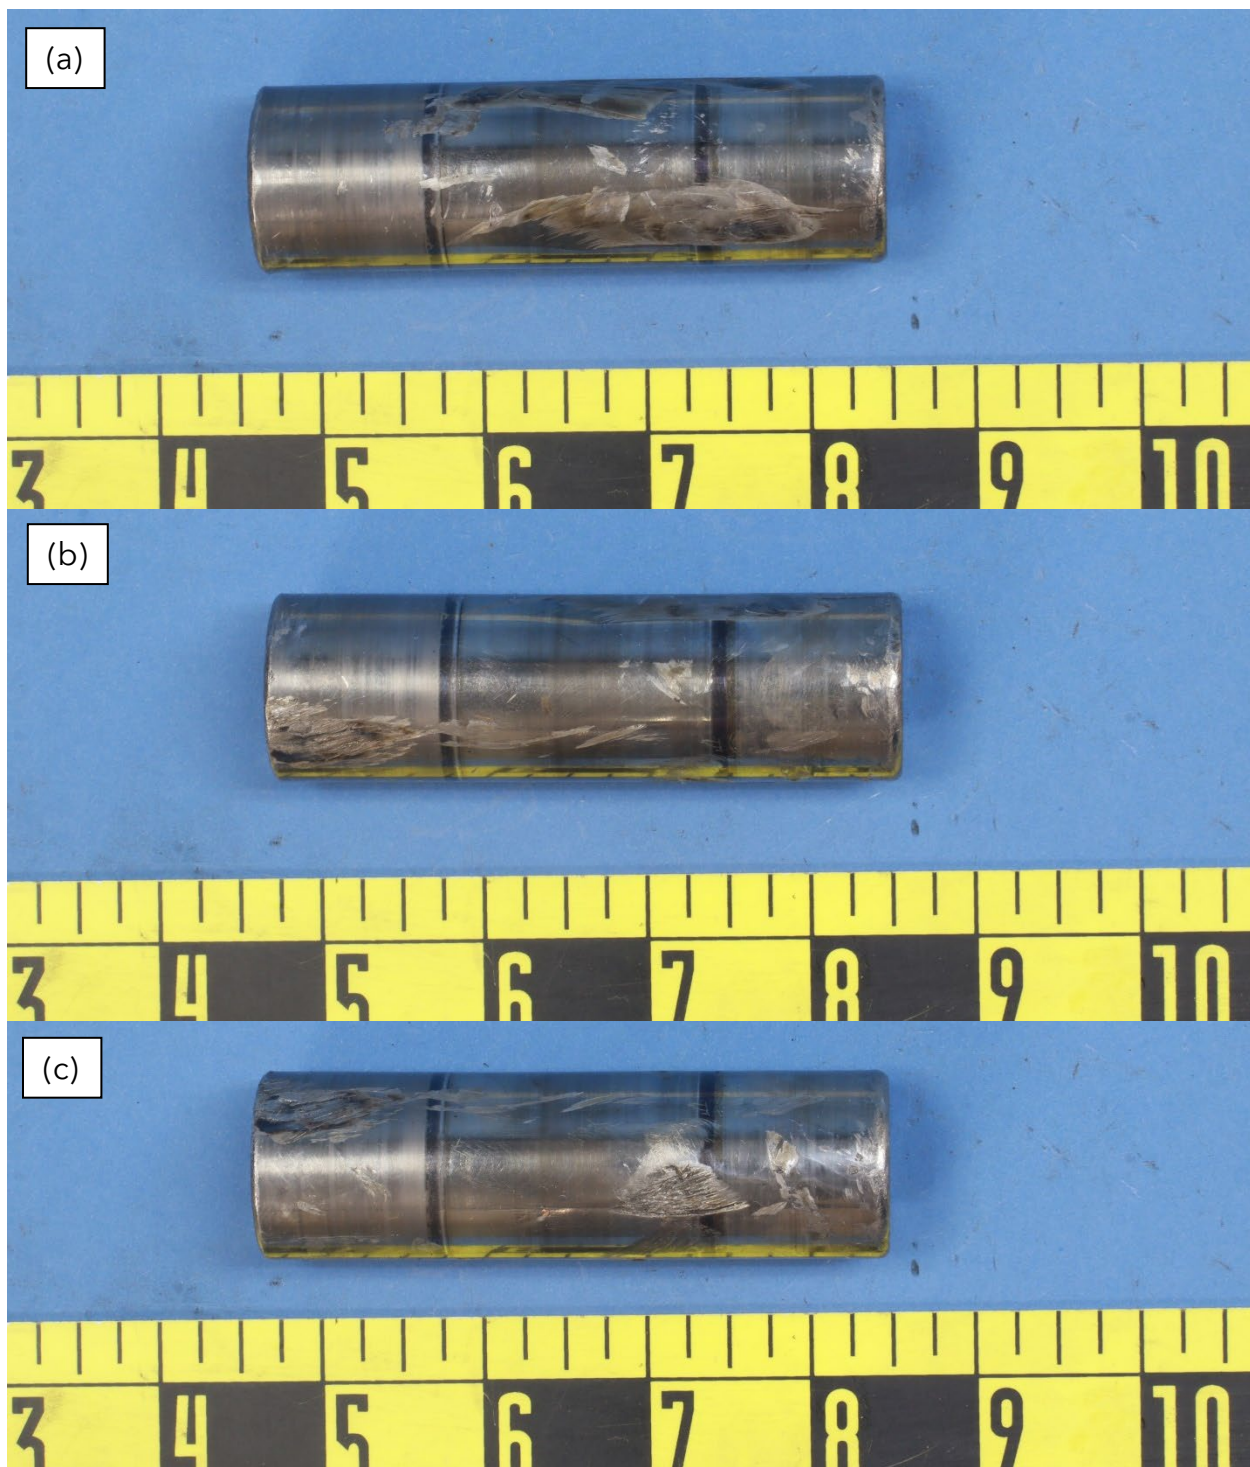
Figure 21 shows multiple views of the piston pin from the side as received. The pin exhibited two prominent darker circumferential wear marks, consistent with rotation against the bearing faces of the connecting rod. Views of the end faces of the piston, shown in Figure 22, revealed three radial cracks on the faces. These cracks had progressed longitudinally along part of the pin.

**Figure 21.** Circumferential views of the piston pin from (a) the 0°, (b) 120°, and (c) the 240° rotations.

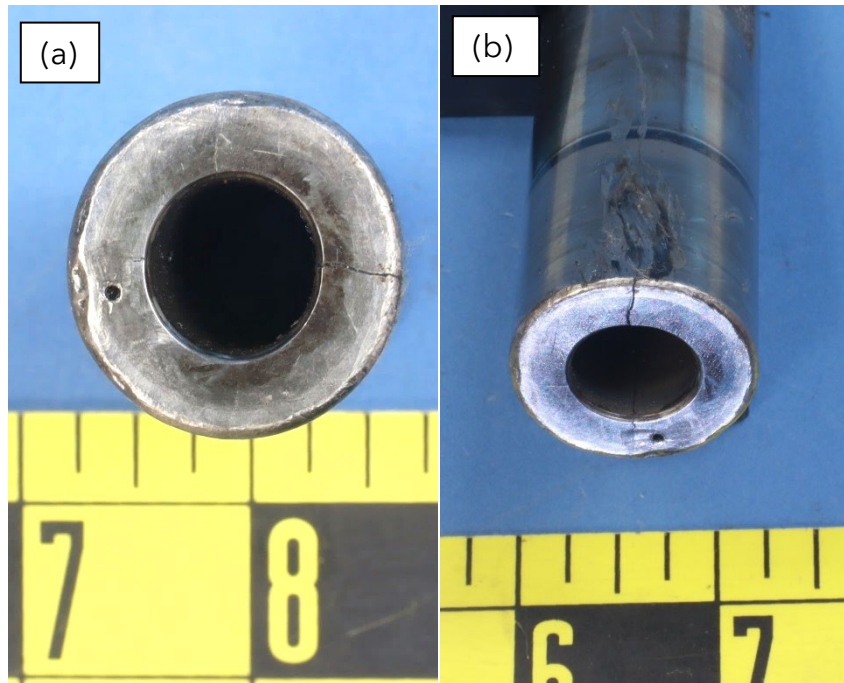
**Figure 22.** The piston pin face showing cracks from (a) an end view and (b) an angled view.

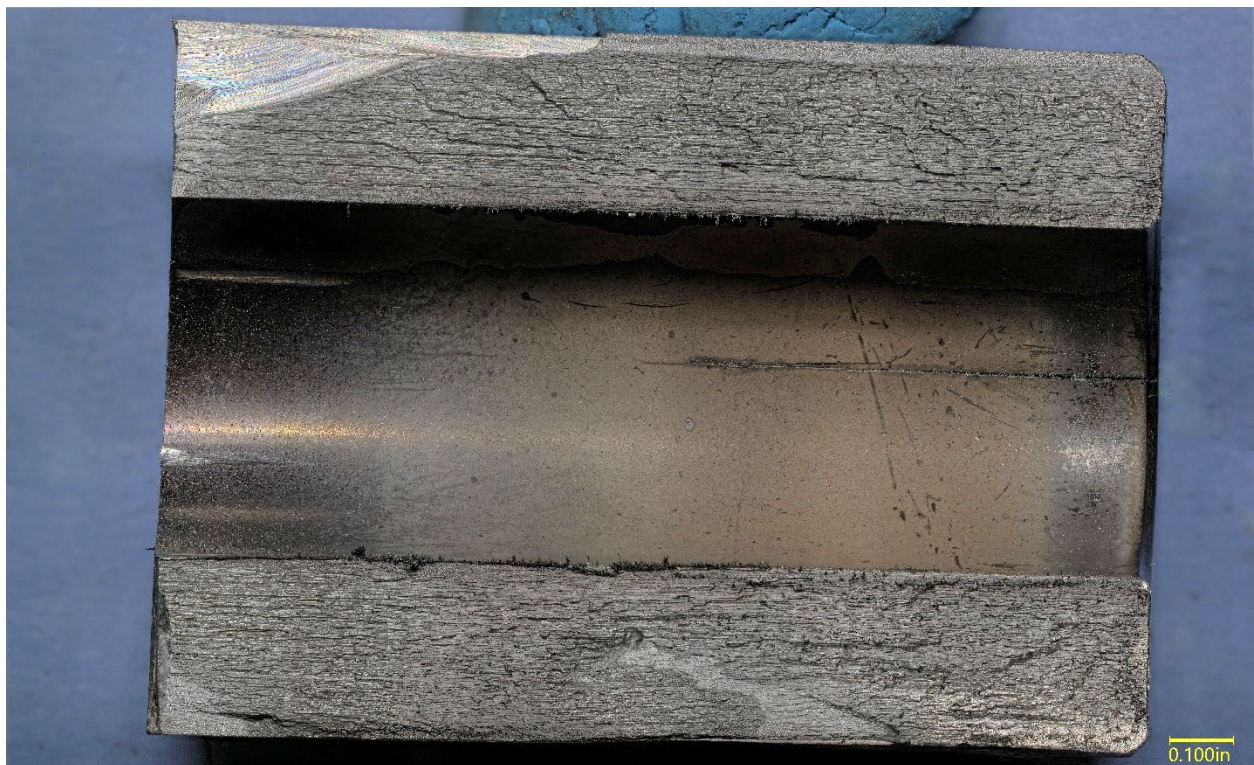
One crack was intentionally backcut and laboratory-opened to reveal the crack faces, as illustrated in Figure 23. The cracks were generally shaped convex facing inward, exhibiting longer depths along the pin bore than the outer surface. River patterns emanating from the bore were observed as well. These features were consistent with crack origination from the pin bore rather than the outside surface of the pin.

**Figure 23.** One of the opened crack faces from the piston pin.

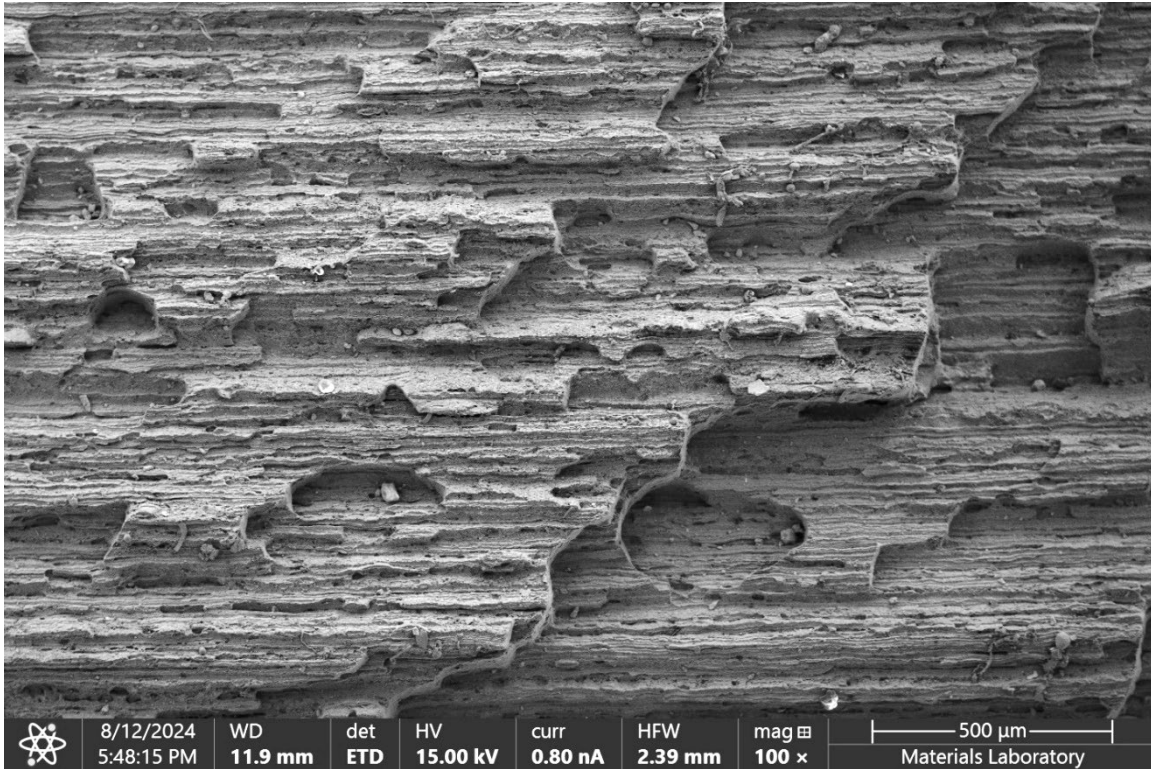
The opened pin cracks were cleaned with acetone and examined using a SEM. Figure 24 shows a typical area of the opened cracks, revealing elongated granular structure and tortuous elevation. The topography of the fracture was consistent with the grain orientation of the pin microstructure, elongated along the length of the pin or the forging direction.

**Figure 24.** SE micrograph of a typical area of the opened crack in the piston pin.

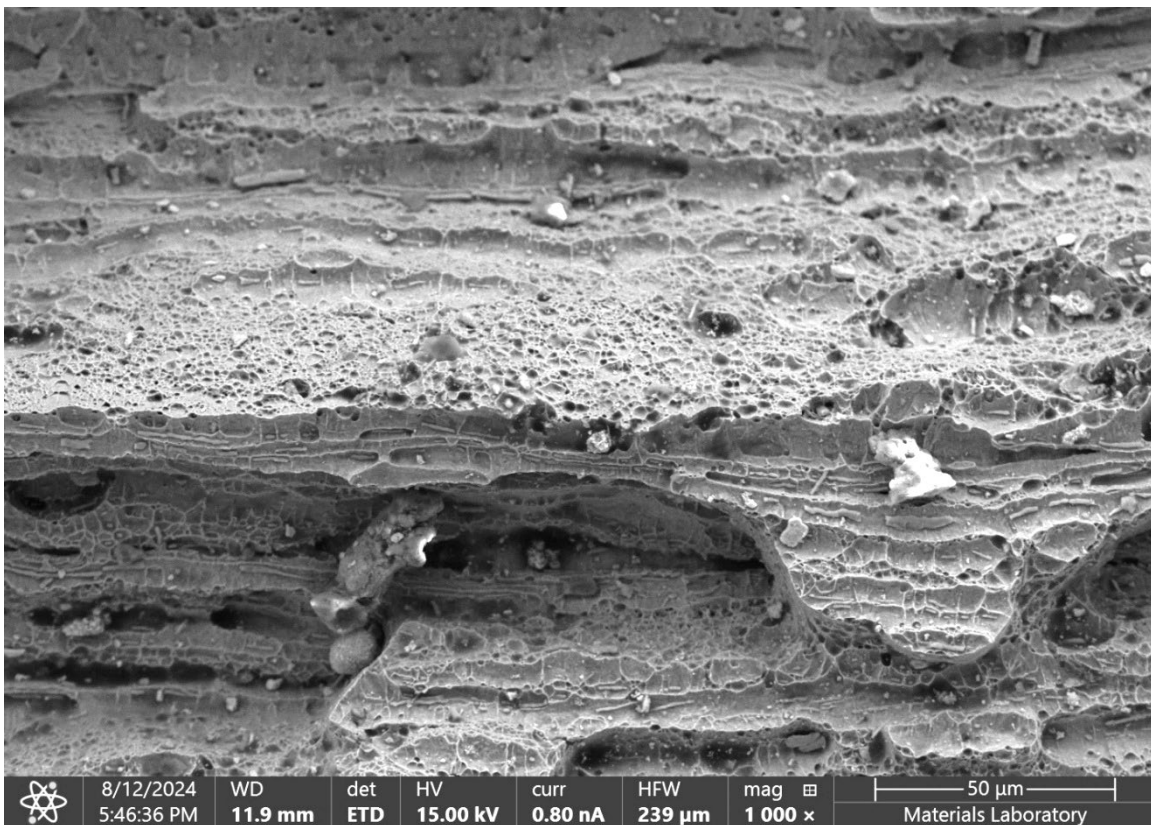
As shown in Figure 25, the fracture surface exhibited dimpled rupture, with mixed sizes of larger, oval dimples and finer, more equiaxed dimples (Figure 26). Along the outer edge of the opened pin cracks, the fracture surface was blockier and more faceted, as shown in Figure 27. Closer views in Figures 28 and 29 show that this fracture surface area consisted of mixed intergranular and dimpled rupture fracture features. These characteristics were consistent with a case-hardened outer surface. These features were consistent with the overstress of the piston pin.

**Figure 25.** SE micrograph of large and fine dimpled rupture on the open piston pin crack.

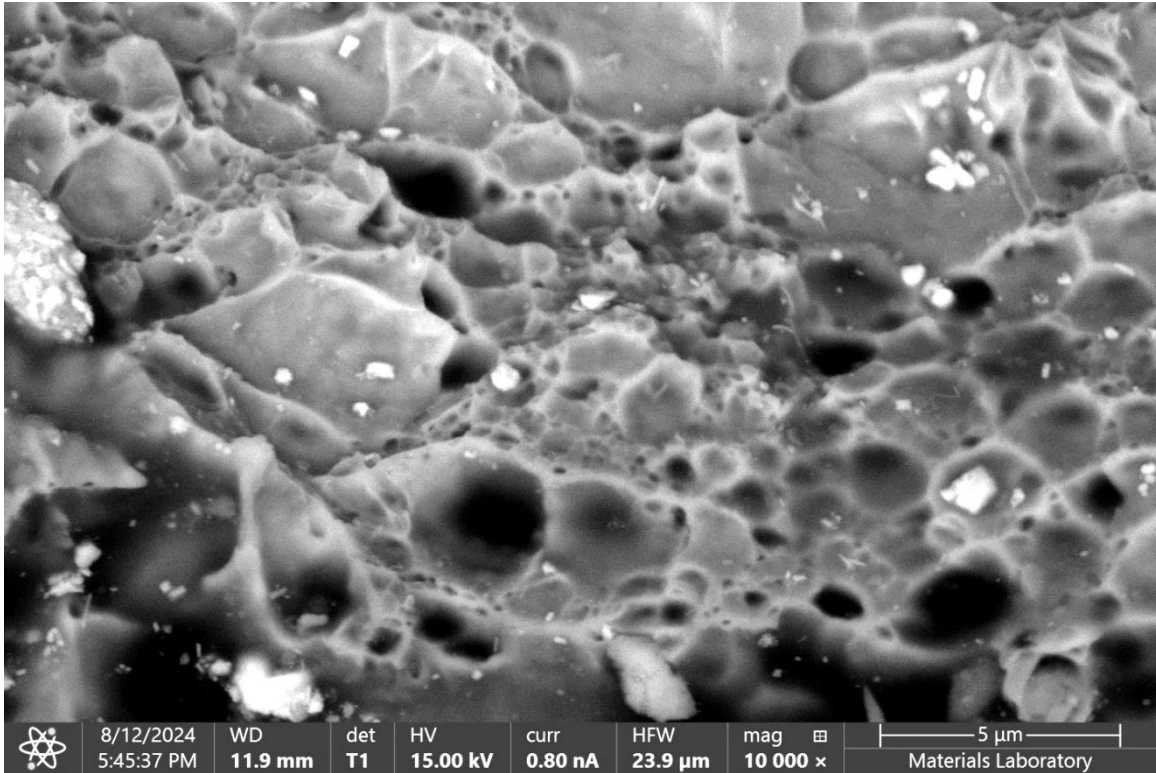
**Figure 26.** SE micrograph of the dimpled rupture from the opened piston crack.

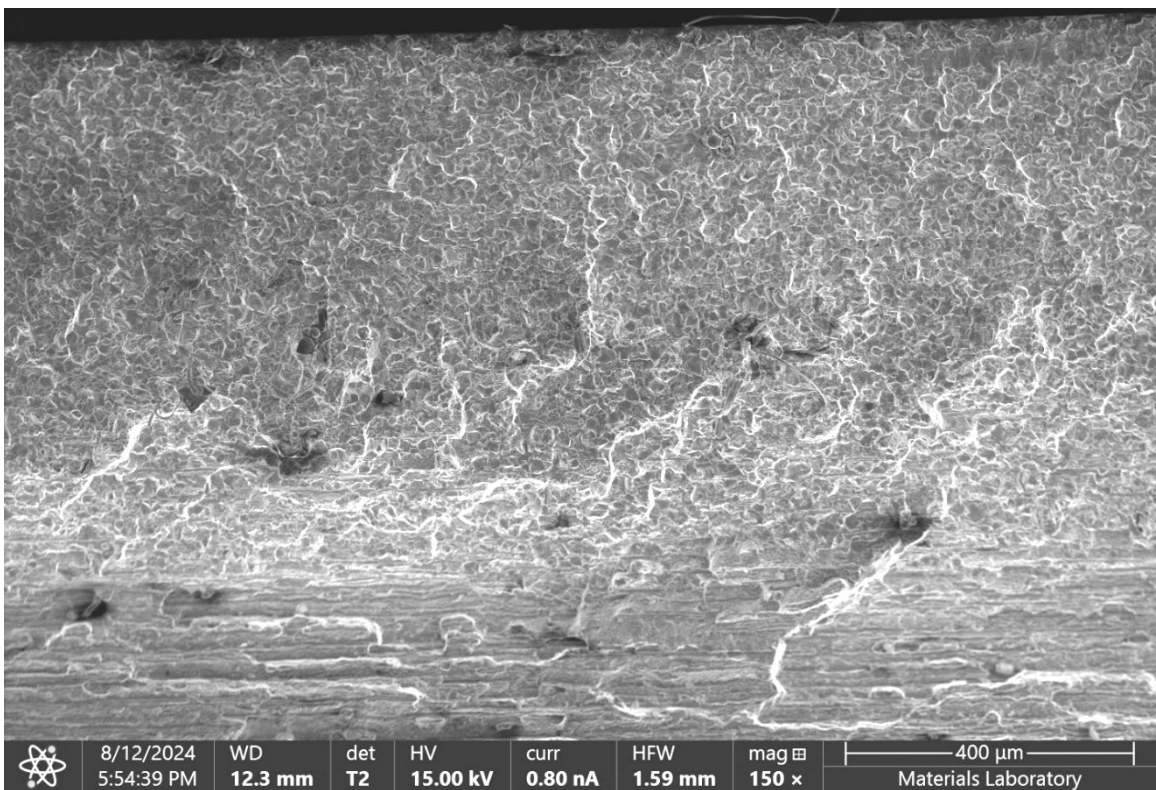
**Figure 27.** SE micrograph of the opened crack edge with the pin exterior, showing different fracture regions.

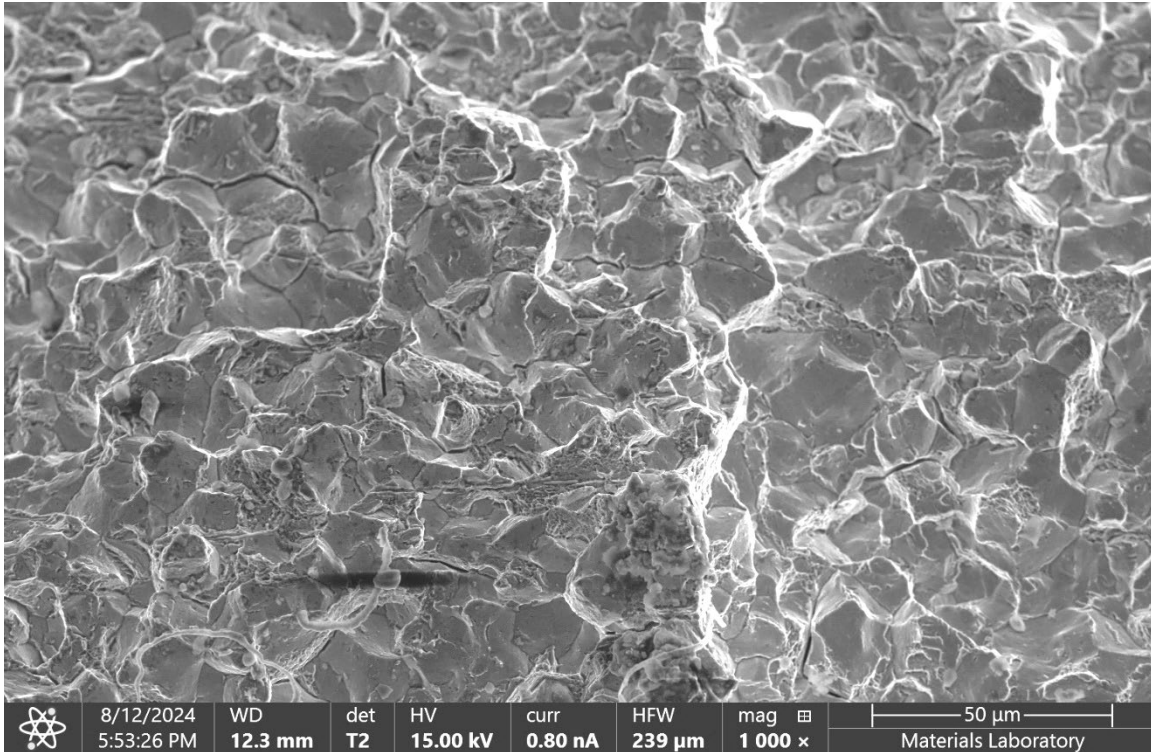
**Figure 28.** SE micrograph of a closer of the outward fracture features of the opened pin crack.

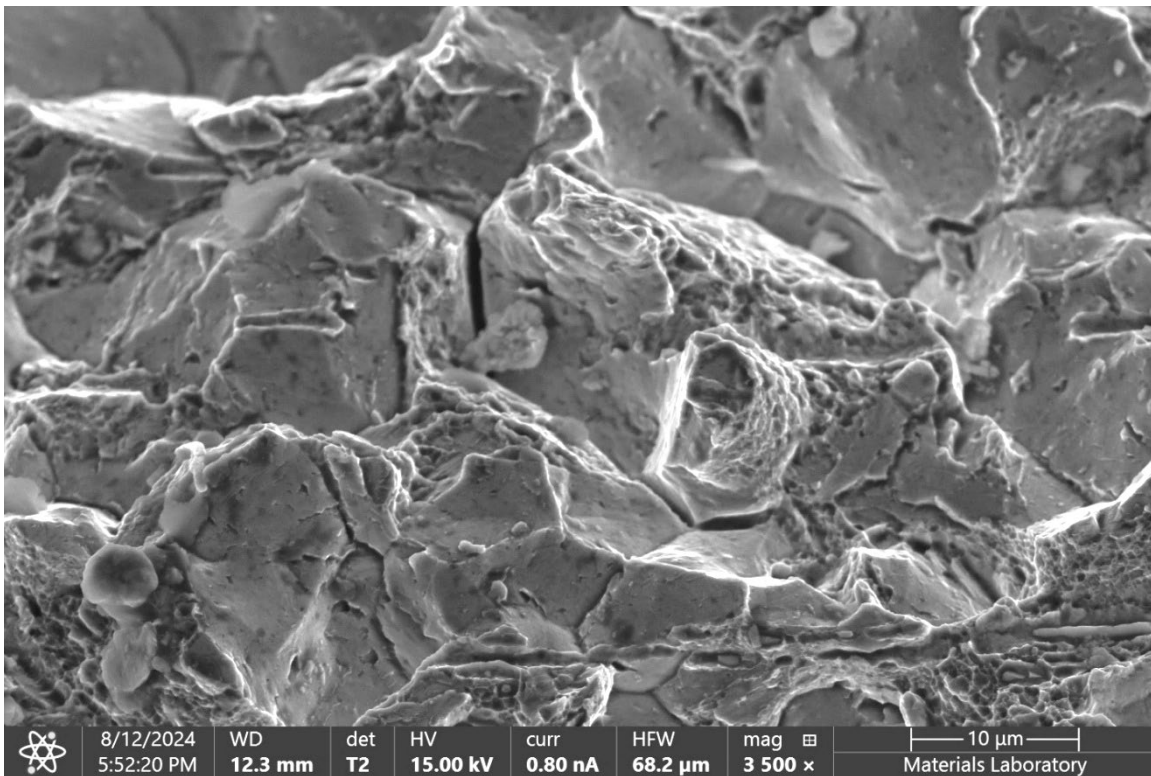
**Figure 29.** SE micrograph of the region in Figure 28, showing intergranular fracture and dimpled rupture along grain facets.
