ANC24LA028

## INVESTIGATION PHOTOGRAPHS

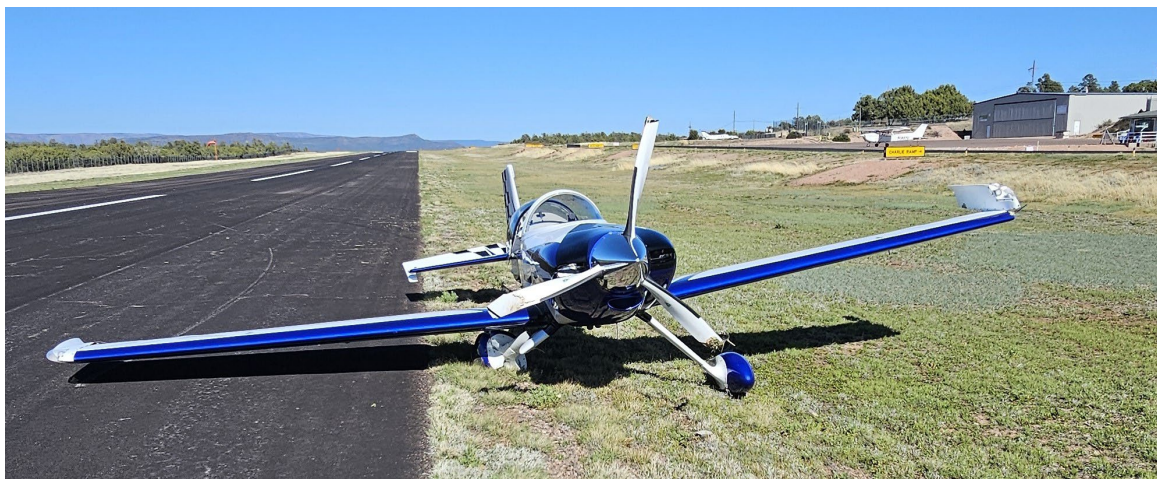
**Photograph 1 - Image of accident airplane viewed from the front (Courtesy of Operator)**

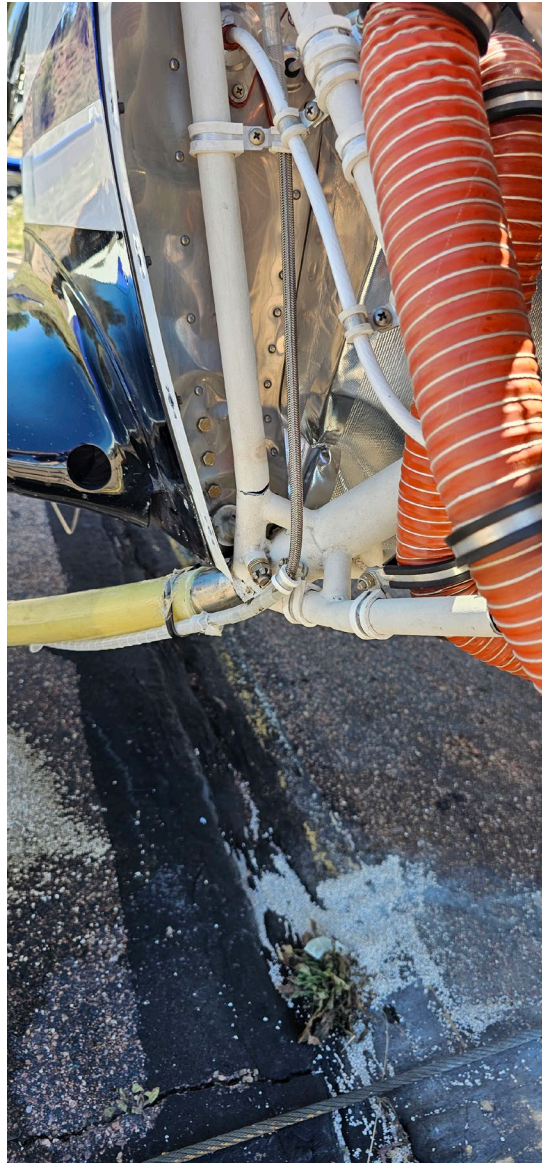
**Photograph 2 - Image of fractured engine mount tubing (Courtesy of Operator)**

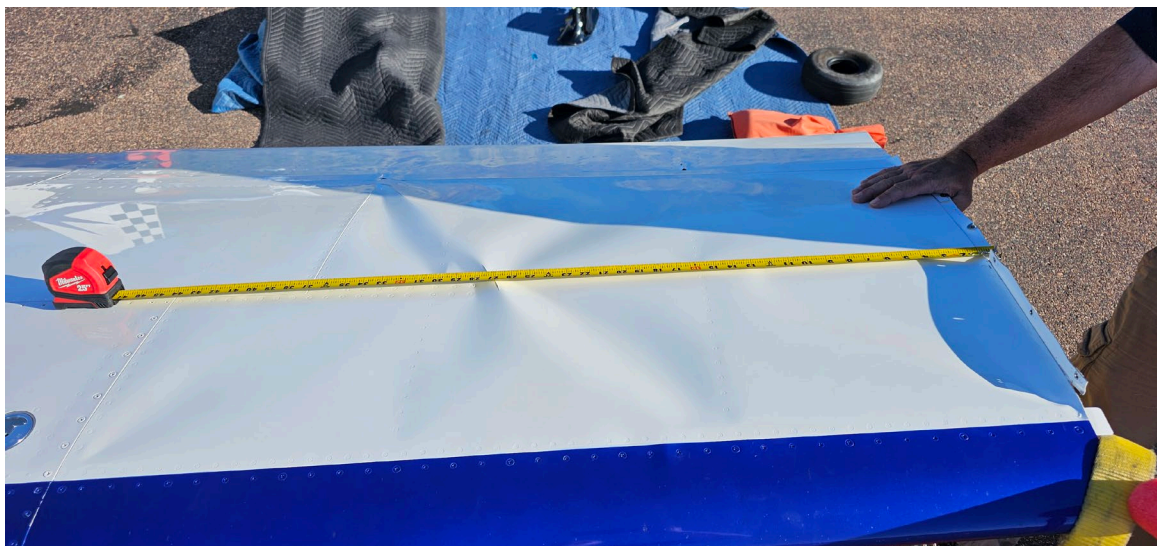
**Photograph 3 - Image of outboard left wing viewed from above (Courtesy of Operator)**

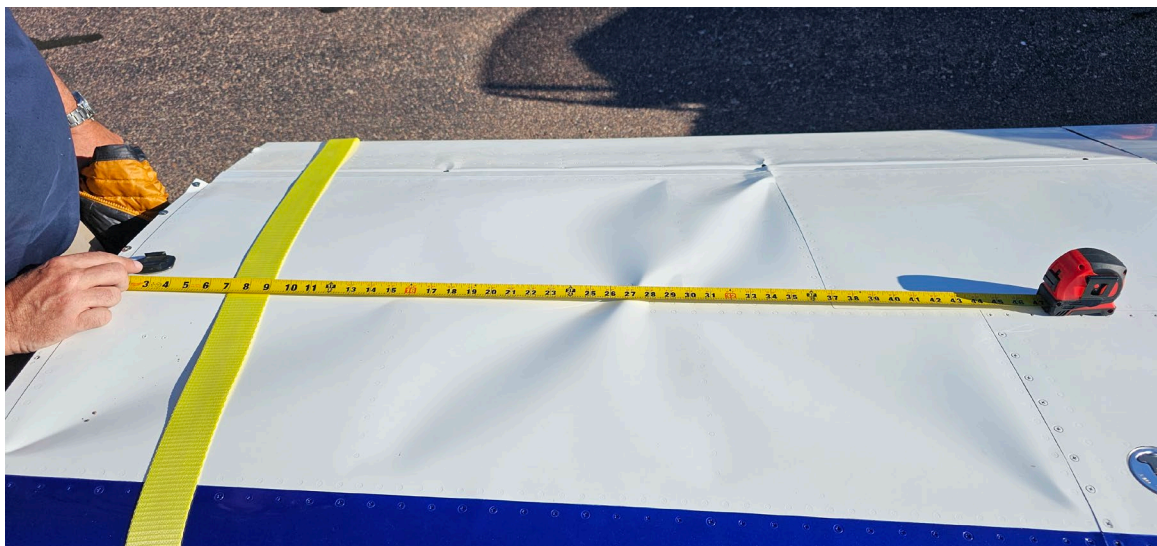
**Photograph 4 - Image of outboard right wing viewed from above (Courtesy of Operator)**
