# National Transportation Safety Board

ANC24LA036

## **MATERIALS LABORATORY**

Factual Report 25-034

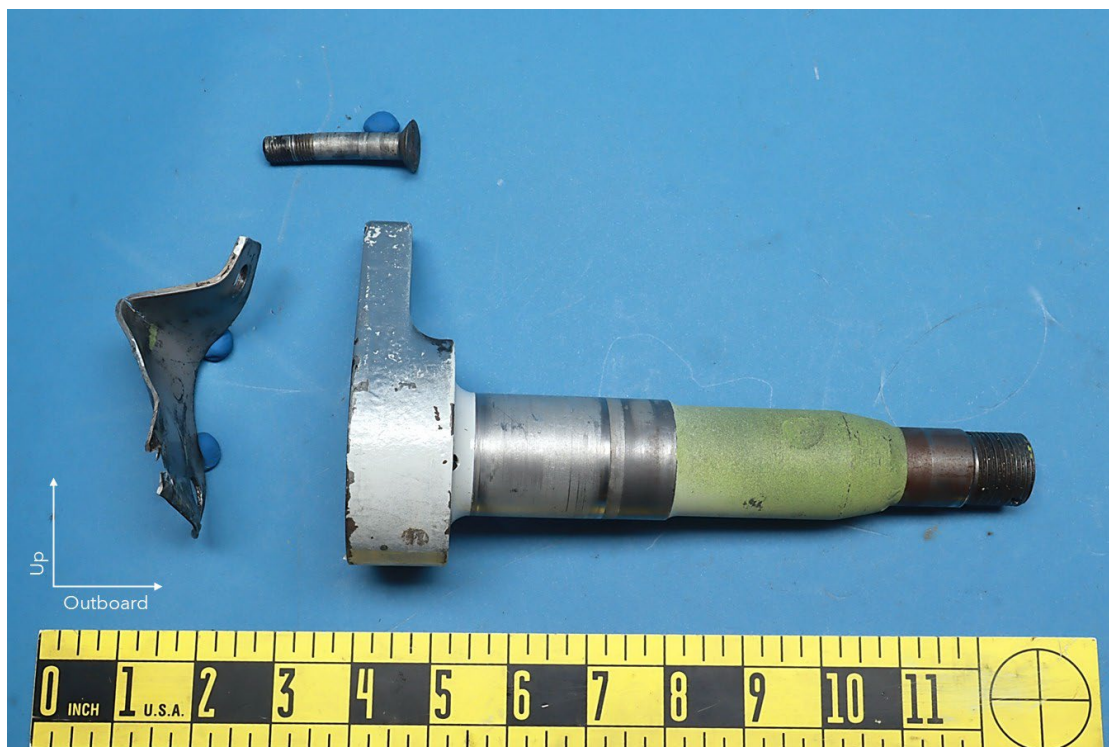
The right main landing gear axle, a tapered shim, and a countersunk attachment bolt from the accident aircraft, shown in figure 1, were submitted to the materials laboratory for examination. The axle component consisted of a variable diameter shaft region with an integrated collar where it attached to the landing gear spring with three attachment bolts. Two of the bolts at the lower end inserted from the landing gear spring side and engaged with the threaded collar; the countersunk bolt at the upper end inserted from the axle side and was secured with a nut on the landing gear spring side. The tapered shim was sandwiched between the axle and landing gear spring with the thicker side oriented upward.

**Figure 1.** Photograph of the axle (right), tapered shim (left), and countersunk bolt (above) as received.

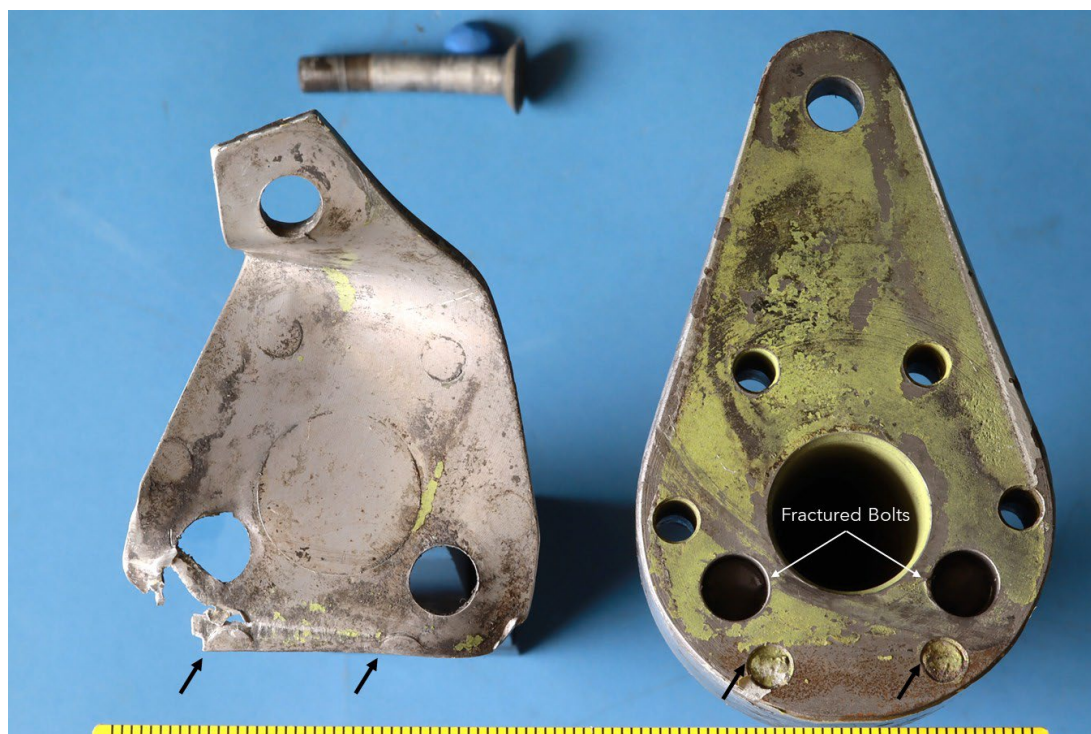
Figure 2 shows a view of the mating faces of the axle and tapered shim. The two fractured lower bolt shafts were retained in the axle, shown more closely in figure 3. The tapered shim was bent and buckled outboard, downward, and slightly aft. Two curved witness marks were observed near the lower edge of the tapered shim as indicated by the black arrows in figure 2. These witness marks were aligned with the hole features on the mating axle collar surface, also indicated by black arrows.

**Figure 2.** Photograph of the mating surfaces of the tapered shim (left) and axle (right). Corresponding witness marks are indicated by black arrows.

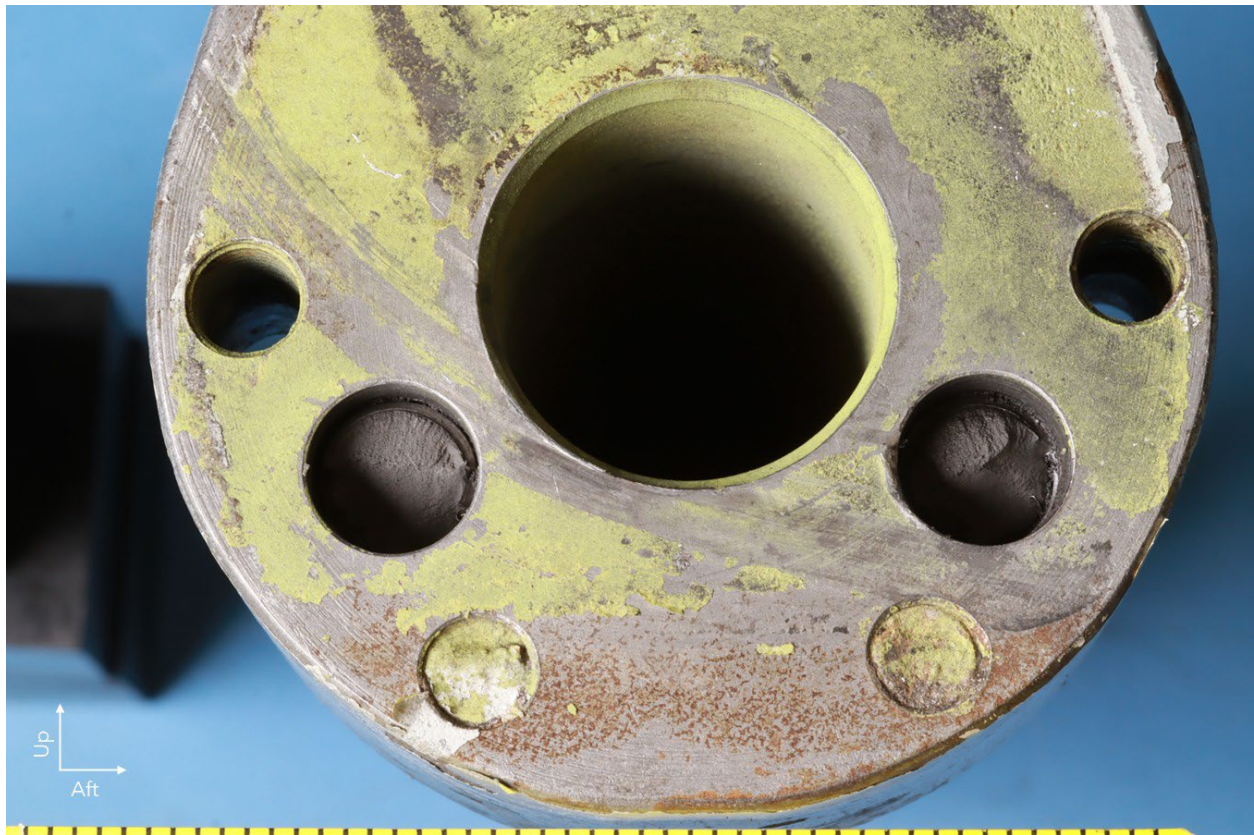
**Figure 3.** Photograph showing the fractured bolt shafts retained in the axle.

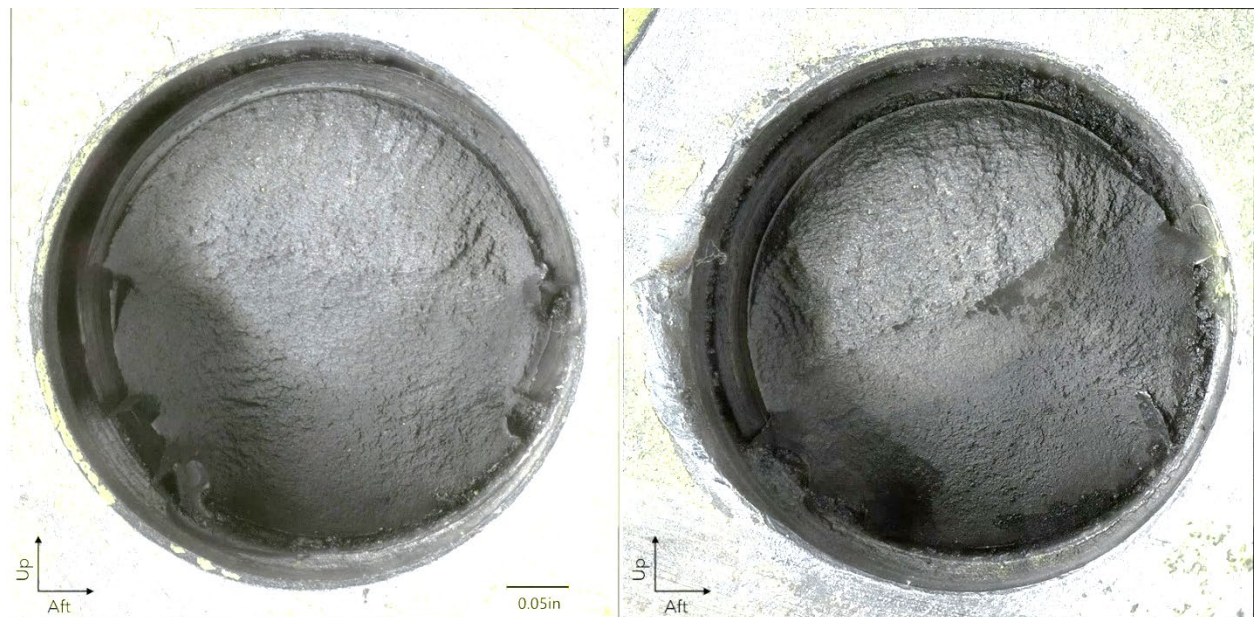
The fractured bolt shafts retained in the axle exhibited a relatively rough, matte gray fracture surface morphology. Magnified images are shown in figure 4. The fracture surfaces were cleaned using soapy water and a soft bristled brush followed by a water rinse and subsequent solvent cleaning with acetone. Radial features were observed emanating from a thread root at the upper edge of both bolts over a relatively flat fracture surface through approximately

40% of the bolt cross section at which point the fracture continued downward along an outboard and slightly aft slanted plane through the remainder of the bolt. The relatively flat fracture surface at the top of the bolt was consistent with overstress fracture from a downward bending load prior to final fracture in downward and slightly aft bending.

**Figure 4.** Digital microscope images of the fractured bolt shafts retained in the axle. Radial fracture features emanated from the top of the fasteners over a relatively flat plane which transitioned to a slanted fracture path.

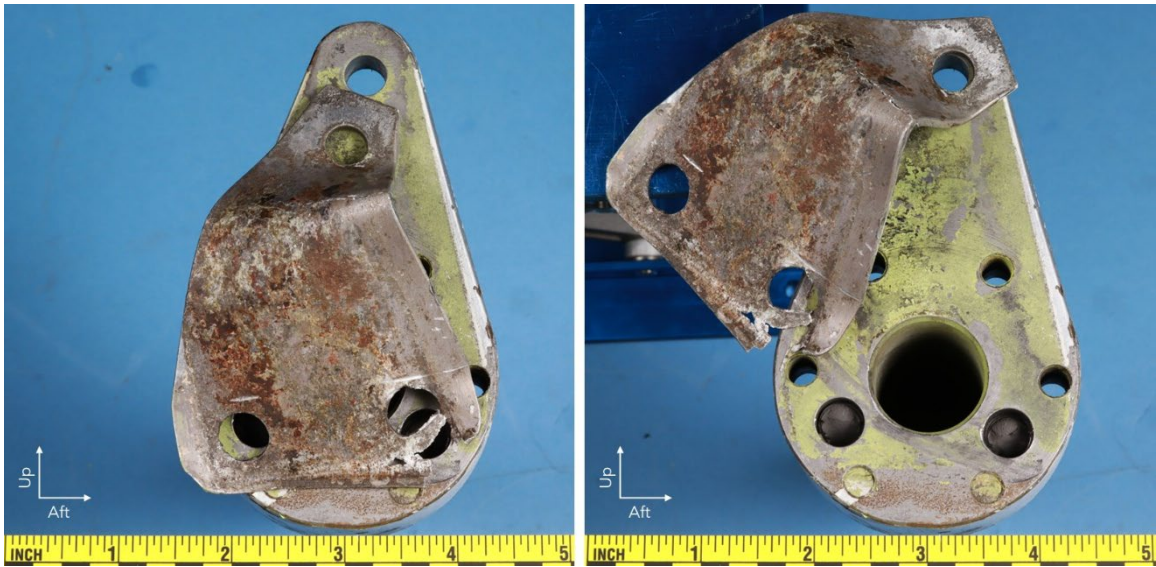
Figure 5 shows images of the tapered shim aligned with the axle at the lower attachment holes, left, and the upper attachment hole, right. A curved witness mark of scraped primer along the face of the axle collar aligned with the corner of the tapered shim in the deformed and rotated condition.

**Figure 5.** Photographs of the tapered shim aligned with the bottom fastener holes (left) and the top fastener hole (right) relative to a curved witness mark where the primer had been scraped away.

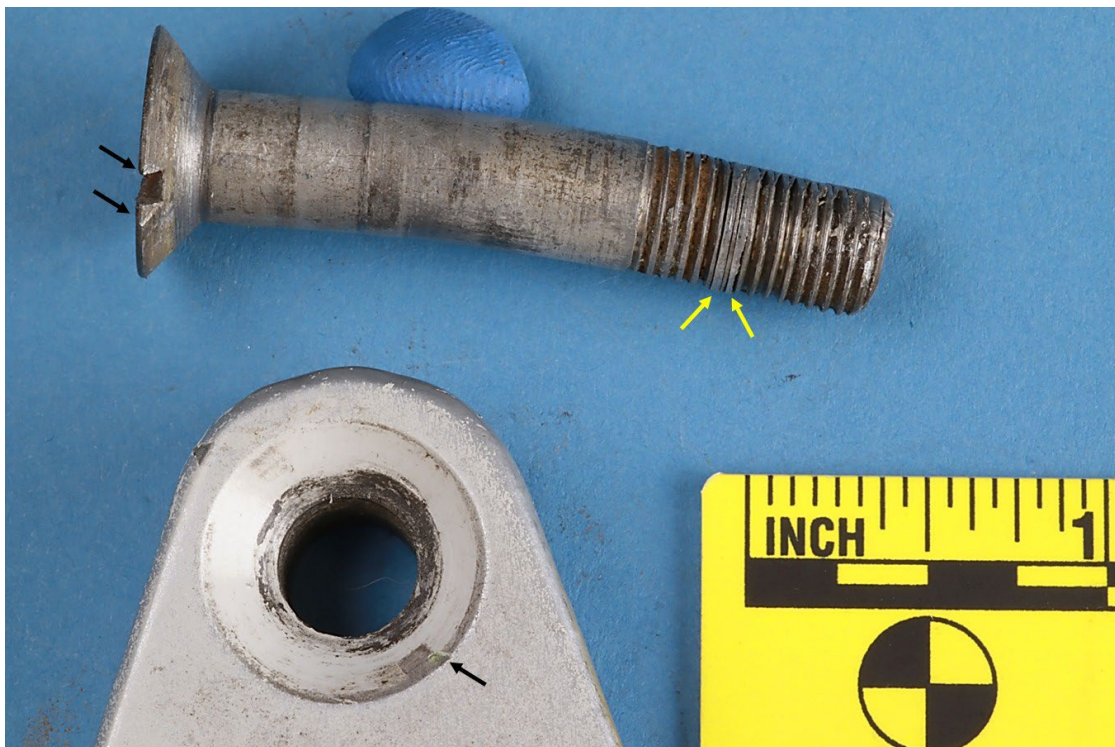
Figure 6 shows the orientation of the countersunk bolt with the upper attachment hole for the axle. Two diametrically opposite witness marks on the white painted region of the countersink in the axle aligned with the slot of the fastener head. Corresponding witness marks were observed on the bearing surface of the fastener head where an area of chipped paint was observed on the axle as indicated by the black arrows in Figure 6. With the bolt oriented in this position, a downward bend was observed along the bolt axis. Portions of metal, consistent with the presence of a nut were retained in two of the thread roots of the bolt as indicated by yellow arrows. The thread profile along the upper surface of the bolt was smeared and flattened.

**Figure 6.** Photograph of the countersunk attachment bolt relative to the countersink in the axle. Witness marks on the fastener aligned with chipped paint on the axle. Fragments of metal were retained in the fastener threads as indicated by yellow arrows.
