ANC24LA036

## INVESTIGATION PHOTOGRAPHS

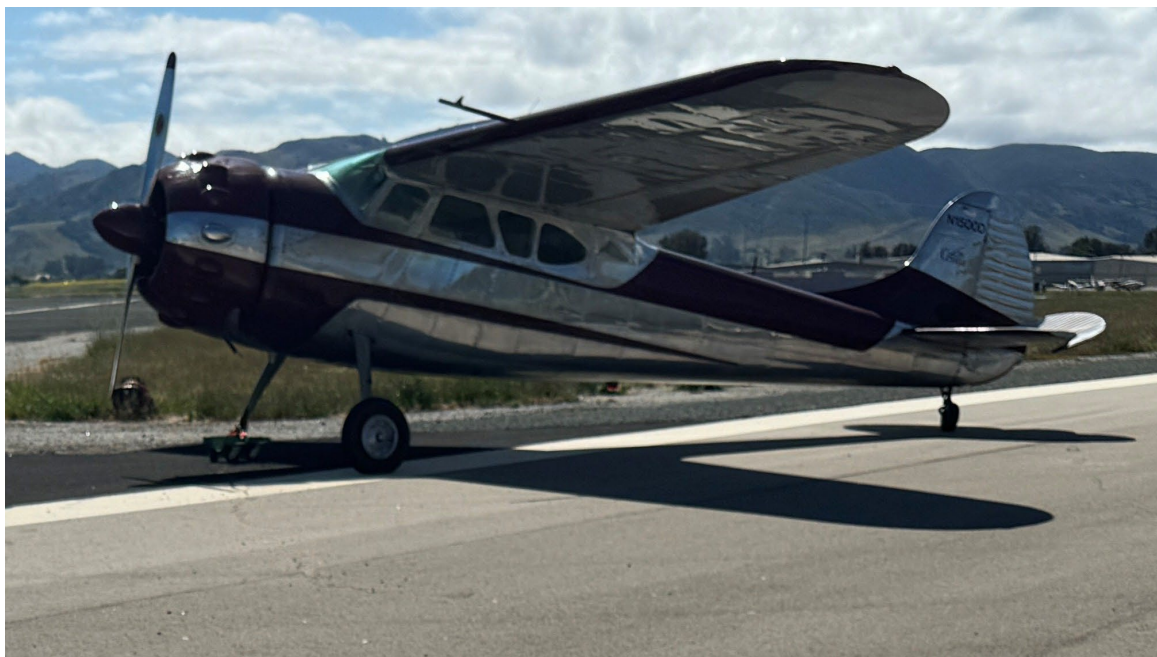
**Photograph 1 - Image of accident airplane (Courtesy of Airport Operations)**

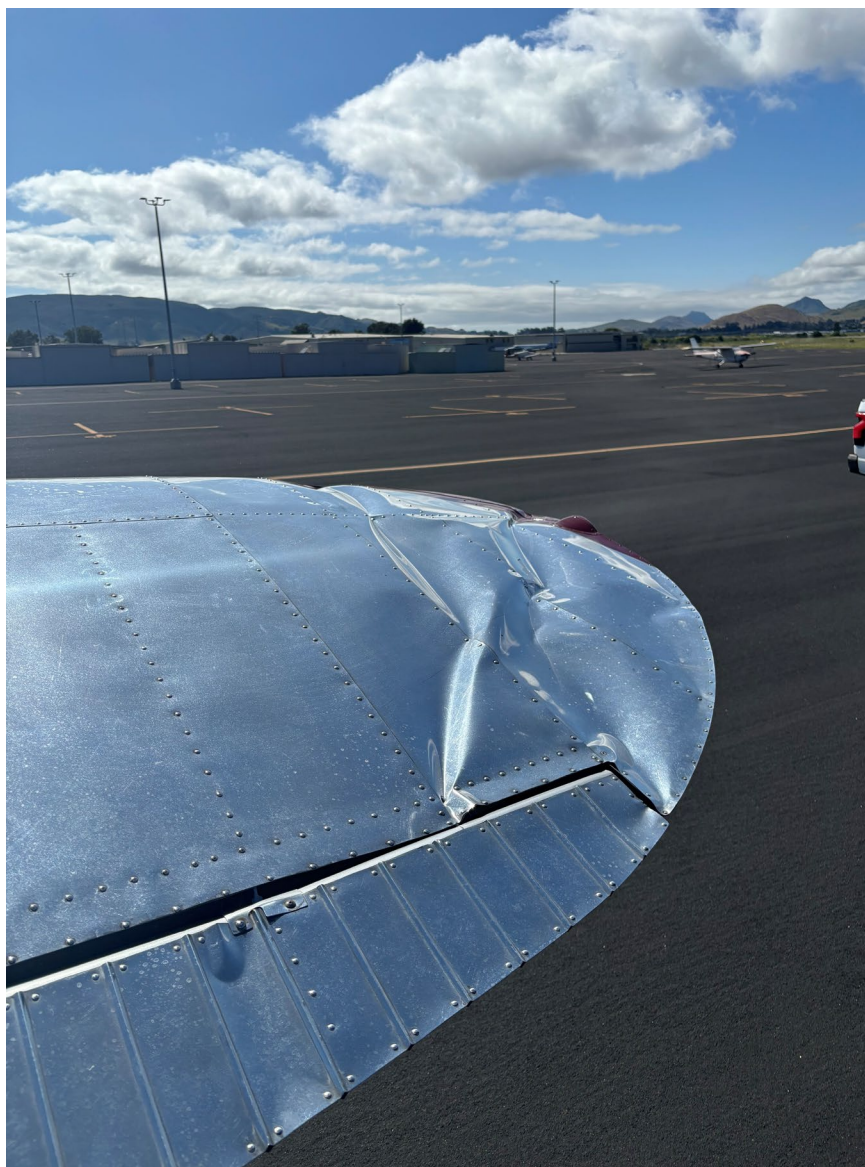
**Photograph 2 - Image of damaged right wingtip and aileron (Courtesy of Airport Operations)**

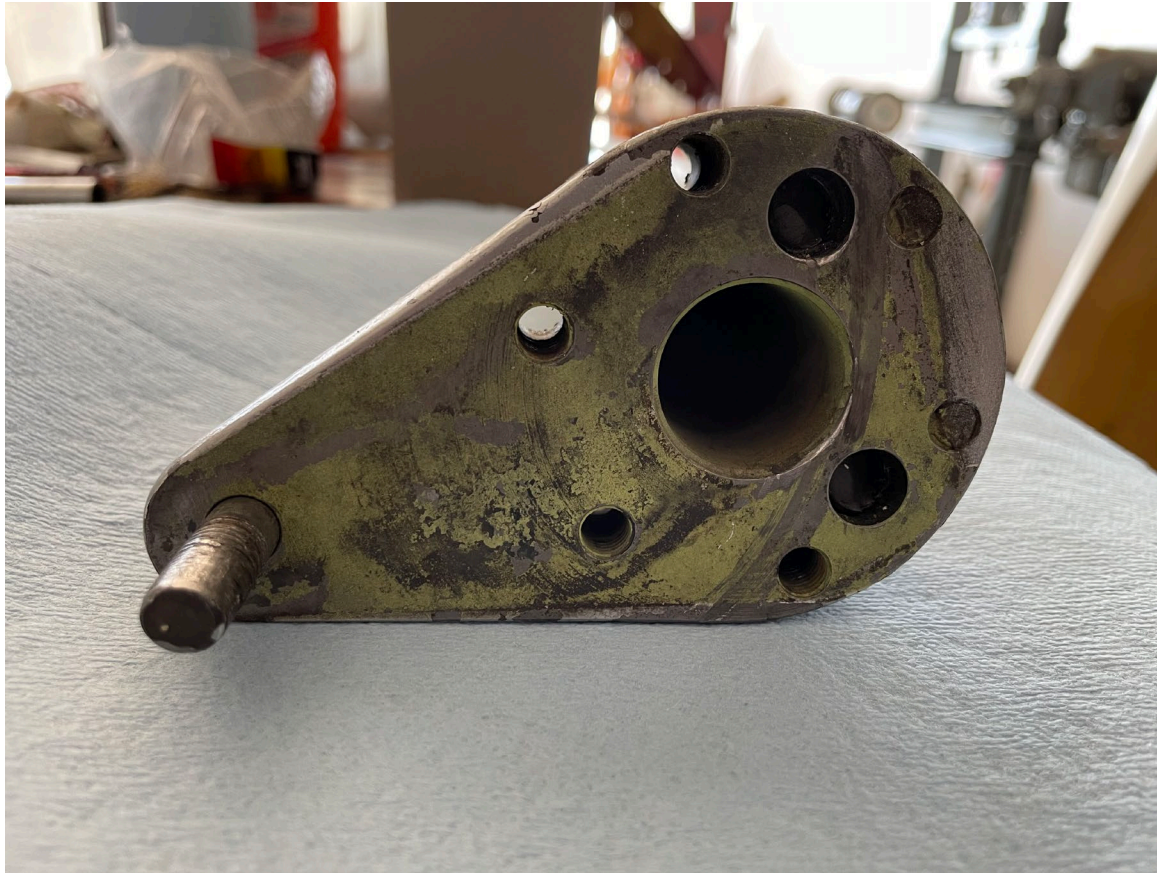
**Photograph 3 - Image of right main landing gear axle (NTSB Photo)**
