# National Transportation Safety Board

ANC24LA042

## **WRECKAGE EXAMINATION**

Location: Willow, Alaska  
Date: May 31, 2024  
Time: 1900 Local  
0300 Zulu  
Airplane: Cessna 170A

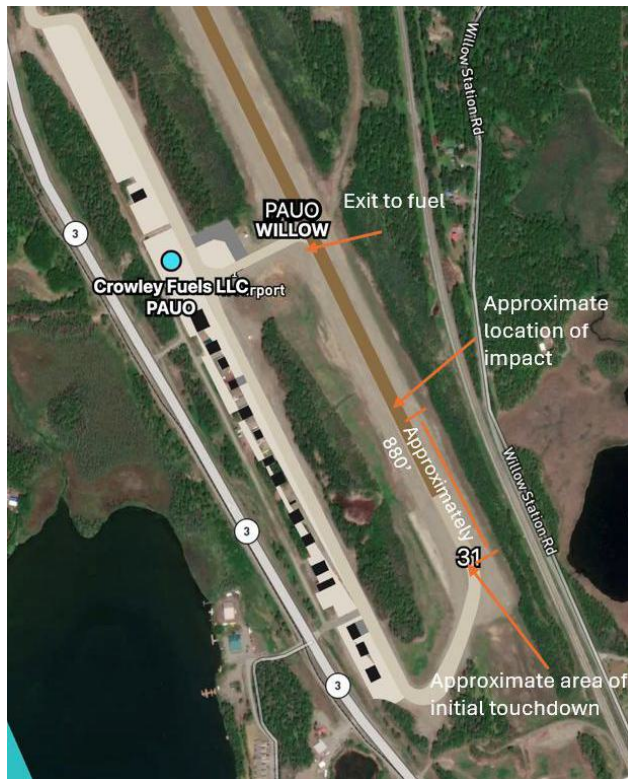
**Figure 1**

The accident occurred at the Willow Airport on runway 31, a dirt/gravel strip that is 4,400 feet long and 75' feet wide. The pilot reported touching down near the beginning of the runway and entering a "fast taxi" to the exit for fuel (Figure 1). It is estimated that the airplane traveled approximately 880 feet before the pilot reduced the throttle to idle to get ready to exit the runway.

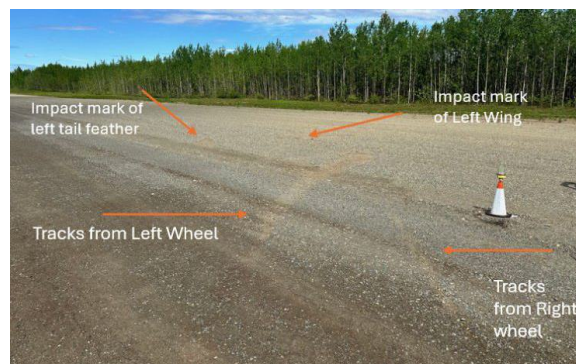
An inspection of runway 31 revealed tracks from the accident aircraft as well as wing and elevator scars in the gravel consistent with the pilot's record of events (Figure 2). The tracks indicated that the airplane traveled in a gradual right turn approximately 120 feet from the center of the runway to the point where the wing and elevator impacted the ground.

**Figure 2 Wheel marks and impact marks**

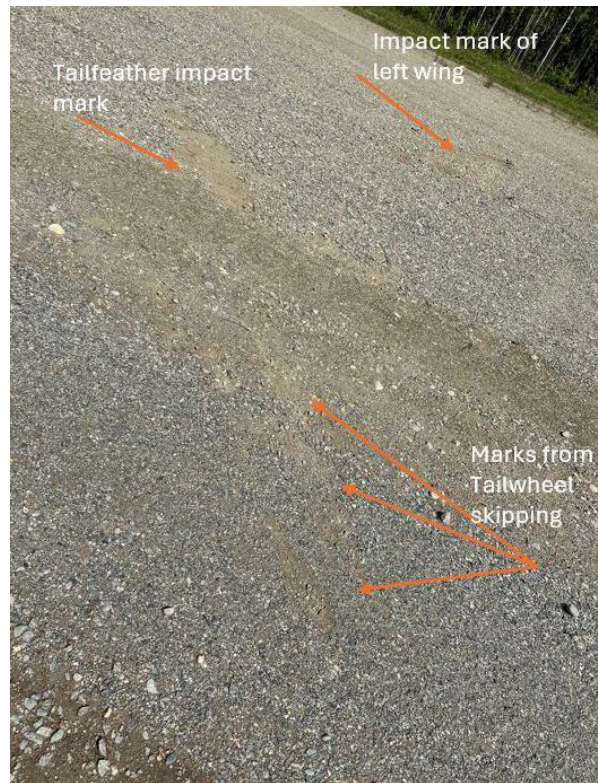
Tracks from the tail wheel were also noted in the gravel indicating that the tail wheel was skipping prior to or during impact of the left wing and elevator (Figure 3). The impact scar from the left wing was approximately 11 feet in length.

**Figure 3 Impact marks from tailwheel**

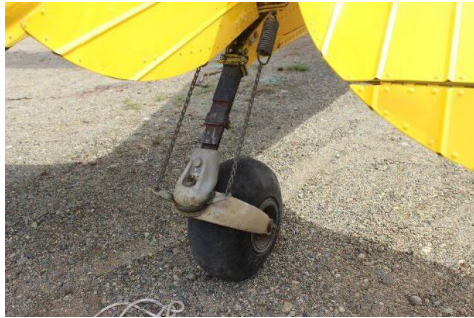
The tail wheel rotated without resistance a full 360° (Figure 5). The steering arm is observed to be bent (figure 4), the rigging of the steering chains tension is taut. The leaf spring was observed to have no anomalies.

**Figure 5 Tail wheel assembly**

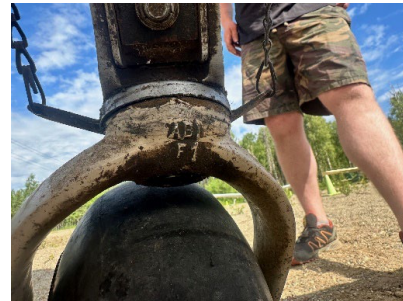
**Figure 4 Steering arm**

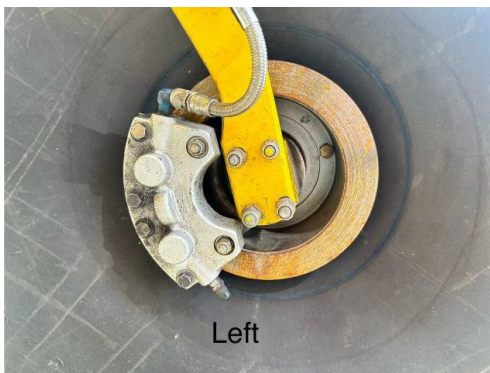
The brake calipers and pads (Figure 6-7) on both wheels were examined as well as the master brake cylinder (Figure 8-9). The brake pedals were moved the master brake cylinder functioned normally. No hydraulic leaks in the brake system were noted. There did not appear to be any rubbing from the double puck brake pads on the drum.

**Figure 6 Left brake caliper and brake pad**

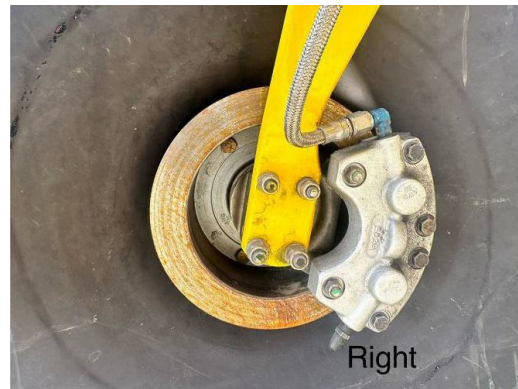
**Figure 7 Right brake caliper and brake pad**

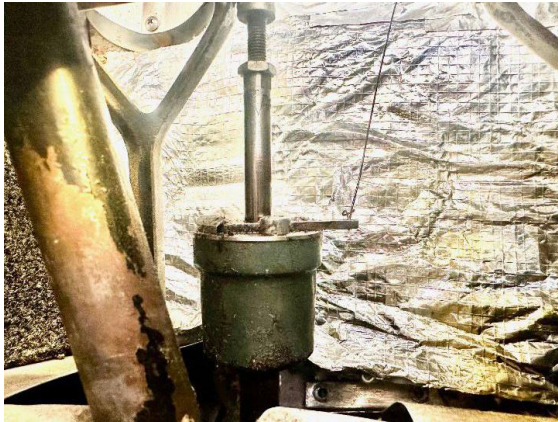
**Figure 8 View of master brake cylinder**

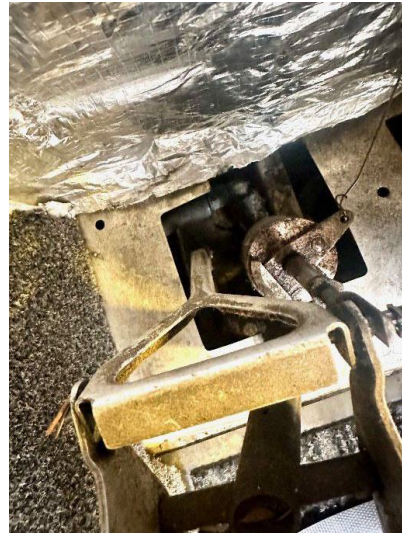
**Figure 9 Top view of master brake cylinder**
