ANC24LA049

## INVESTIGATION PHOTOGRAPHS

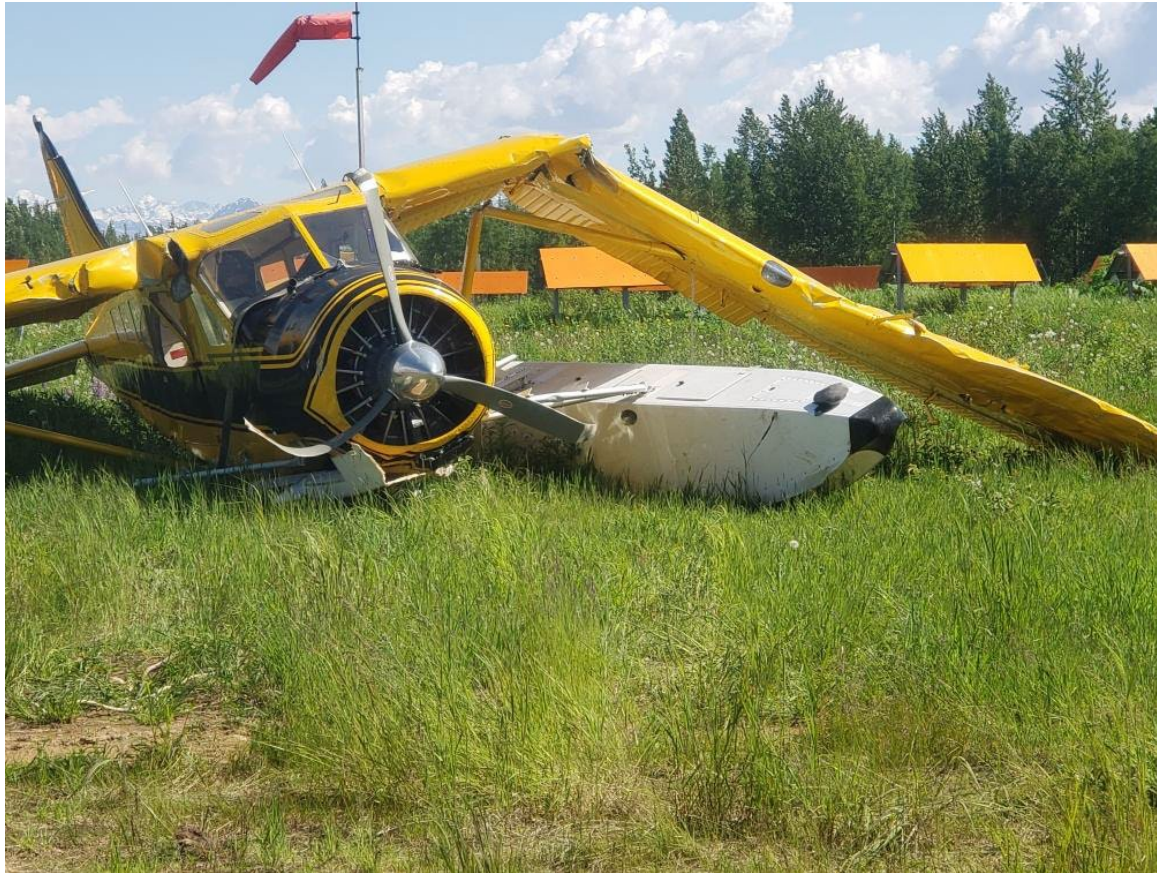
**Photograph 1 - View of accident airplane after recovery.**

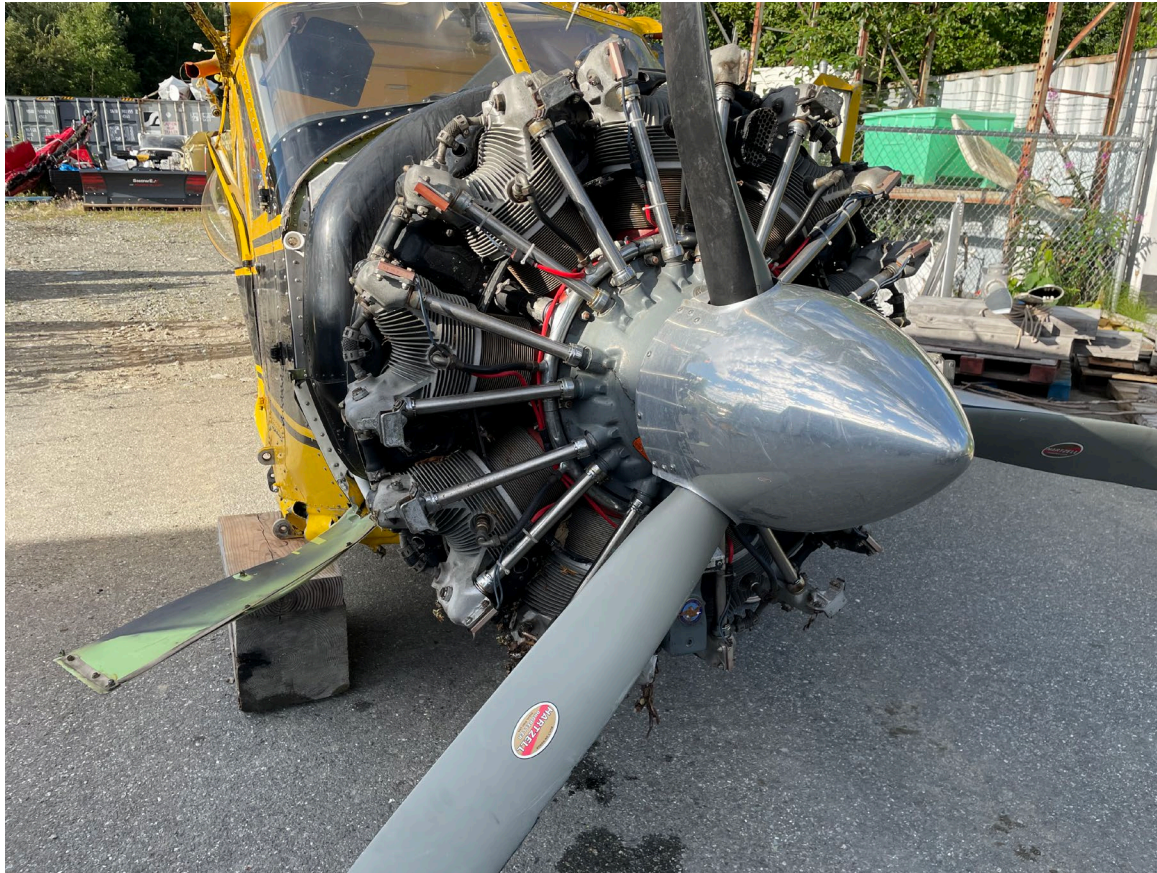
**Photograph 2 - View of engine during engine examination**
