# National Transportation Safety Board

ANC24LA049

## ENGINE EXAMINATION

Location: Port Alsworth, Alaska  
Date: June 10, 2024  
Time: 1635 Local  
Airplane: DeHavilland DHC-2 N4957

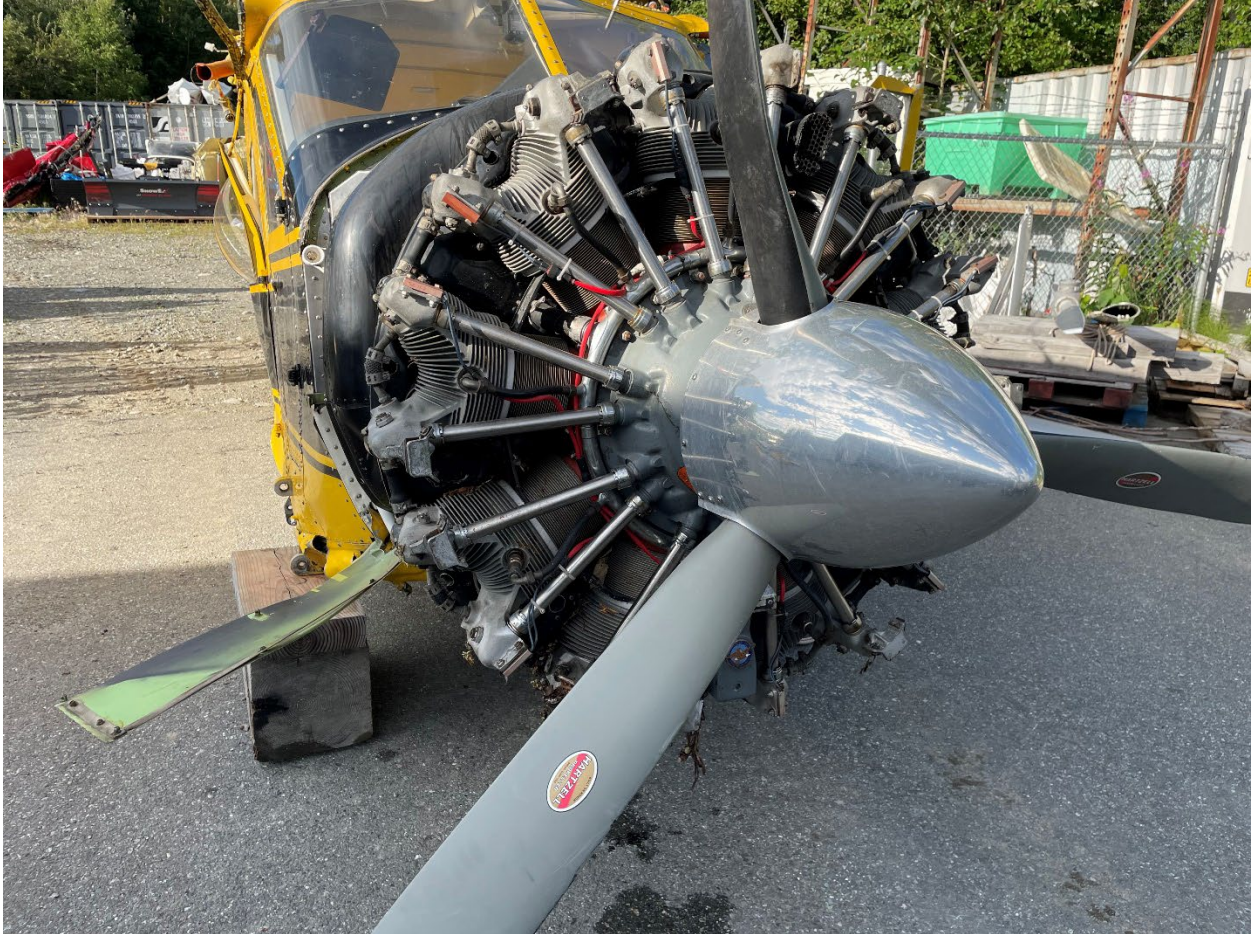
**Figure 1** View of the engine.

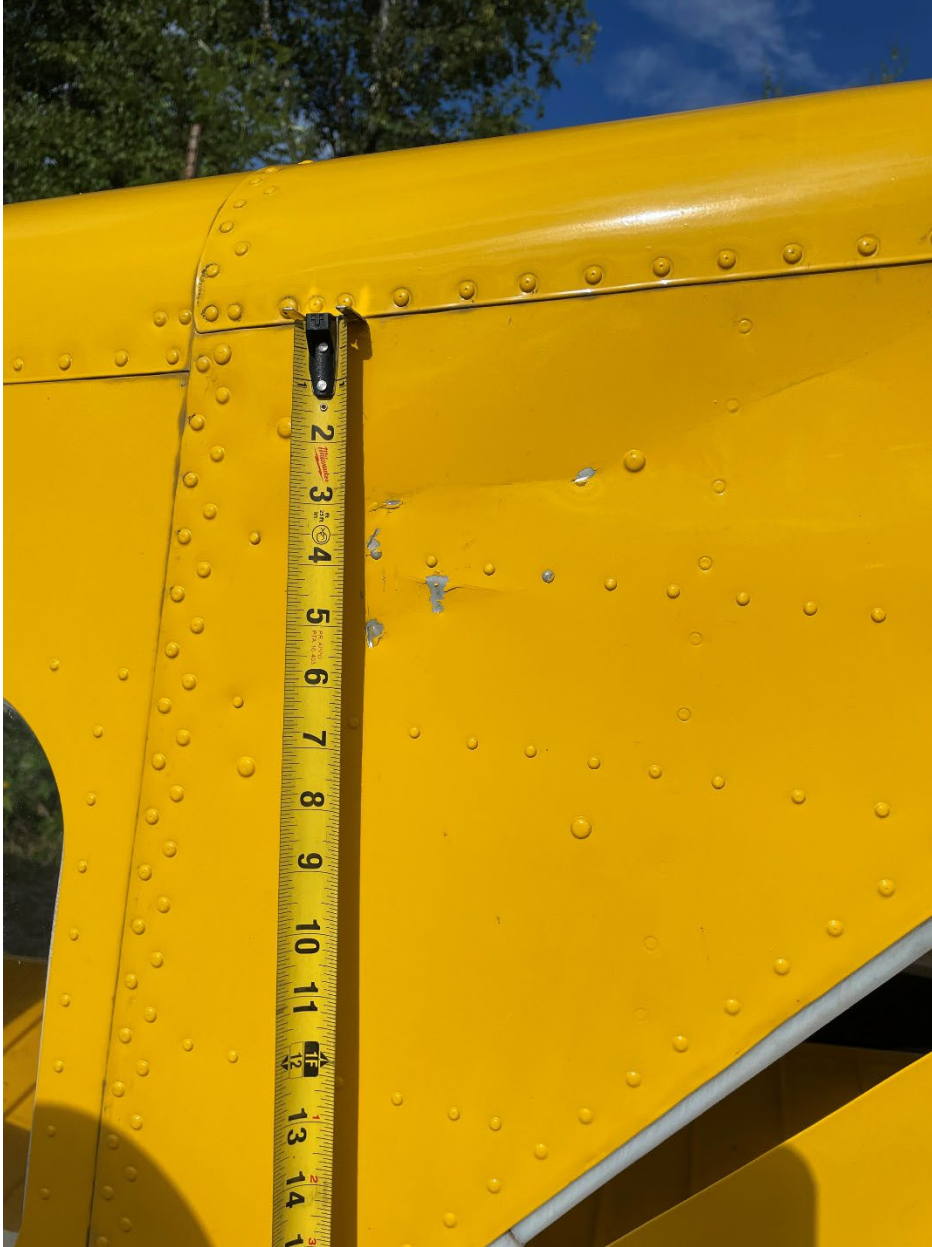
Witness marks were observed on both sides of the fuselage indicating flap position at impact. All connections to the engine instruments were secure and undamaged.

**Figure 2. View of witness mark left by right side flap during impact.**

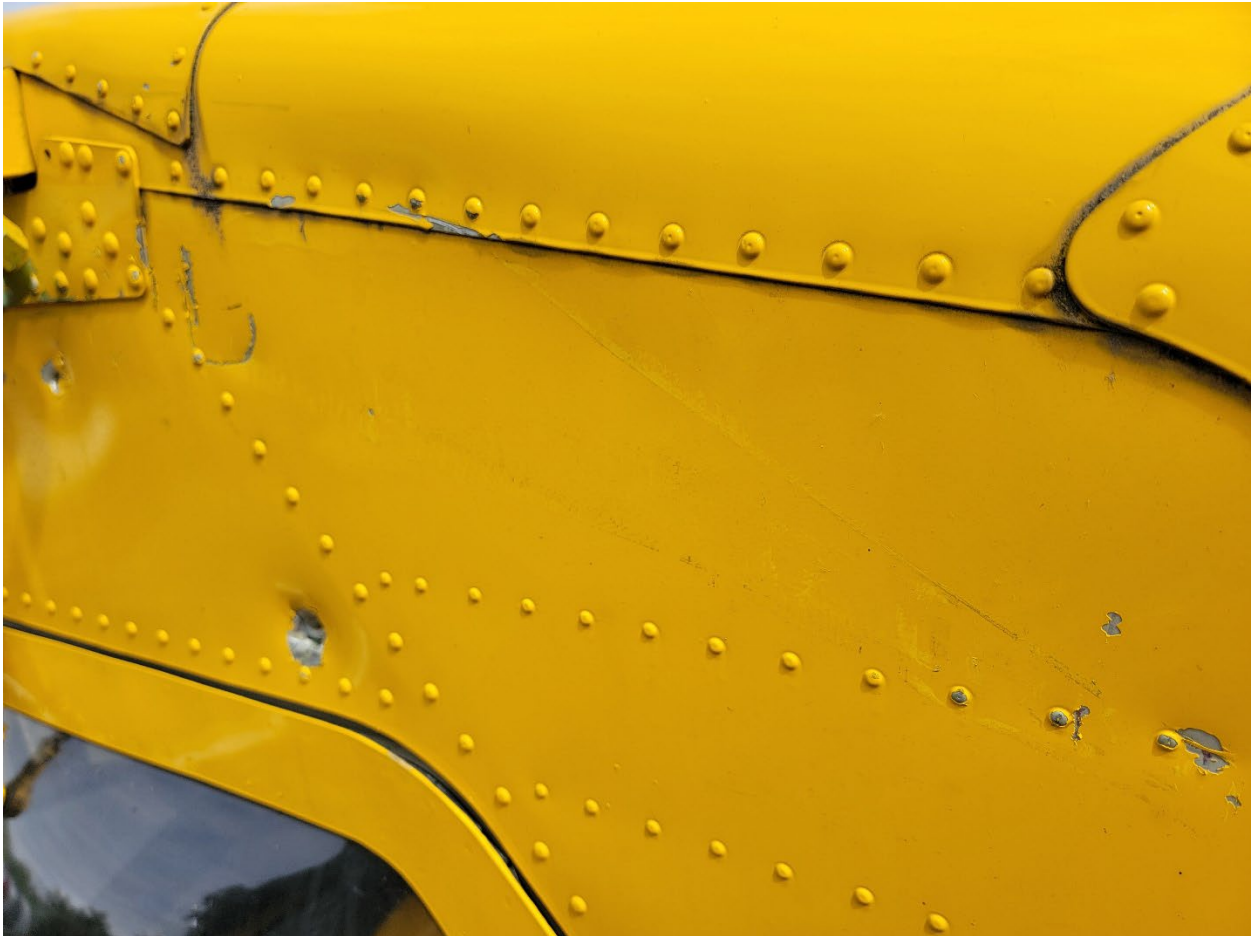
**Figure 3**View of witness mark left by left side flap during impact.

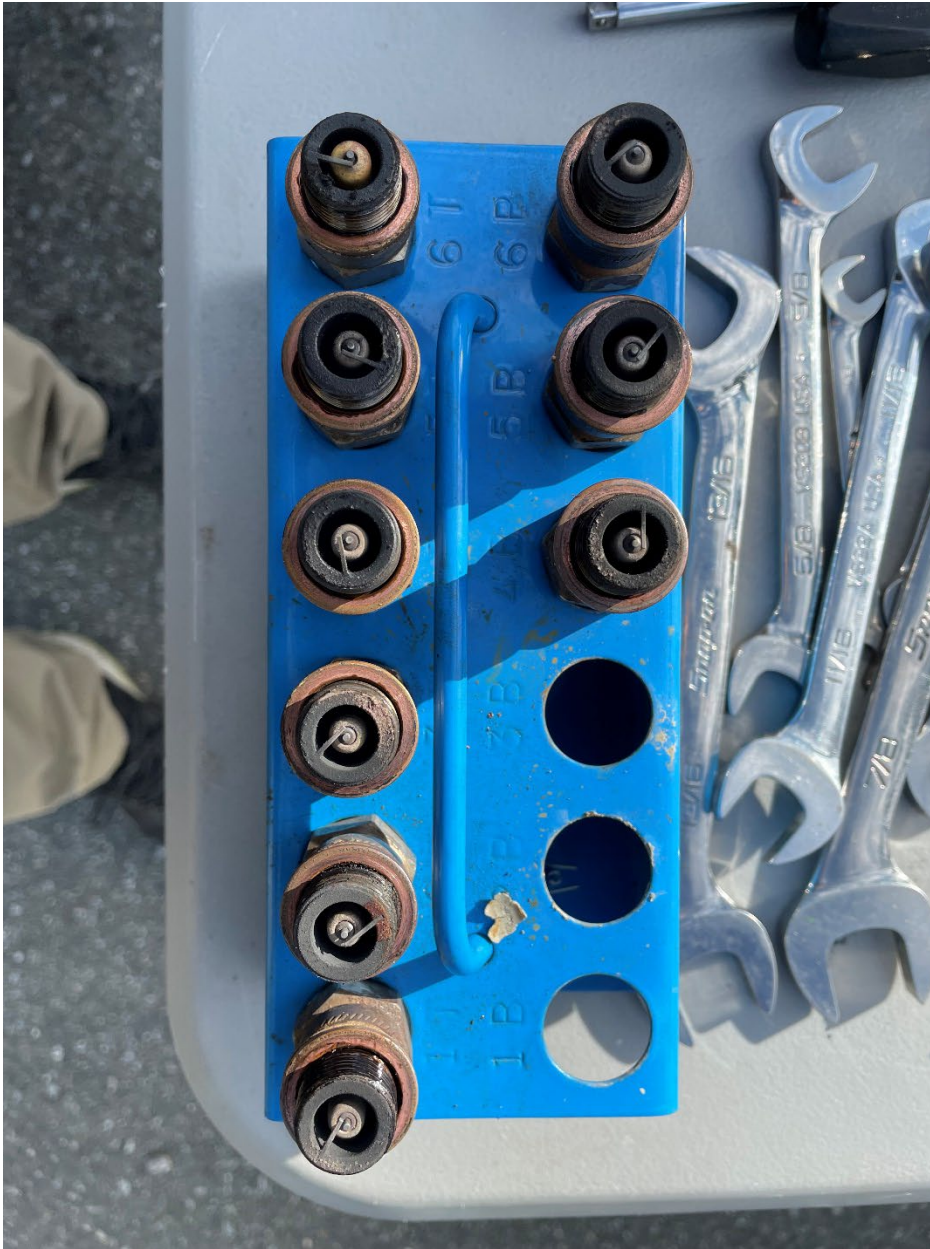
The engine turned over freely despite being heavily damaged. Pulled the spark plugs which were fine wire style plugs and there were no abnormalities observed.

**Figure 4 Sparkplugs removed from engine.**

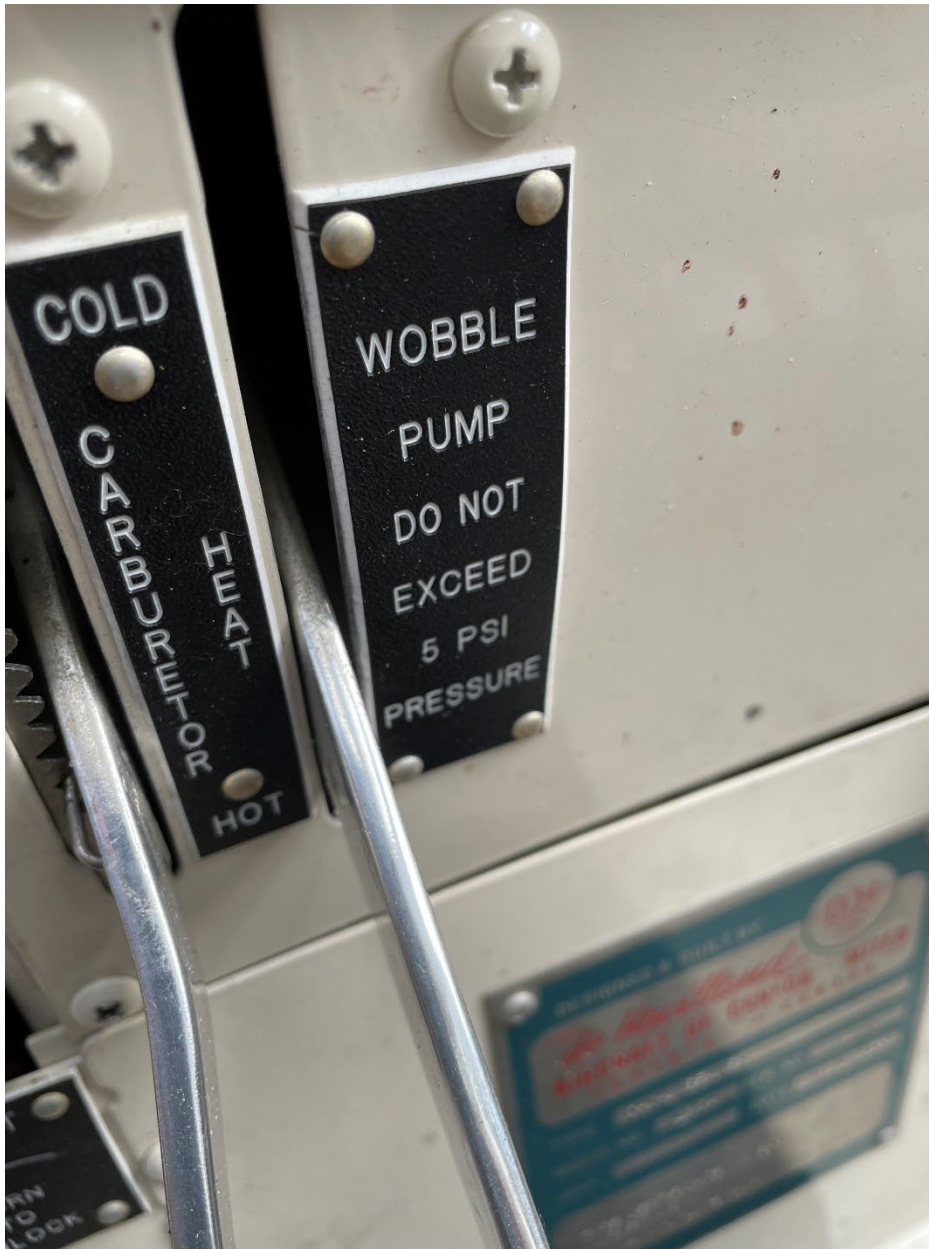
The induction system up to and including the carburetor was free of debris and no obstructions were found. All engine controls functioned properly and went stop to stop. The carburetor heat was in the "HOT" or "ON" position. The main fuel line was disconnected at the engine side of the firewall and fuel flowed on all three tanks.

**Figure 5 View of the carburetor heat control lever.**

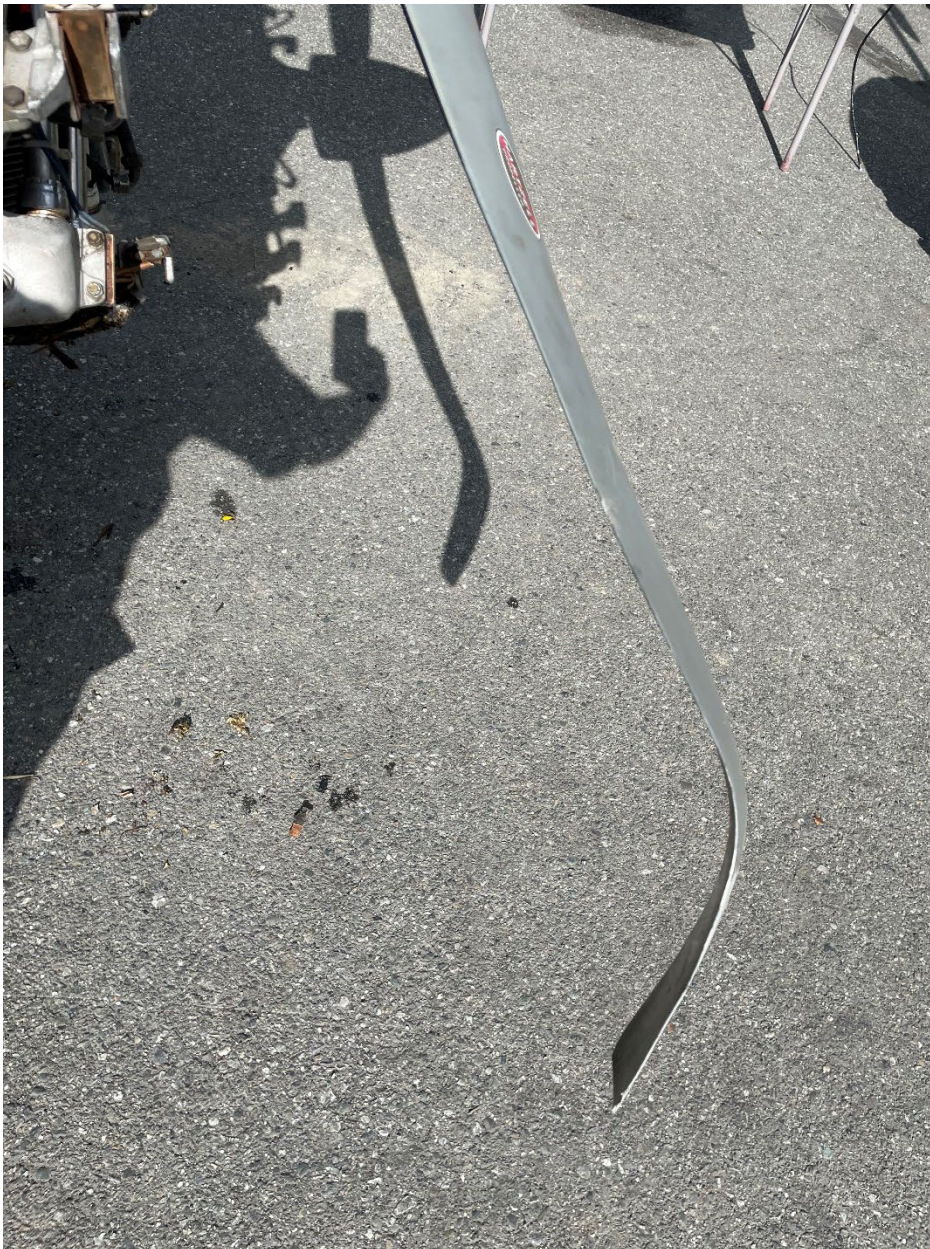
**Figure 6 Propeller one**

The propeller control was free and correct and went stop to stop. The propellers exhibited tip bending due to impact; however, there was no rotational scoring present.
