ANC24LA055

## INVESTIGATION PHOTOGRAPHS

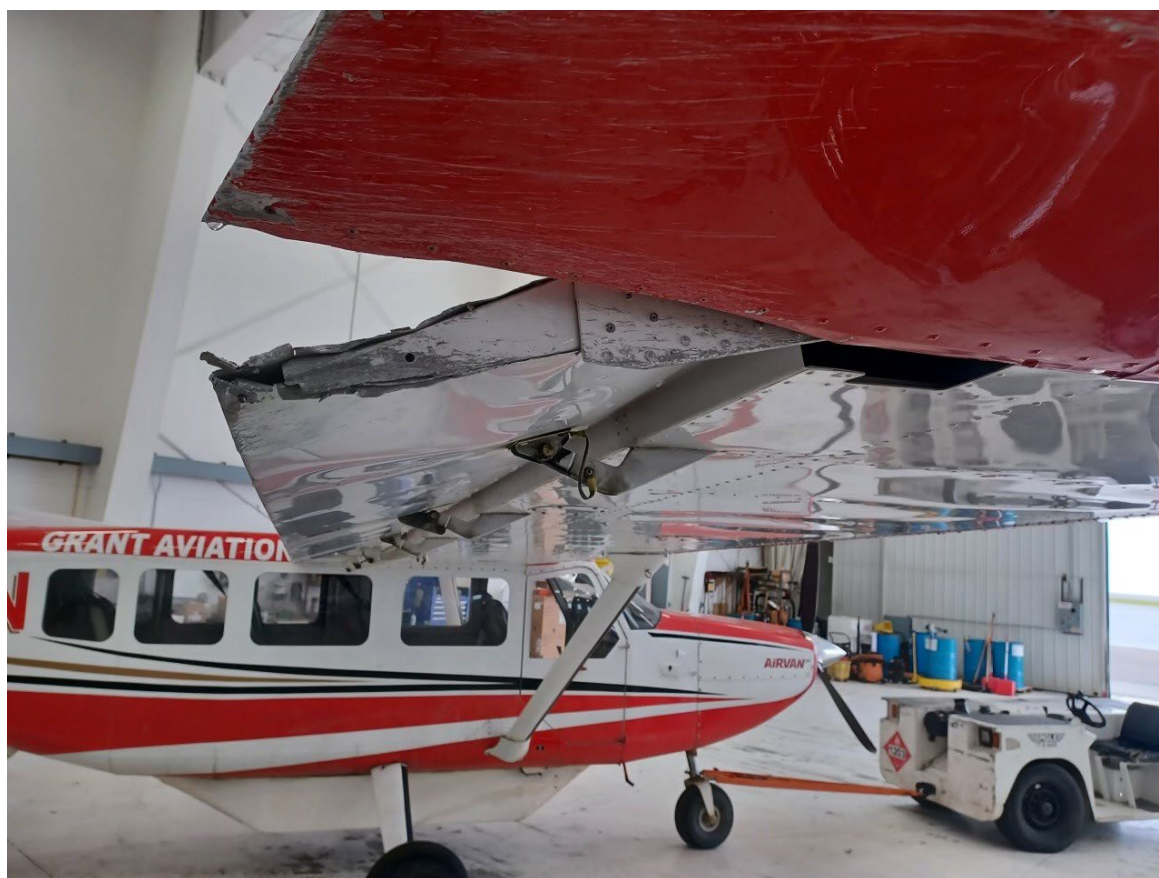
**Photograph 1 - View of damage to the bottom of the wing and aileron (Courtesy of operator)**

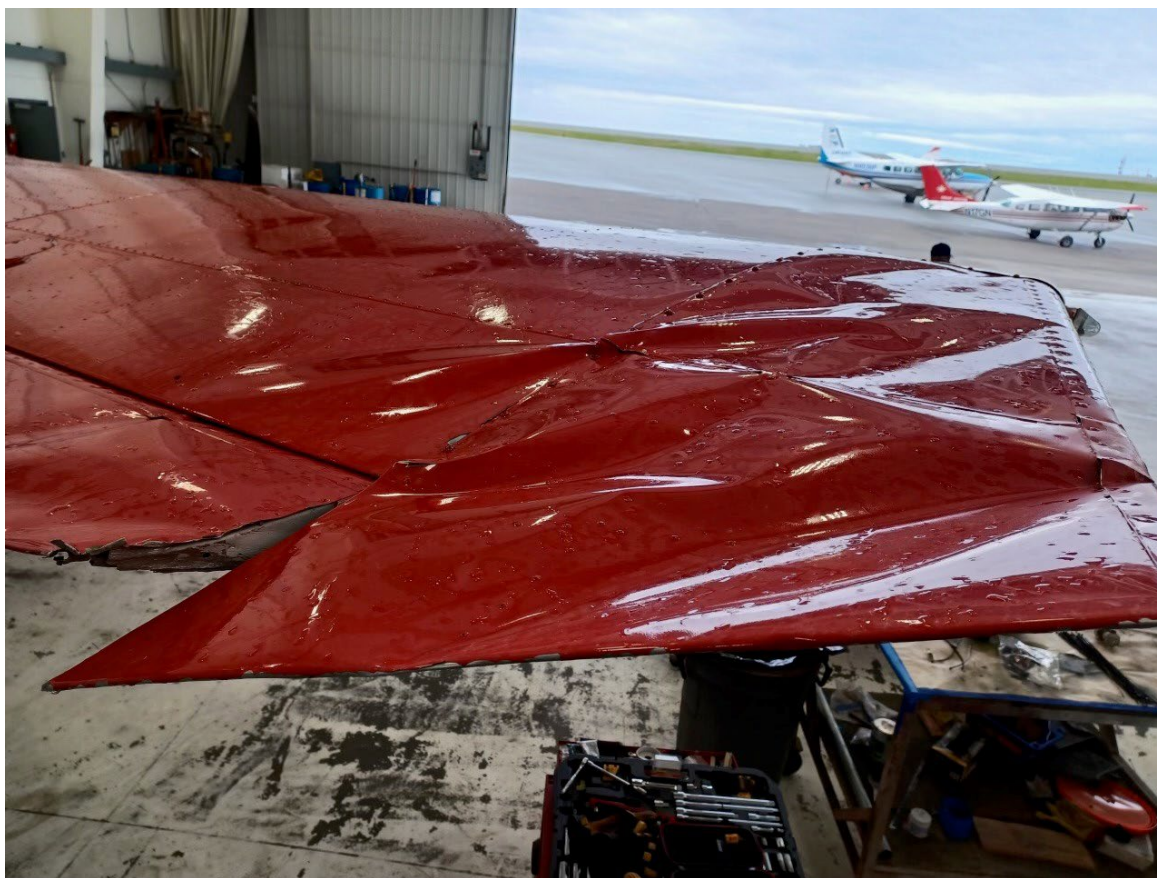
**Photograph 2 - View of damage to the top of the wing (Courtesy of operator)**

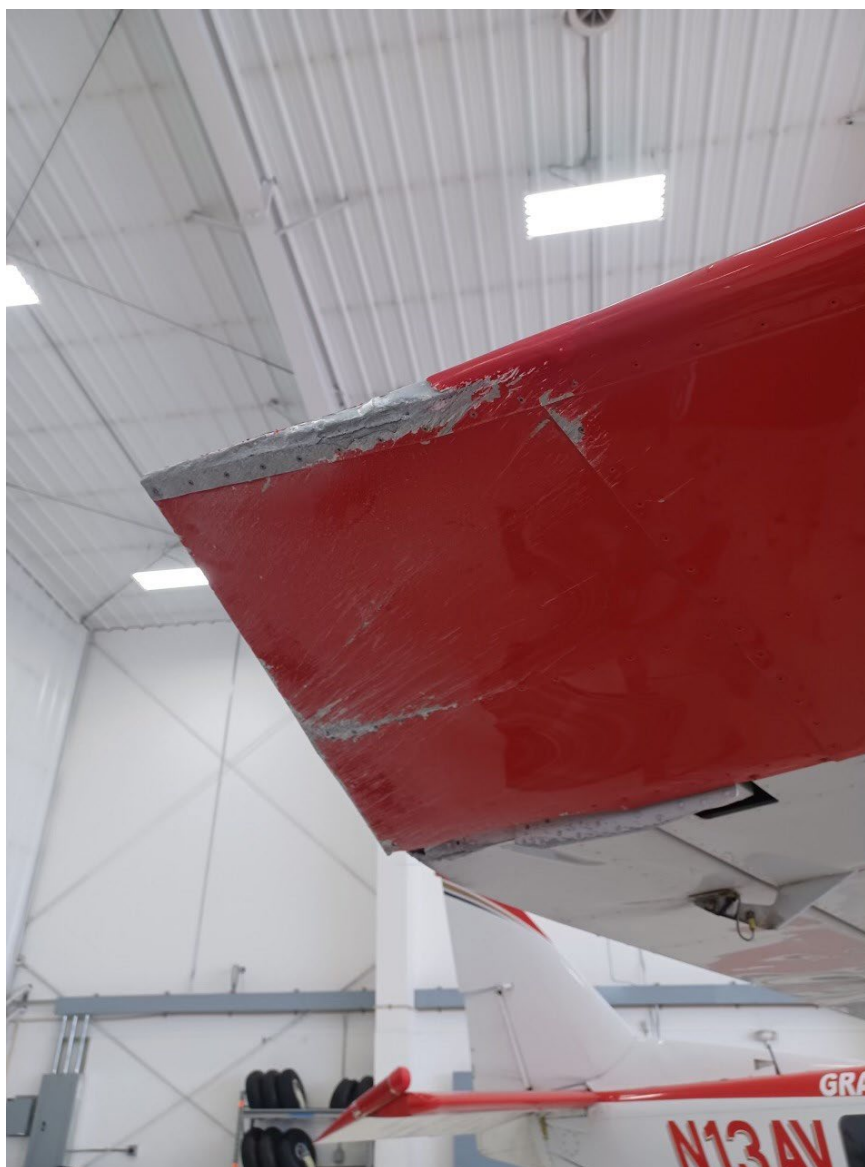
**Photograph 3 - View of wingtip damage (Courtesy of operator)**
