ANC24LA057

## INVESTIGATION PHOTOGRAPHS

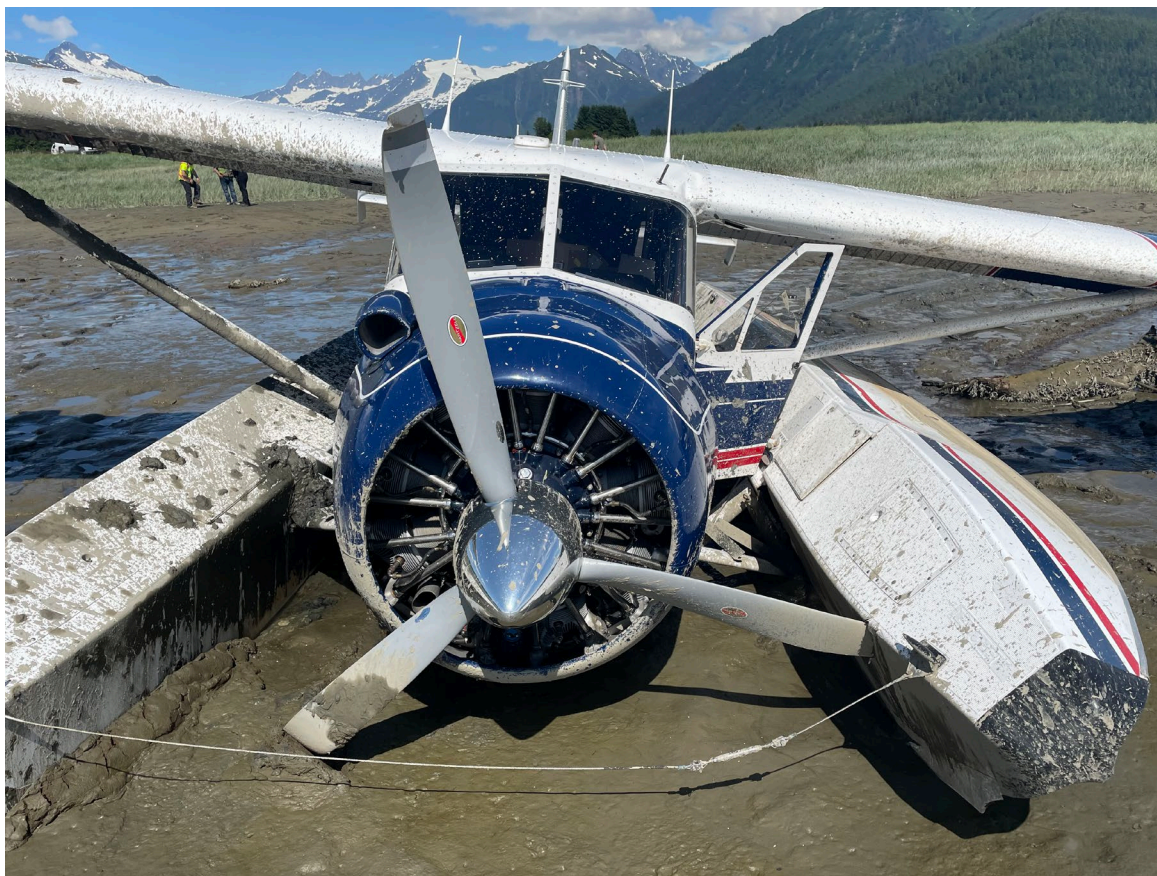
**Photograph 1 - View of the front of the airplane where it came to rest. (Courtesy of FAA)**

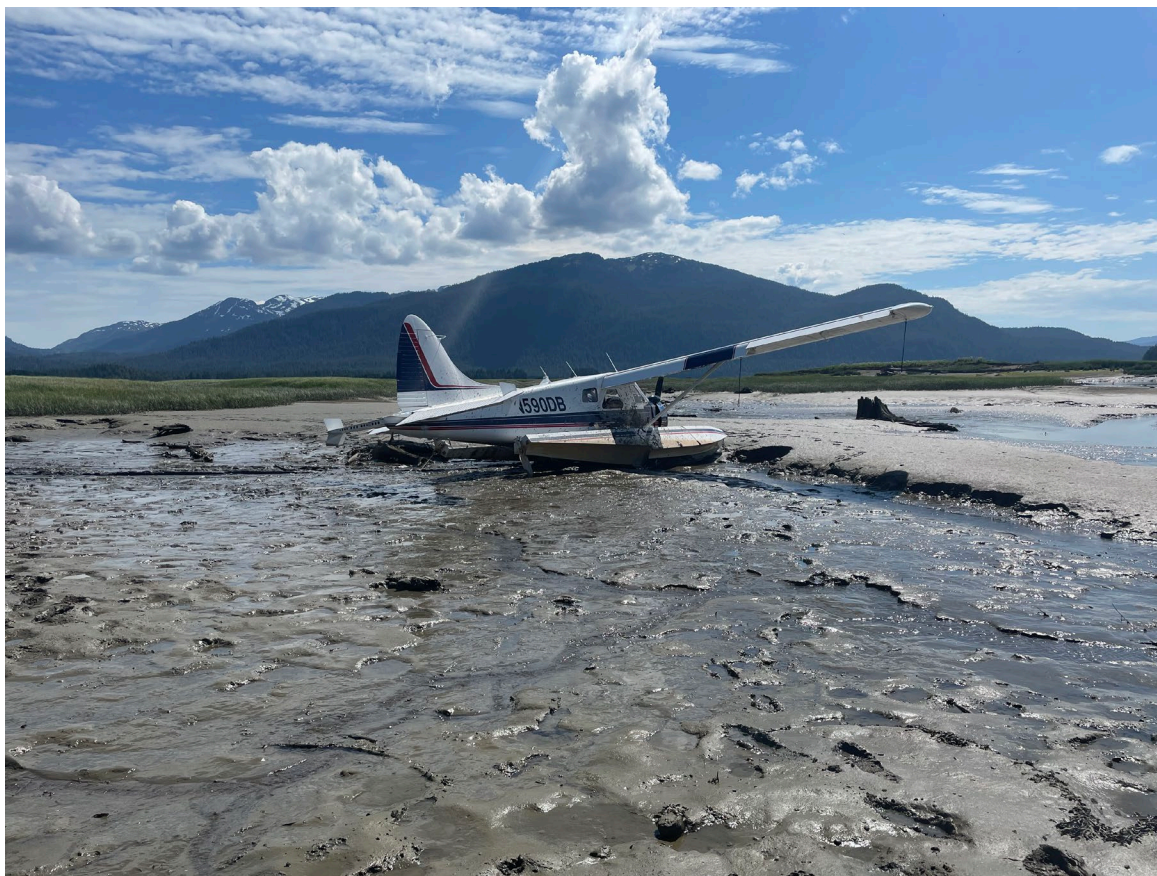
**Photograph 2 - View of right side of the airplane where it came to rest. (Courtesy of FAA)**

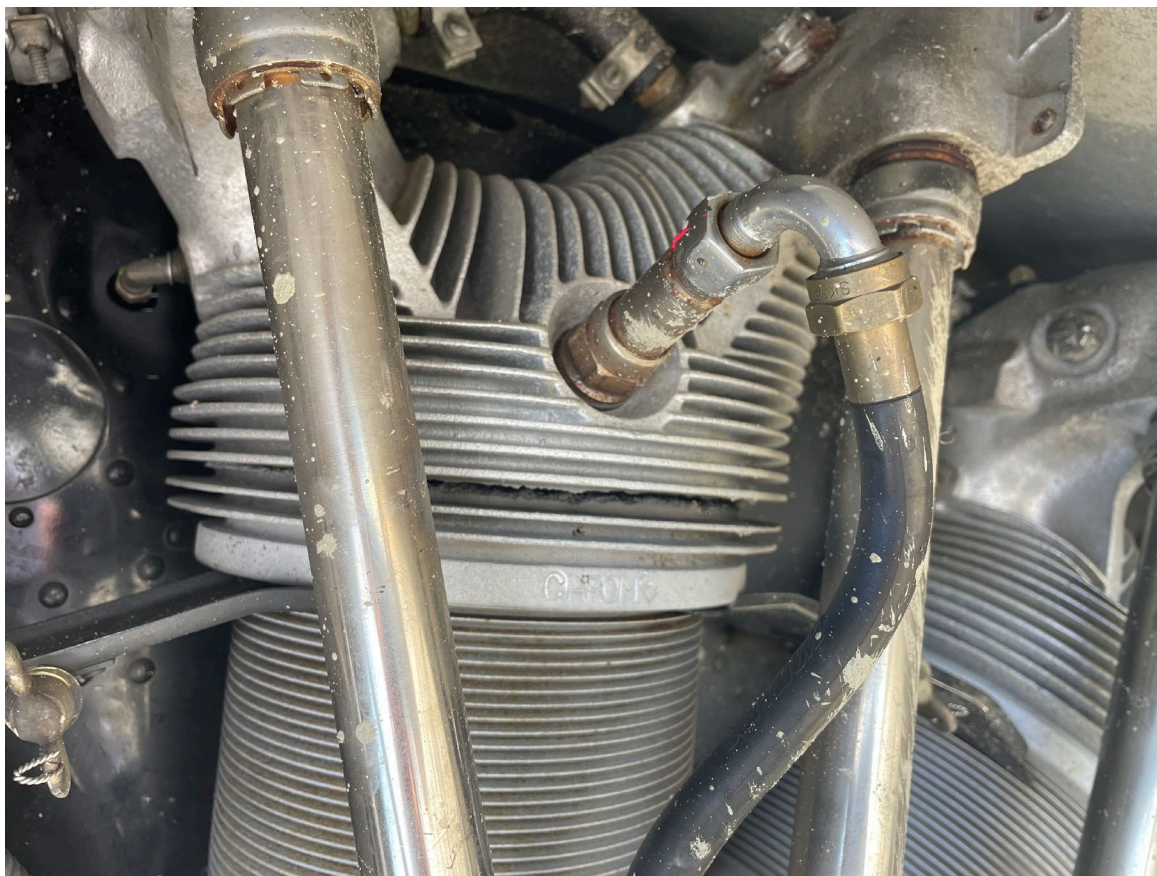
**Photograph 3 - View of the cracked No. 9 cylinder (Courtesy of FAA)**
