# National Transportation Safety Board

ANC24LA064

## **MATERIALS LABORATORY**

Factual Report 25-049

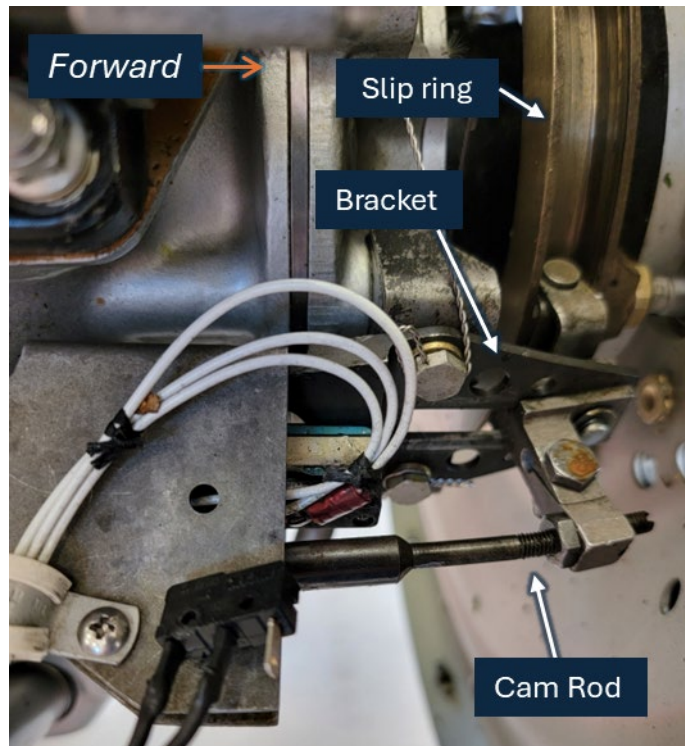
Components from a beta switch assembly from a P&WC PT6A-34 turboprop engine were submitted to the Materials Laboratory for examination. Figure 1 shows the as-received components and Figure 2 shows an assembly schematic for these components. Figure 3 is a picture taken of the assembly during a post-accident examination, showing that the assembly was consistent with the schematic drawing. As discovered during the examination, the cam rod and the guide rail on the potentiometer bracket were bent; per the investigator-in-charge, these parts were straightened by the operator and intended for return to the field prior to entering custody of the NTSB (Figure 4). As a result, the components did not exhibit the same degree of bending deformation at the time of the examination.

accident aircraft, the slip ring was in a far-forward position and the cam rod was outside of the bushing. The end of the rod rested against the forward face of the bushing.

**Figure 3.** Beta switch assembly as found during engine examination. The bracket and cam rod were bent (NTSB photo).

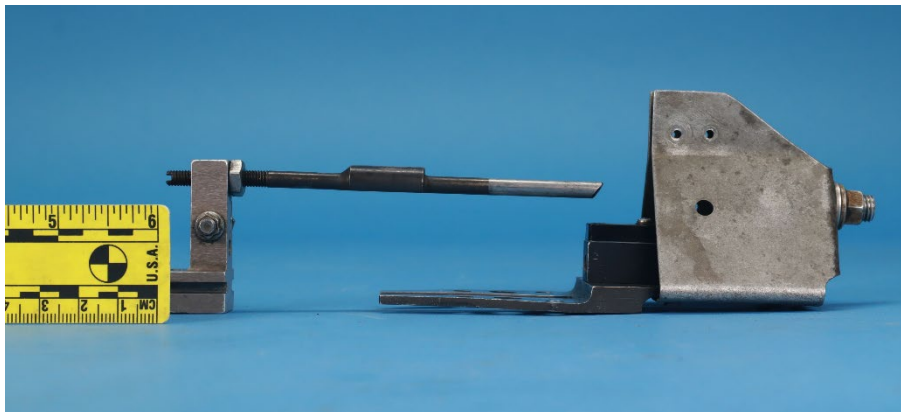
**Figure 4.** Cam rod and potentiometer bracket as submitted to the laboratory. The pieces had been re-straightened after the engine examination.

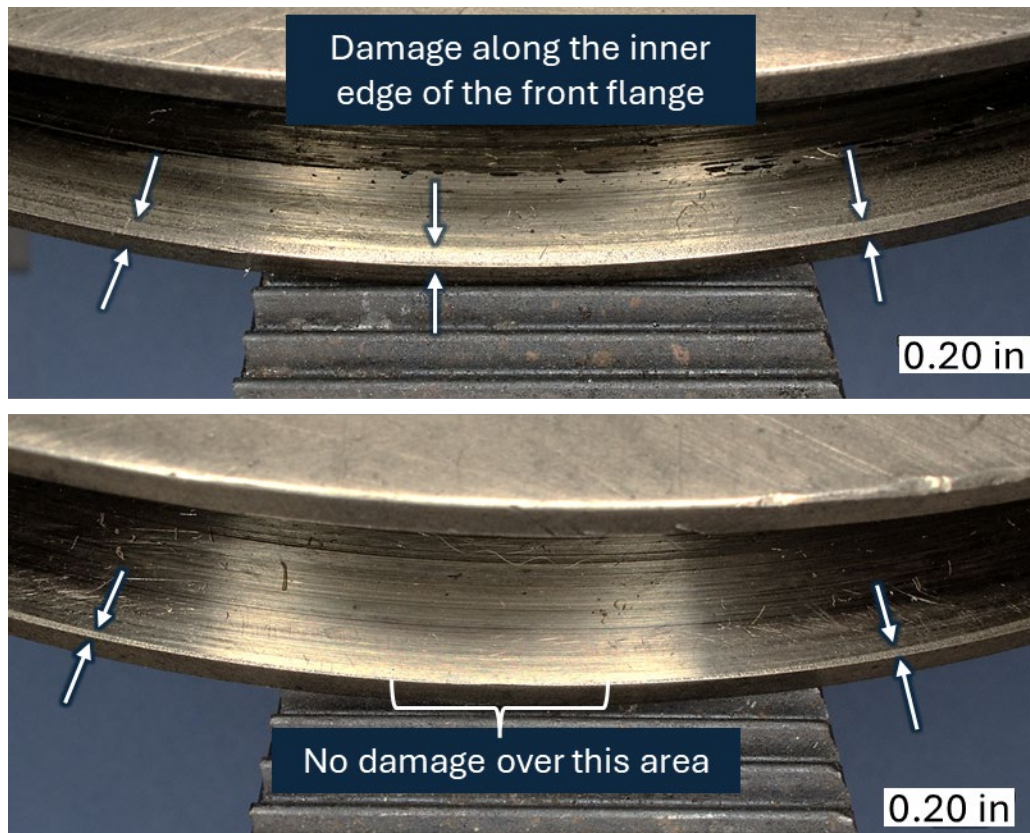
The components were examined visually. The circumferential c-channel of the slip ring was 0.505 inches wide and showed black residue on all inner faces. The number "24533" was engraved into one of the three legs on the forward face of the ring. The outside edge of the forward flange was worn. Figure 5 shows the damage at the edge of the flange. The damaged area appeared smeared and pitted, consistent with hard contact. This smearing extended around most of the circumference of the ring, with a width of approximately 0.02 inch. The width of the smeared area was mostly constant, except for an approximately 1-inch long segment where the width reduced to 0 inch.

**Figure 5.** (Top) Smearing and pitting damage along the edge of the c-channel of the slip ring, indicated by white arrows. (Bottom) Section where no damage was seen.

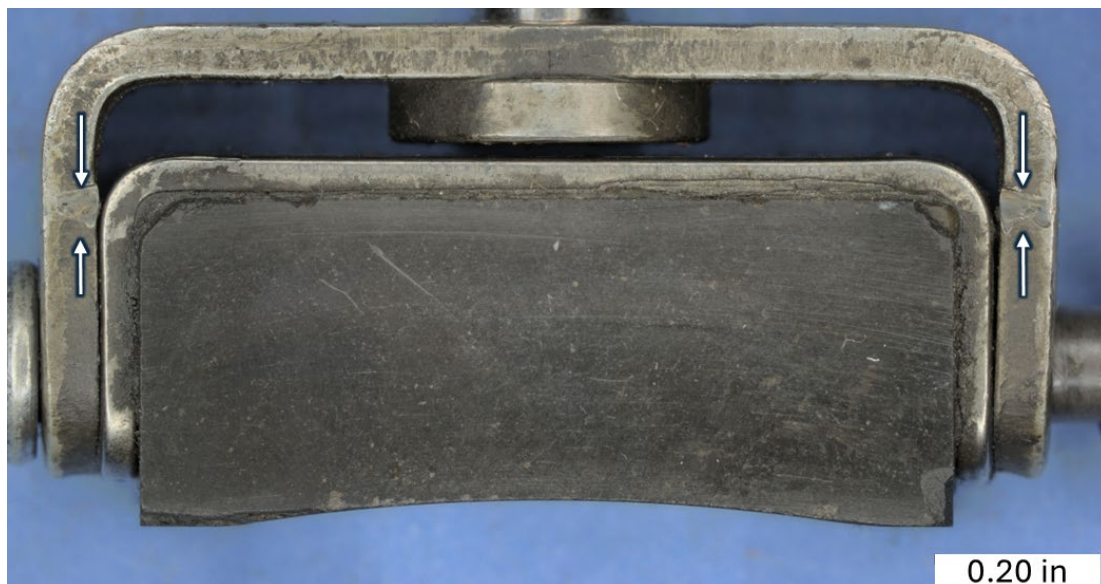
Figure 6 shows the carbon block and yoke. The carbon block had a thickness of 0.497 inch. The upper and lower surfaces of the block showed scratches and wear consistent with expected normal use. The Y-shaped metal yoke showed damage in two locations; a groove was visible in each leg of the 'Y'. Both grooves had smeared, shiny surfaces, consistent with hard contact. At their widest point, the grooves were approximately 0.04 inch wide. The directionality of the smearing and position of the grooves were consistent with the legs contacting the edge of the slip ring as the ring was spinning.

**Figure 6.** The carbon block and yoke. White arrows indicate grooves found on the yoke.

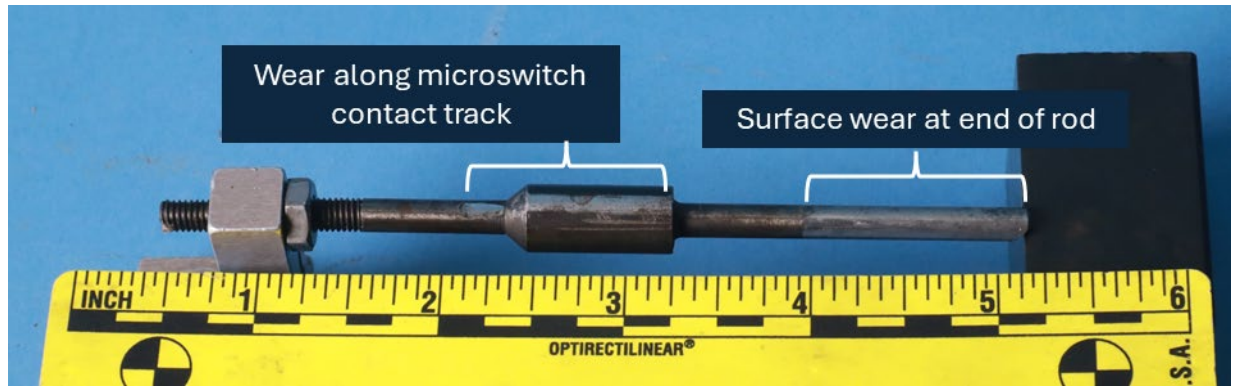
The sliding clamp block and cam rod were submitted as a single assembly. The cam rod was threaded through a nut and the clamping block. The end of the cam rod was chamfered; per the manufacturer, the rod was normally manufactured with a flat end. The chamfer was approximately 45° off-axis of the rod, and the flat face had a smeared appearance consistent with hard contact. The rod was approximately 4.6 inches long from the lower end of the chamfer to the end of the threaded section, and approximately 3.8 inches from chamfer to the nut. The total length of the rod including the chamfered end was approximately 4.8 inches. The rod was mostly black or brown in appearance, with shiny, silver-colored sections consistent with surface wear (Figure 7). The worn areas corresponded to sections that were expected to be in contact with other components during normal use. A wear strip along the cam was consistent with the location of a microswitch housed in the bracket. The rod was silver in color at the chamfered end; this extended 1.2 inches towards the cam. This was consistent with the section of the rod that fed into the t-bushing during normal use.

**Figure 7.** Surface wear along the cam rod.

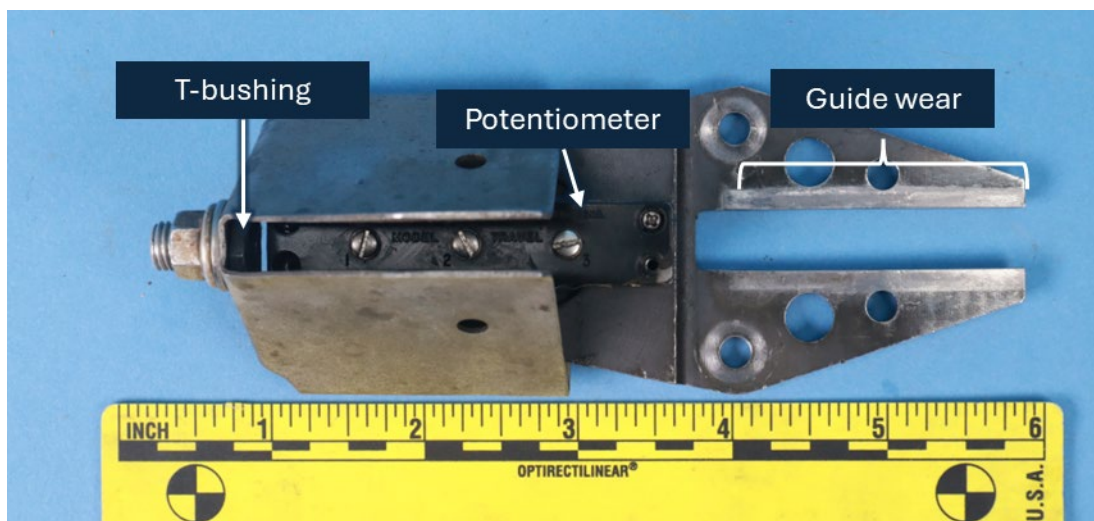
The potentiometer and microswitch bracket is shown in Figure 8. Silver-colored surface wear was visible along the guide for the clamp block. Shallow gouges were visible on the surface of the t-bushing inside the bracket (Figure 9). These gouges were located towards the outside of the bracket, approximately where the chamfered end of the rod was resting in the field images taken post-accident. The

**Figure 8.** Microswitch and potentiometer bracket.

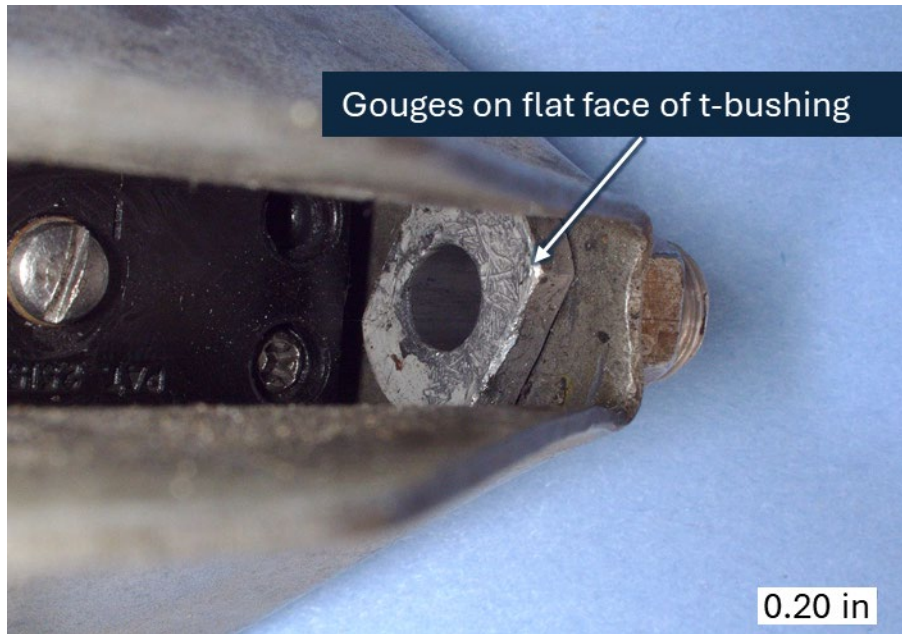
**Figure 9.** Gouges on the surface of the t-bushing, in the area where the end of the cam rod was in contact with the bushing.

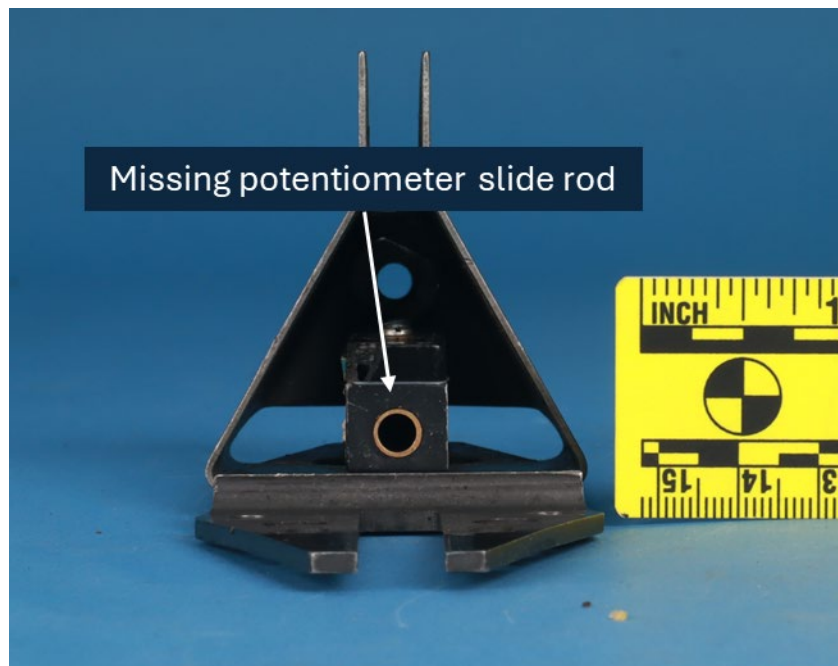
potentiometer was missing the slide rod insert (Figure 10); the slide rod was not recovered.

**Figure 10.** The potentiometer slide rod was not recovered.
