# National Transportation Safety Board

ANC24LA064

## WRECKAGE EXAMINATION

Location: Petersville, AK  
Date: July 12, 2024  
Time: 1700L  
Airplane: N535KT DeHavilland DHC-2T

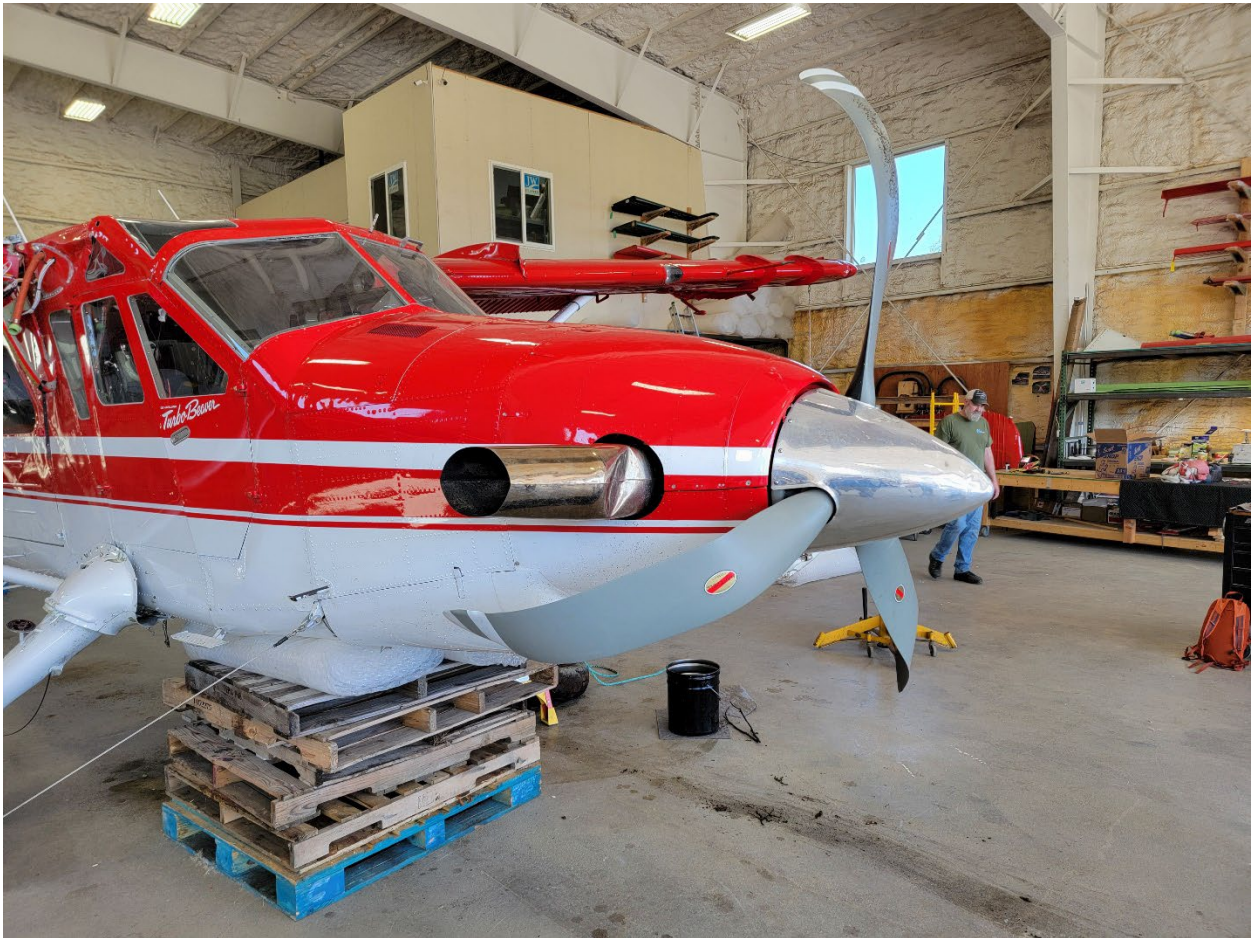
**Figure 1 View of accident airplane before examination**

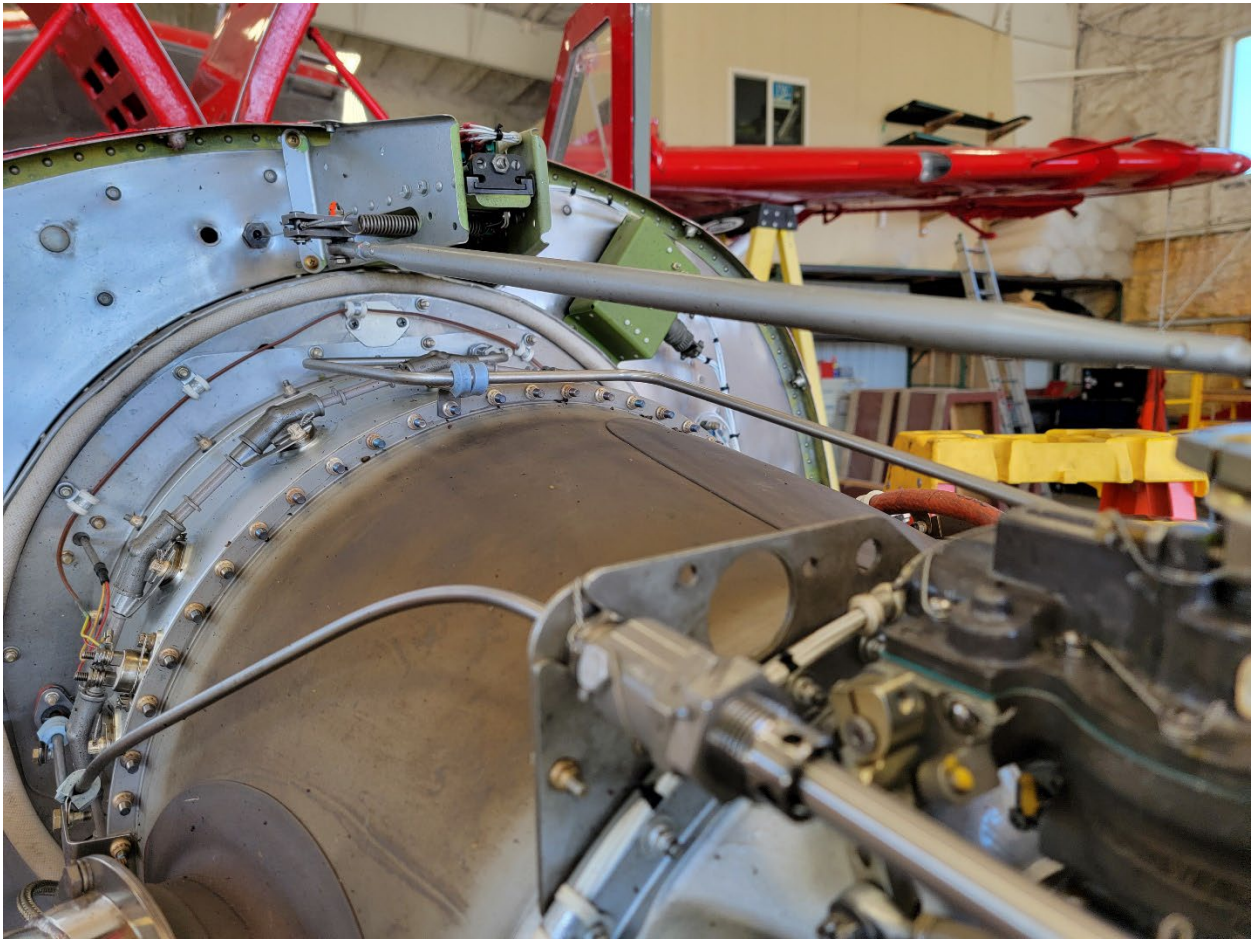
Confirmed propeller control continuity from the cockpit controls to the propeller governor. There was no oil on the engine dip stick. Chip detector was checked and no chips were observed. Reduction gear box filter screen was clean, and the oil looked clean. Governor screen was clean.

**Figure 2 view of control to propeller governor**

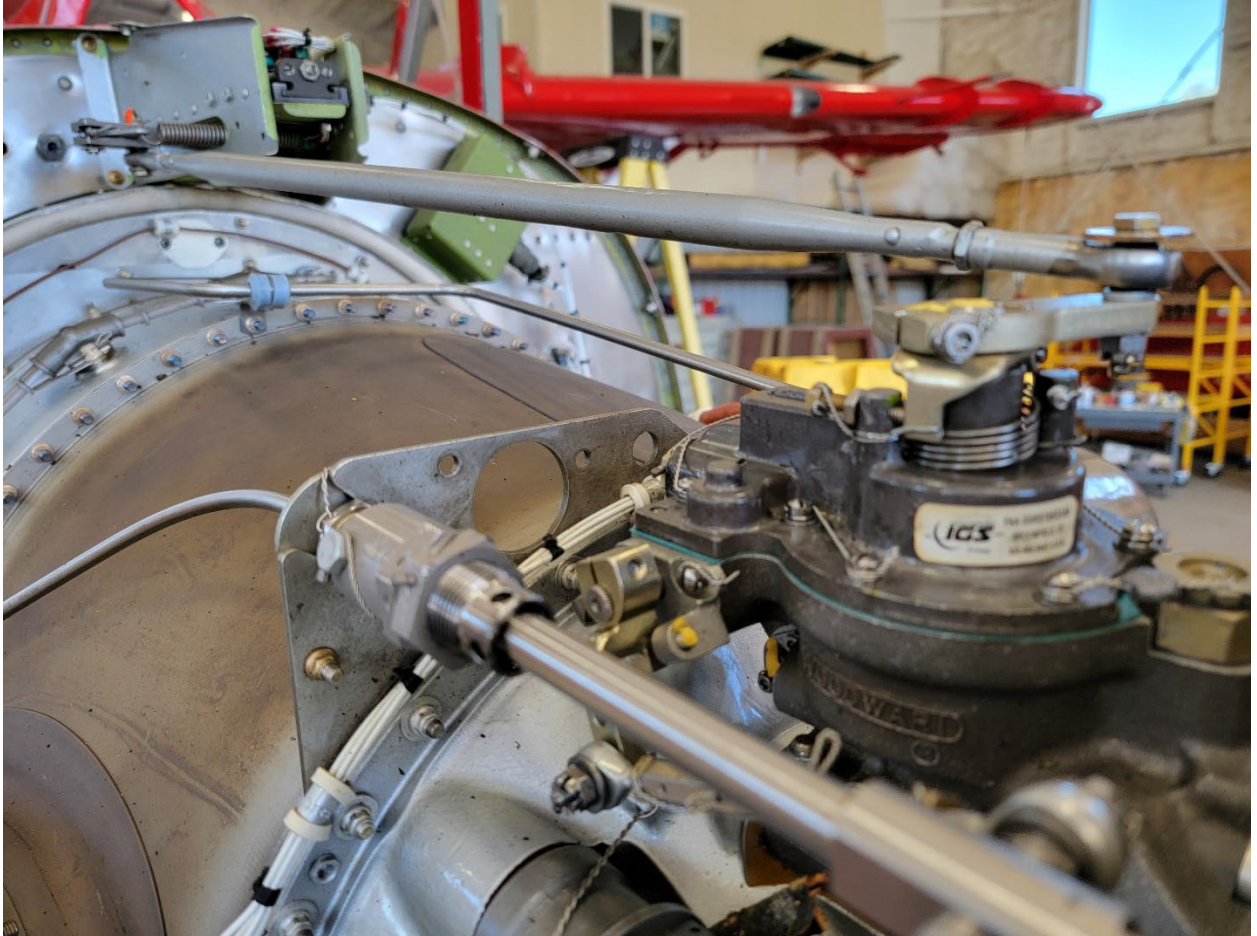
**Figure 3 View of propeller governor**

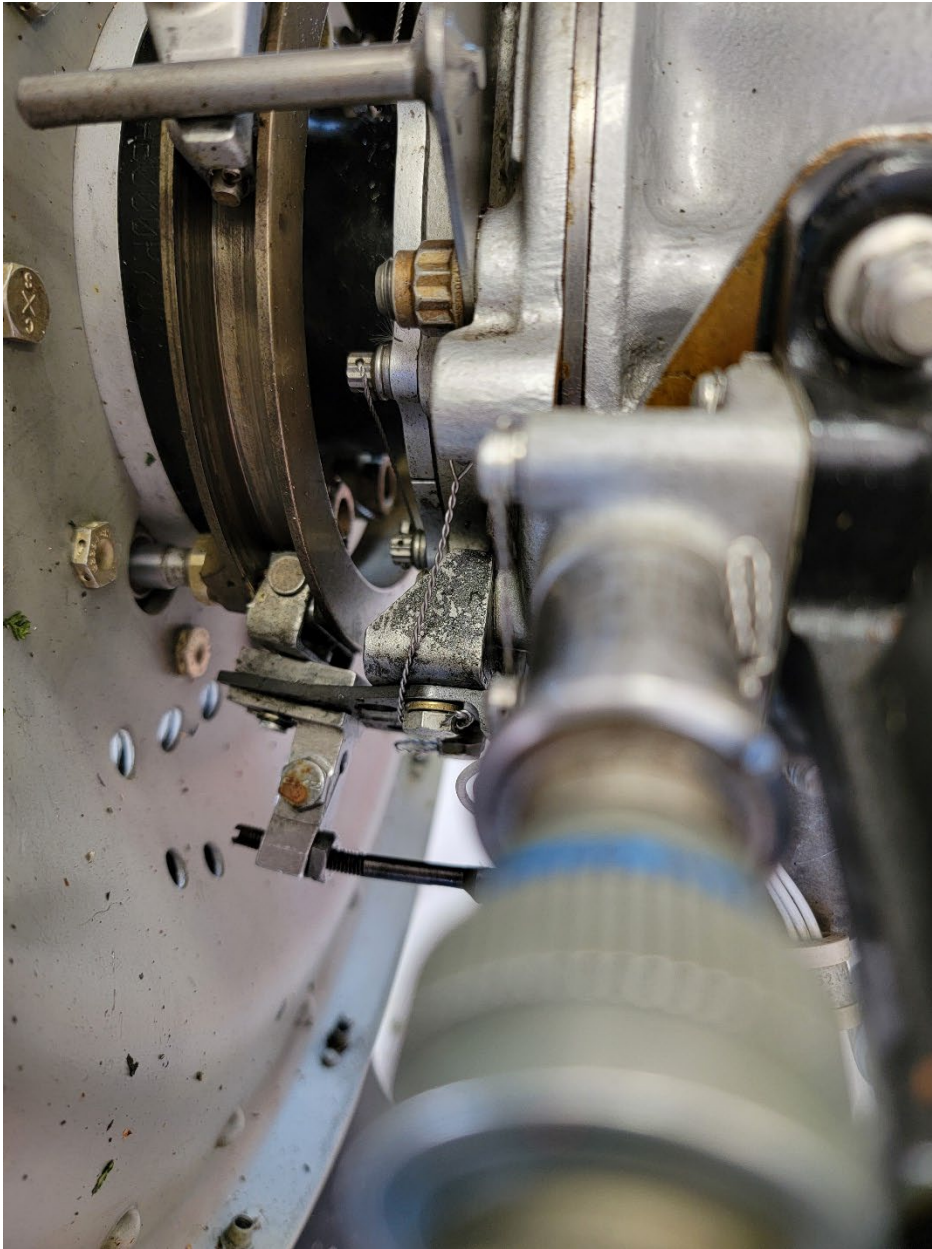
**Figure 4 View of bent cam rod installed on airplane**

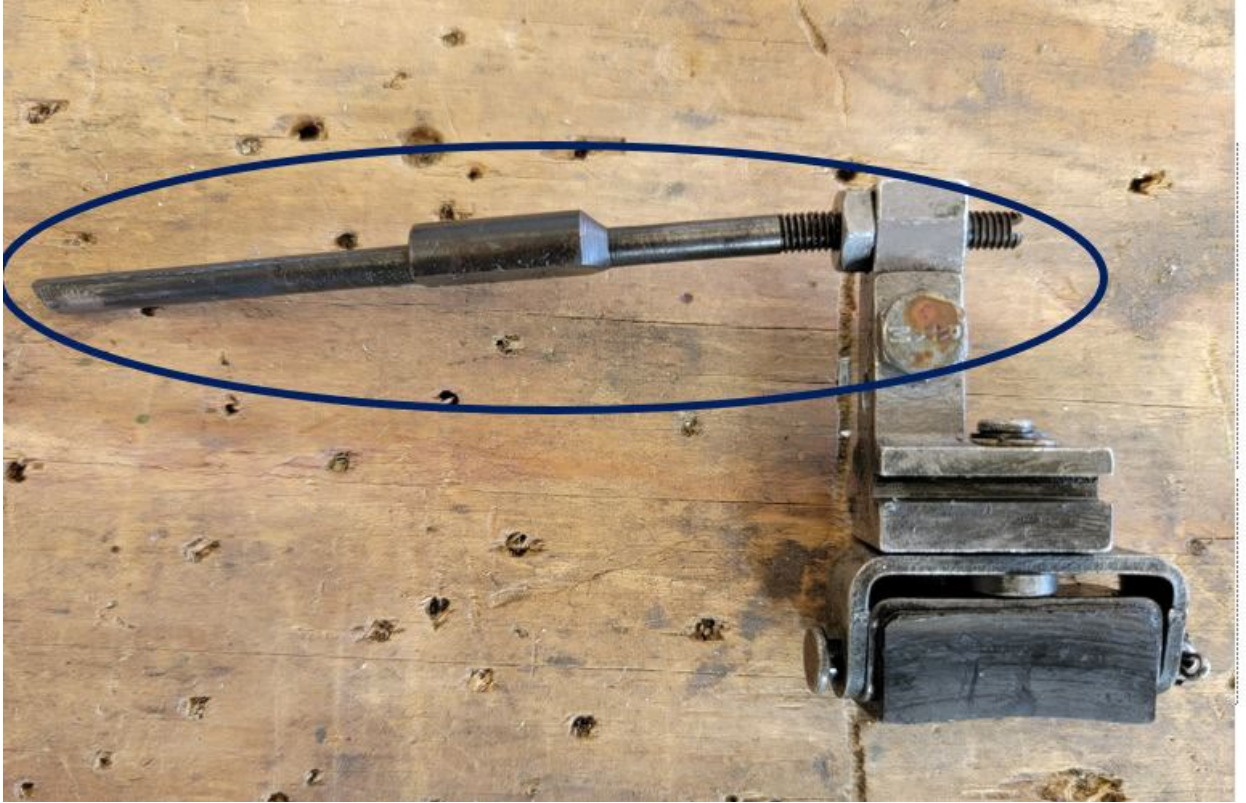
**Figure 5 View of cam rod**

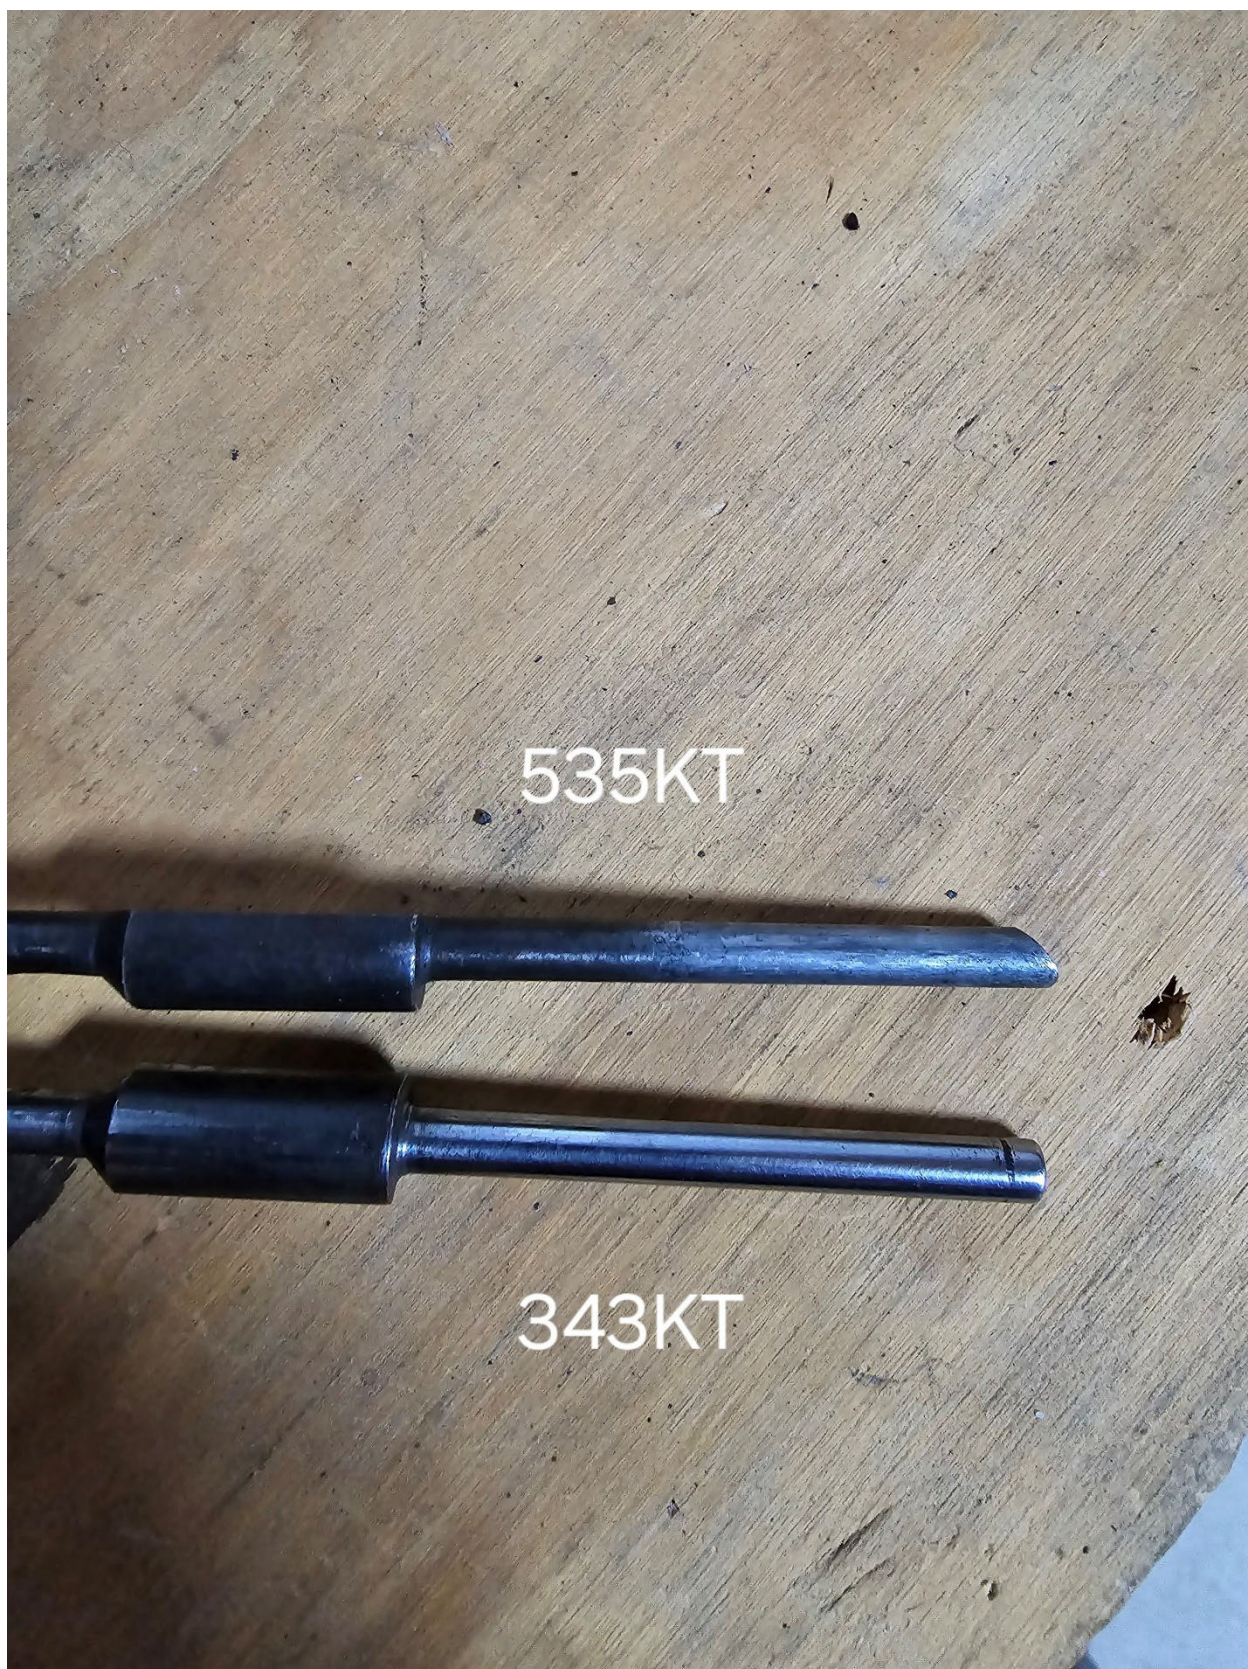
**Figure 6 View of bent cam compared to an undamaged cam rod.**

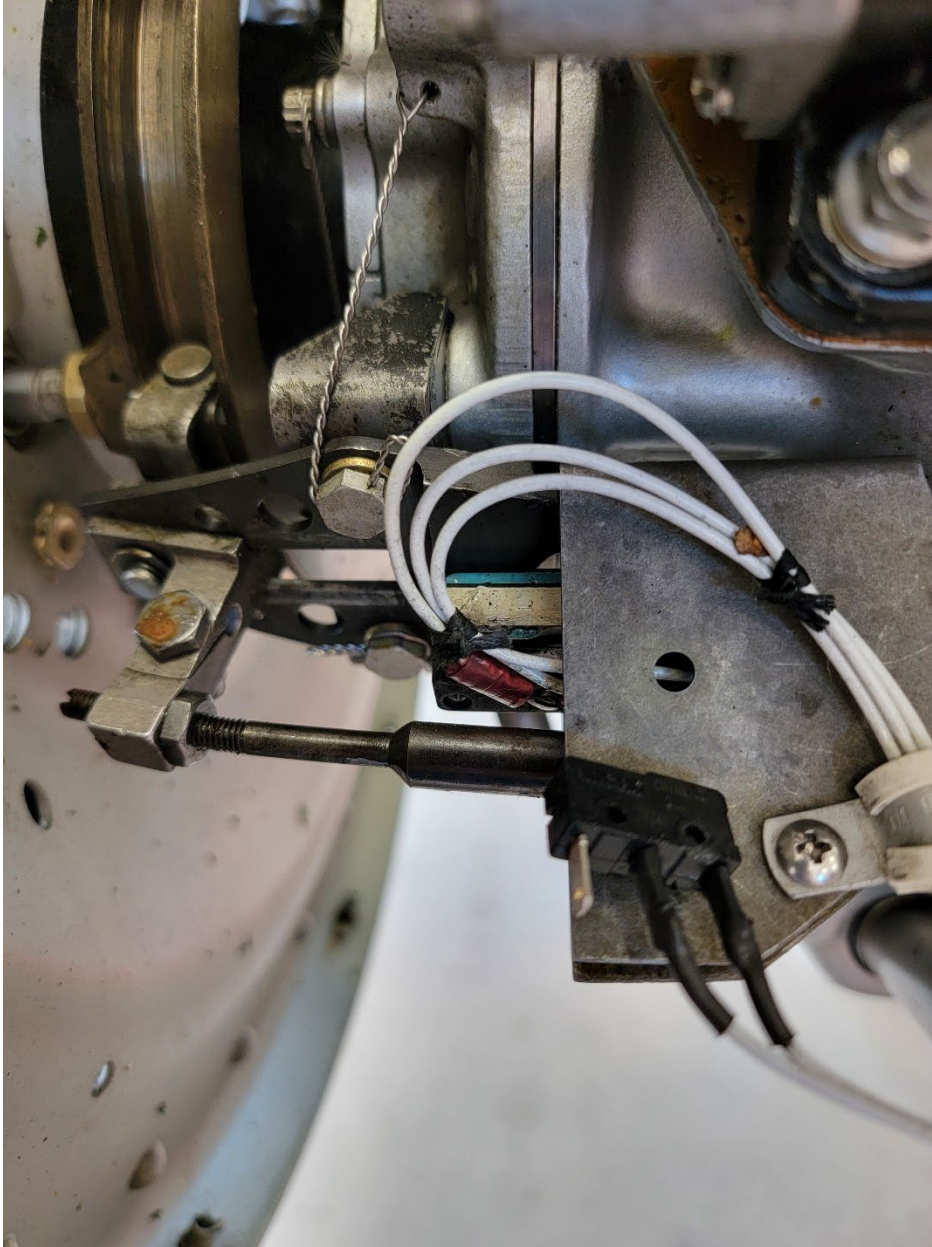
**Figure 7 View of bent cam rod.**

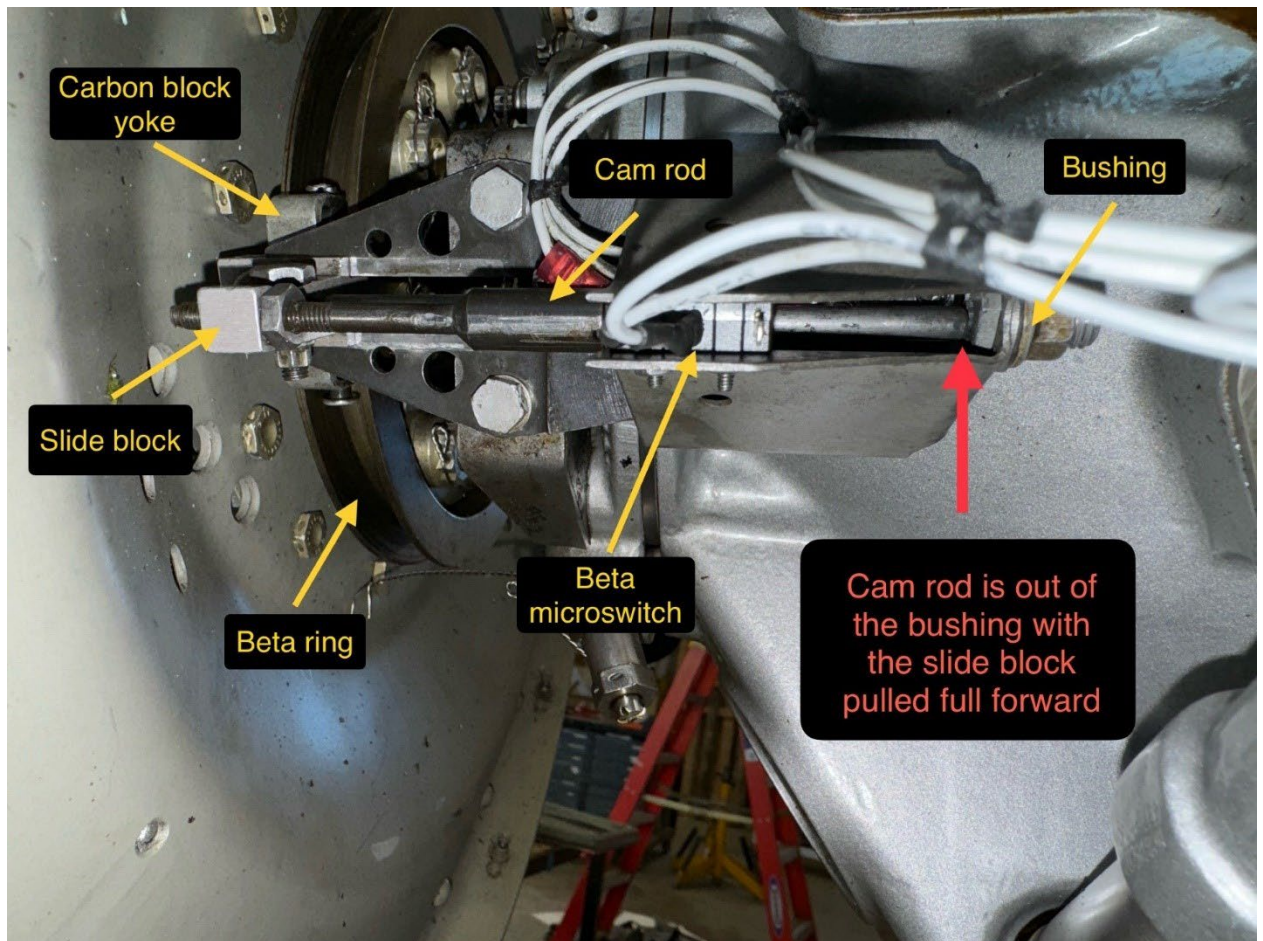
Beta ring micro switch position component was jammed.

**Figure 8 Exemplar of the Beta ring**

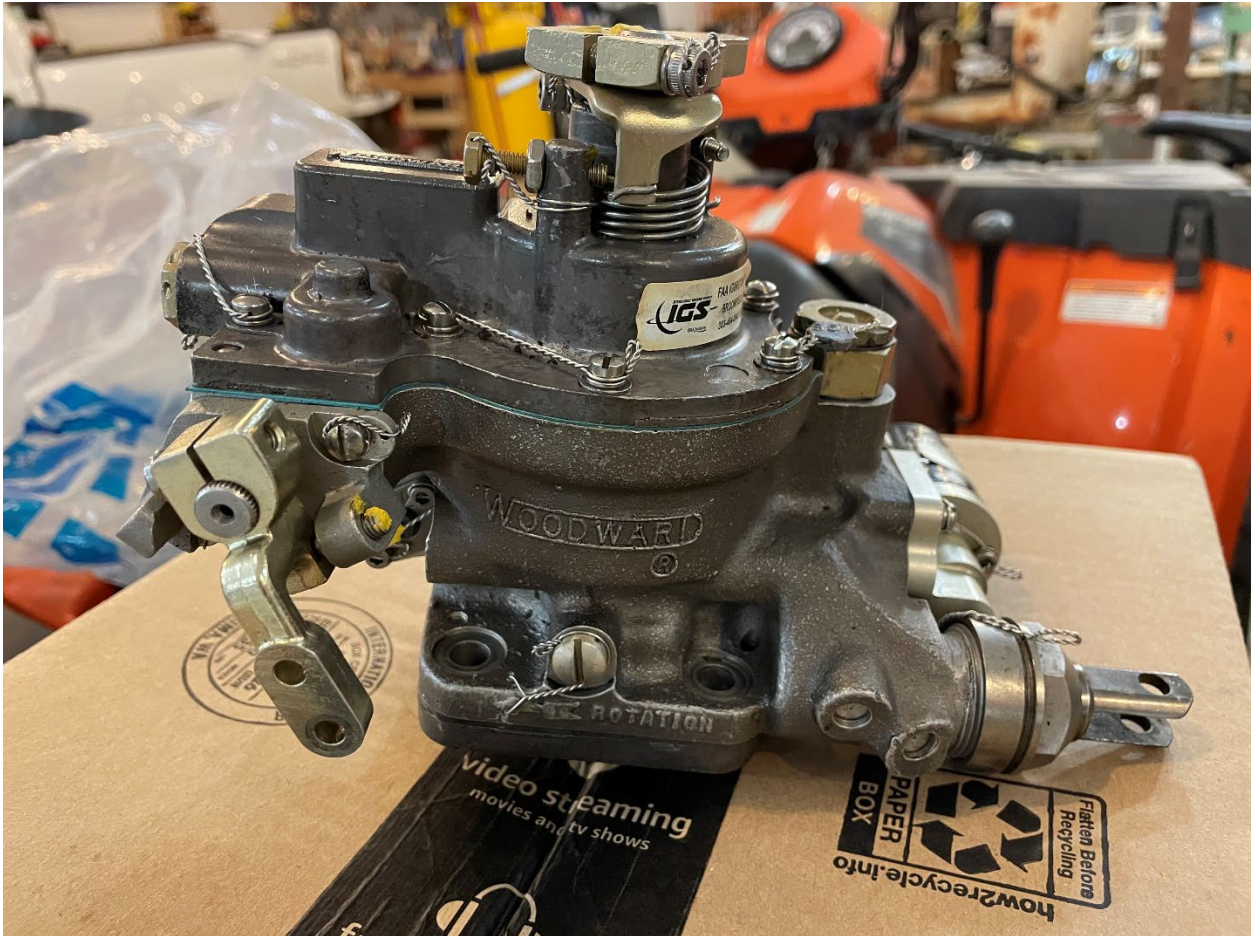
With the governor removed the propeller blades were released from the start locked position. When the blades were released, high pressure oil was discharged from where the governor was removed. Hobbs show 542.9.

**Figure 9 Governor removed for testing**
