**National Transportation Safety Board**

ANC24LA064

**EXAMINATION SUMMARY**

Location: Petersville, Alaska  
Date: July 12, 2024  
Time: 1700 Alaska daylight time  
Aircraft: DeHavilland DHC-2T, N535KT

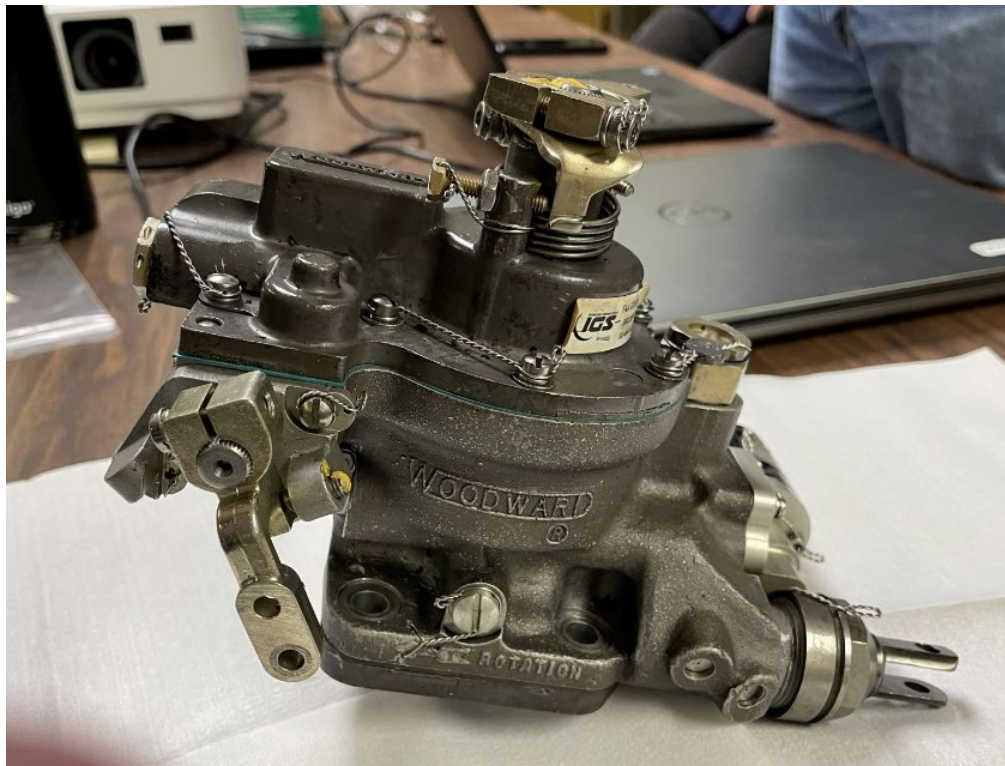
*Figure 1 - Propeller Governor (As Received)*

The propeller governor was received in a sealed carton. The housing appeared intact and undamaged. The drive shaft, speed setting shaft, and air bleed lever appeared undamaged and rotated freely using hand pressure. The levers (air

bleed and max speed), caps (relief valve and air bleed orifice), and max speed stop displayed a gold finish which appeared different from the manufacturer's parts. Similarly, installed lockwire, lockwire seals, and torque sealant were not from the manufacturer.

The data plate was denoted as Woodward which included the part and serial numbers. The revision noted was "New" and the assembly date was "01/2024". A repair station label was affixed to the housing which denoted "IGS" and "FAA IG0R976N/EASA".<sup>1</sup>

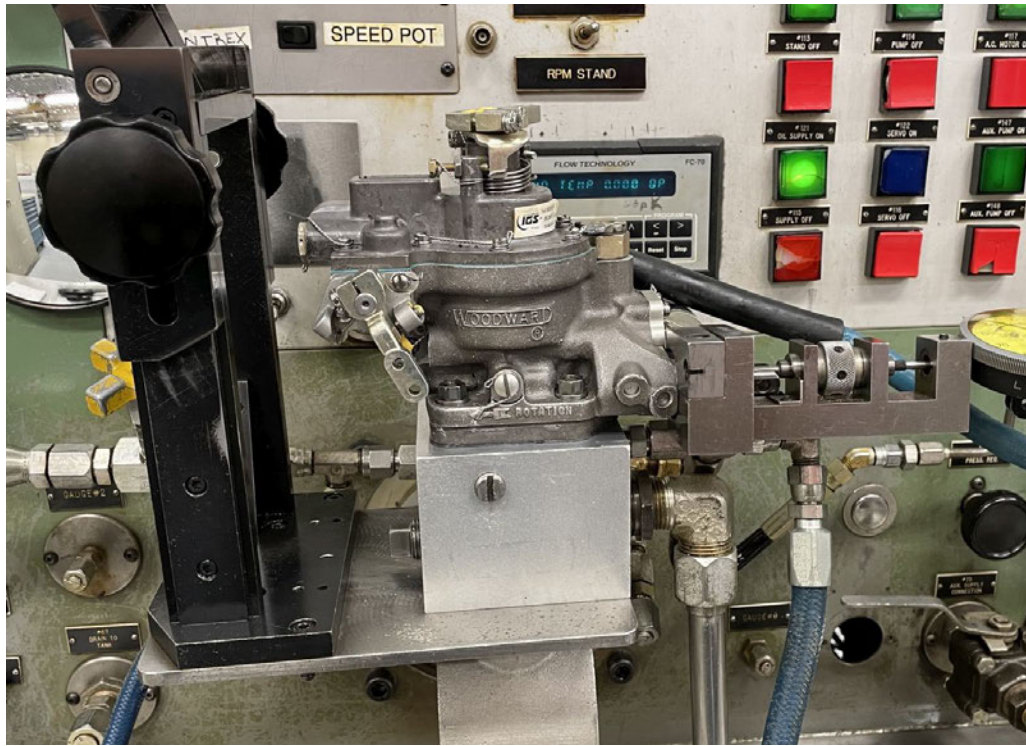
Figure 6 -- Propeller Governor (Installed on Test Bench)

Bench testing was within specification except at two of the data points. First, the overspeed setting was 6 psi at 4,590 rpm. The maximum per the specification was 5 psi. Second, the underspeed setting was 6 psi at 3,983 rpm. The maximum per the specification was 4 psi.

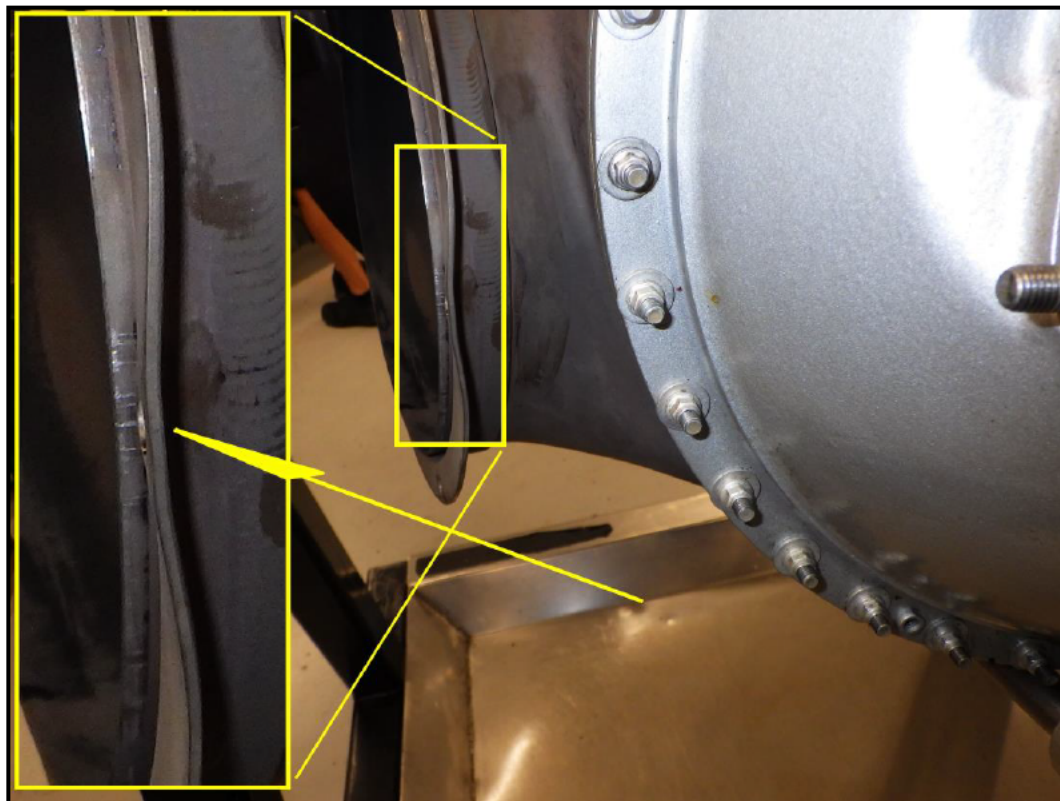
General External Appearance: No buckling damage was found on the GG case and the exhaust duct. The GG case was found with one fractured bolt at one of the engine mounting pads. The exhaust duct was found with a bent exhaust port flange on the right side of the engine. See photographs #3 to #9.

Photograph #5: Engine front right side view (at receiving) bent exhaust flange

The engine serviceable condition can be restored thru the PWC’s provided combined workscope of sudden stoppage and hard landing, listed in the light overhaul section of the P&WC’s engine Overhaul Manual.

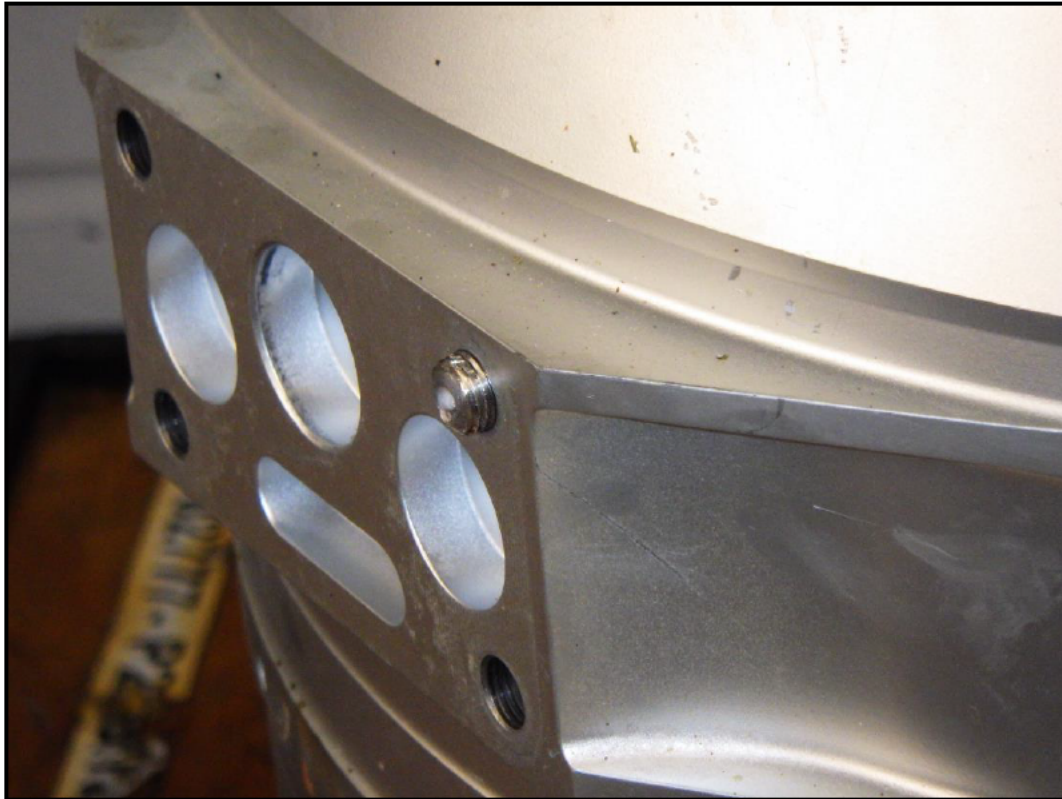
Photograph #9: GG case with a fractured mounting pad bolt.

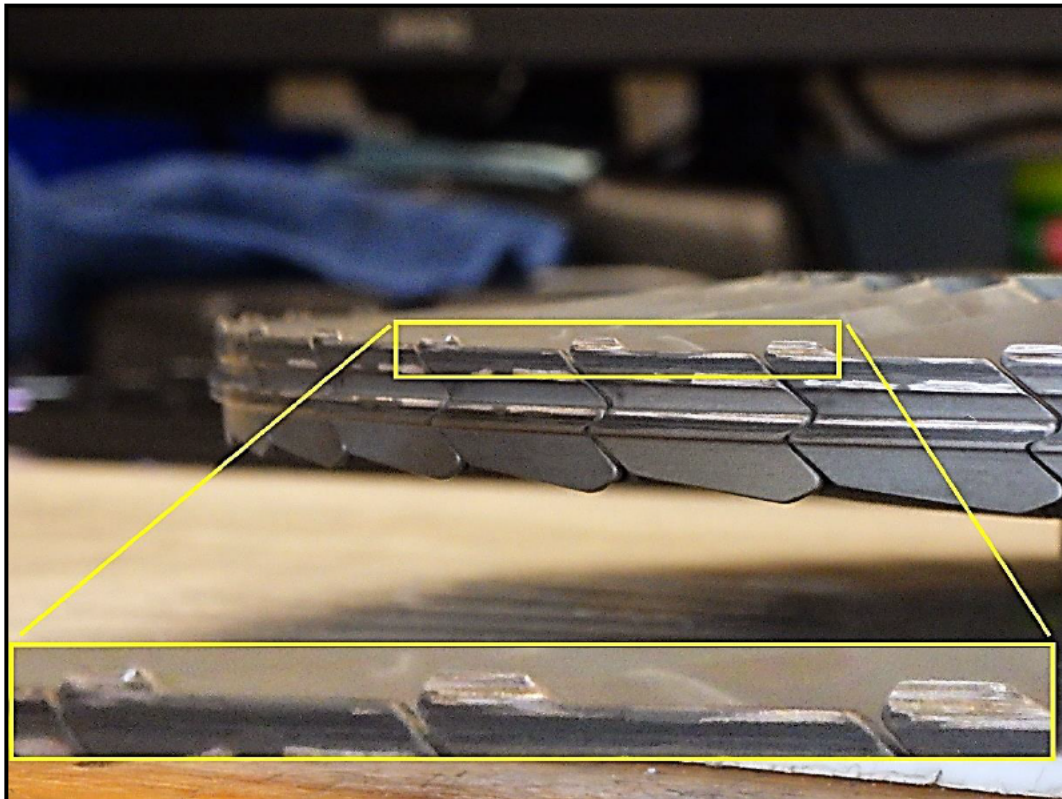
Power Turbine Disk  
And PT Shroud Housing: Blade tip and blade path rub. See photographs #10 and #11.

StandardAero found damage consistent with the reported incident. The exhaust duct was found with distortion on the exhaust port flange. The gas generator case had a fractured bolt in a mounting pad. There was no buckling damage found on both, gas generator and exhaust cases. The power turbine shroud housing and the power turbine disk assembly were found with heavy blade tip/path rub.

Photograph #10: PT disk blade tip damage.

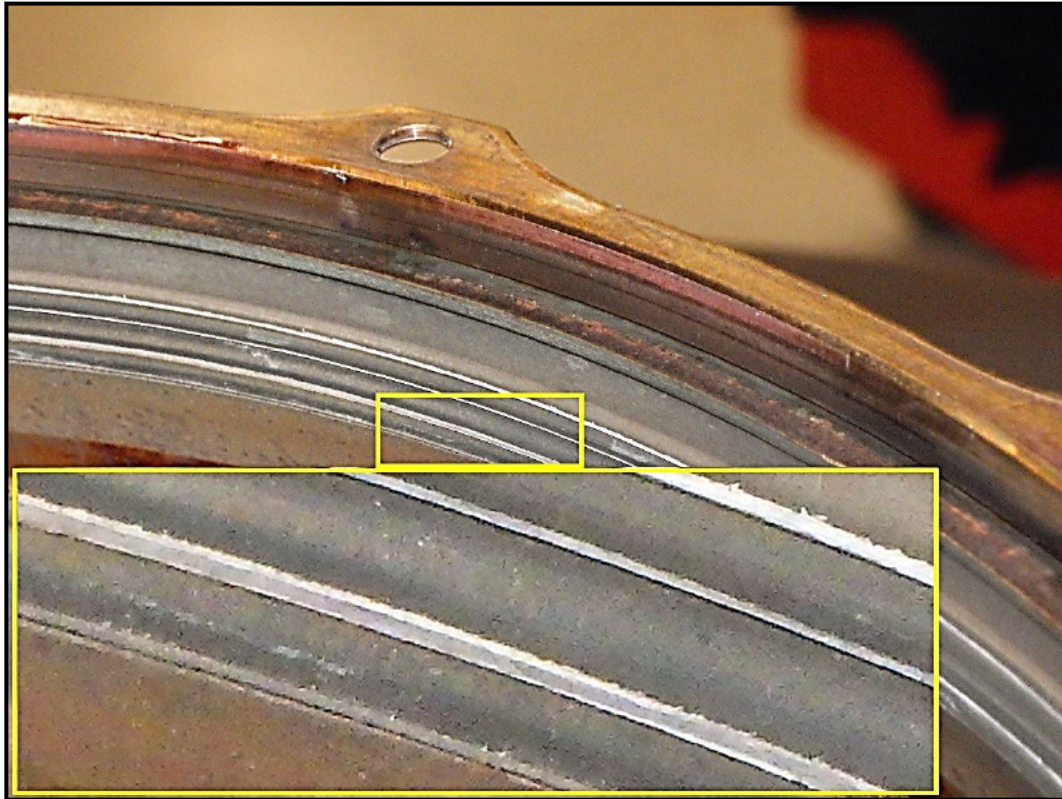
Photograph #11: PT shroud housing damage. Blade path's knife edge rubs.
