## 7/29/24 – 85W Narrative

At approximately 2pm Monday, 29 July, a solo flight rapidly deteriorated from excellent soaring conditions into a forced off field landing in a field causing damage to the glider. Causal factors include spatial disorientation and unexpected heavy sink with contributing factors of atmospheric haze (looking westbound) and task saturation. The result was an outfield landing and ground loop east of Huntsville at 3:30pm.

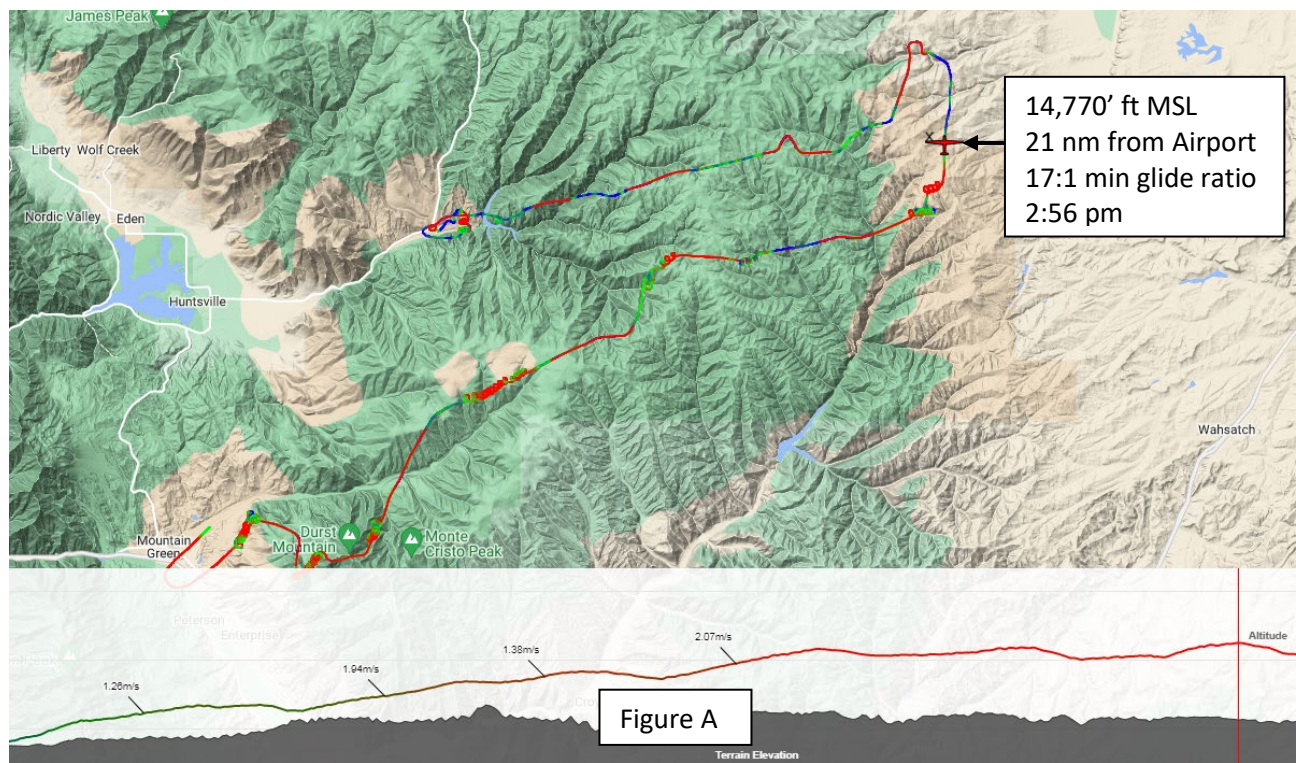
Takeoff was normal. Exceptionally good thermals (4+ knots) allowed a release at 7300' MSL (1717 AGL) at 2:04. Thermals on the mountain ridge, Big Mahogany, and Durst Peak were strong resulting in a climb to 11,000' by 2:21. Thermals and connecting clouds above continued to be exceptionally good headed east, resulting in a max altitude of 14,770 at 2:56, a distance of 21 NM from Morgan County Airport, and a minimum required glide ratio of 17:1 at the point depicted by the Glider in Figure A (next page).

Coincident to this point, the thermalling technique objective and flight plan objective of 20nm eastbound were both successfully completed and a decision was made to glide back to Morgan County Airport.

Approximately 2 miles north of the position in Figure A, was a good looking cumulus cloud, with more clouds strategically lined up eastbound overhead. The decision was made to fly this route home to take advantage of the thermals (presumed nearby under the cumulus) consistent with the preflight weather brief of good thermals until 4:30-5:00 pm and consistent with the excellent thermalling conditions encountered up to this point in the flight with similar clouds.
