# National Transportation Safety Board

ANC24LA073

## **ENGINE EXAM**

Location: Lake Hood, Alaska  
Date: August 28, 2024  
Time: 8:24  
17:24  
Airplane: DeHavilland DH-2 Beaver

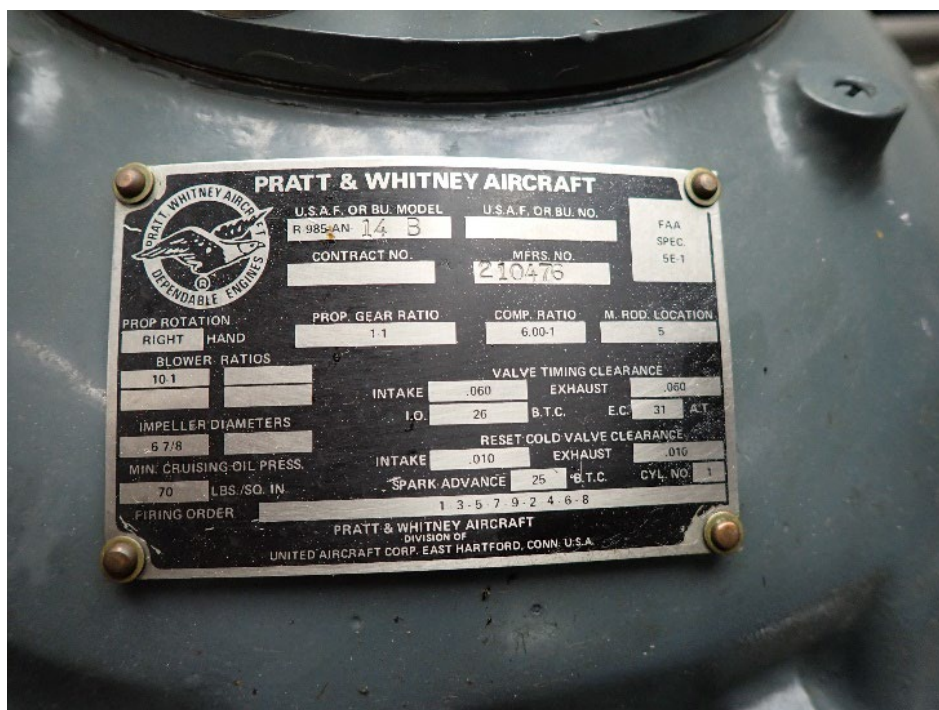
Figure 1 Engine Data Tag

The Pratt and Whitney R985-AN-14B engine SN 210476 was sent to Tulsa Aircraft engines for an engine exam. On October 7, 2024 the engine was removed from the crate and mounted on a stand (Figure 1,2,3). The engine had 1,483 hours since major overhaul (TSMOH) at the time of the accident. The previously installed Stromberg carburetor and No. 3 cylinder were included.

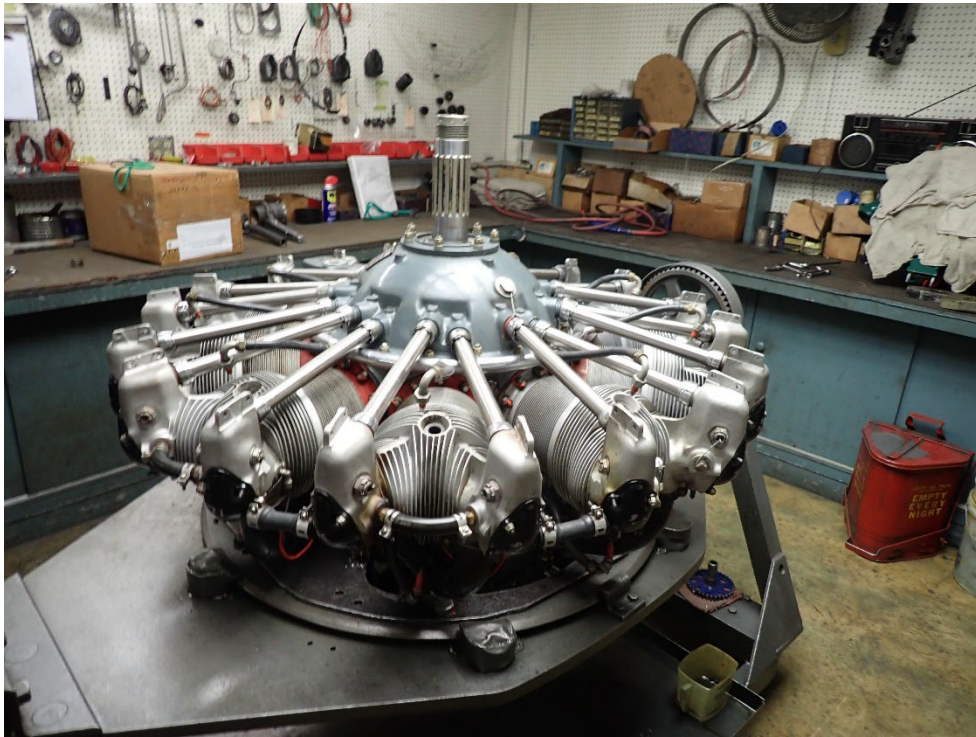
**Figure 2 Engine mounted on stand**

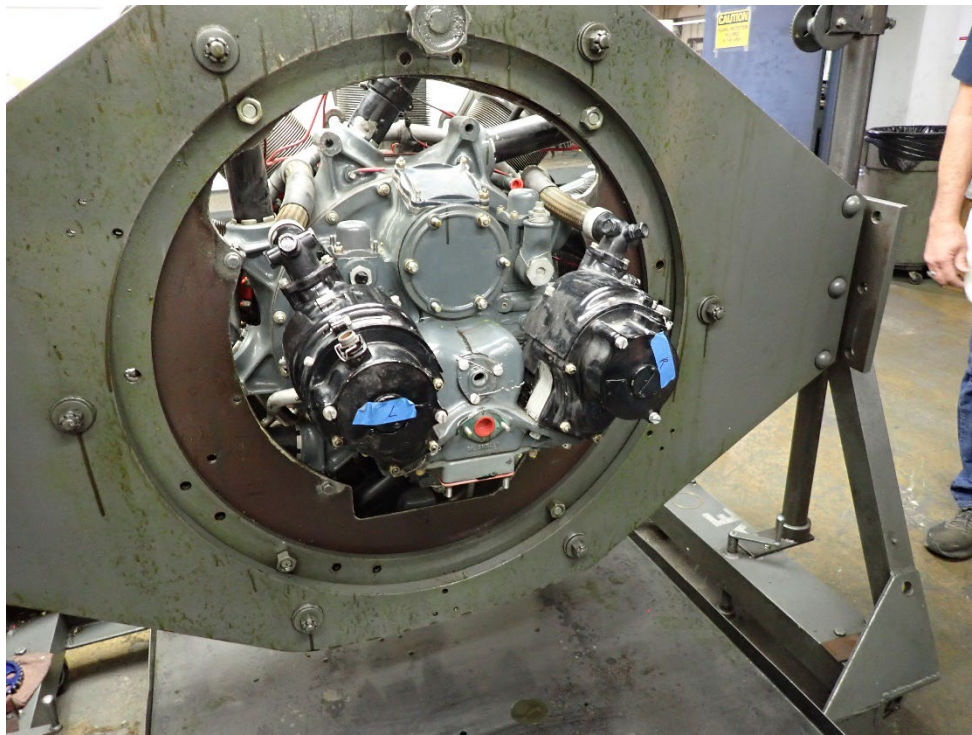
**Figure 3 Engine accessory case**

The crank shaft rotated smoothly and thumb compressions were observed on all cylinders. Timing was checked on the No. 1 cylinder, the left side was 24° and the right was 25°, within normal limits. Continuity with the magnetos, supercharger, and accessory drives was confirmed. Compression on all 9 cylinders was confirmed.

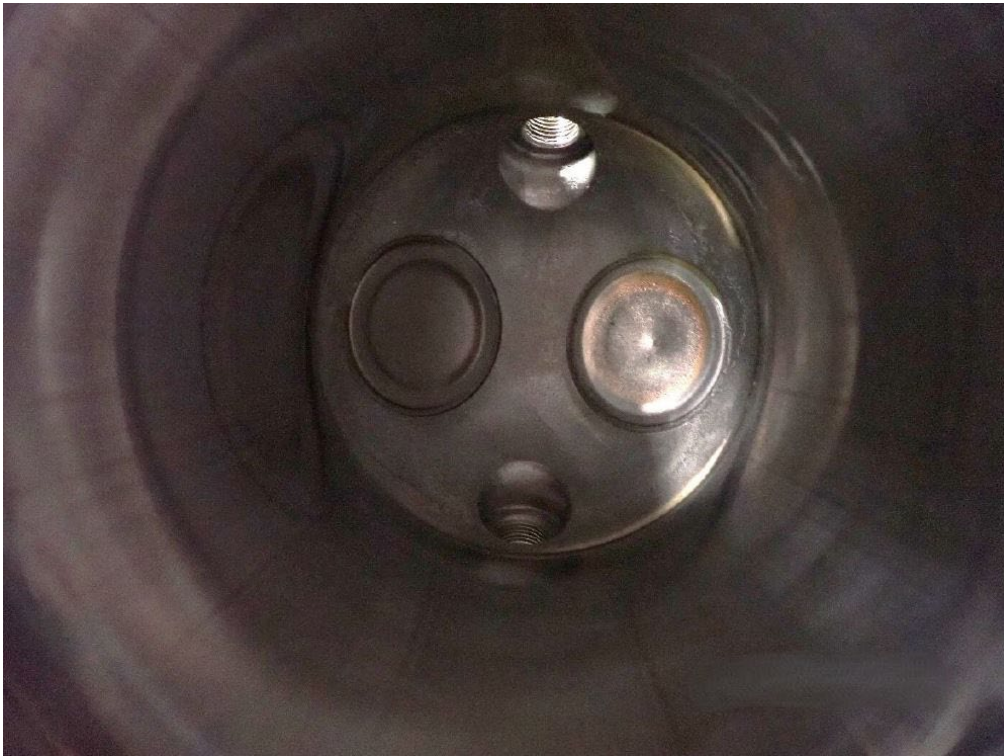
The condition of cylinders No. 1, 2, 4 through 9 were found in a condition consistent with the number of hours, 1483.9 Since Major Overhaul (TSMO) (Figure 5).

**Figure 5 Cylinder No. 1**

All cylinders were found in serviceable condition. Cylinder No. 3 was found in a condition consistent with the number of operational hours, 5.5 hours in service.

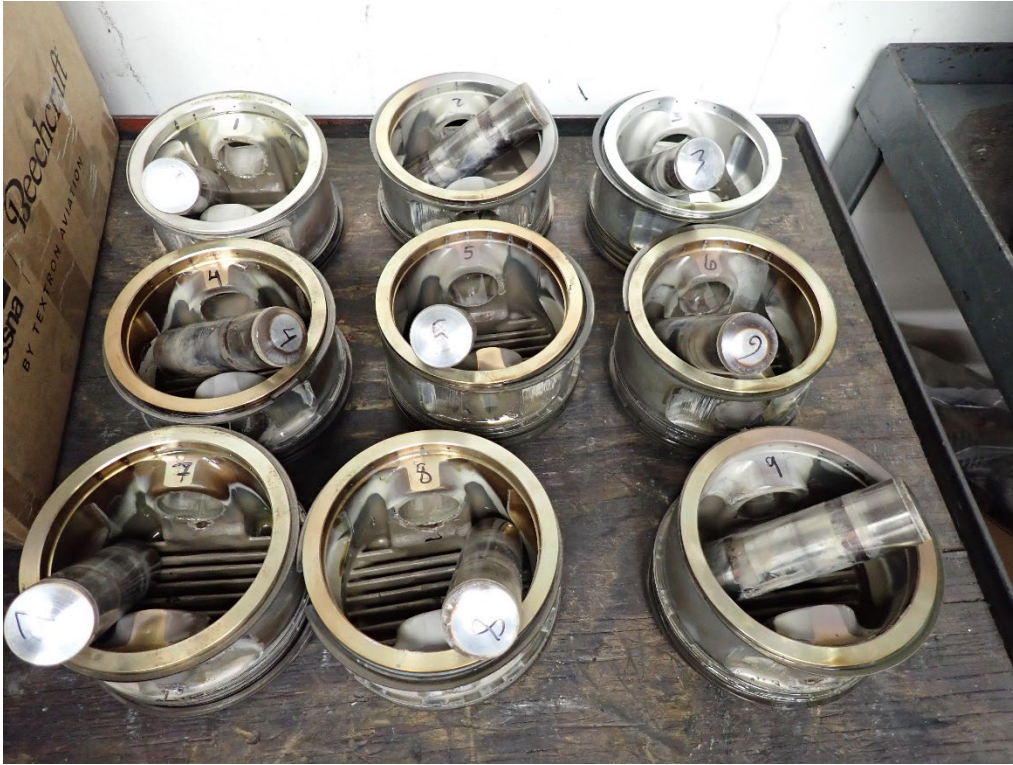
Pistons and piston pins were inspected and found in a condition consistent with the number of operational hours (Figure 6). Pistons and piston pins were found in serviceable condition. The valves and valve rocker arms moved freely and were found in serviceable condition.

**Figure 6 Pistons and piston pins**

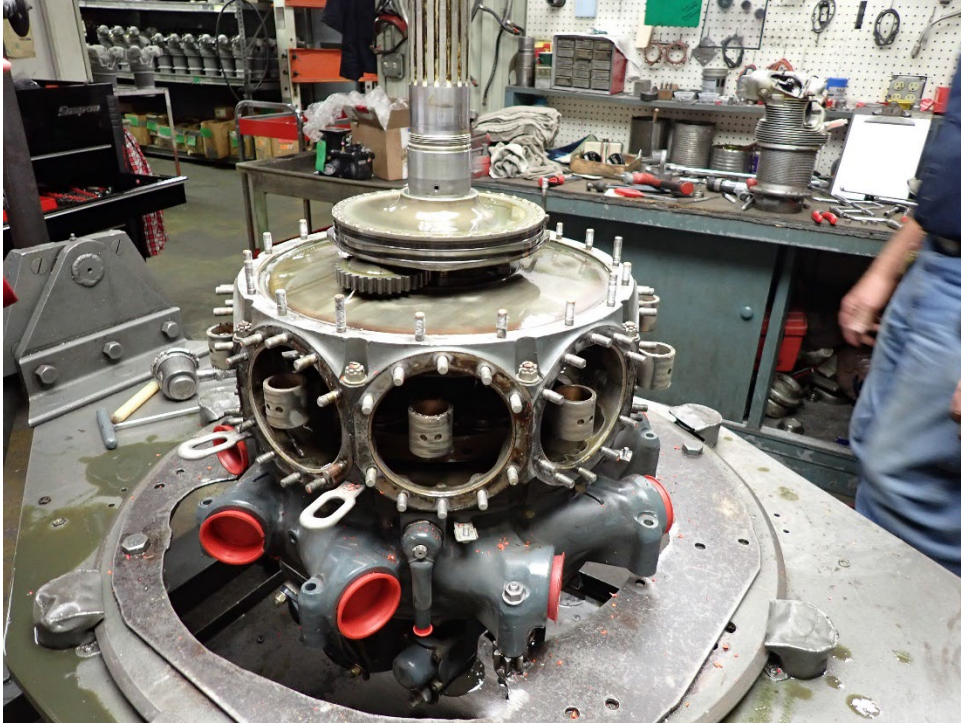
The nose case was removed exposing the cam ring and gears (Figure 7). Run out of the camshaft was done to measure lobe height, the cam lobes were within normal limits. The engine case was not disassembled at this time as continuity and smooth operation was confirmed. Visual inspection of the master rod, articulating rods and accessory section showed no abnormalities. Engine case was found to be in serviceable condition. The crankshaft was not removed from the crankcase as freedom of movement and continuity was confirmed.

**Figure 7 Cam ring, gears, and cam lobes**

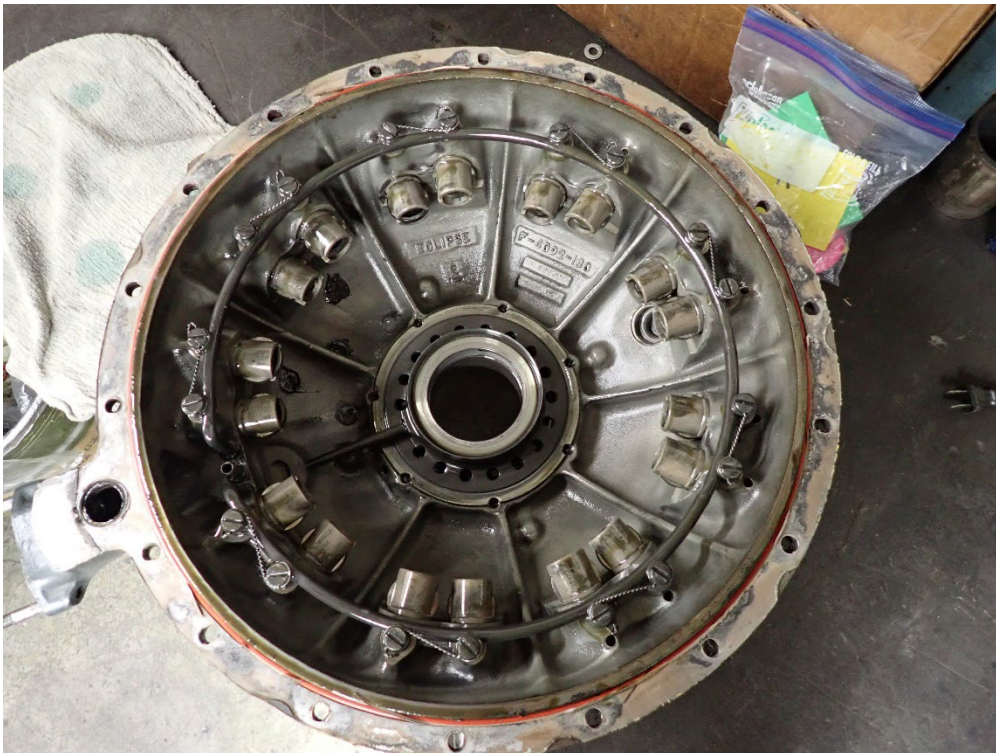
A dial indicator was installed to check the cam ring runout and cam lobe lift. Cam ring was found in serviceable limits. Continuity was confirmed with crankshaft. The cam roller tappets located in the nose case were found in good condition. All rollers and tappets moved smoothly and freely (Figure 8).

**Figure 8 Nose case and roller tappets**

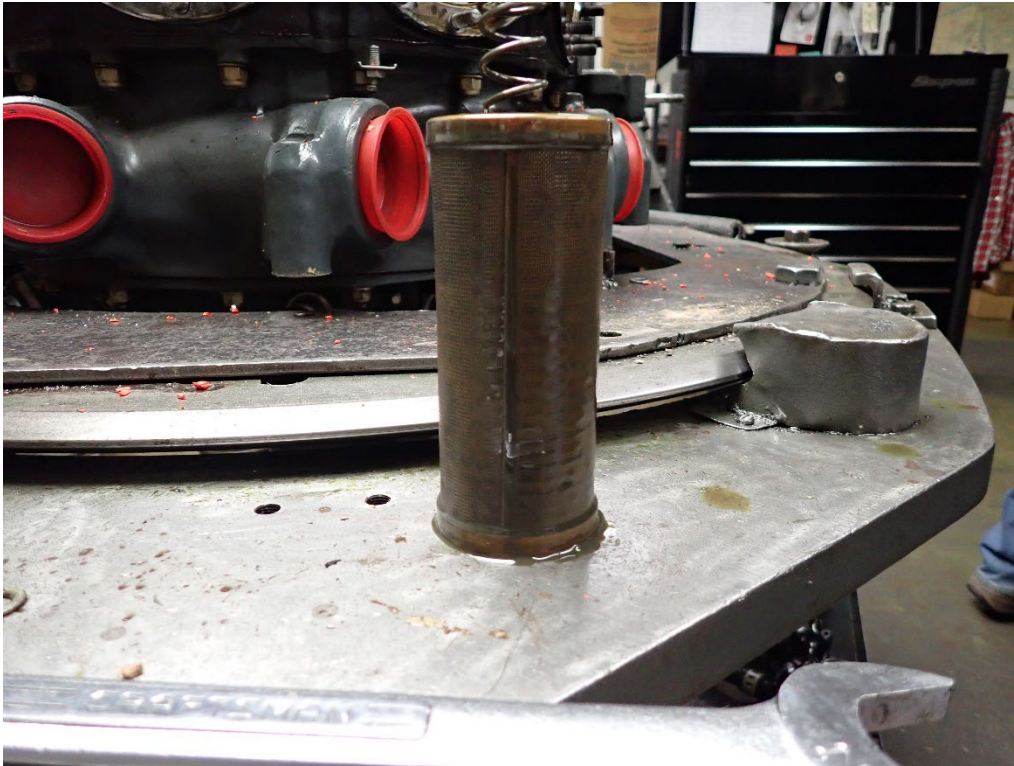
The engine exhibited no indications that the lubrication system was not functioning normally. No heat signatures or thermal damage was found that would indicate oil starvation of any lubricated moving parts. The smooth operation of all the components and visual appearance of the engine internals deemed removing the complete accessory case or splitting the crankshaft case halves unnecessary. The oil screen was removed and found to be clean (Figure 9).

**Figure 9 Engine oil screen**

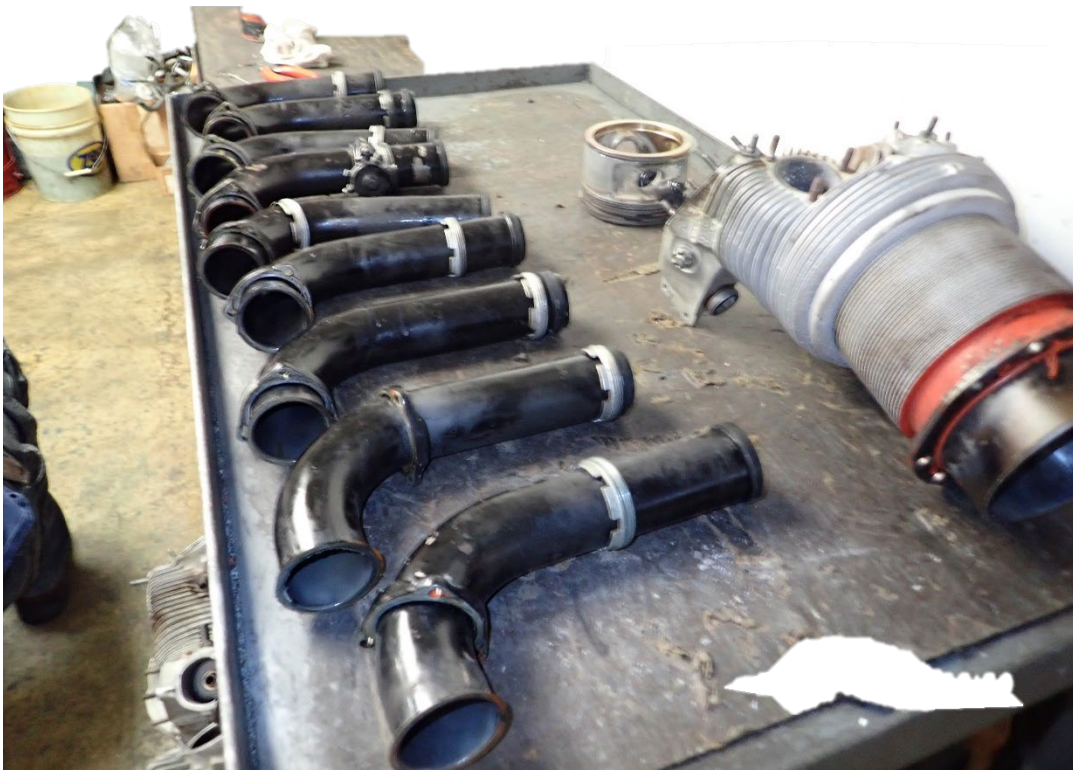
The super charger was inspected and found to be in serviceable condition and continuity with the engine was confirmed. The intake tubes were removed and found in serviceable condition along with the seals (Figure 10).

**Figure 10 Intake tubes**

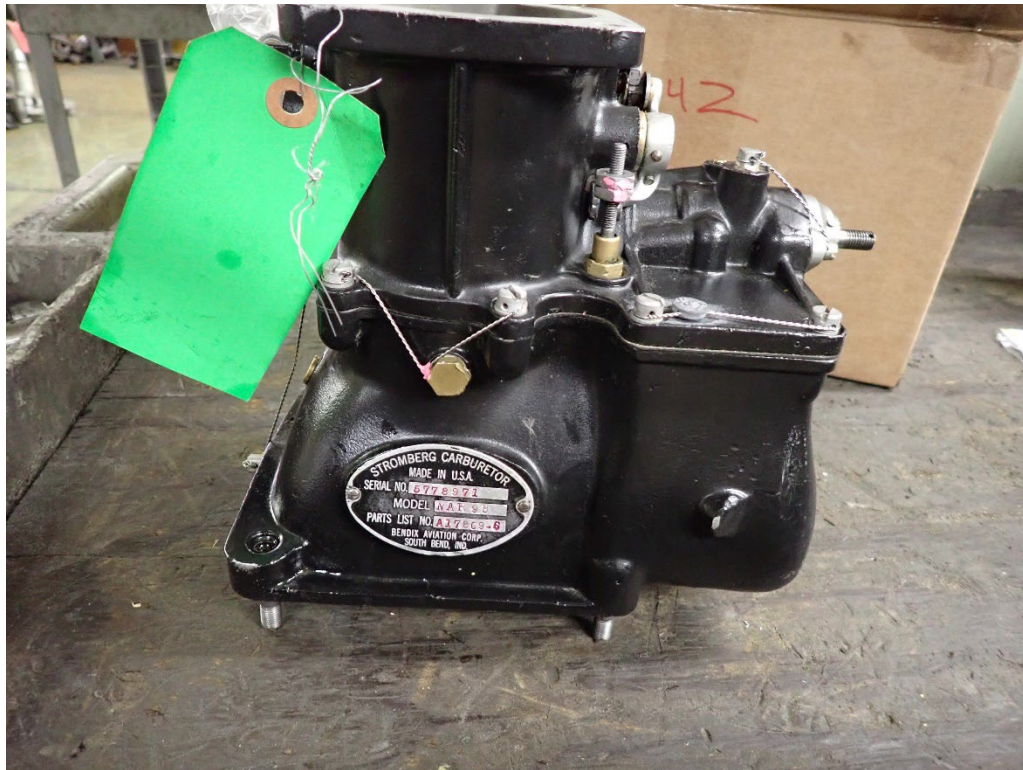
The Stromberg Model NAR 9B carburetor SN 5778971 was disassembled, it was observed to be excessively dry (Figure 11). The accelerator pump and float moved normally (Figure 12). Fine metal and non-metal particles were found in the carburetor bowl (Figure 13). The Carburetor fuel screen was inspected and found to have minor debris which appeared to be silicone sealant on the screen (Figure 14). Small non-metal particles were observed past the carburetor screen in the economizer. The impeller was intact and rotated smoothly. The fuel pump drive gears turned in sync with the magneto drive gears and impeller when the crank shaft was rotated.

**Figure 11 Stromberg carburetor**

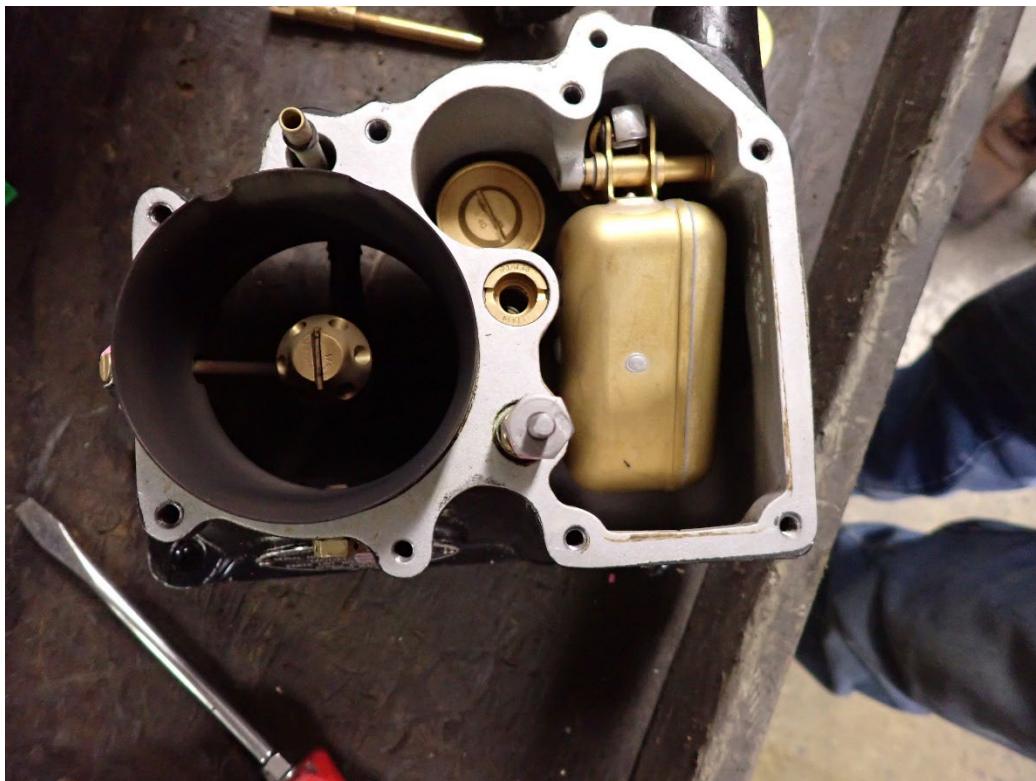
**Figure 12 Carburetor with float**

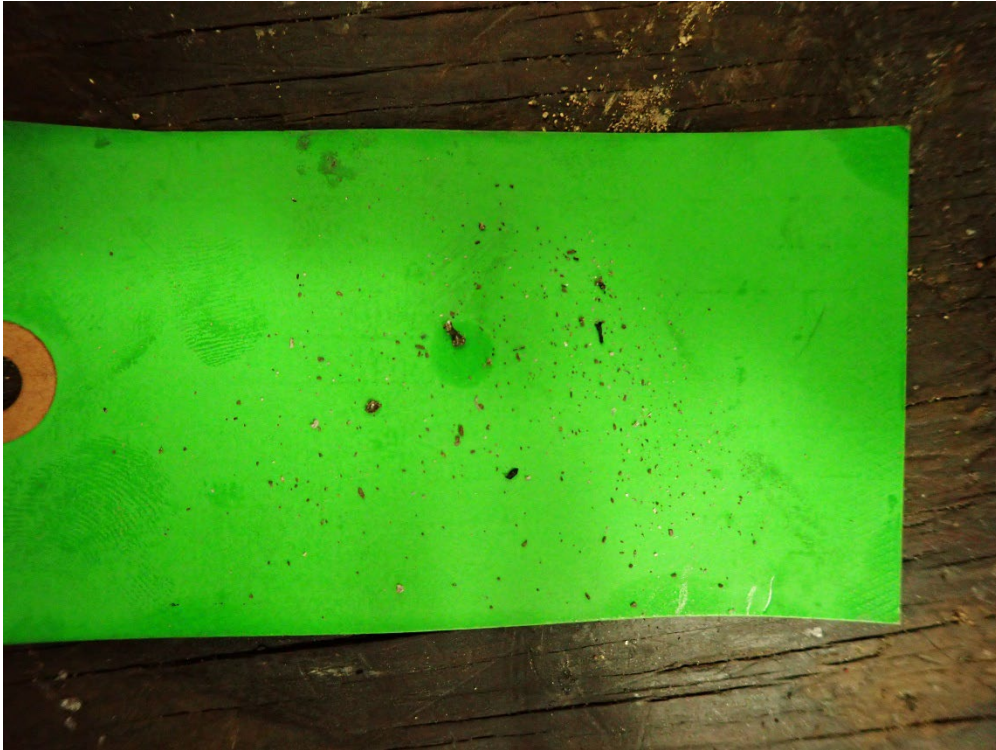
**Figure 13 Debris found in carburetor**

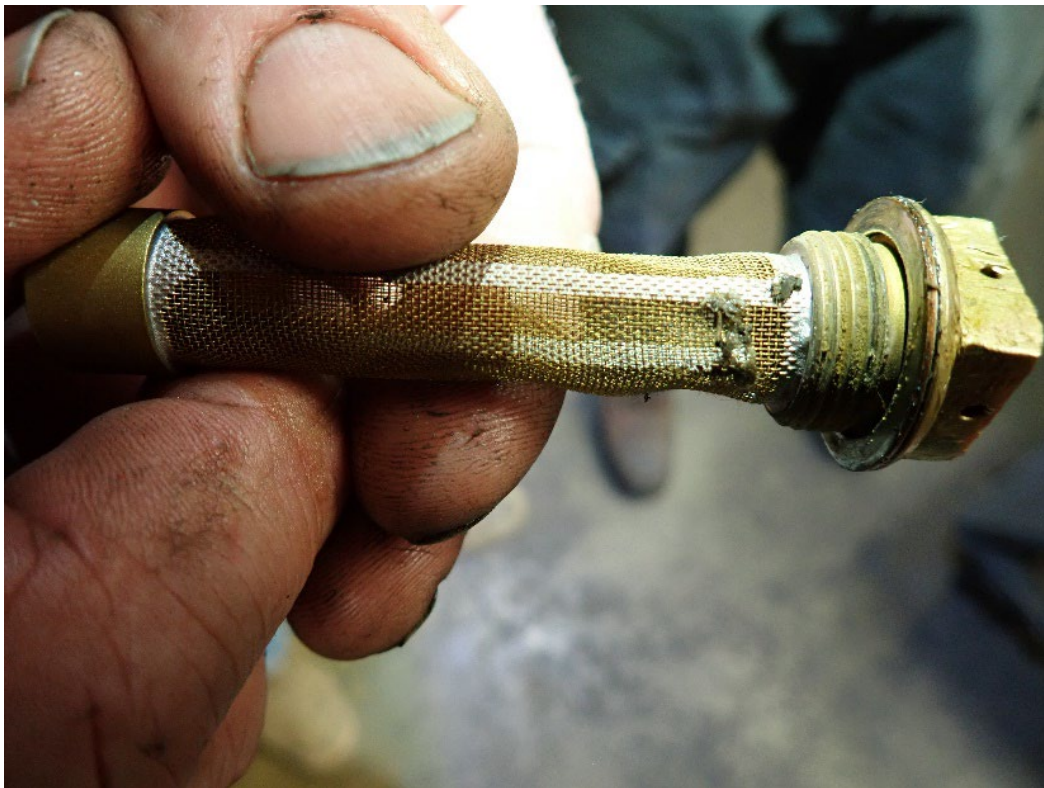
**Figure 14 Carburetor fuel screen**
