# National Transportation Safety Board

ANC24LA077

## **COMPONENT EXAM**

### **1.0 Tail Rotor Flex Coupling Assembly**

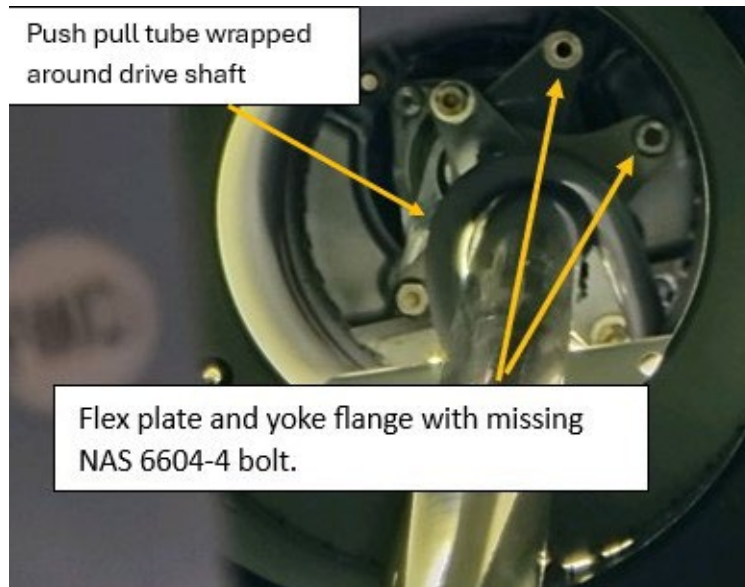
The FAA was present when the tail rotor gear box, drive shaft and push pull tube were removed from the Robinson R44. One of the NAS6604-4 bolts connecting the Flex Plate to the Yoke Flange of the tail rotor gear box was observed to be

missing (Figure 1). The bolt and associated NAS 1149F0432P washers were located at the bottom of the tail boom below the flex coupling assembly (Figure 2).

**Figure 1 Flex plate and yoke flange with missing bolt.**

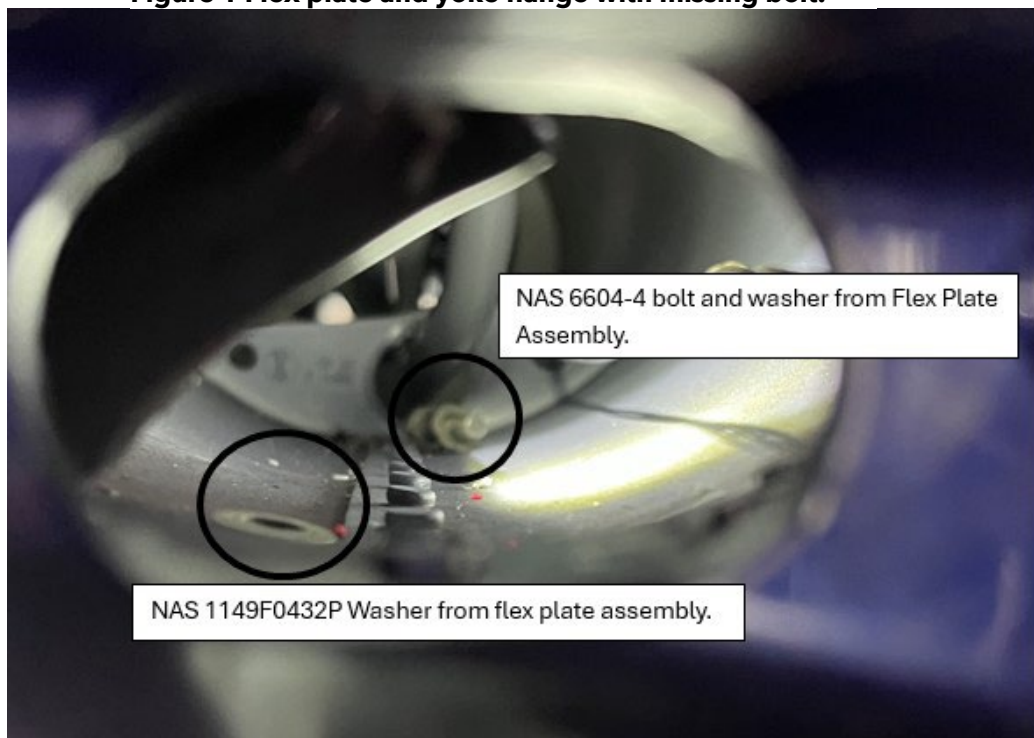
**Figure 2 Missing bolt and washer located on bottom of tail boom.**

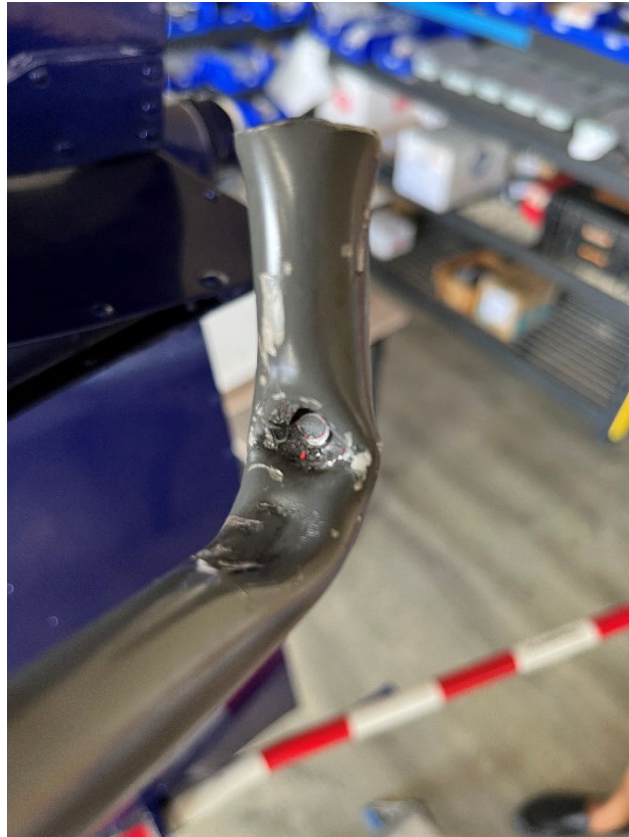
The tail rotor push pull tube had a witness signature of a bolt which had embedded itself into the tube, which resulted in the push pull tube wrapping around the drive shaft and fracturing below the tail rotor drive shaft (Figure 1, 3). The NAS6604-4 bolt matched the witness marks on the tail rotor push pull tube.

**Figure 3 Tail rotor push pull tube with witness signature from bolt.**

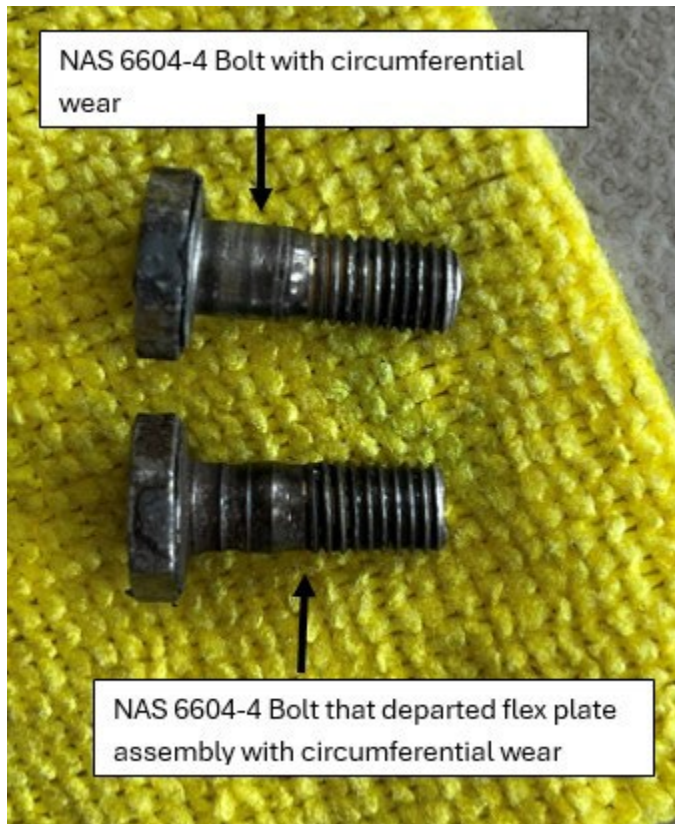
**Figure 4 NAS 6604-4 bolts with circumferential wear**

The 2 NAS 6604-4 bolts displayed significant circumferential wear (Figure 4). The flex plate and yoke flange displayed significant wear and the B330-13 palnut associated with the missing bolt was significantly deformed (Figure 5).

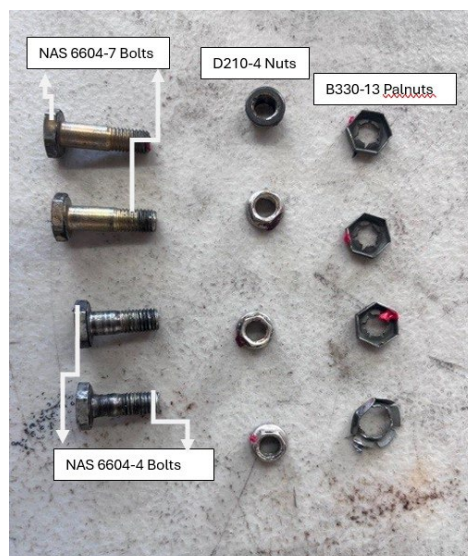
**Figure 5 Nuts, bolts and washers from flex plate assembly**

The 2 NAS6604-4 bolts and associated washers from the flex coupling assembly were found to have significant wear signatures (Figure 5). The 2 NAS6604-7 bolts from the flex coupling assembly showed no wear. The yoke flange and flex plate showed deformation where both NAS 6604-4 bolts were attached (Figure 6, 7, 8).

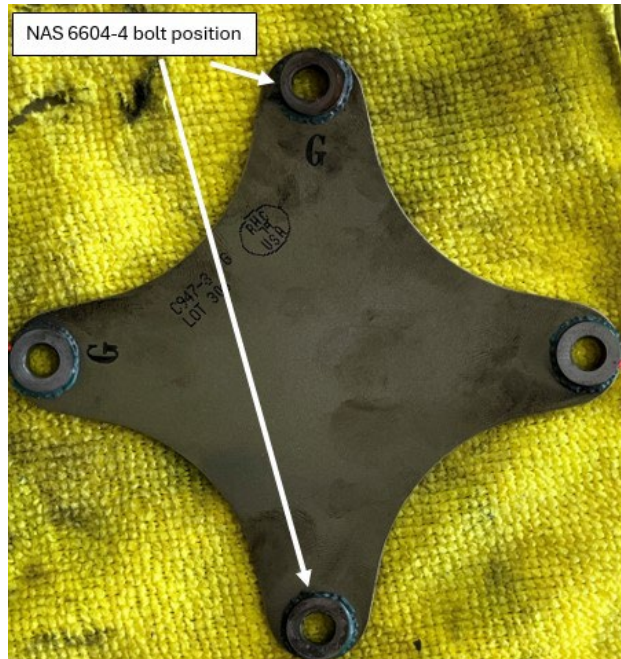
**Figure 6 Aft Flex Plate**

One of the bonded washers from the flex plate was observed to be unglued when the bolt was removed.

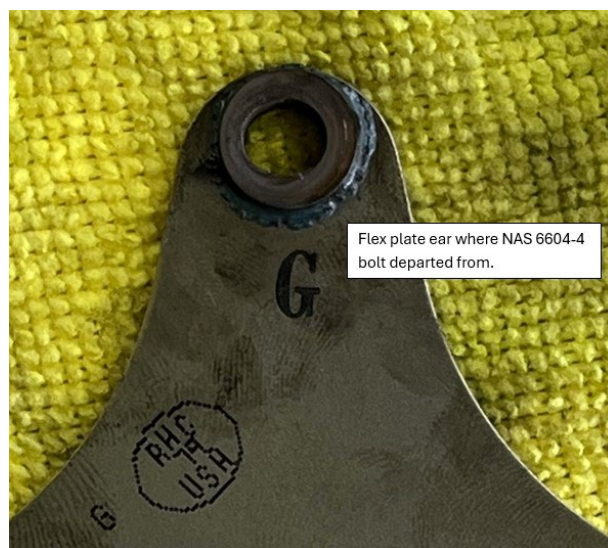
**Figure 7 Ear of aft flex plate with wear signature**

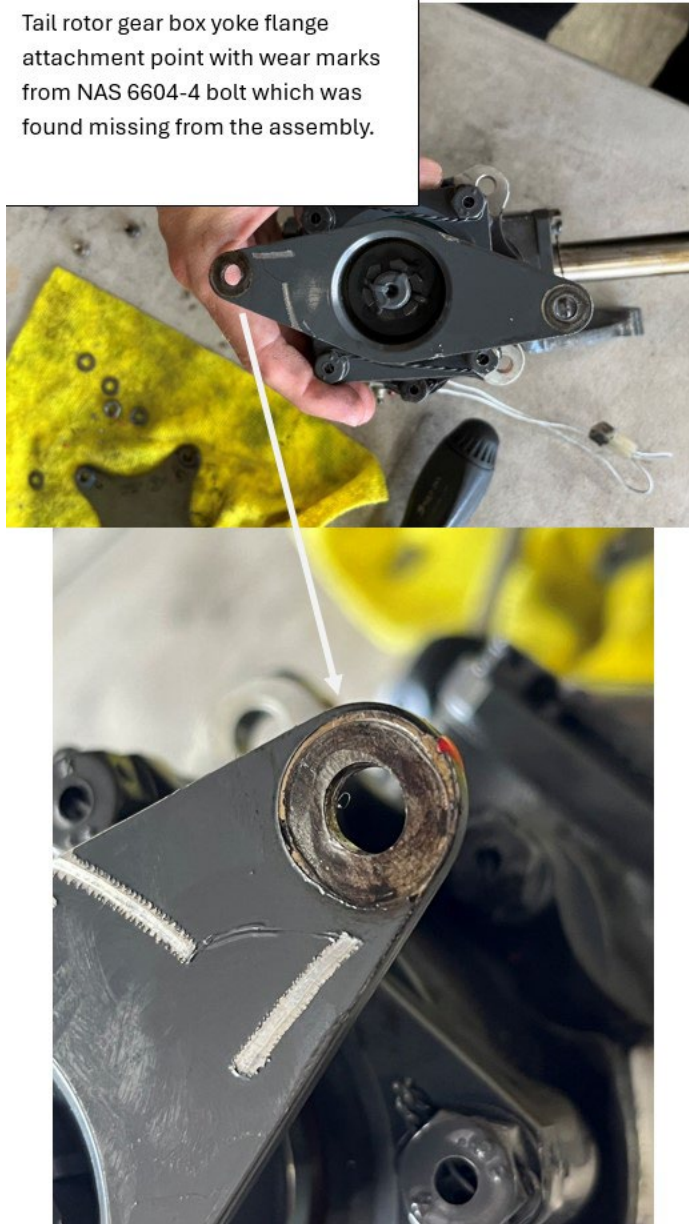
**Figure 8 Tail rotor drive shaft yoke flange**

Tail rotor gear box yoke flange attachment point with wear marks from NAS 6604-4 bolt which was found missing from the assembly.
