ANC24LA077

## INVESTIGATION PHOTOGRAPHS

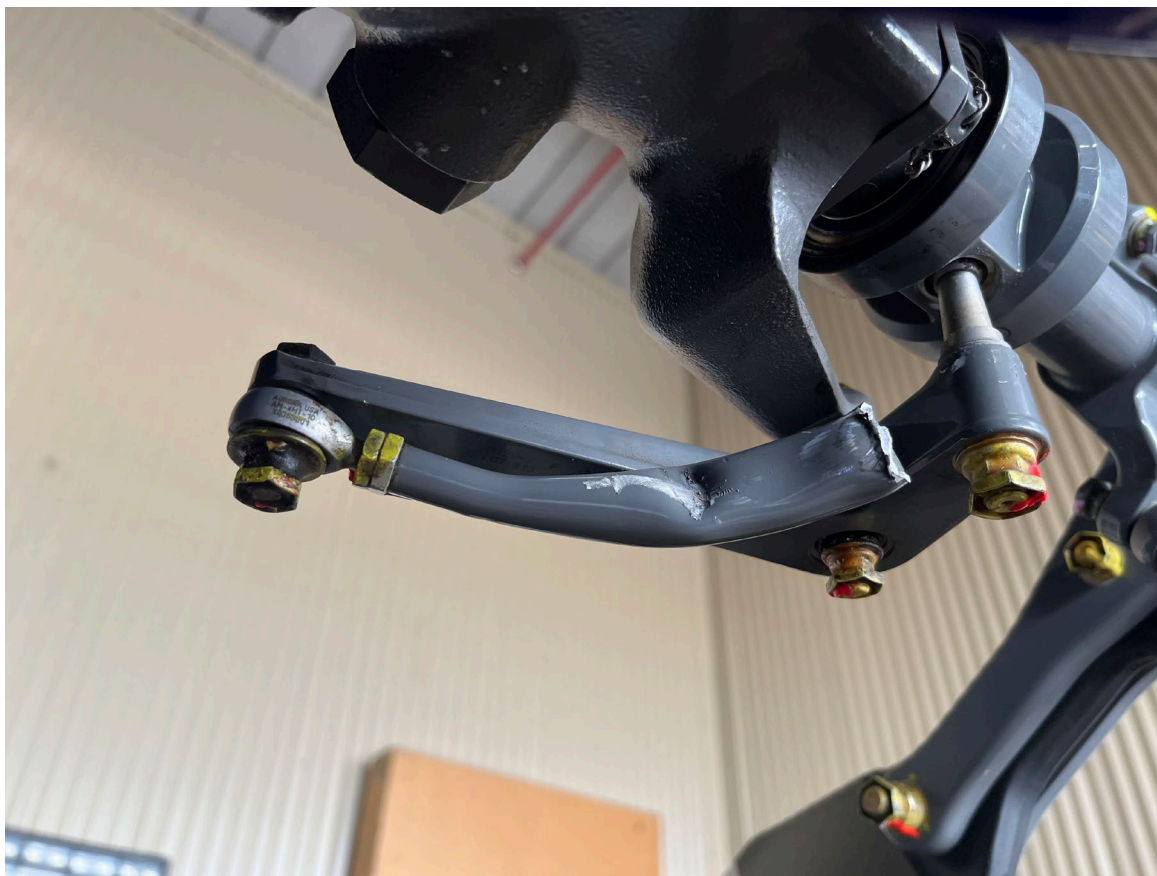
**Photograph 1 - Push pull tube fractured at bell crank (Courtesy of FAA)**

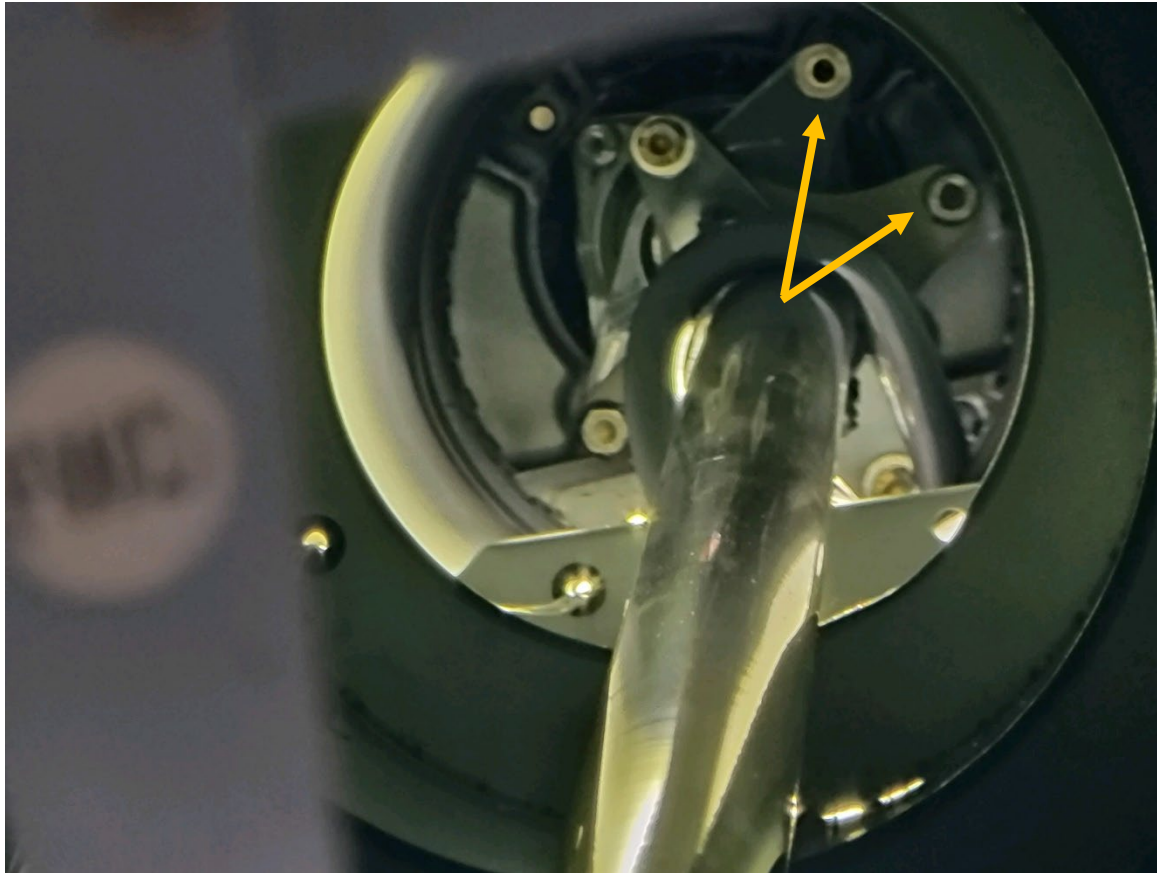
**Photograph 2 - Bolt missing from flex plate yoke assembly (Courtesy of FAA)**

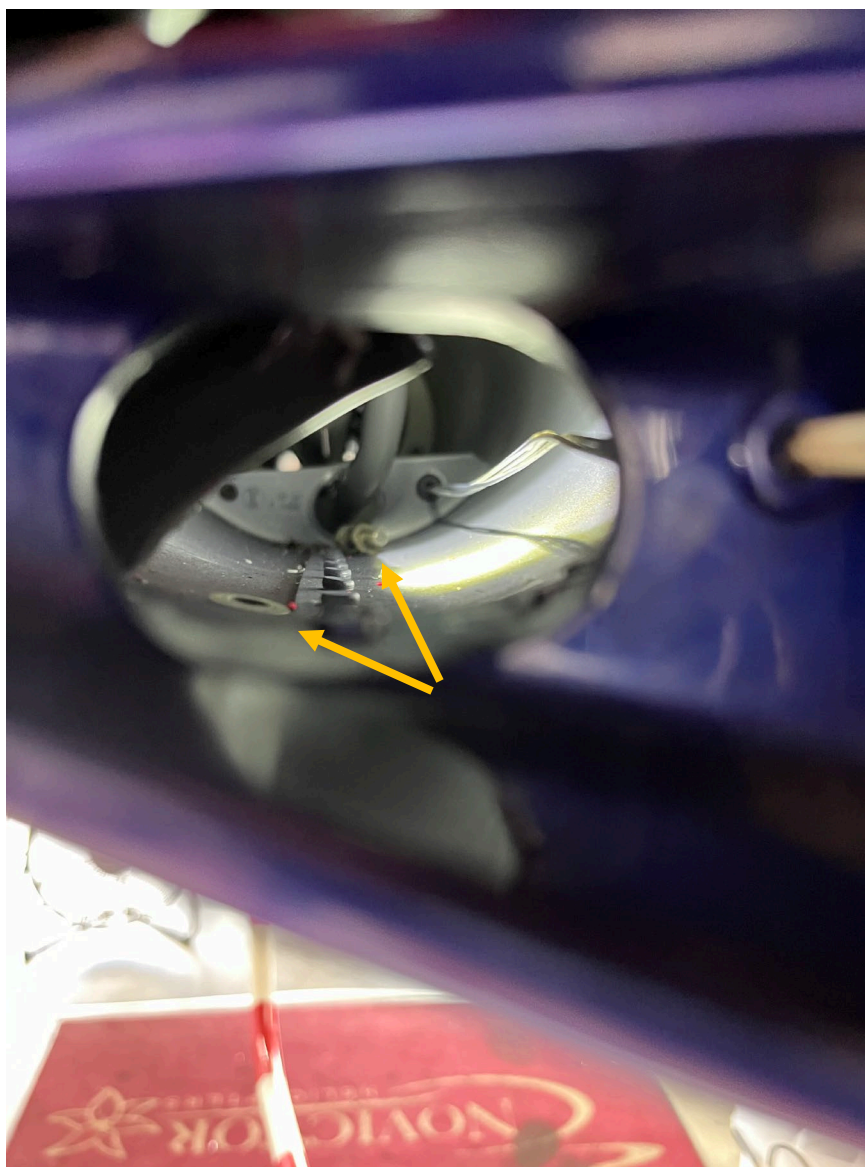
**Photograph 3 - Bolt and washer from flex plate assembly in tail boom (Courtesy of FAA)**

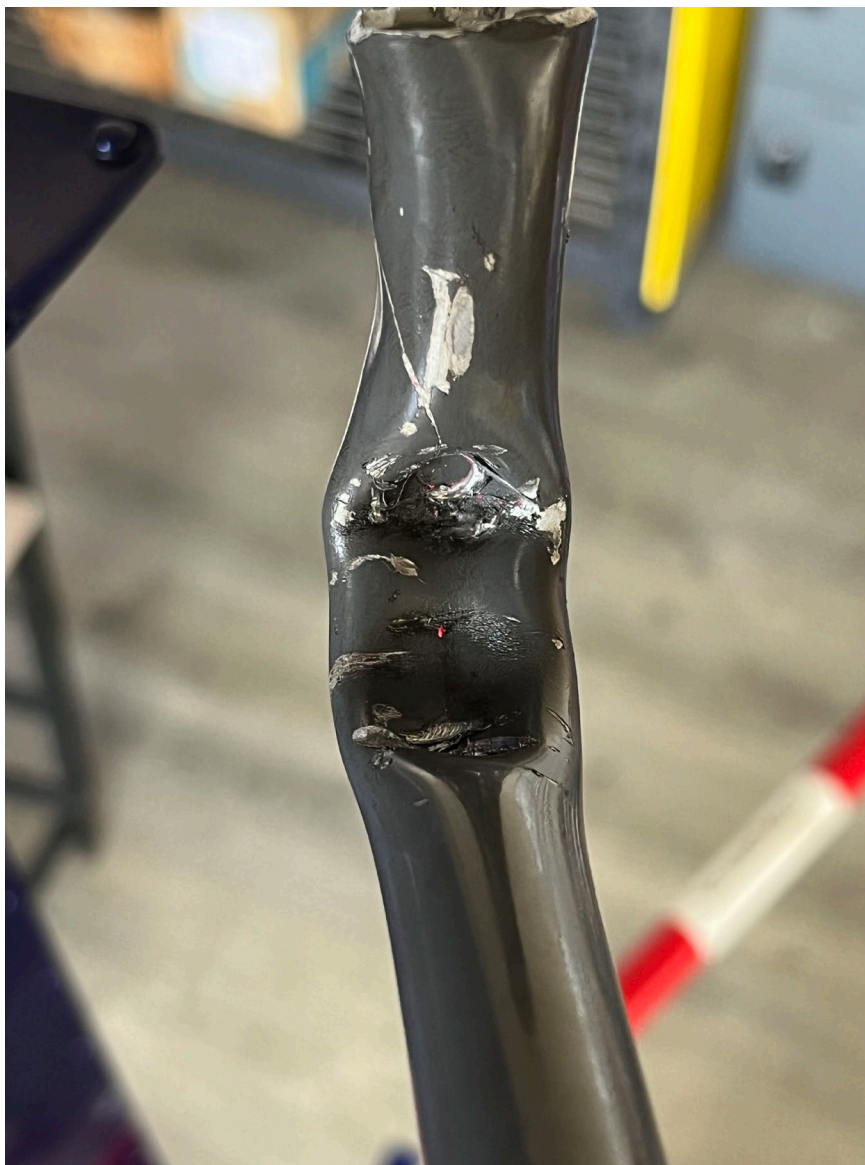
**Photograph 4 - Push pull tube with witness signature from bolt (Courtesy of FAA)**
