ANC24LA093

## INVESTIGATION PHOTOGRAPHS

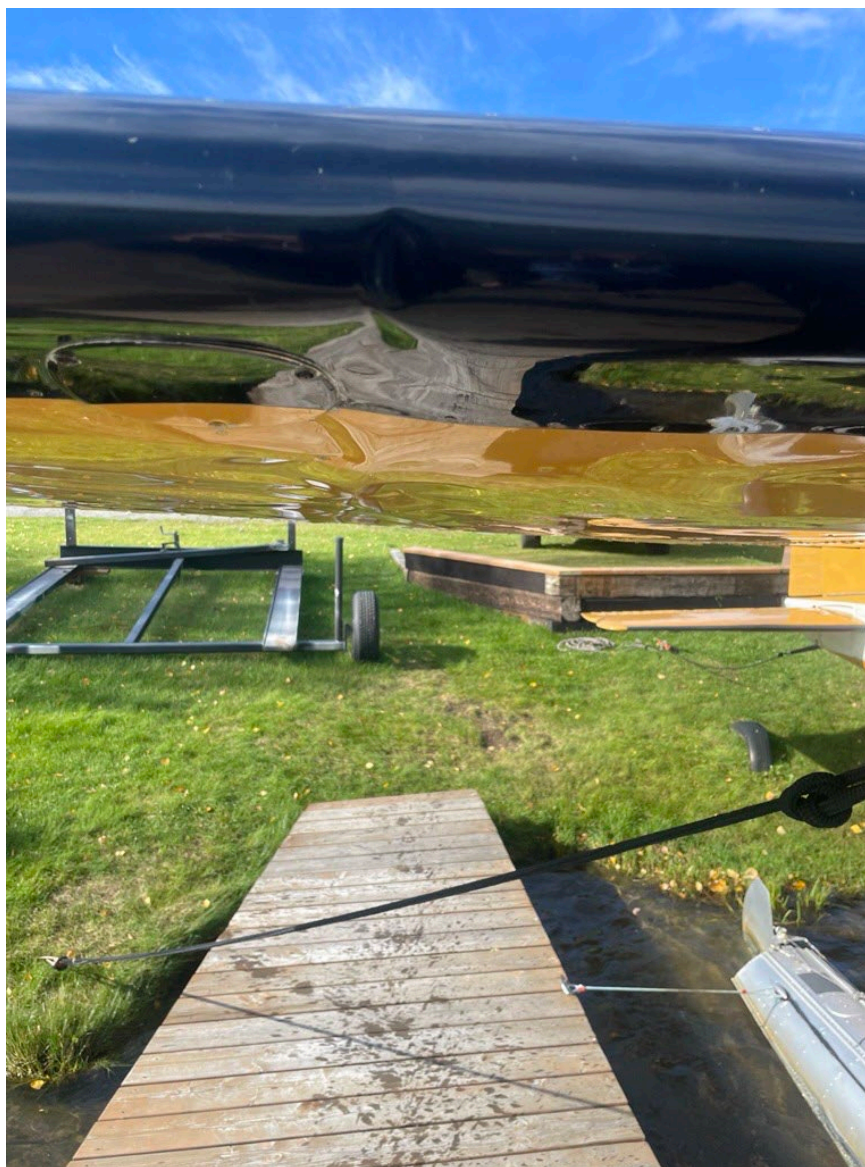
**Photograph 1 - View of damage to the bottom of right wing (Courtesy of pilot)**

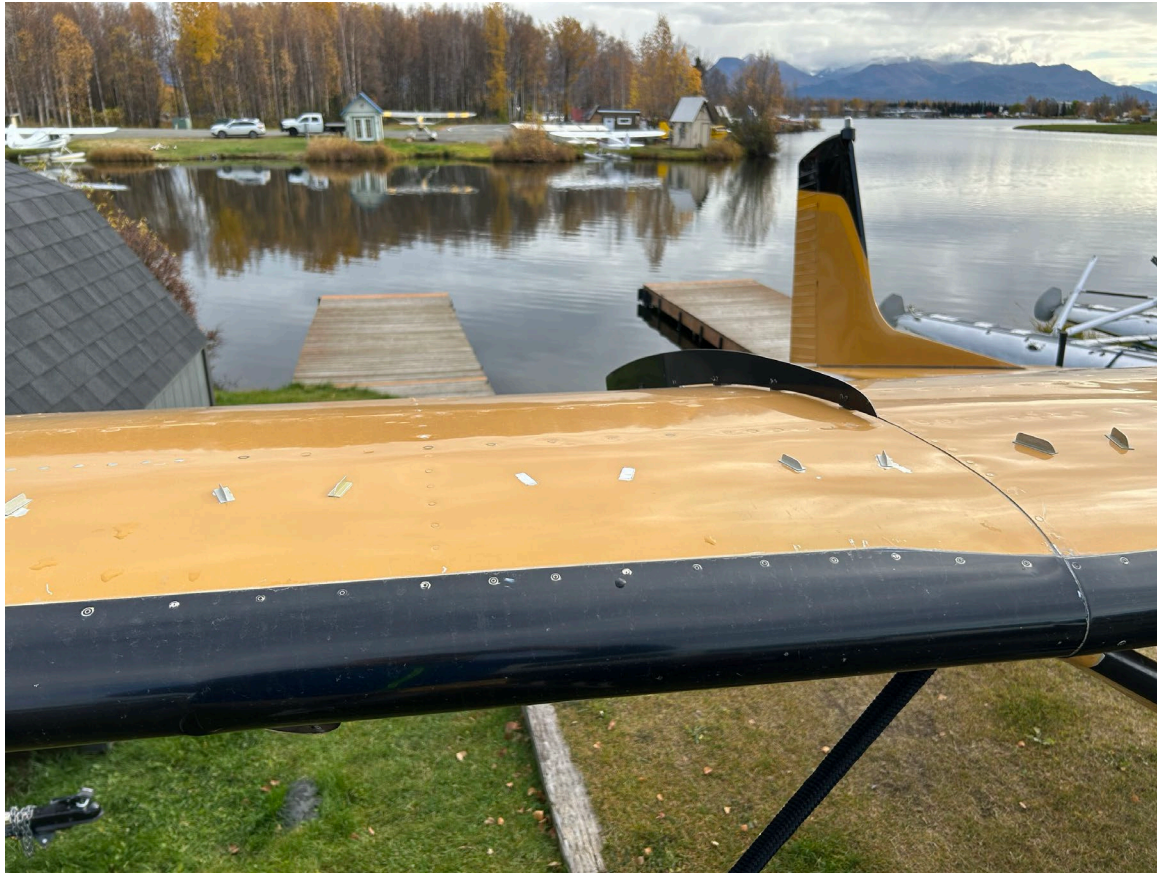
**Photograph 2 - View of the top of the right wing missing vortex generators (Courtesy of FAA)**

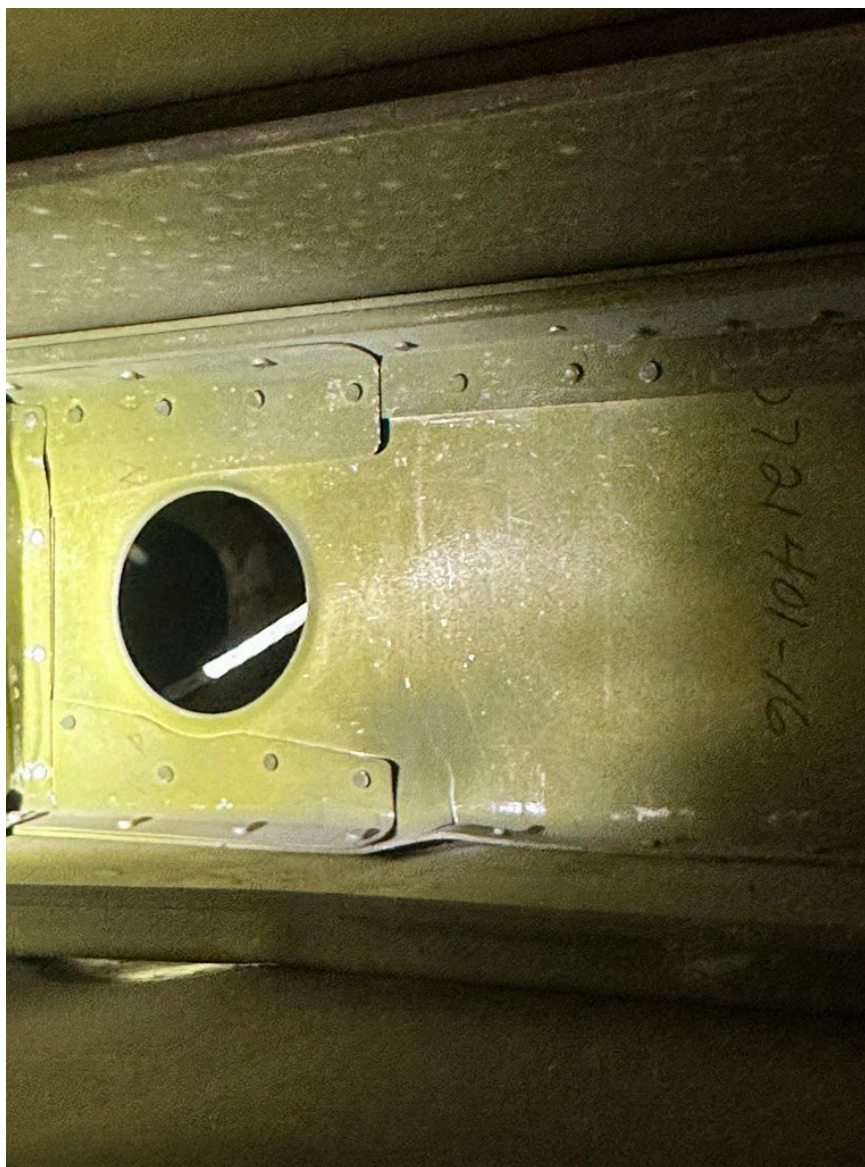
**Photograph 3 - View of damage to right spar (Courtesy of pilot)**
