ANC24LA101

## INVESTIGATION PHOTOGRAPHS

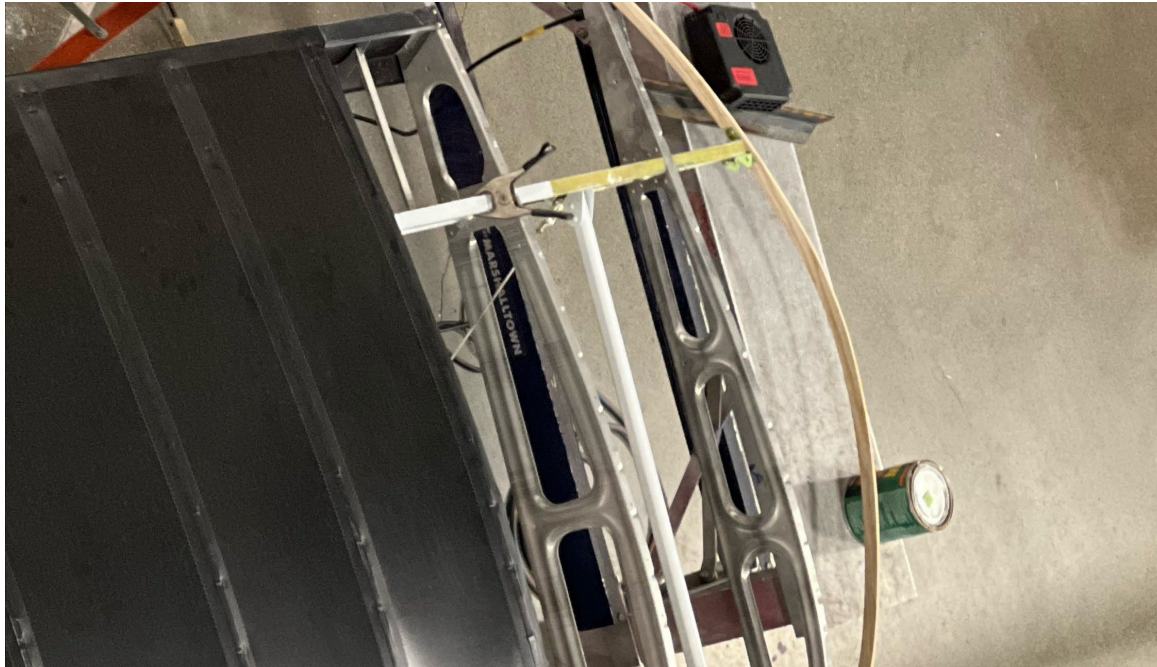
**Photograph 1 - repair of spar and wing ribs (Courtesy of Owner)**
