# National Transportation Safety Board

ANC25LA005

## **ENGINE EXAM**

Location: Lanai, Hawaii  
Date: October 24, 2024  
Time: 15:35 Hawaii-Aleutian Standard Time  
3:25 ZULU  
Airplane: Cessna 150

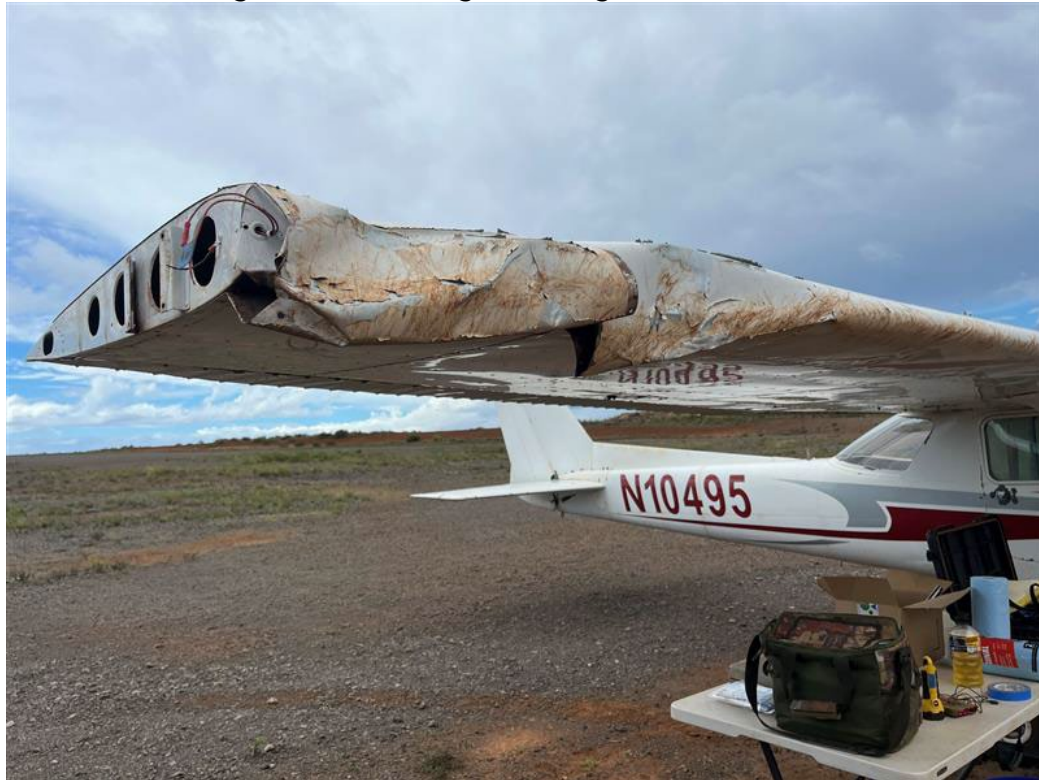
The right wing sustained substantial damage during the forced landing event (Figure 1). No other damage to the fuselage or wings was observed.

**Figure 1**Damage to right wing

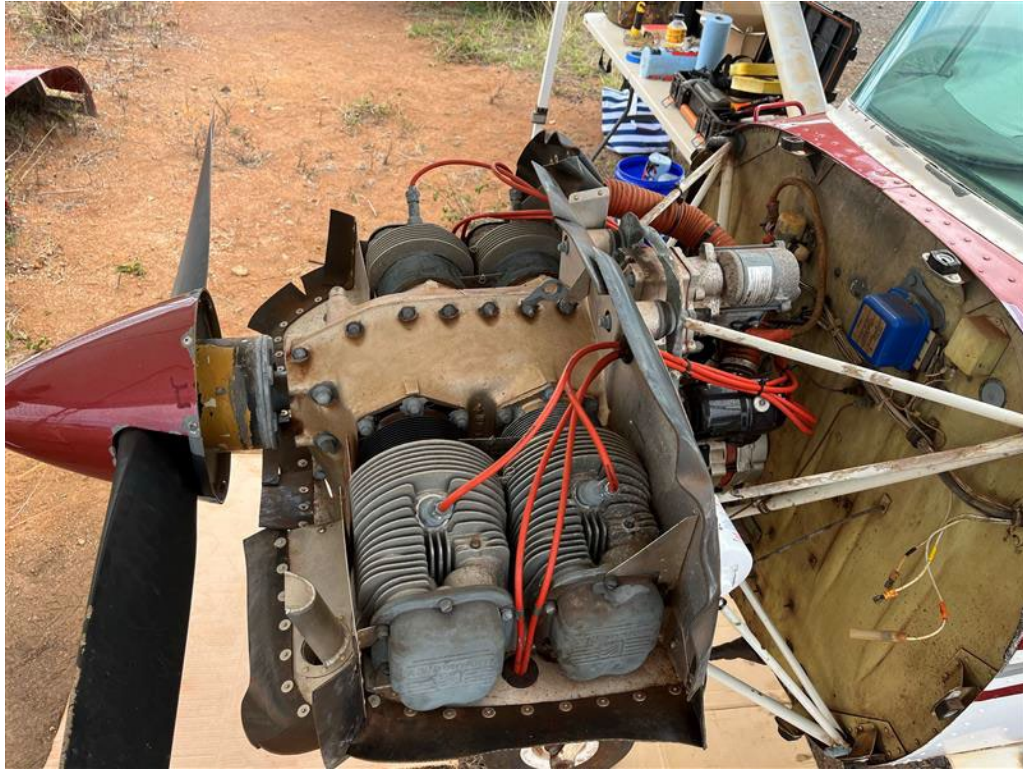
The Continental O-200A engine SN 199608-9A was installed on the airplane on May 28, 2020 (Figure 2). The engine was rebuilt by Signature Engines in February of 2020, the total time since new was 5376.9 hours. At the time of the accident the engine had about 566 hours since overhaul. The last annual inspection was completed on July 12, 2024.

**Figure 2 Left side view of airplane engine**

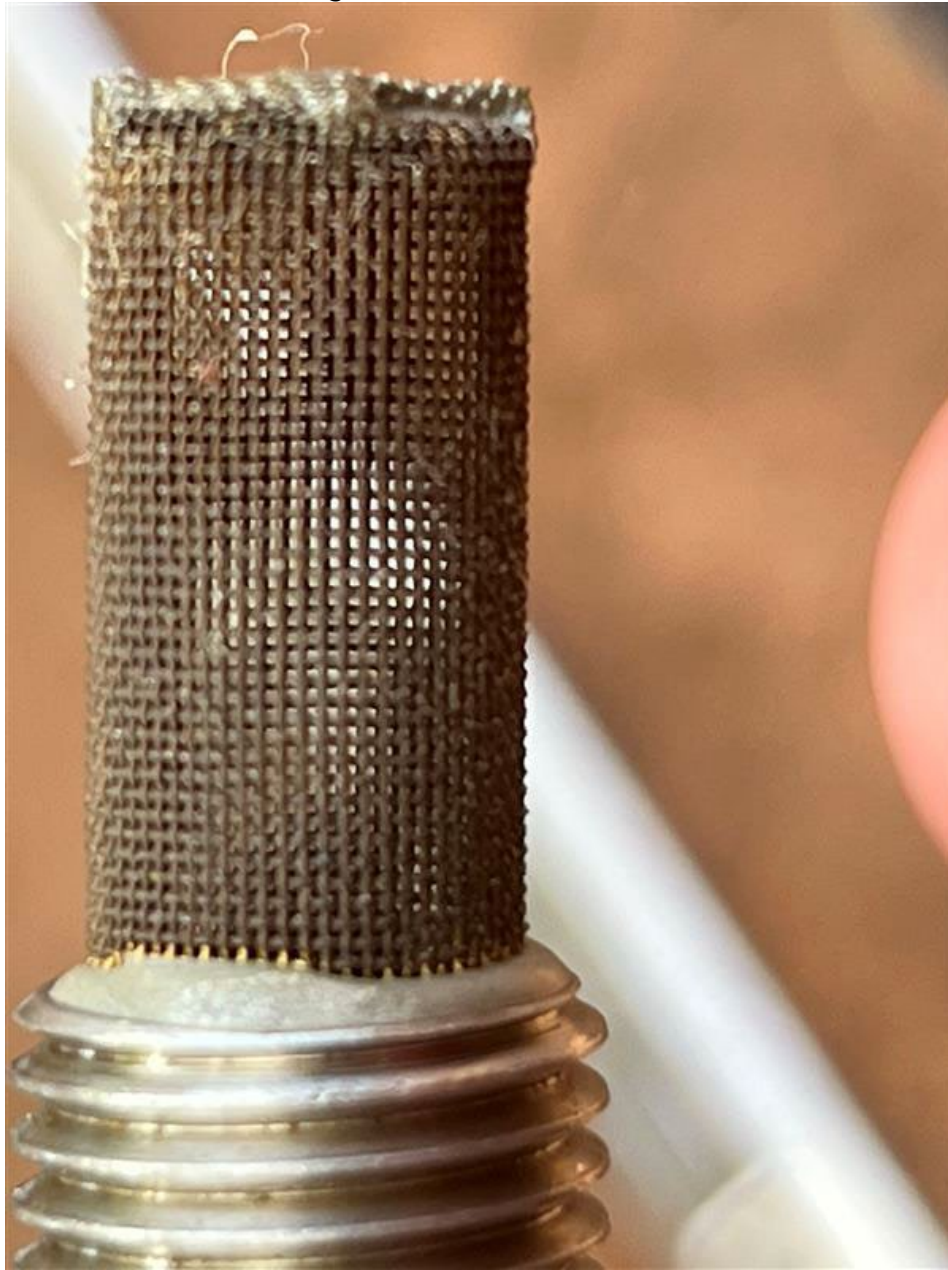
The fuel lines into the carburetor were secure and no leaks observed. The last chance fuel screen was removed from the carburetor, a couple of very short, fine white fibers were found streaming from the screen, otherwise it was largely unobstructed. Both fuel caps were opened and observed to have positive pressure and normal unobstructed venting.

**Figure 3 Carburetor last chance screen**

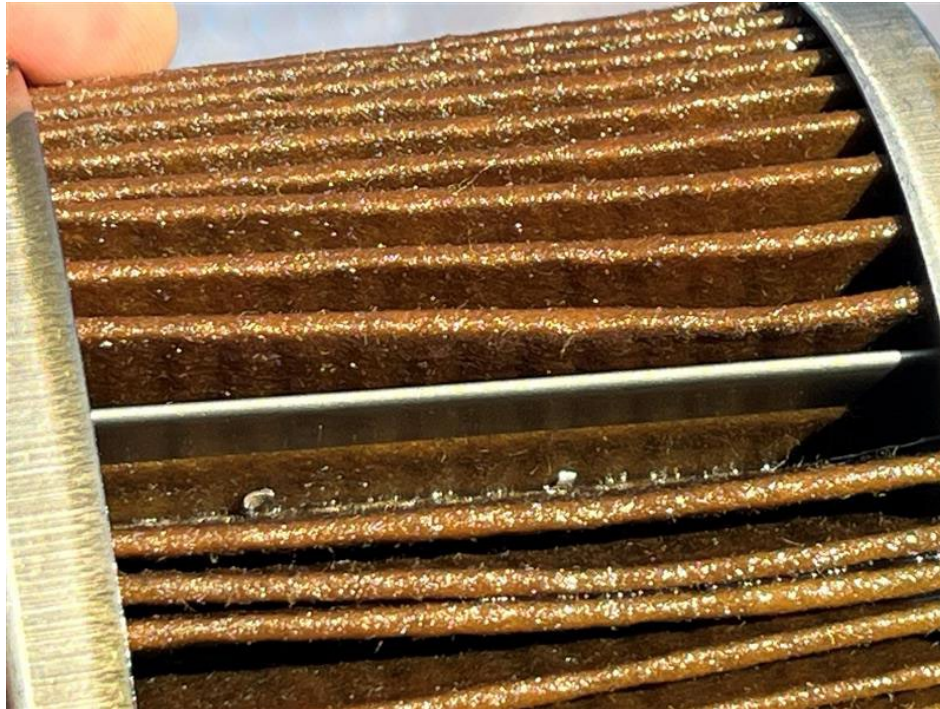
The oil filter was removed, small flakes of metal were observed in the oil filter media.

**Figure 4 Engine oil filter media with metal particulates**

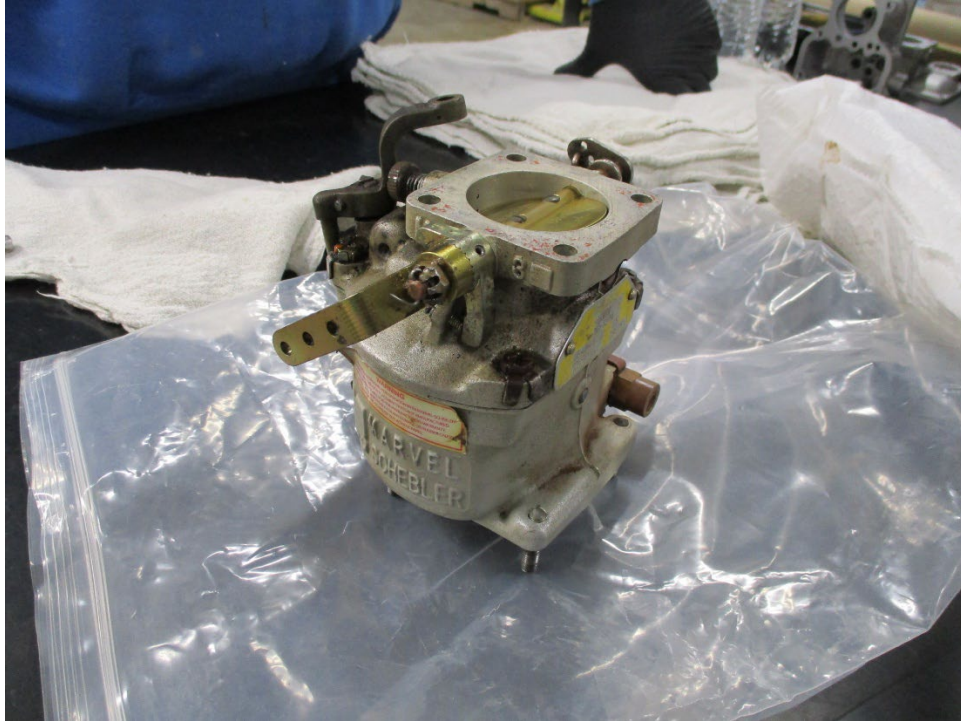
**Figure 7 Carburetor presented at inspection**

On December 5, 2024 with FAA oversight the carburetor was flow tested and disassembled for inspection at the Marvel Schebler facility in North Carolina. The flow test results were normal and no anomalies were found when the carburetor was disassembled (Figures 5-9).

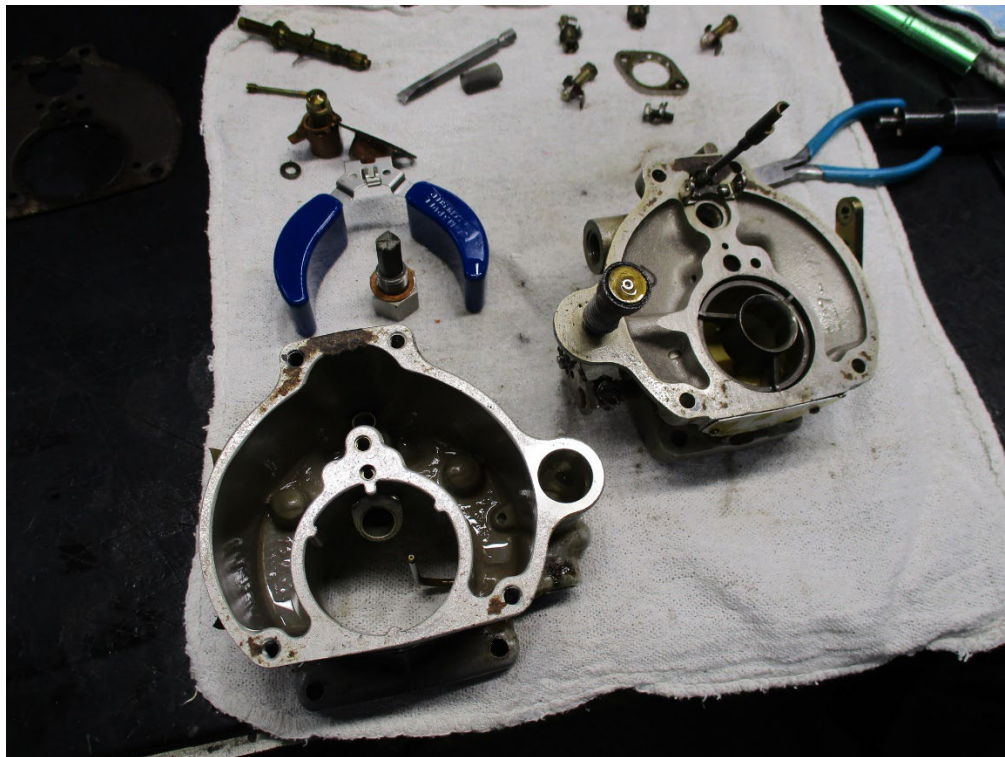
We observed a technician disassembly the carburetor. Some small amounts of debris were noted on internal filters, but nothing that would cause any significant operational issues. It appeared normal for a carburetor in service for this amount of time.

No other issues were noted from the teardown. All other parts were in good working order and no defects were noted.

**Figure 8 Carburetor disassembled at inspection**

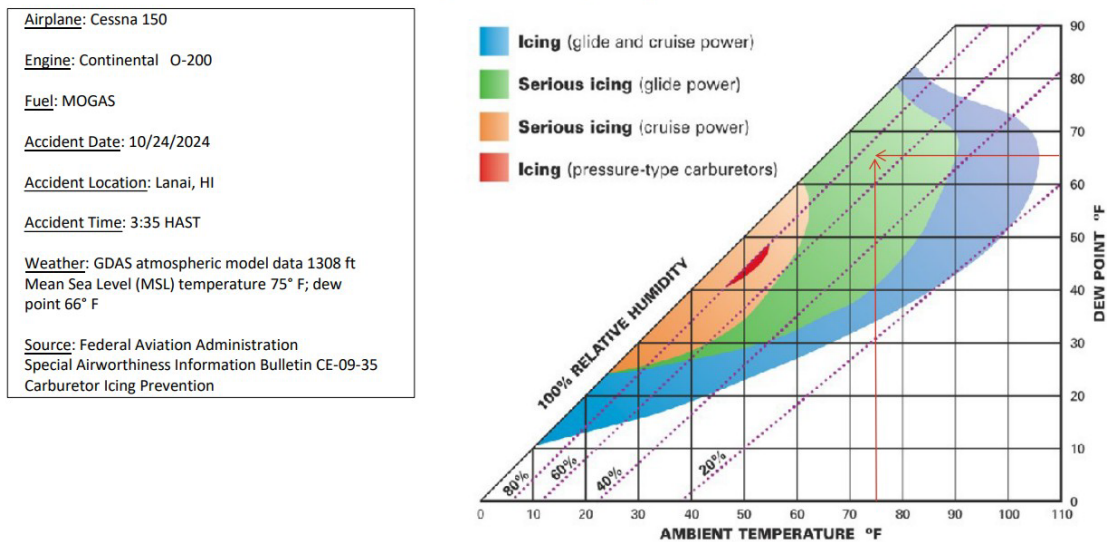
**Figure 9 Carburetor icing probability graph**

Carburetor icing conditions were evaluated on the day and time of the accident, the calculated relative humidity at this temperature and dewpoint was 70 percent. Review of the icing probability chart contained in the Federal Aviation Administration Special Airworthiness Information Bulletin CE-09-35 revealed the atmospheric conditions at the time of the accident were “conducive to serious icing at glide [idle] power.” Although weather conditions reported at the time of the accident were conducive to the accumulation of carburetor icing at glide power, the pilot reported that he used carburetor heat prior to takeoff and had full power applied during the climb out.
