ANC25LA009

## INVESTIGATION PHOTOGRAPHS

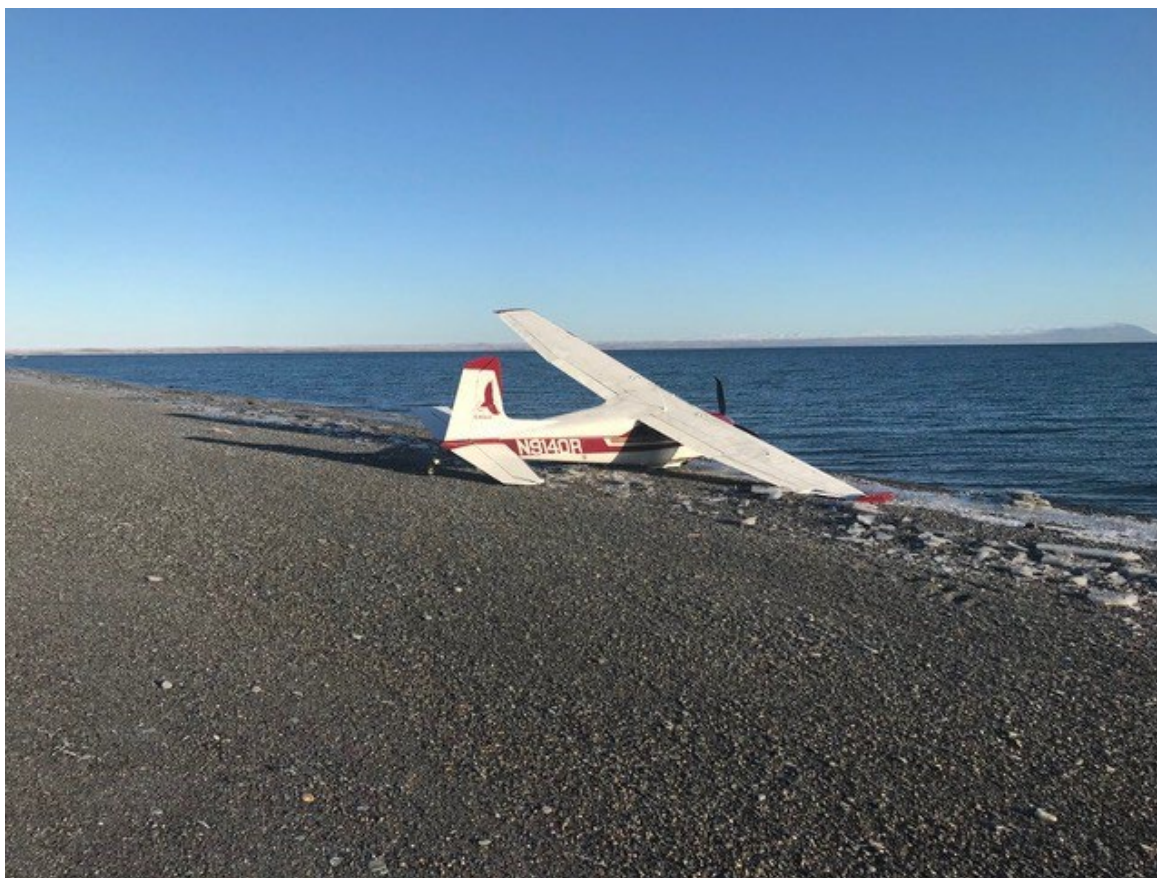
**Photograph 1 - Accident airplane at accident site (Courtesy of owner)**

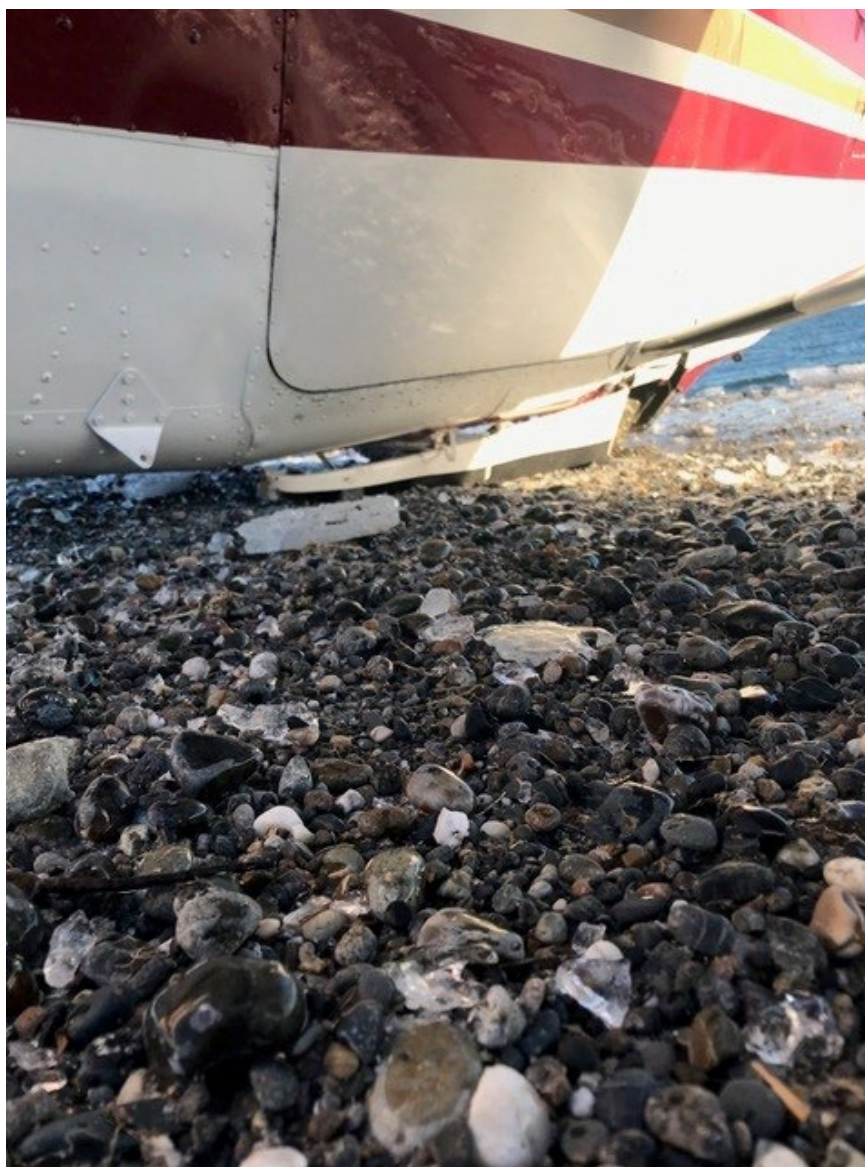
**Photograph 2 - Right gear leg folded under fuselage (Courtesy of owner)**
