ANC25LA012

## INVESTIGATION PHOTOGRAPHS

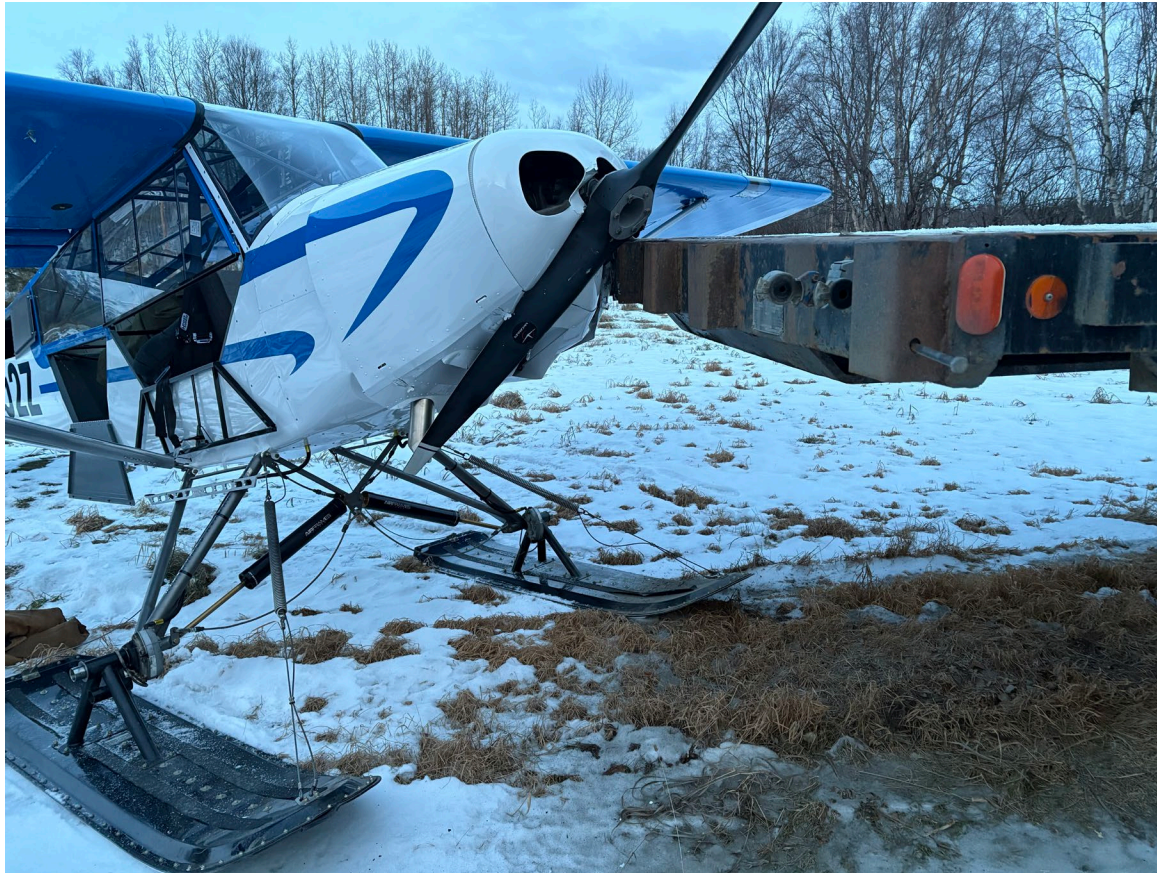
**Photograph 1 - Accident airplane at accident site (Courtesy of owner)**

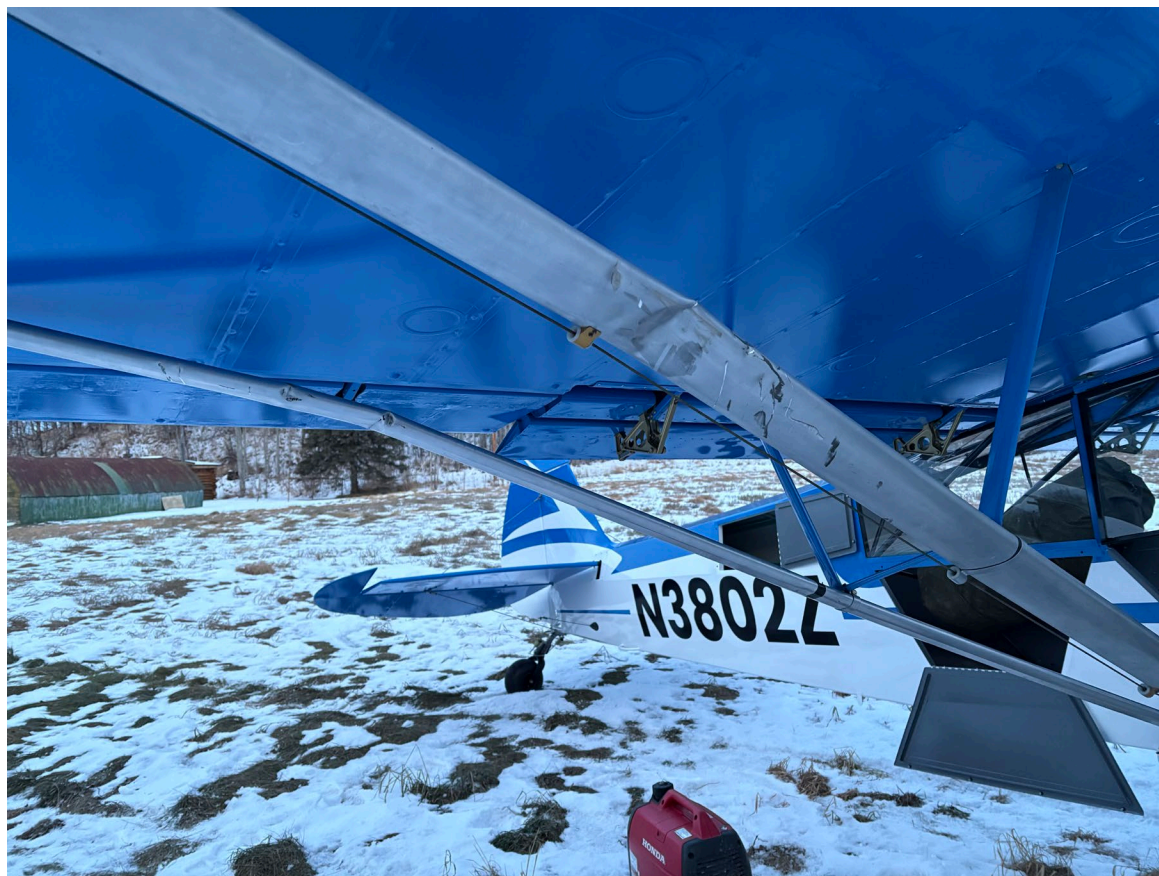
**Photograph 2 - Damage to the right wing lift strut (Courtesy of owner)**
