# National Transportation Safety Board

ANC25LA017

## **ENGINE EXAM**

Location: Anchorage, Alaska  
Date: February 2, 2025  
Time: 03:54  
23:54  
Airplane: Cessna 182F

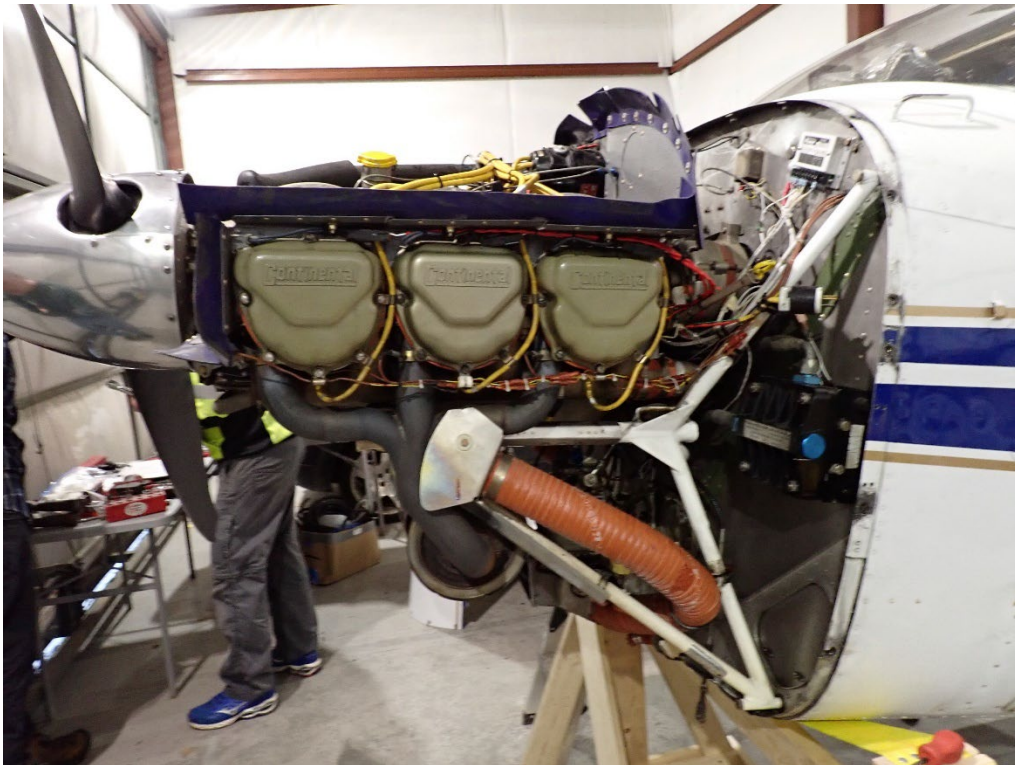
The continental O-470-R Serial Number 8118170-R engine was securely attached to the firewall.

**Figure 1 Airplane engine presented at examination**

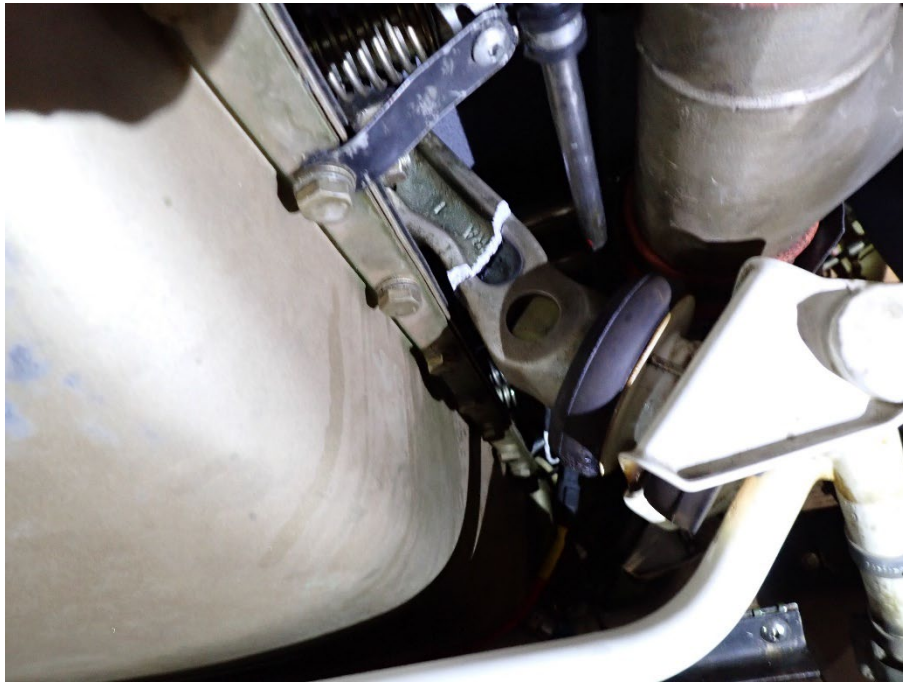
The front left engine mount was observed to be broken between the engine mount pad and the engine.

**Figure 2 Broken engine mount**

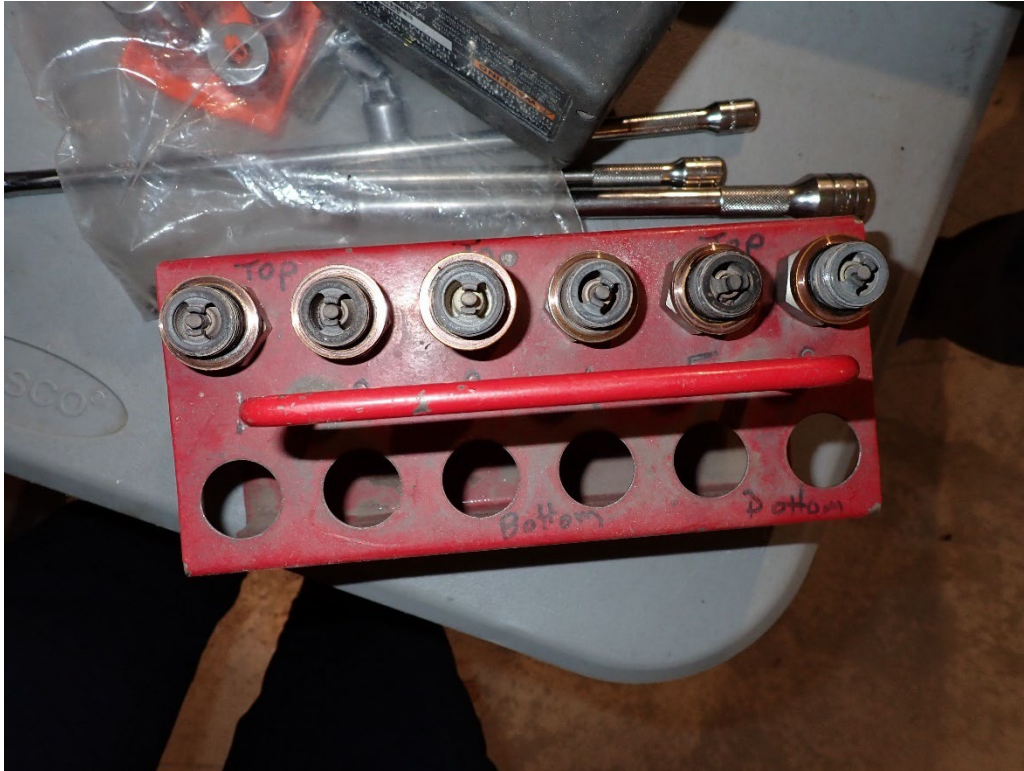
Continuity was confirmed between the mixture, throttle, carburetor heat, and propeller controls in the cockpit to the engine. The carburetor heat line was impact separated just prior to the carburetor. The carburetor flange was impact damaged. The ignition harness was in good condition and all leads were firmly attached to the spark plugs. The top 5 tempest spark plugs and 1 champion spark plug were removed. All electrodes were covered in grey deposits and had normal wear signatures when compared to the Champion Check-A-Plug AV-27 chart.

**Figure 3 Spark plugs**

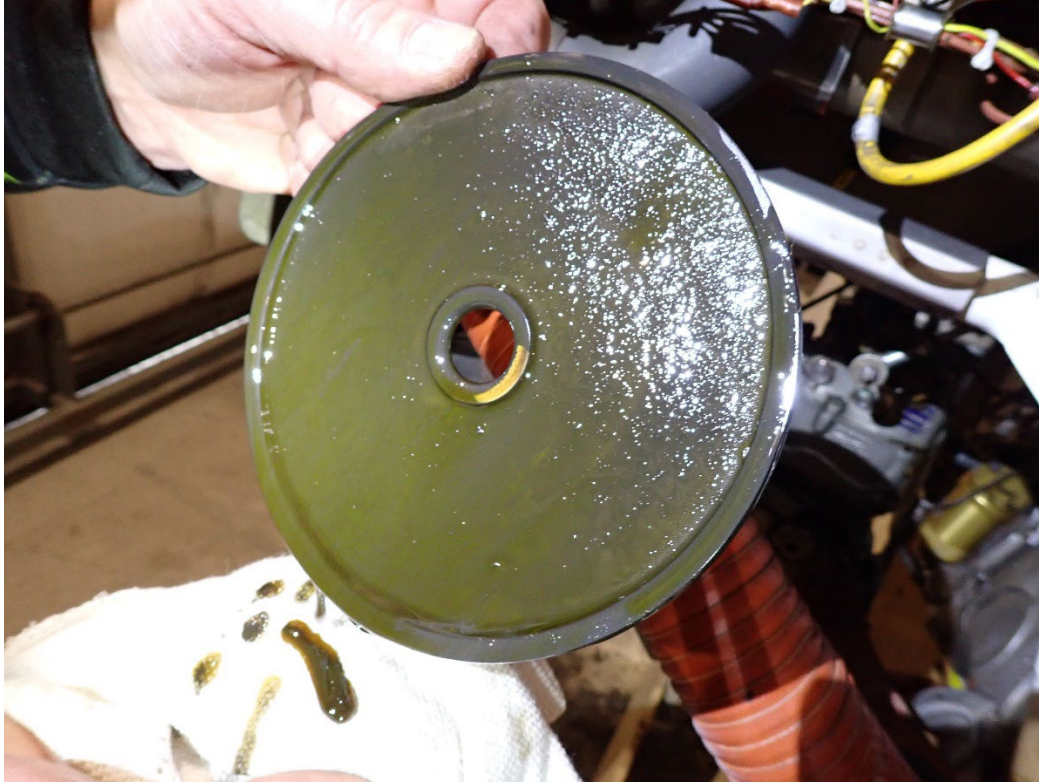
The oil screen was firmly attached to the fire wall. The oil screen was removed, a magnet was used to detect metal particulates, no metal particulates were detected.

**Figure 4 Engine oil filter**

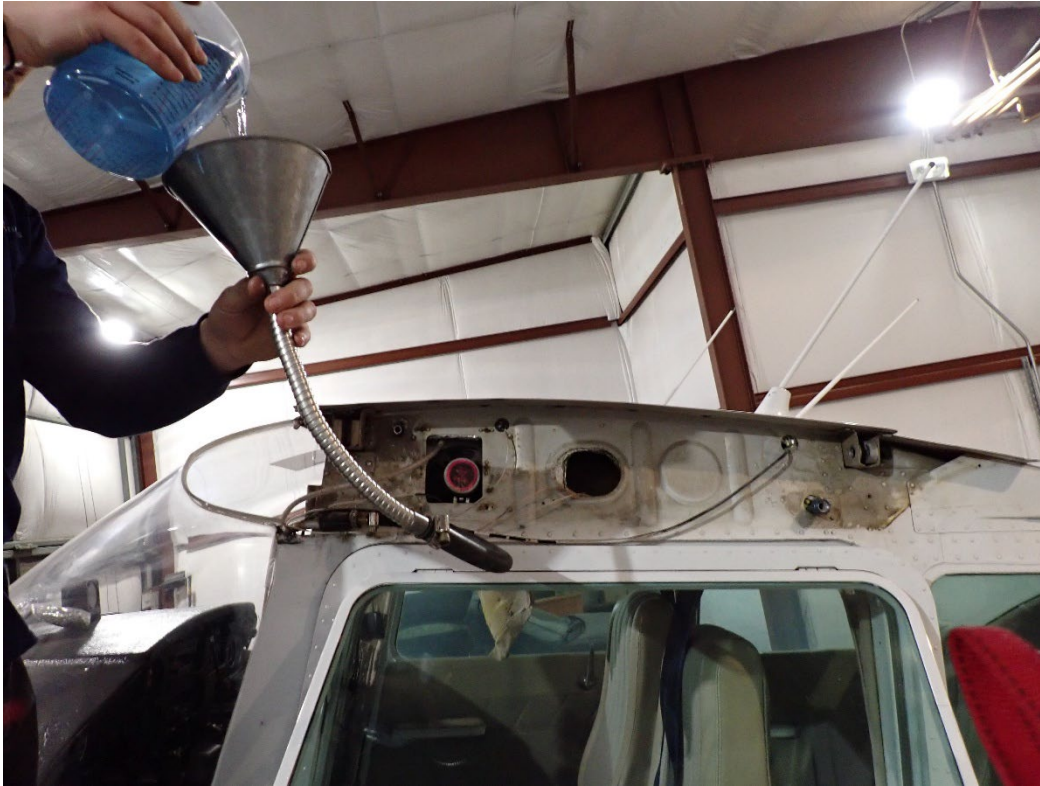
A fuel flow test was conducted, a funnel was connected to the forward fuel lines in each tank and clean fuel was added; after about 5-6 seconds fuel was observed draining from the fuel line to the carburetor. Testing of the fuel selector valve confirmed normal valve operation in all selectable positions.

**Figure 5 Fuel flow test with forward fuel line**

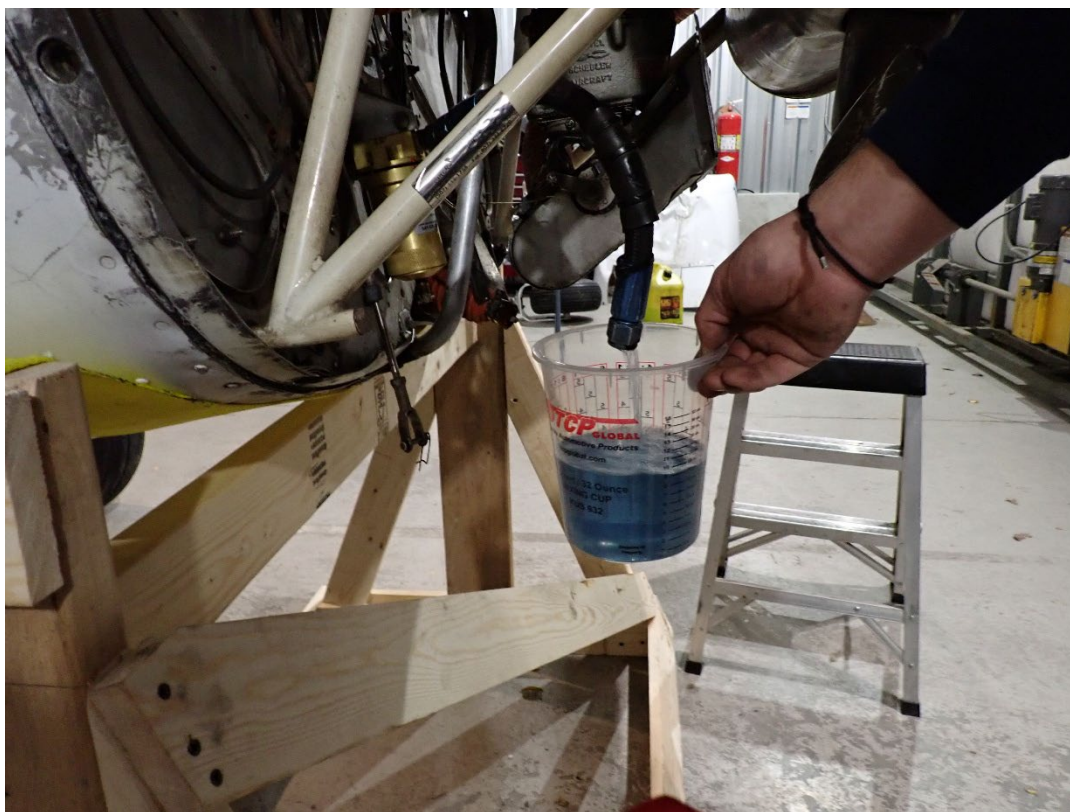
**Figure 6 Fuel flow test carburetor fuel line**

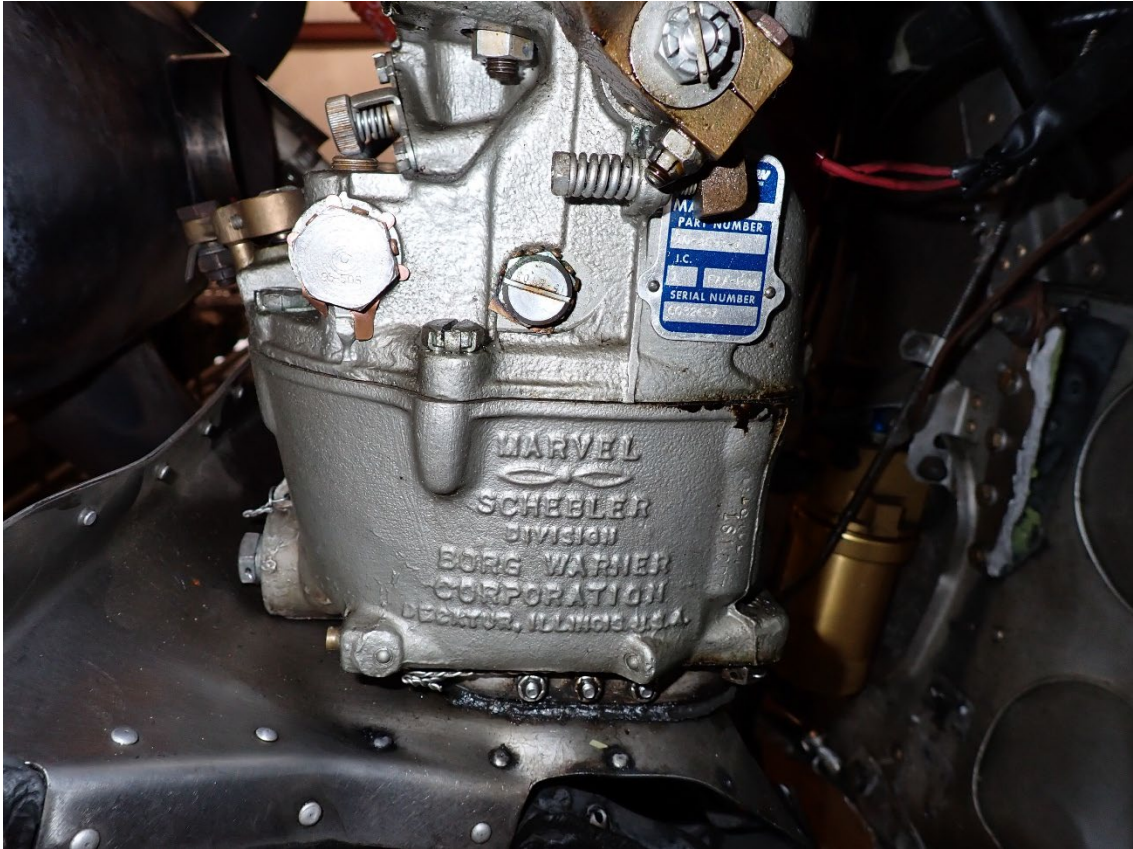
The carburetor was not removed and inspected because the fuel delivery to the carburetor was confirmed and there were no other indications that the carburetor was not functioning normally during flight.

**Figure 7 Undamaged carburetor**
