# National Transportation Safety Board

ANC25LA017

## METEOROLOGY

Environmental Conditions

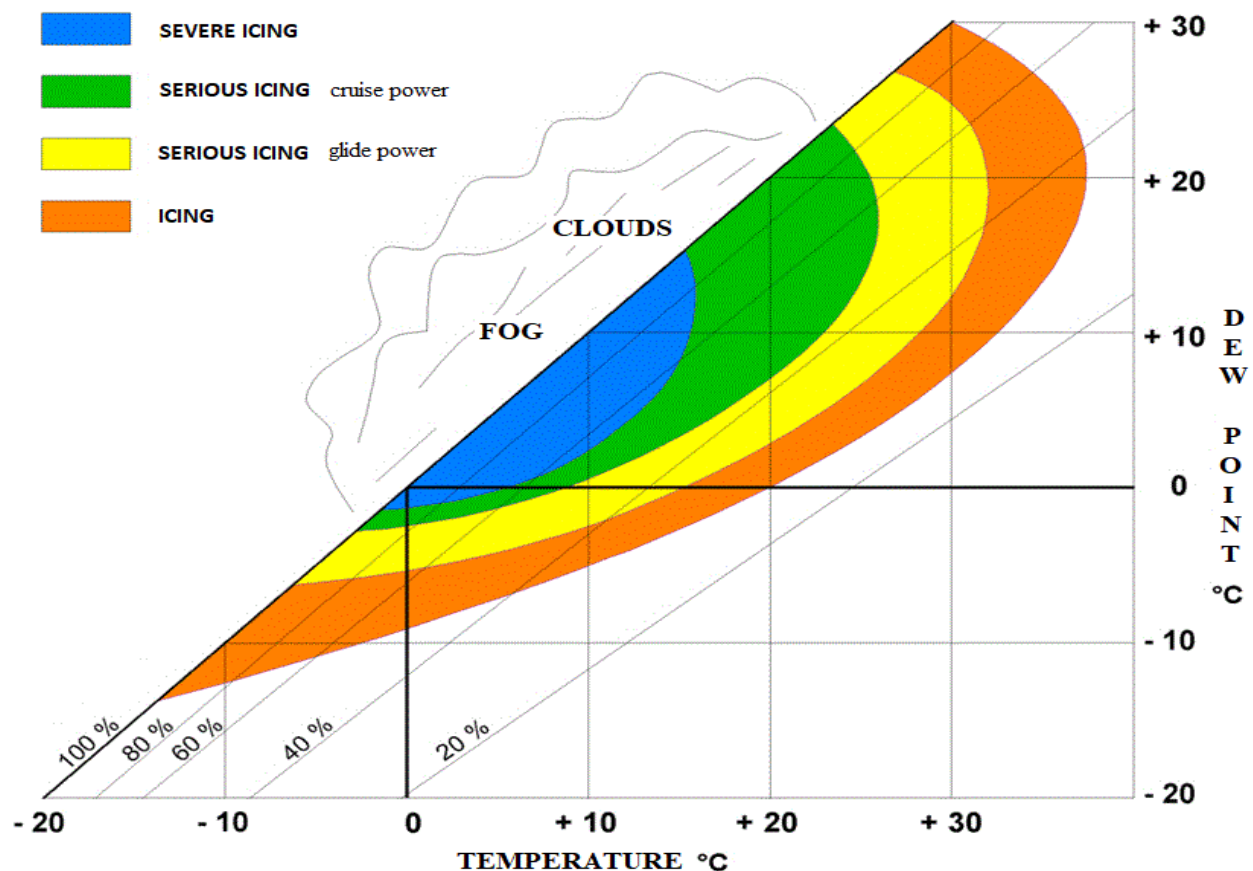
An analysis by the RAOB program identified a “trace” amount of carburetor icing in the lowest 700 feet of this atmosphere.

- The following chart identifies the carburetor icing threat in terms of degrees Celsius. The temperatures provided above are around the edge of the “icing” category.
