# National Transportation Safety Board

ANC25LA019

## **ENGINE EXAMINATION NOTES**

Location: Wasilla, Alaska  
Date: February 20, 2025  
Time: 1642 AKDT  
0142 UTC  
Airplane: Piper PA-18-150, N2447J

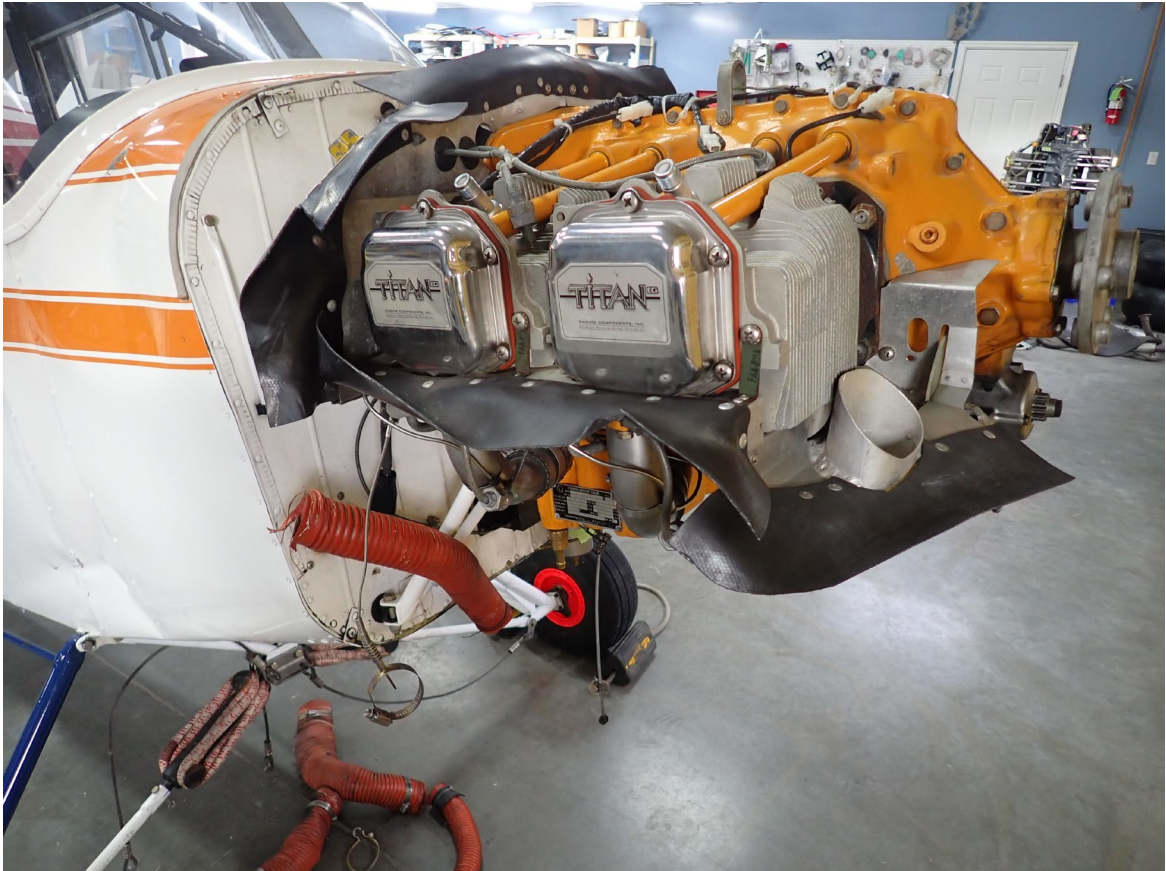
The Airbox, carburetor, exhaust, spinner and prop, and bottom spark plugs were removed by the assisting mechanic prior to investigator arriving at the examination site.

**Figure 1 - Overall view of airplane engine (NTSB Photo)**

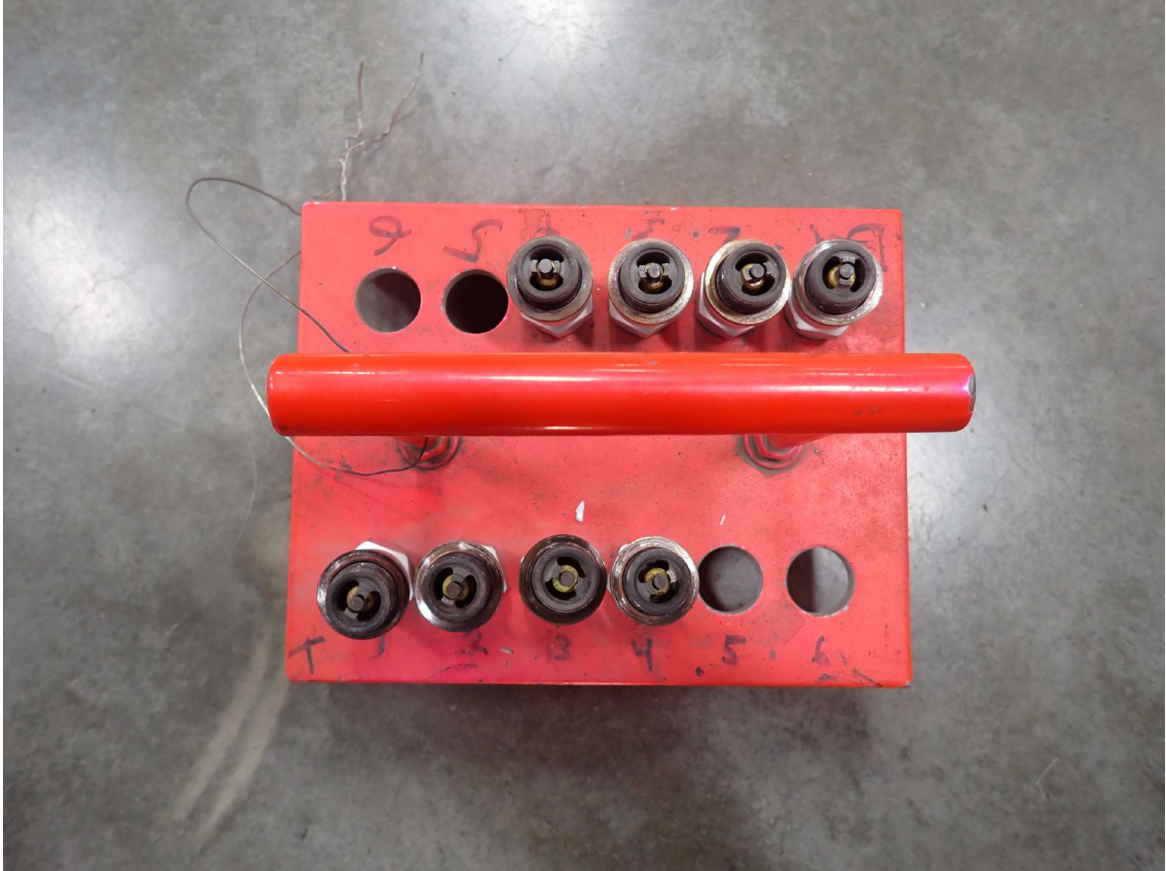
The top and bottom spark plugs were removed and showed signs of normal wear. Thumb compression was verified on all cylinders.

**Figure 2 - Top and bottom spark plugs (NTSB Photo)**

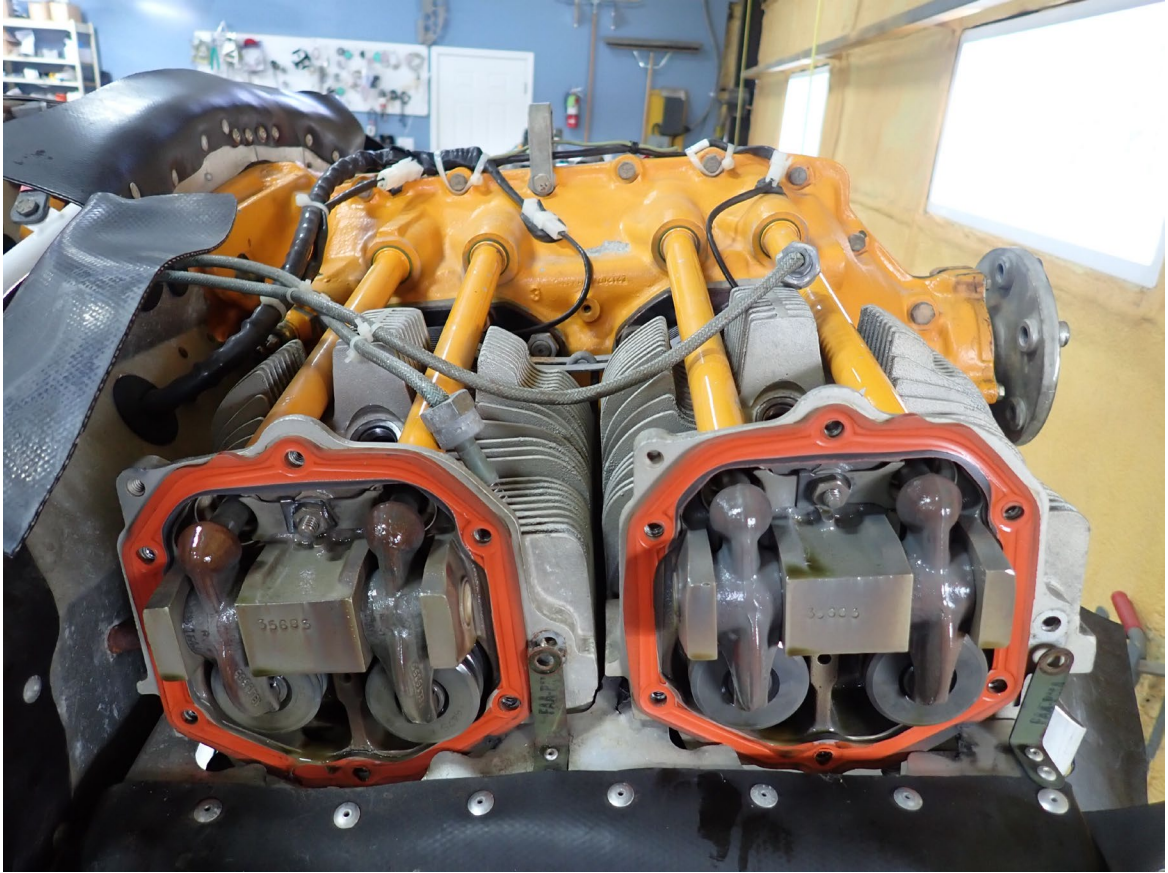
**Figure 3 - Cylinders without rocker box covers (NTSB Photo)**

The rocker box covers were removed, and engine was turned; all intake and exhaust valves functioned normally. The pushrods functioned normally.

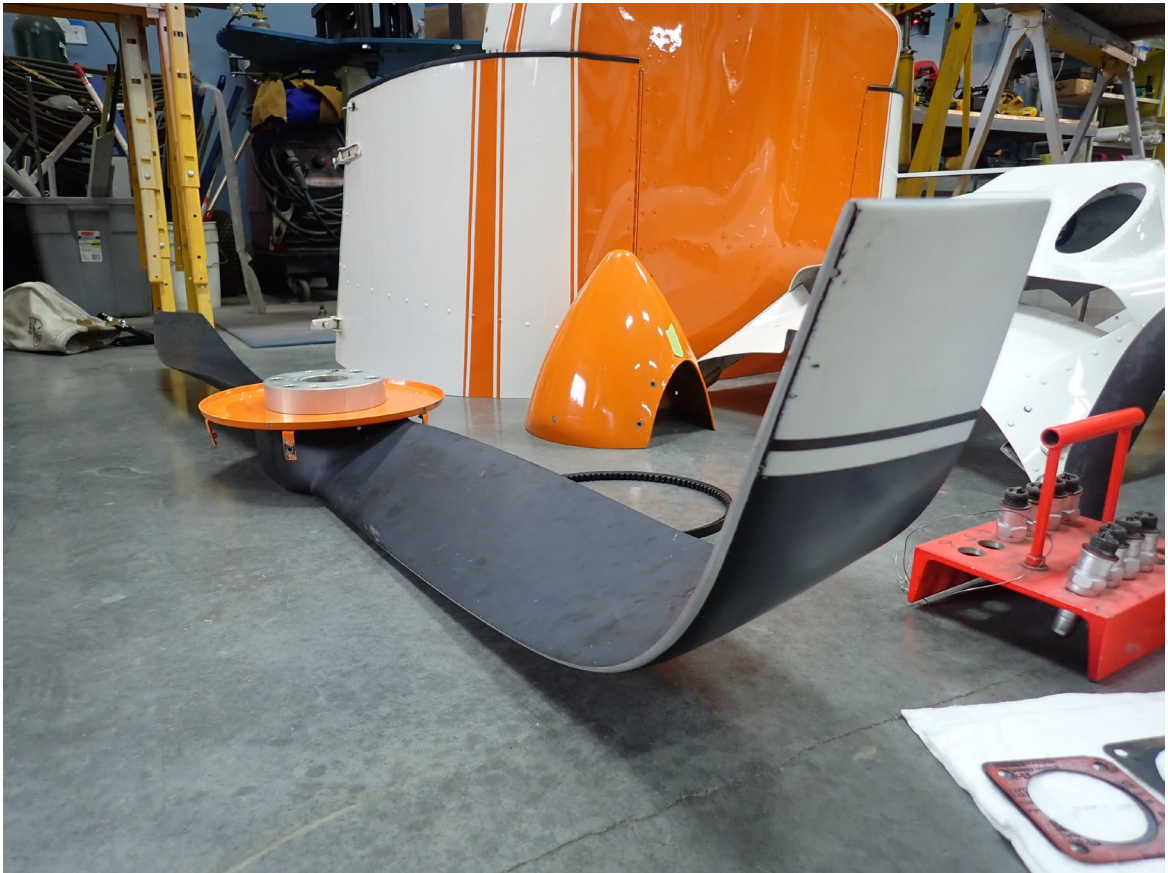
**Figure 4 - Propeller with bent blade tips (NTSB Photo)**

The propeller was removed from the engine prior to the arrival of the investigator at the examination site. The propeller showed deformation in the aft direction on both blade tips.
